Final Reclamation Inspection

Operator: NOBLE ENERGY INC- #100322

API: 05-123-11796

Inspection Photos
Location Name: COX #8-1
API: 05-123-11796

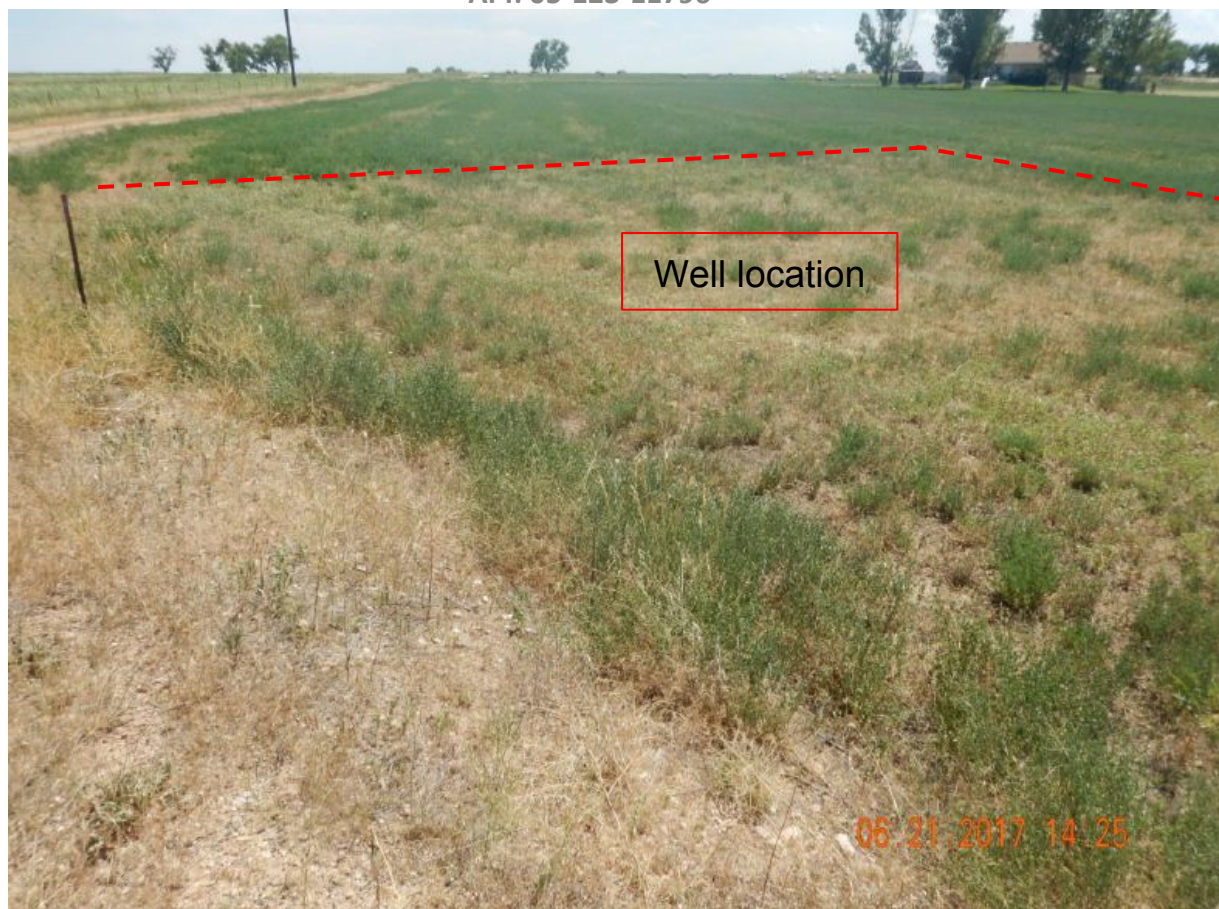
Photo 1. Photo taken on 6/21/2017 from the well location, facing South. Inspection noted vegetation did not appear uniform with reference areas.

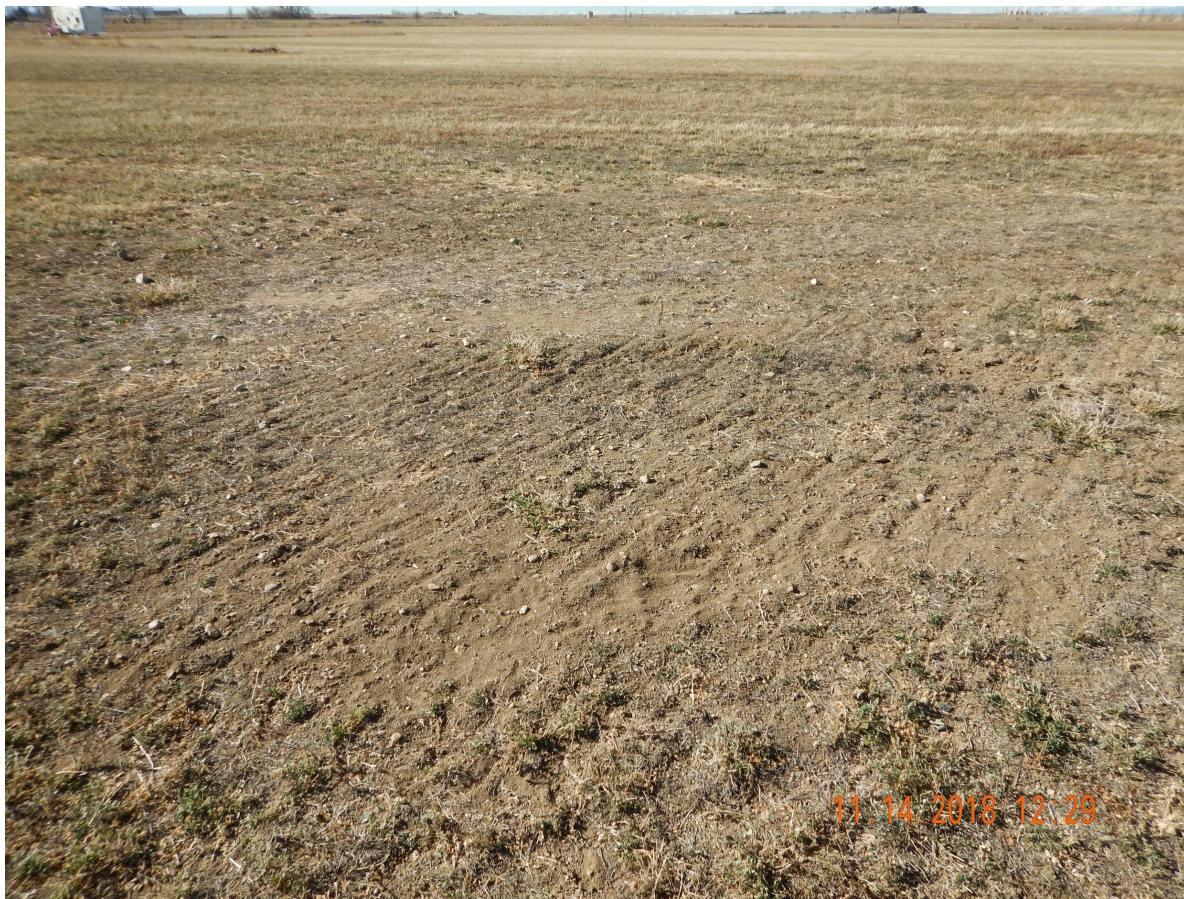
Photo 2. Close-up photo of the well location taken on 11/14/2018, facing West. Well location is not in compliance with Rule 1004 vegetative standards. Little to no establishment of reference area vegetation was observed and gravel did not appear to be properly removed.

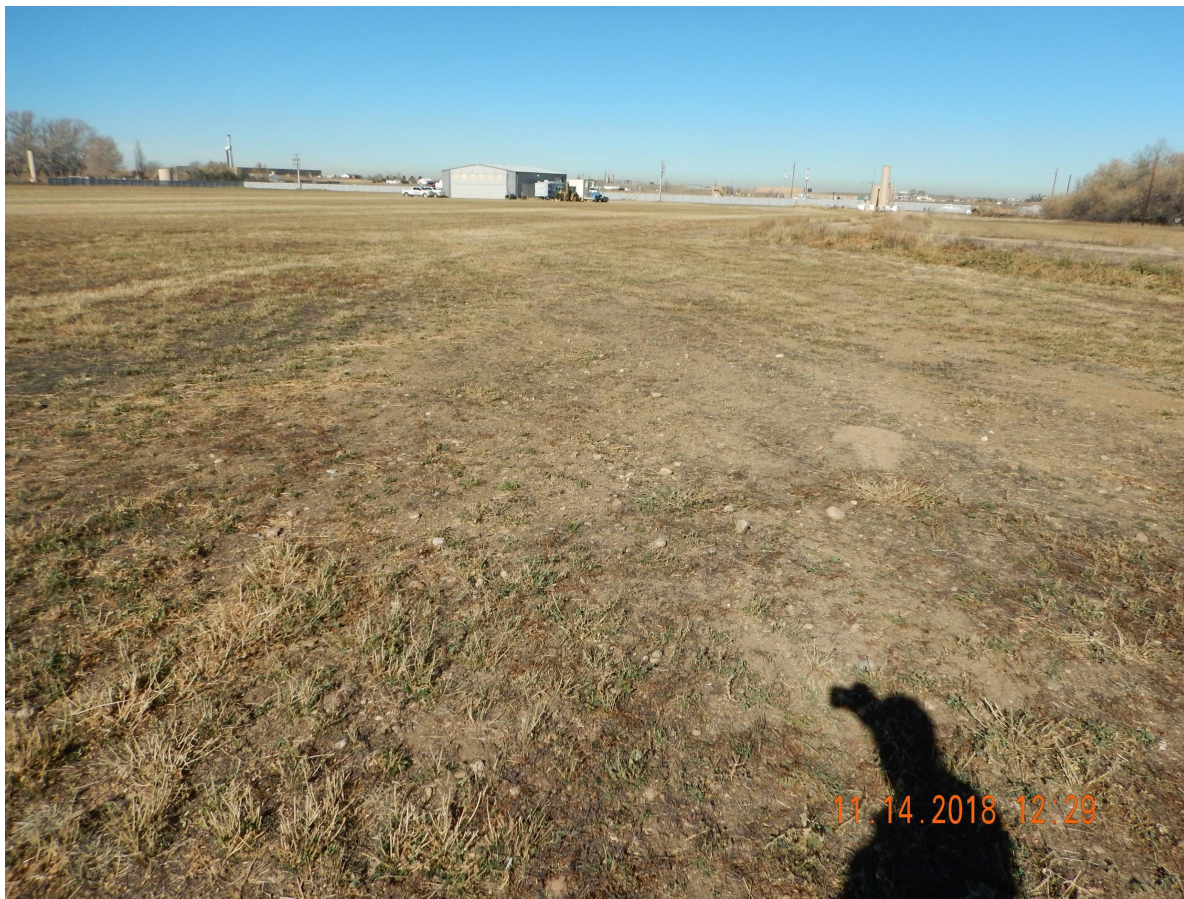
Photo 3. Photo taken from the well location, facing North. See comments under Photo 2.

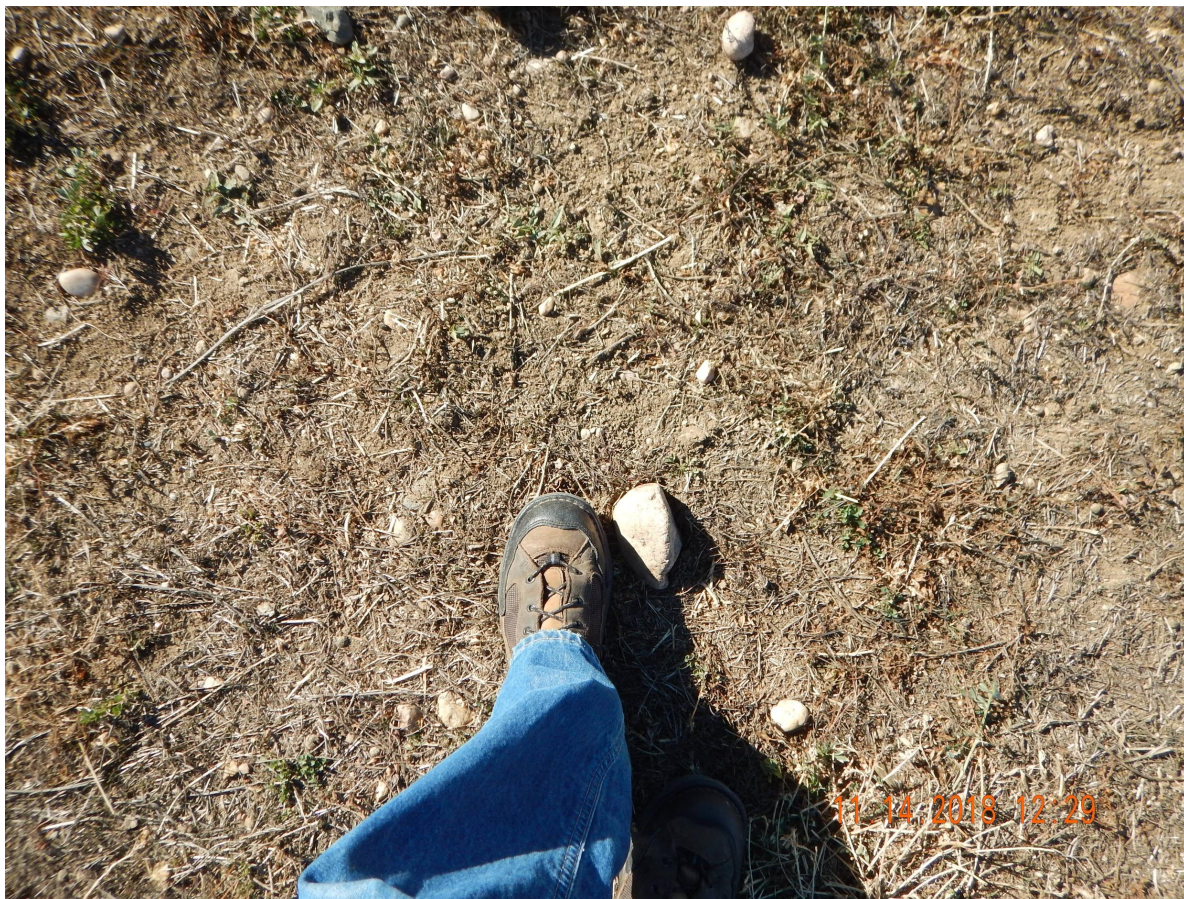
Photo 4. Photo taken from the well location. Photo illustrates the presence of gravel which was not observed in reference areas.

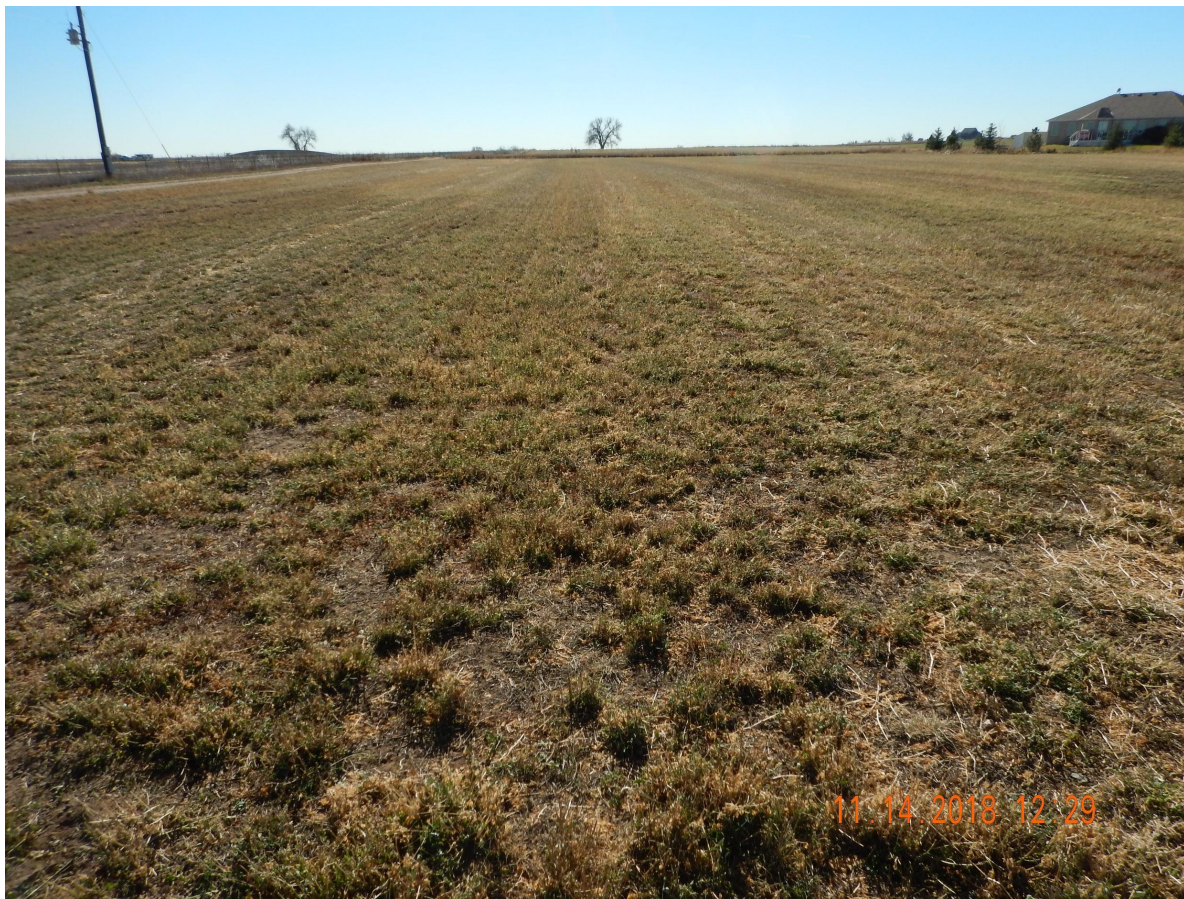
Photo 5. Reference photo taken south of the well location, facing South. Photo illustrates that the well location is not reflective of reference area vegetative levels.
