Inspection Photos

Operator: MARKUS PRODUCTION, INC - 53790

Location ID: 327257

Inspection Doc. Number: 682504191

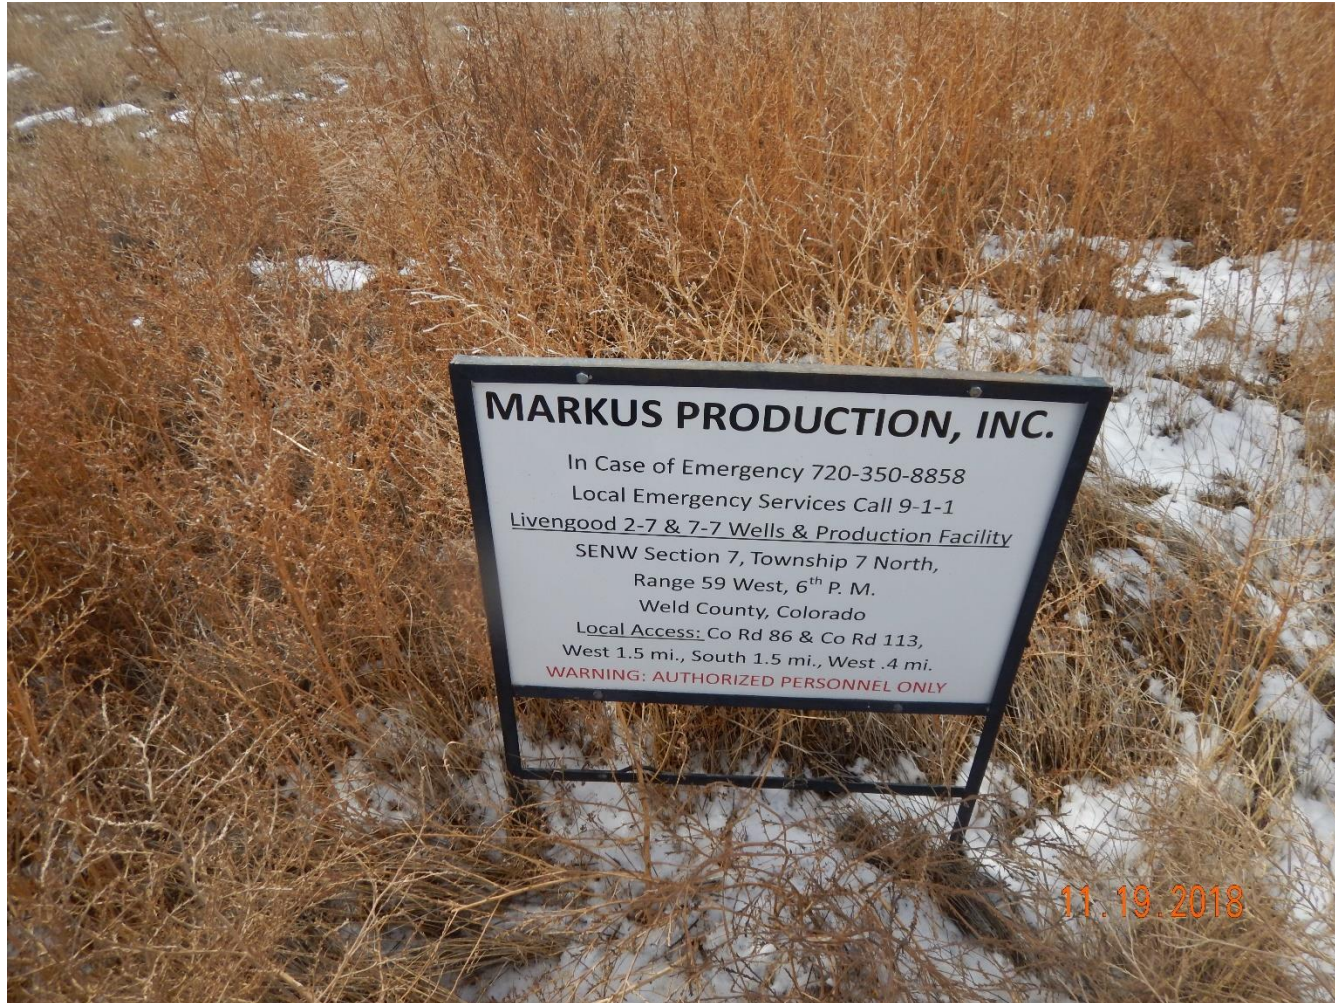
Photo 1: Photo taken from the access road entrance at CR 86 (40.611055°, -104.020340°).

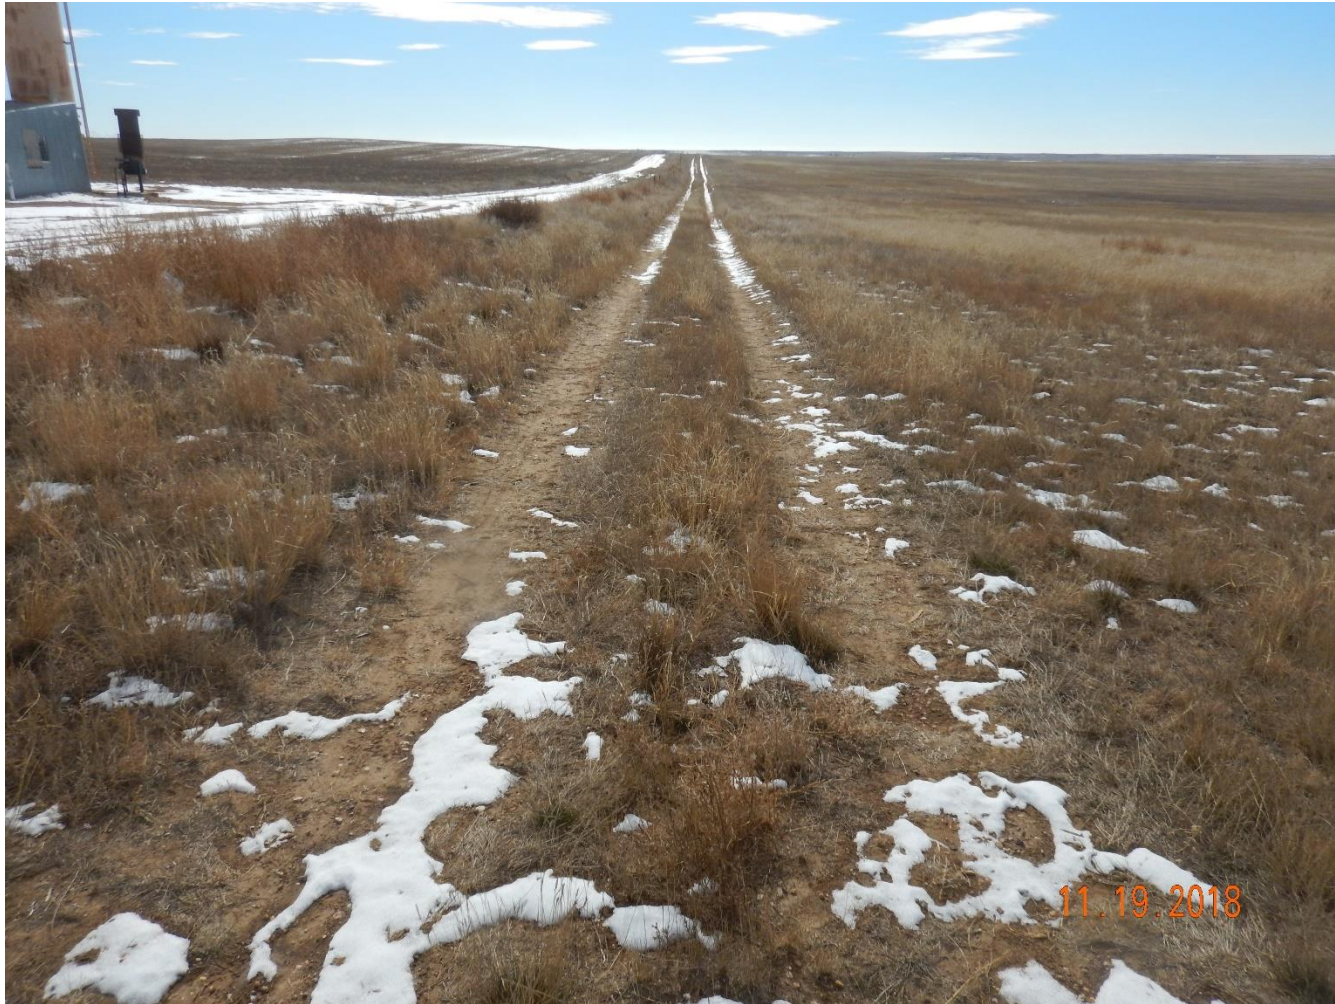
Photo 2: Photo taken from the access road, north of the location, facing south. Photo of access road.

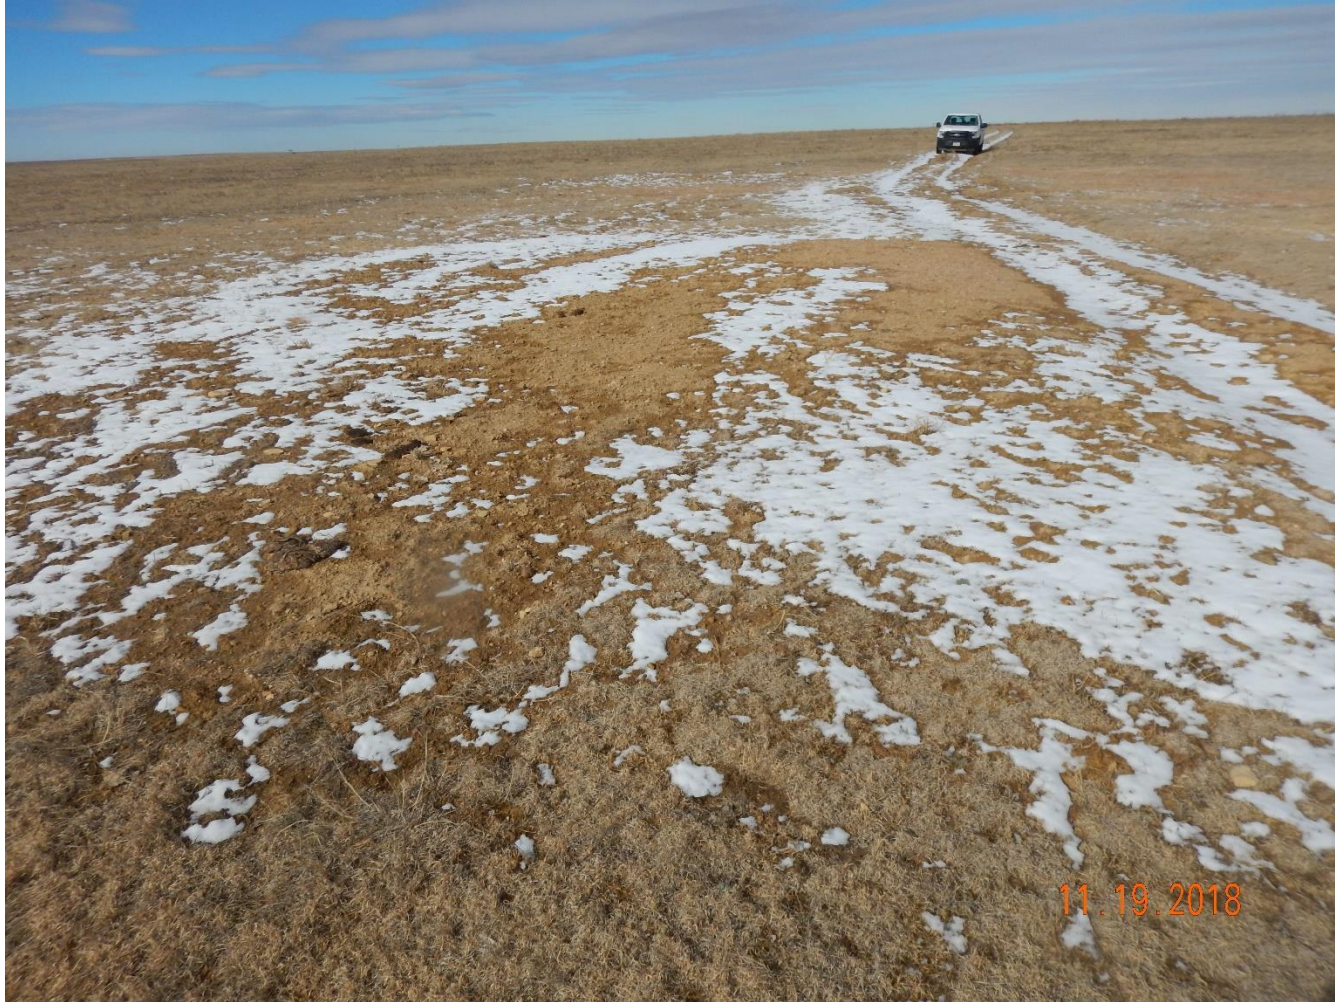
Photo 3: Photo taken from the South end of the location, facing north. Photo shows area of the well that is bare and exposed soil. Well PA 7/5/2017, at least 2 growing seasons have passed; unable to find germination and desirable perennial vegetative establishment at well site

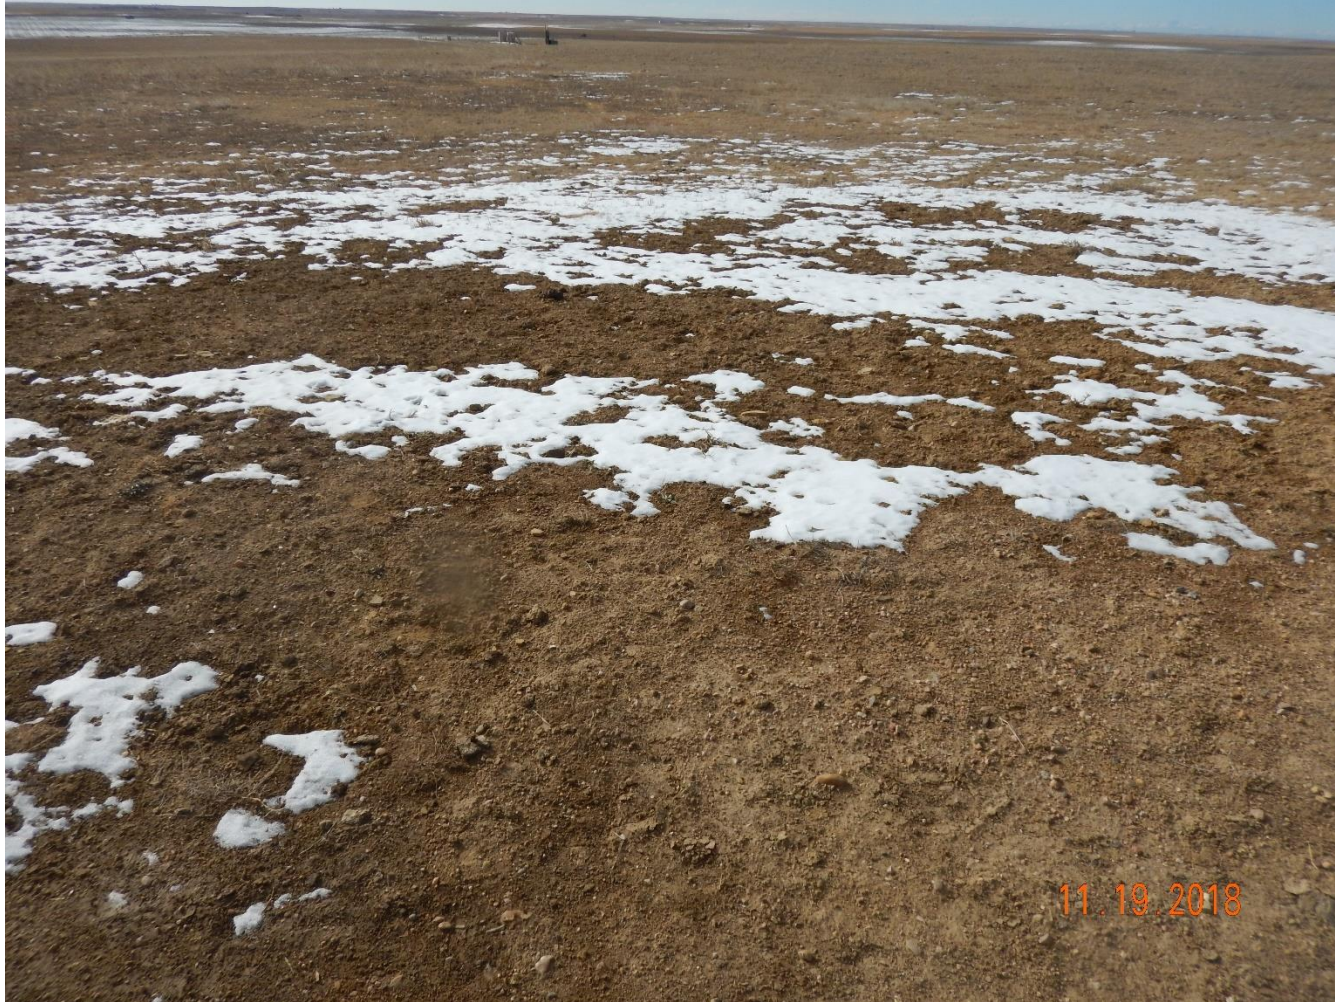
Photo 4: Photo taken from the east end of the well site, facing west. Photo shows area of the well that is bare and exposed soil. Well PA 7/5/2017, at least 2 growing seasons have passed; unable to find germination and desirable perennial vegetative establishment at well site

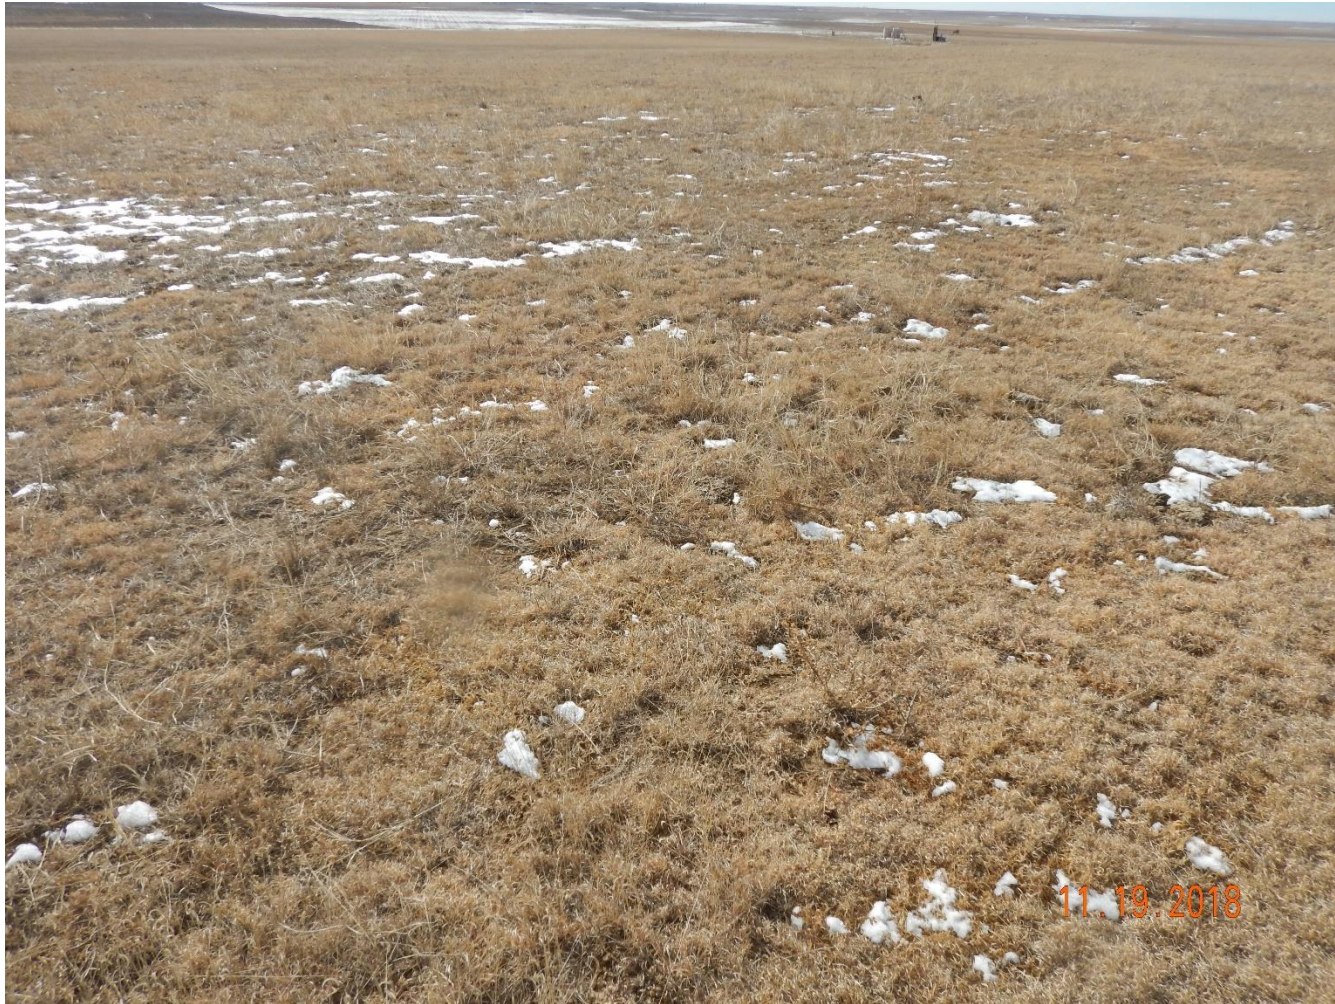
Photo 5: Photo taken from the adjacent reference area. Photo shows vegetation on the reference. Well site is not reflective of the reference area.

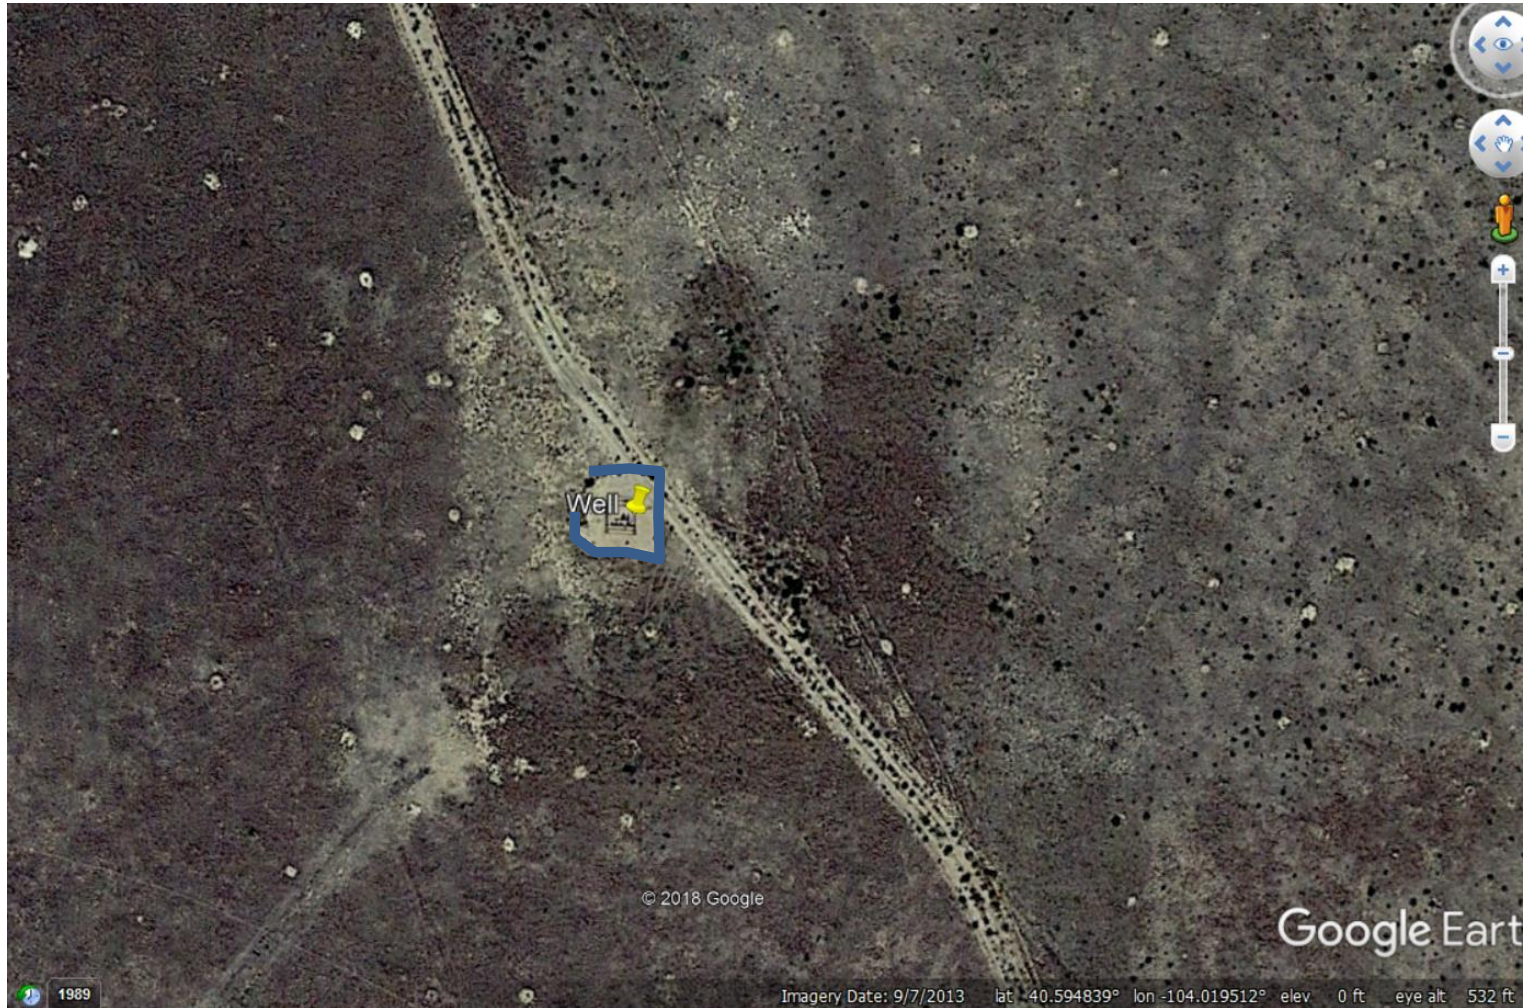
Photo 6: Most recent available (2013) google earth aerial imagery. Photo shows area of the well on the location. Blue outline shows areas where the previous photos show desirable perennial vegetative establishment is not occurring
