Interim Reclamation and Stormwater Inspection

November 28, 2018

Operator: GREAT WESTERN OPERATING COMPANY LLC- #10110

Location ID: 439515

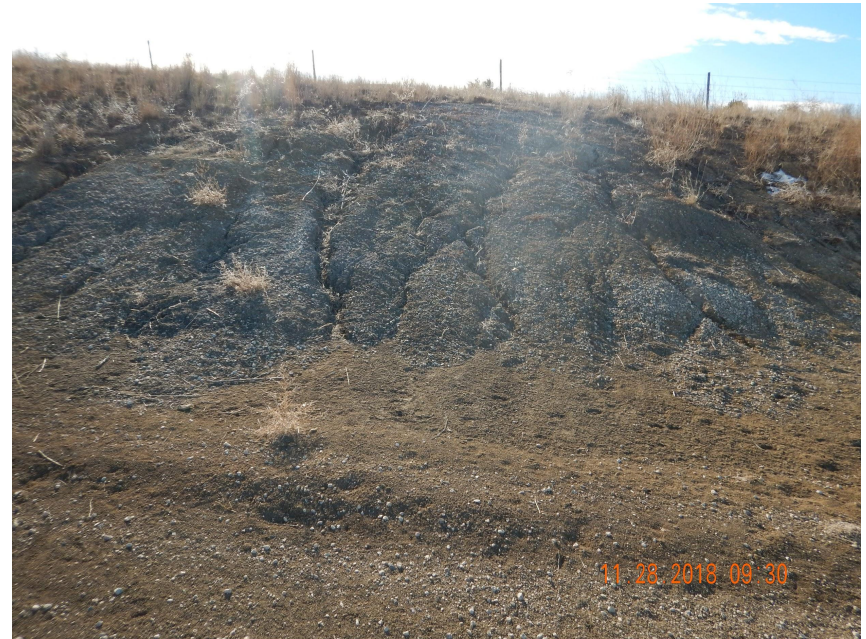
Photo 2. Photo taken from the southwestern cut slope, facing South. Photo illustrates an unstabilized cut slope with the evidence of rill erosion. The entire southern cut slope has not been properly stabilized. This location is not in compliance with Rule 1002 standards.

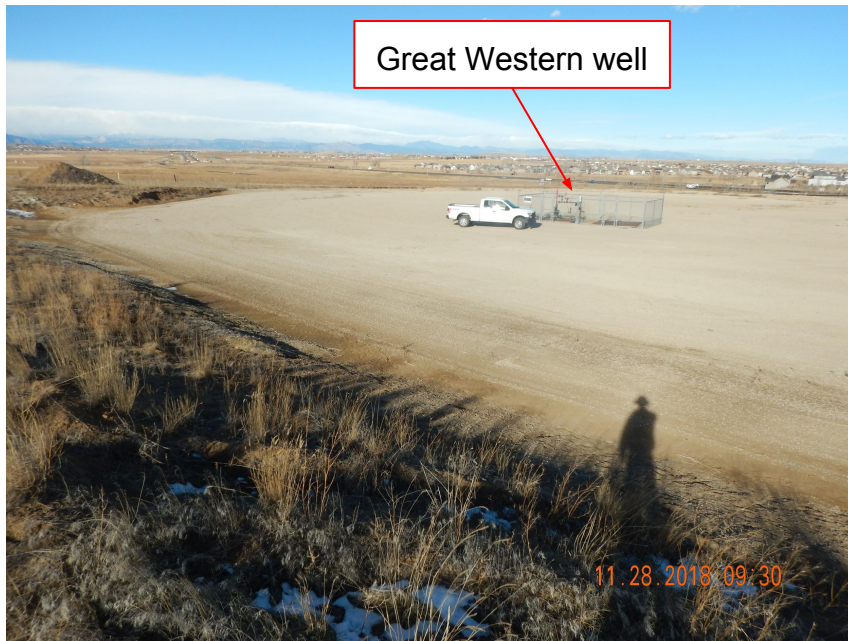
Photo 3. Photo taken from the southern perimeter of the location, facing Northwest. Photo illustrates that interim reclamation has not been performed. This location is not in compliance with Rule 1003 standards.

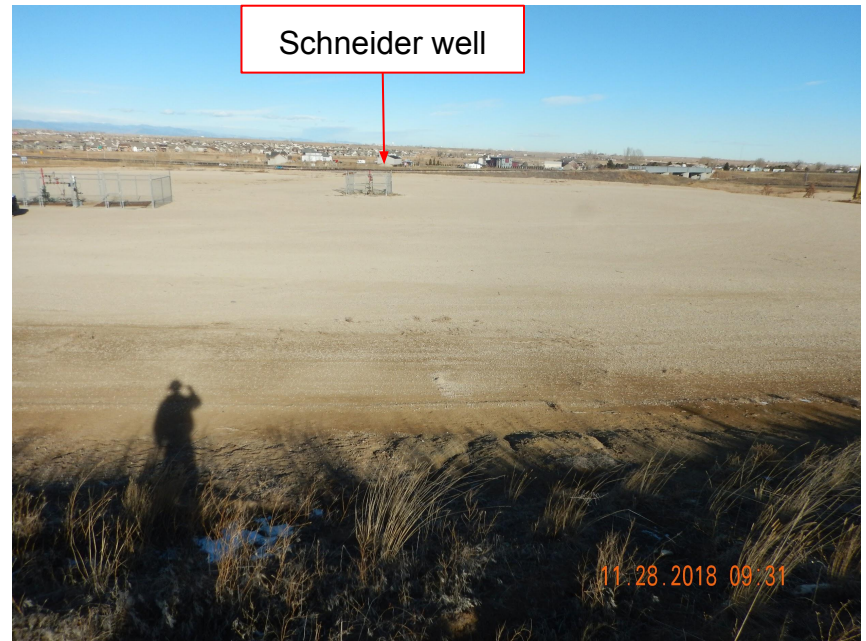
Photo 4. Photo taken from the southern perimeter of the location, facing North. See comments under Photo 3.
