Construction and Stormwater Inspection

Operator: BURLINGTON RESOURCES OIL & GAS LP- #26580

Location ID: 456566

Inspection Photos
Location Name: Fraser 3-64
Location ID: 456566

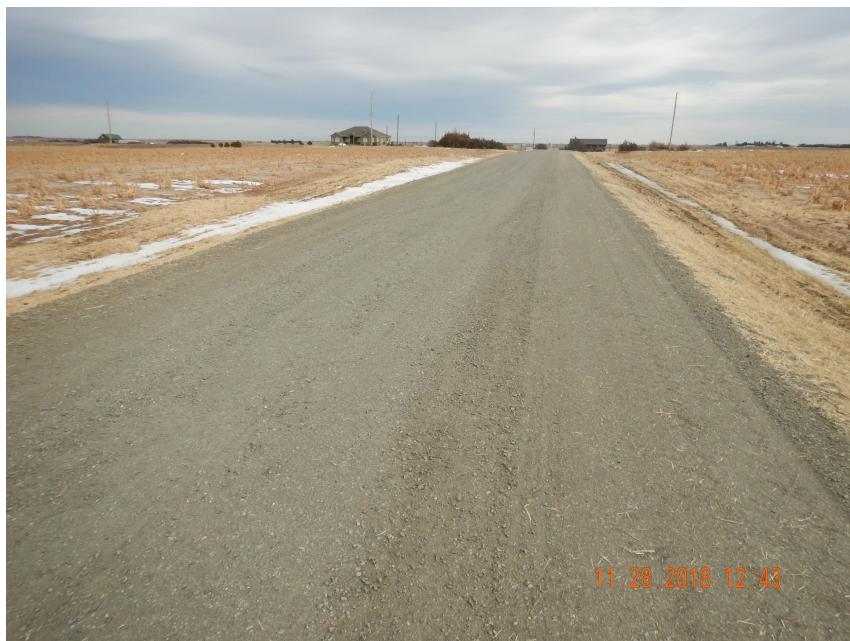
Photo 1. Photo taken from a portion of the main access road, facing East. Photo illustrates the main access road has been stabilized with road base; ditch BMPs have been installed along each side of the main access road which has been stabilized with straw crimped mulch and seeded.

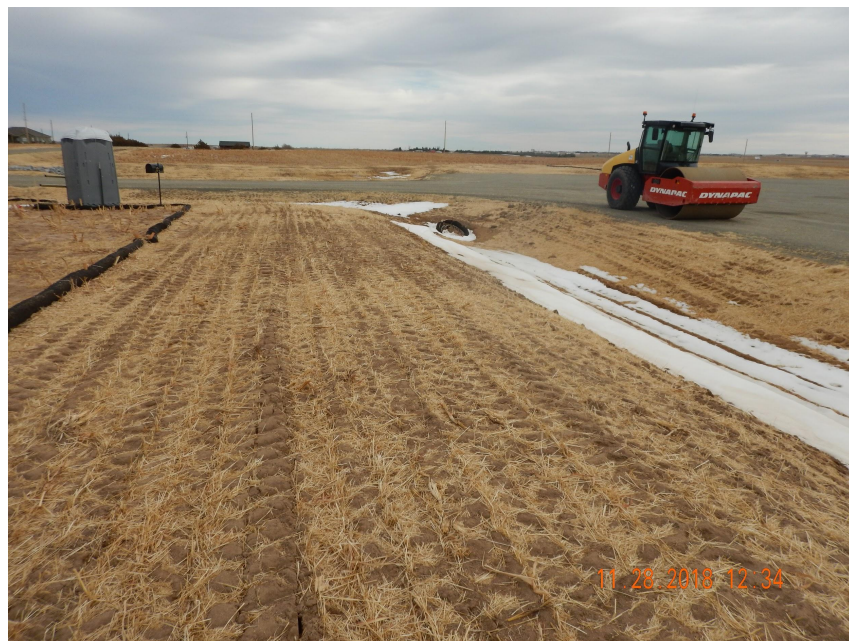
Photo 2. Photo taken from the northern perimeter of the location, facing East. Photo illustrates stormwater BMPs (filtrex wattles and ditch) have been installed and stabilized with straw crimped mulch and seeded. Ditch BMP has been installed around the entire perimeter of the location which is directed to a stabilized sediment trap.

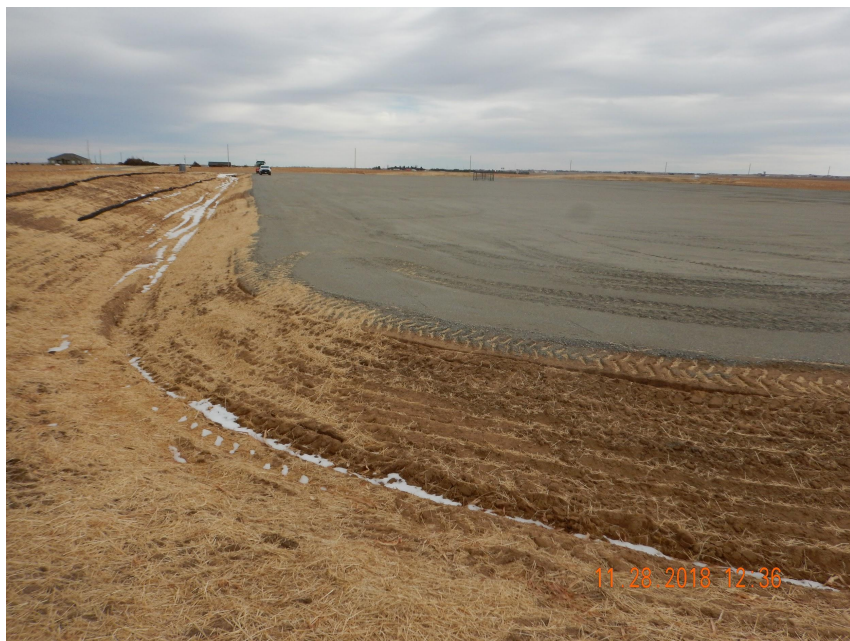
Photo 3. Photo taken of the northwest perimeter of the location, facing East. See comments under Photo 2. Photo also illustrates the entire well pad has been stabilized.

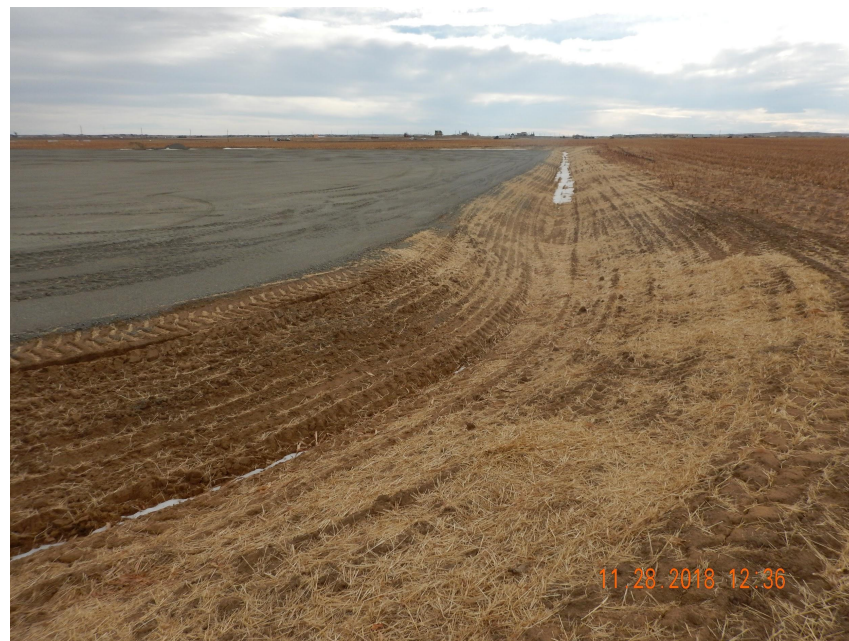
Photo 4. Photo taken from the northwest perimeter of the location, facing South. See comments under Photo 2 and 3.

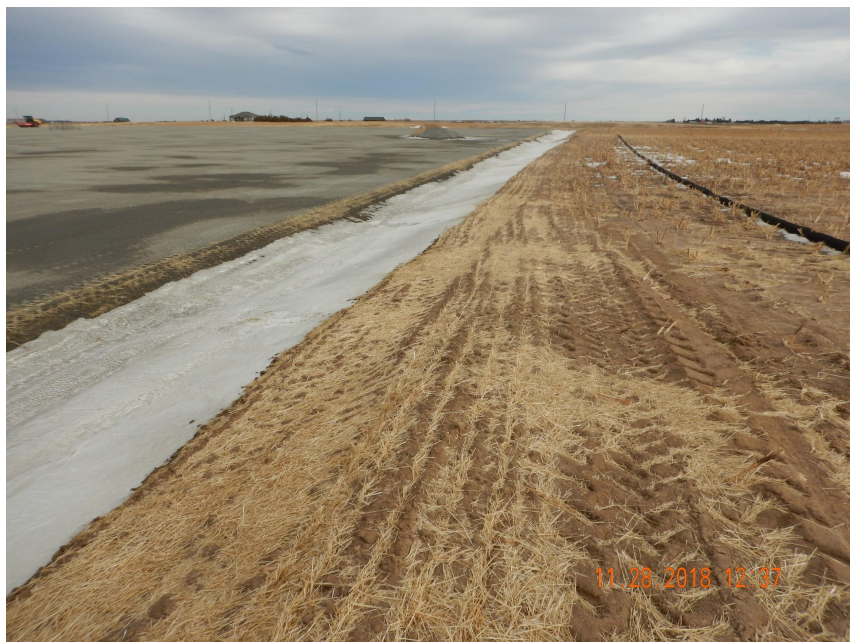
Photo 5. Photo taken from the southwest perimeter of the location, facing East. See comments under Photo 2.

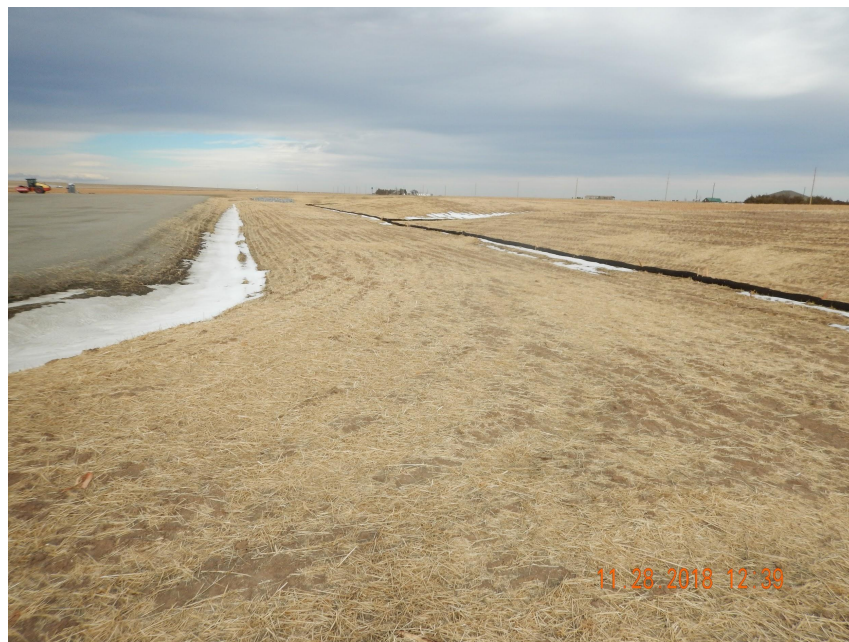
Photo 6. Photo taken from the southeastern perimeter of the location, facing North. See comments under Photo 2.

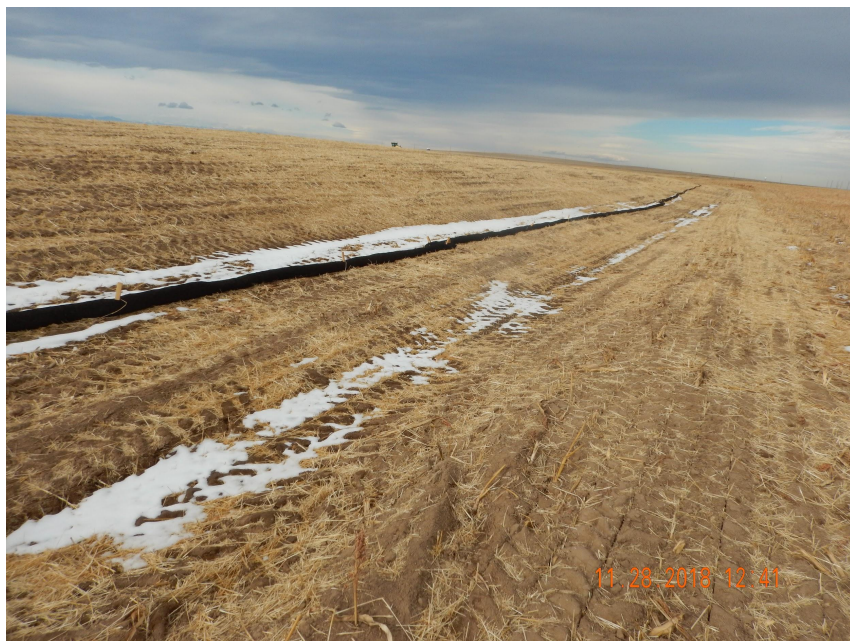
Photo 7. Photo taken from the southeastern perimeter of the location, facing North. Photo illustrates the topsoil stockpile that has been stored along the eastern perimeter of the location. Stockpile has been stabilized with straw crimped mulch and seeded with filter wattle installed along the base of the stockpile.

Photo 8. Photo taken from the eastern perimeter of the location, facing North. See comments under Photo 2 and 7.

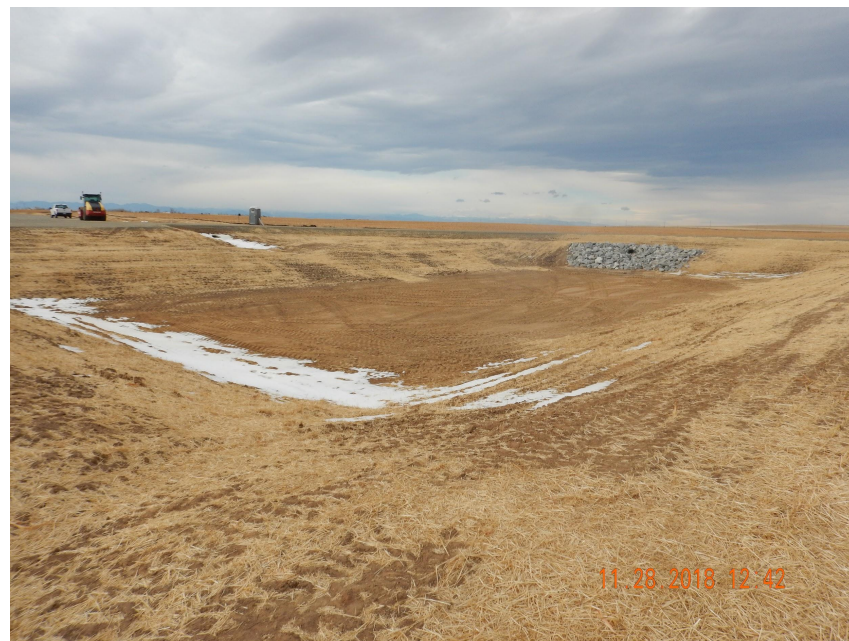
Photo 9. Photo taken from the northeastern perimeter of the location, facing Northwest. Photo illustrates a sediment trap installed with a stabilized outlet.
