Final Reclamation Inspection

Operator: CONOCO PHILLIPS COMPANY- #19160

Location ID: 430595

Location Name: State of Colorado 36 /1

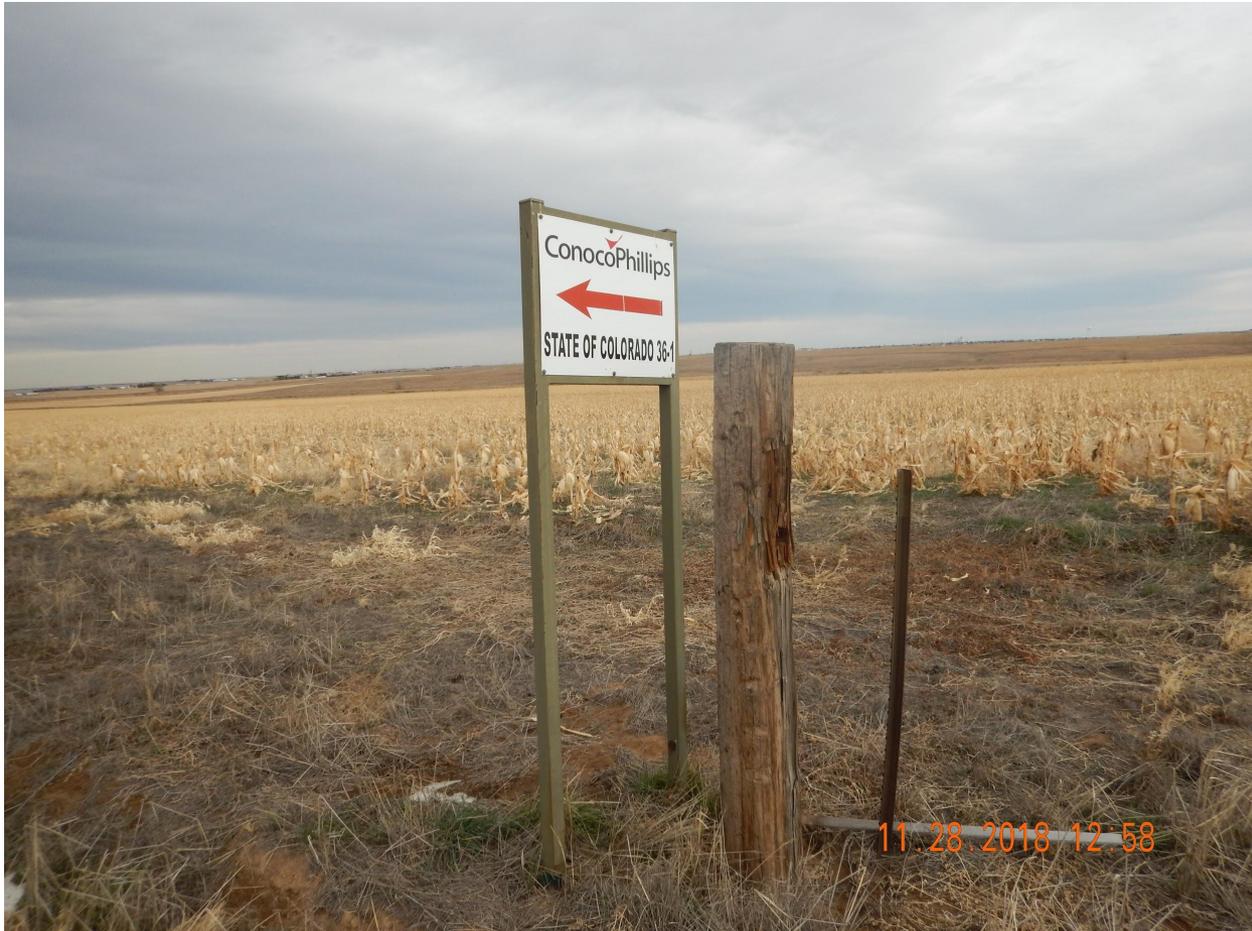
Photo 1. Photo taken from Schumaker Road, facing East. Operator shall remove the Operator sign.

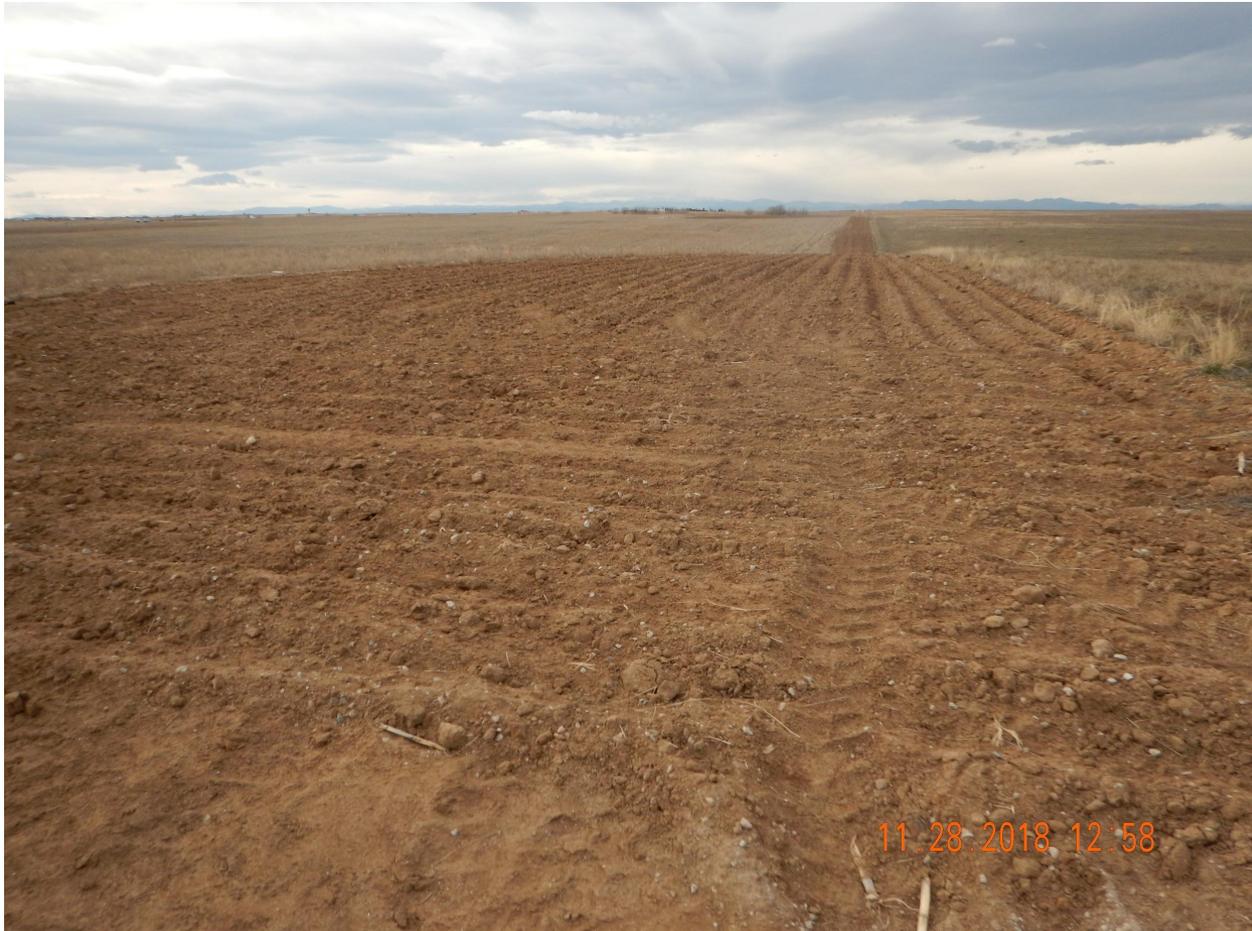
Photo 2. Photo taken south of the well location access road, facing West. It does not appear the access road was cross-rippled. COGCC Staff did not perform a decompaction test but the Operator should have cross-rippled to a depth of 18 inches.

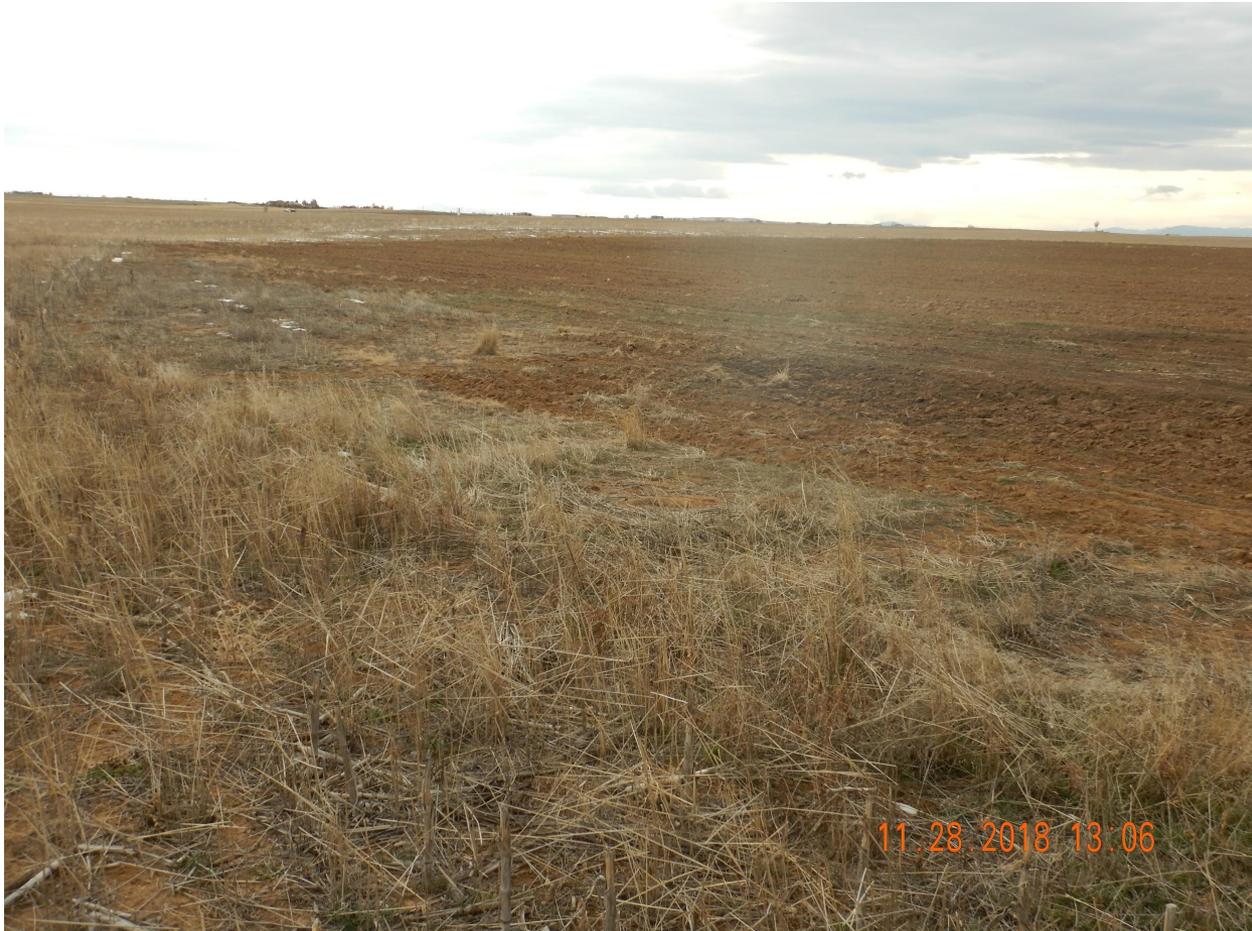
Photo 3. Photo taken from the eastern well location, facing Southwest. No equipment was observed at the location. It is unclear whether or not the location was cross-ripped. It appears the location was only ripped one way. Operator may be required to perform additional reclamation activities (i.e., decompaction) if vegetation does not meet Rule 1004 standards.

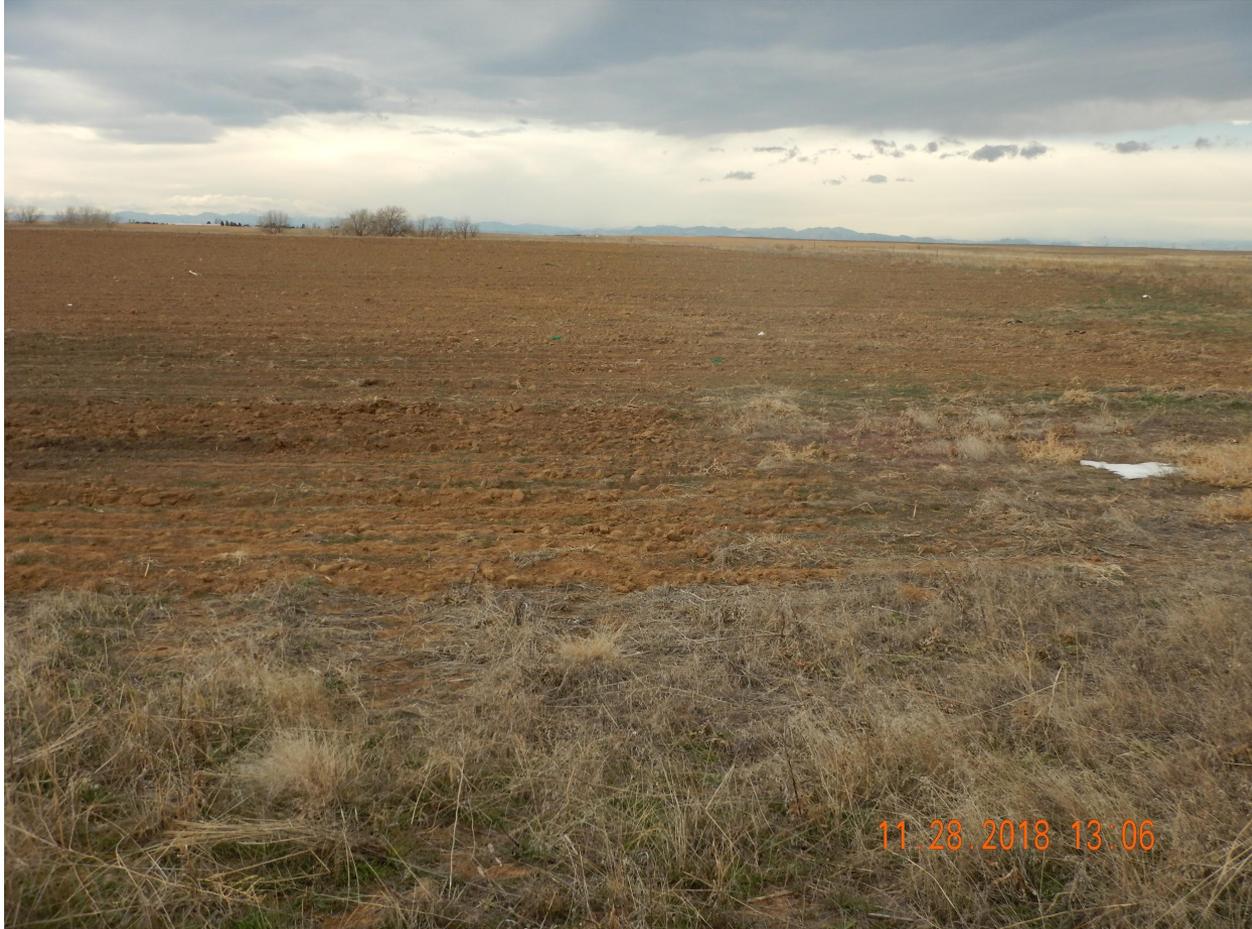
Photo 4. Photo taken from the eastern well location, facing West. See comments under Photo 3.
