**FIGURE 2**  
GROUNDWATER ELEVATION CONTOUR MAP  
HSR-DREYER 5-5  
SWNW SEC 5-T1S-R65W  
ADAMS COUNTY, COLORADO  
KERR-MCGEE OIL & GAS ONSHORE LP

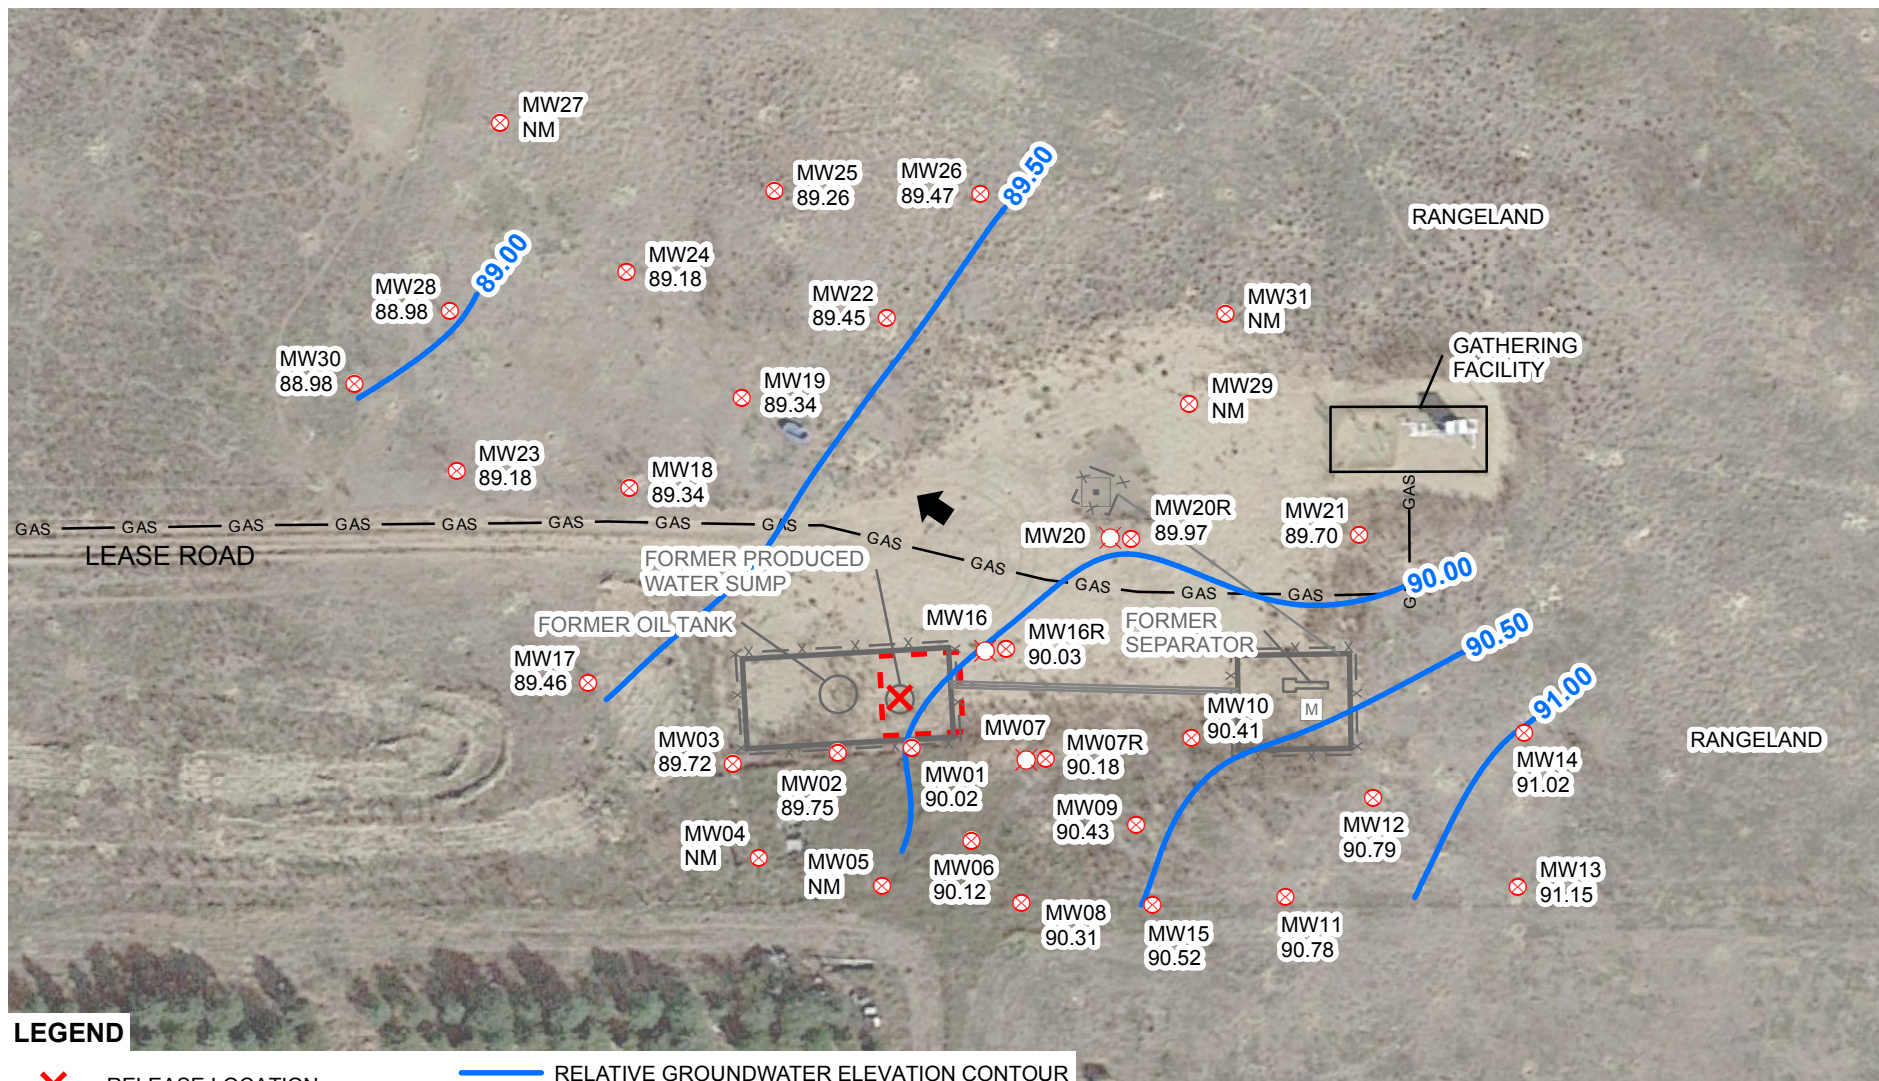
GROUNDWATER ELEVATIONS WERE MEASURED ON SEPTEMBER 13, 2018.  
NM: NOT MEASURED
