# Inspection Photos

Operator: RED HAWK PETROLEUM LLC - 10503

Location ID: 438327

Inspection Doc. Number: 682504182

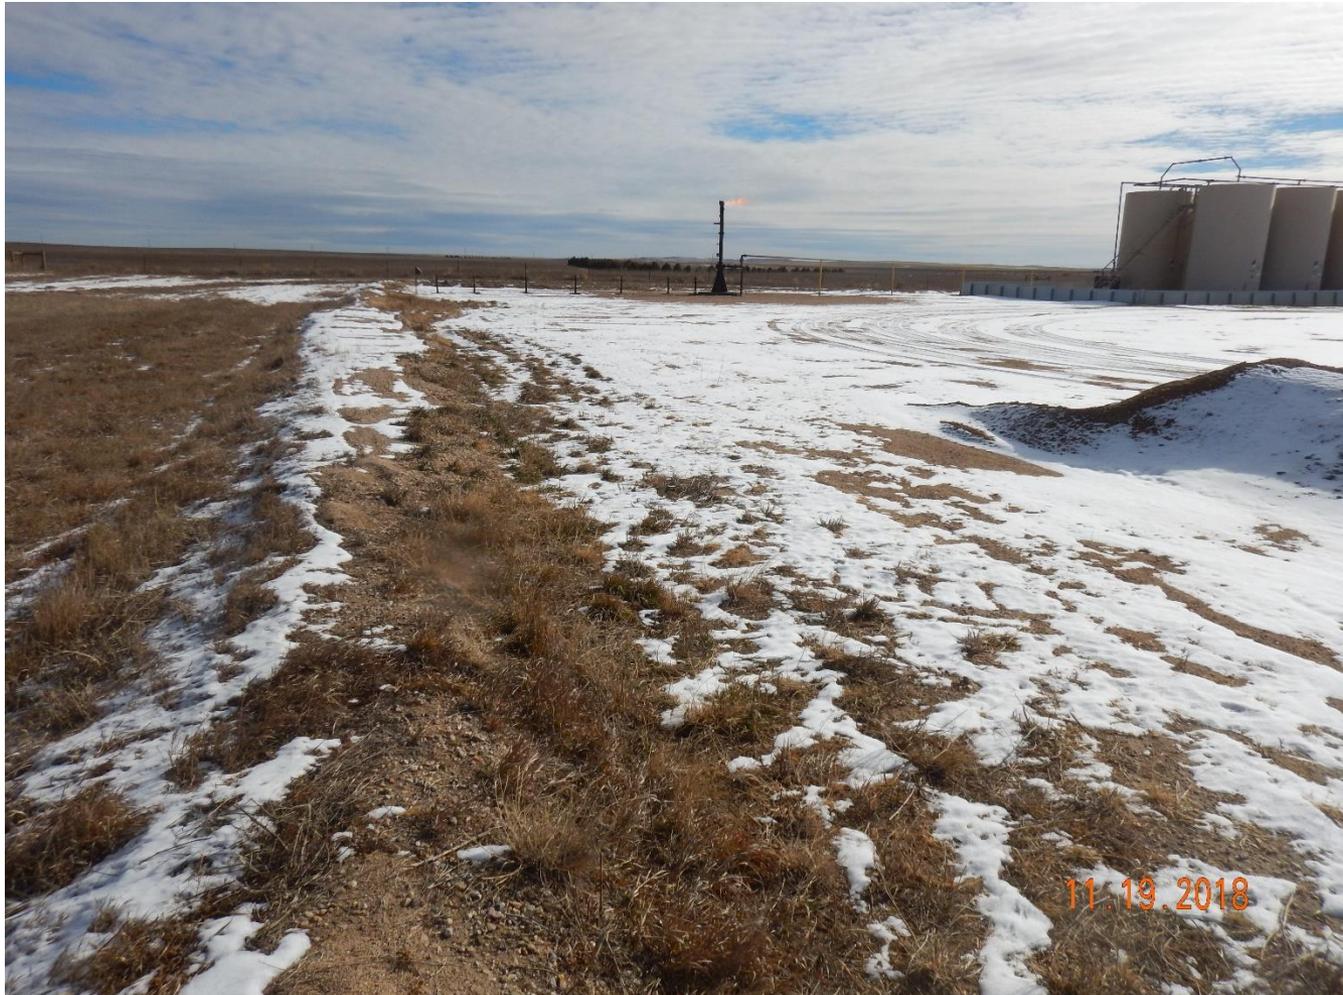
**Photo 1:** Photo taken from the north end of the location, facing east. Photos 1-4 provide an overview of the location from east, southeast, southwest, to west.

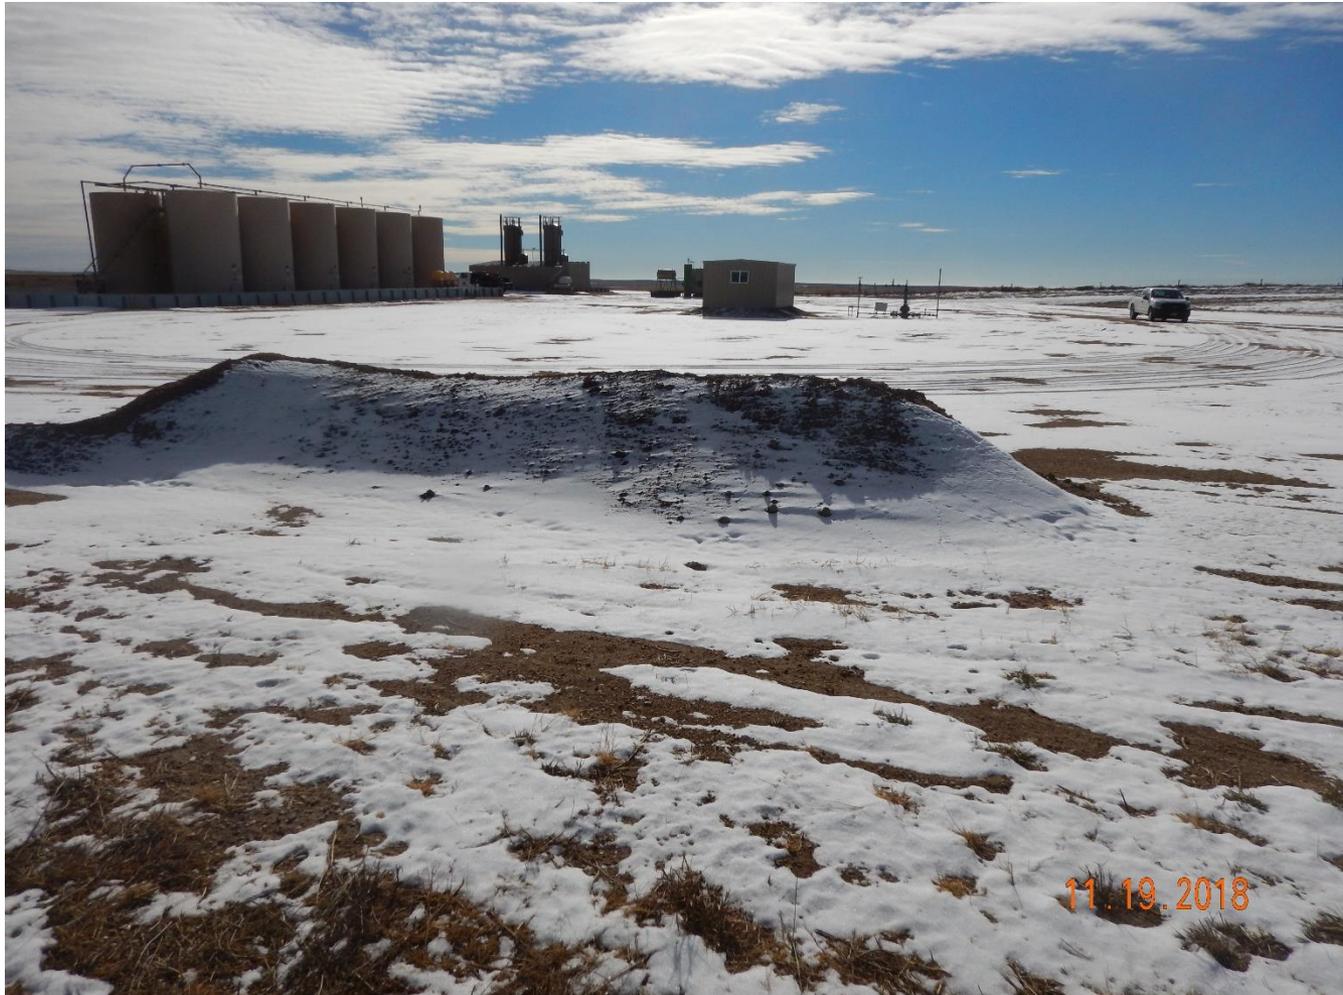
**Photo 2:** See comments under photo 1.

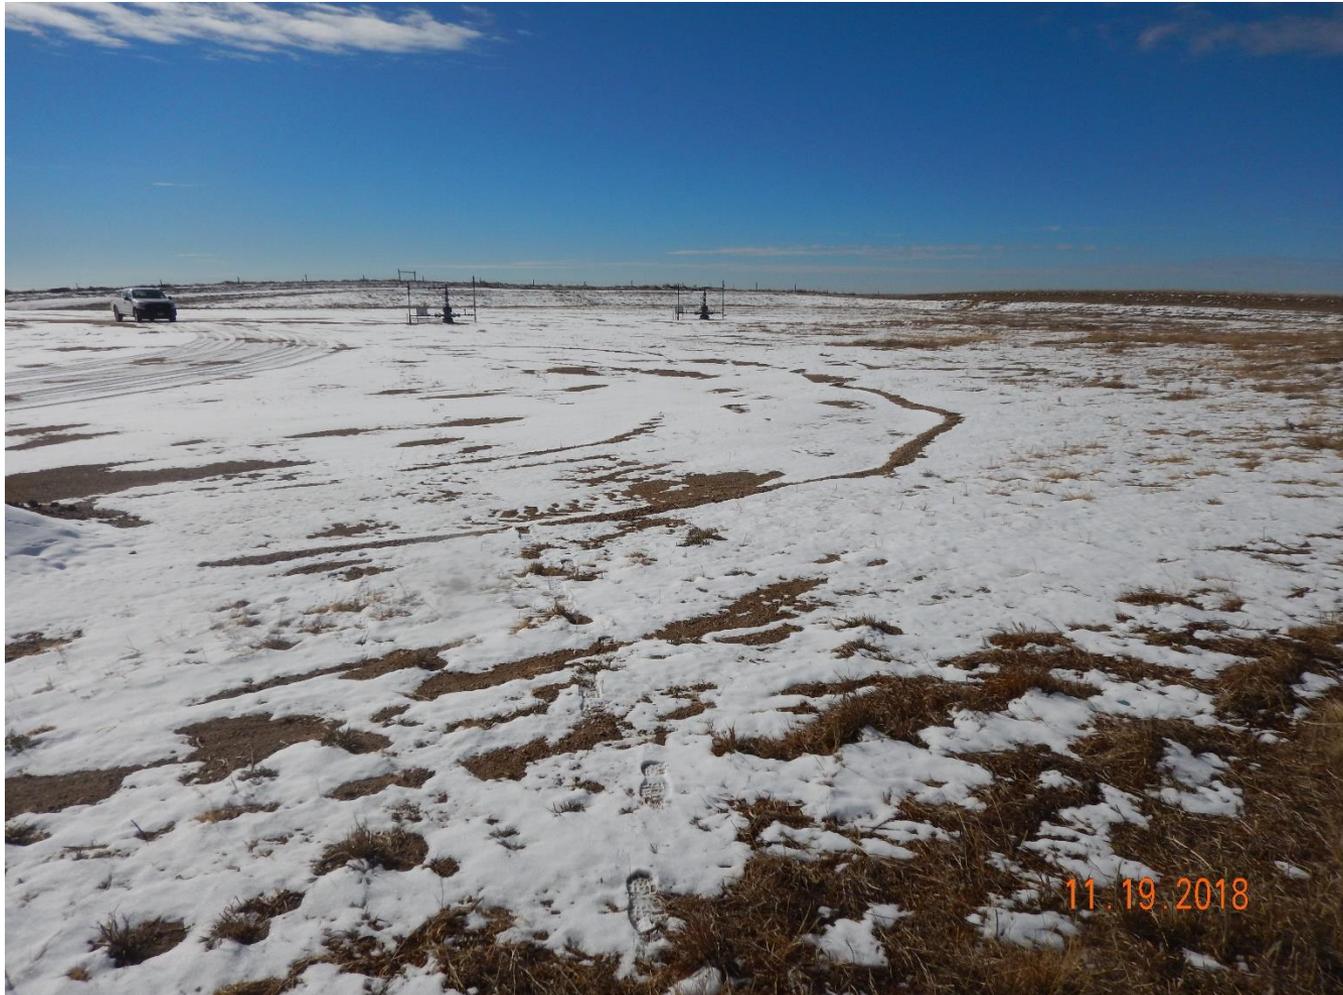
**Photo 3:** See comments under photo 1. Photo also shows no additional interim reclamation activities appear to have been conducted on the west end of the location; location has not been reduced in size.

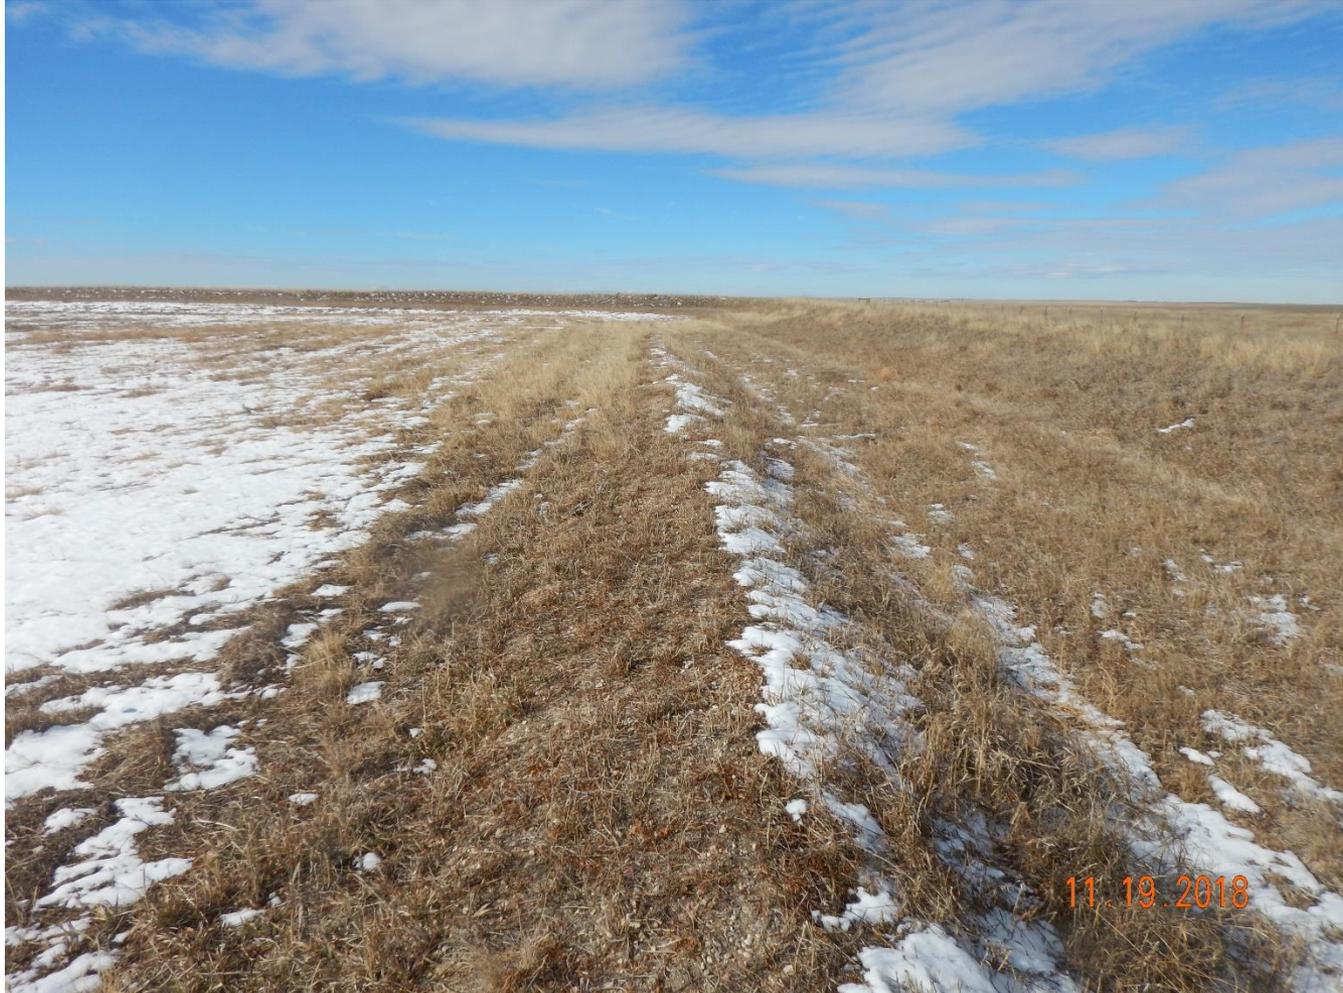
**Photo 4:** See comments under photo 1. Photo also shows no additional interim reclamation activities appear to have been conducted on the west end of the location; location has not been reduced in size.

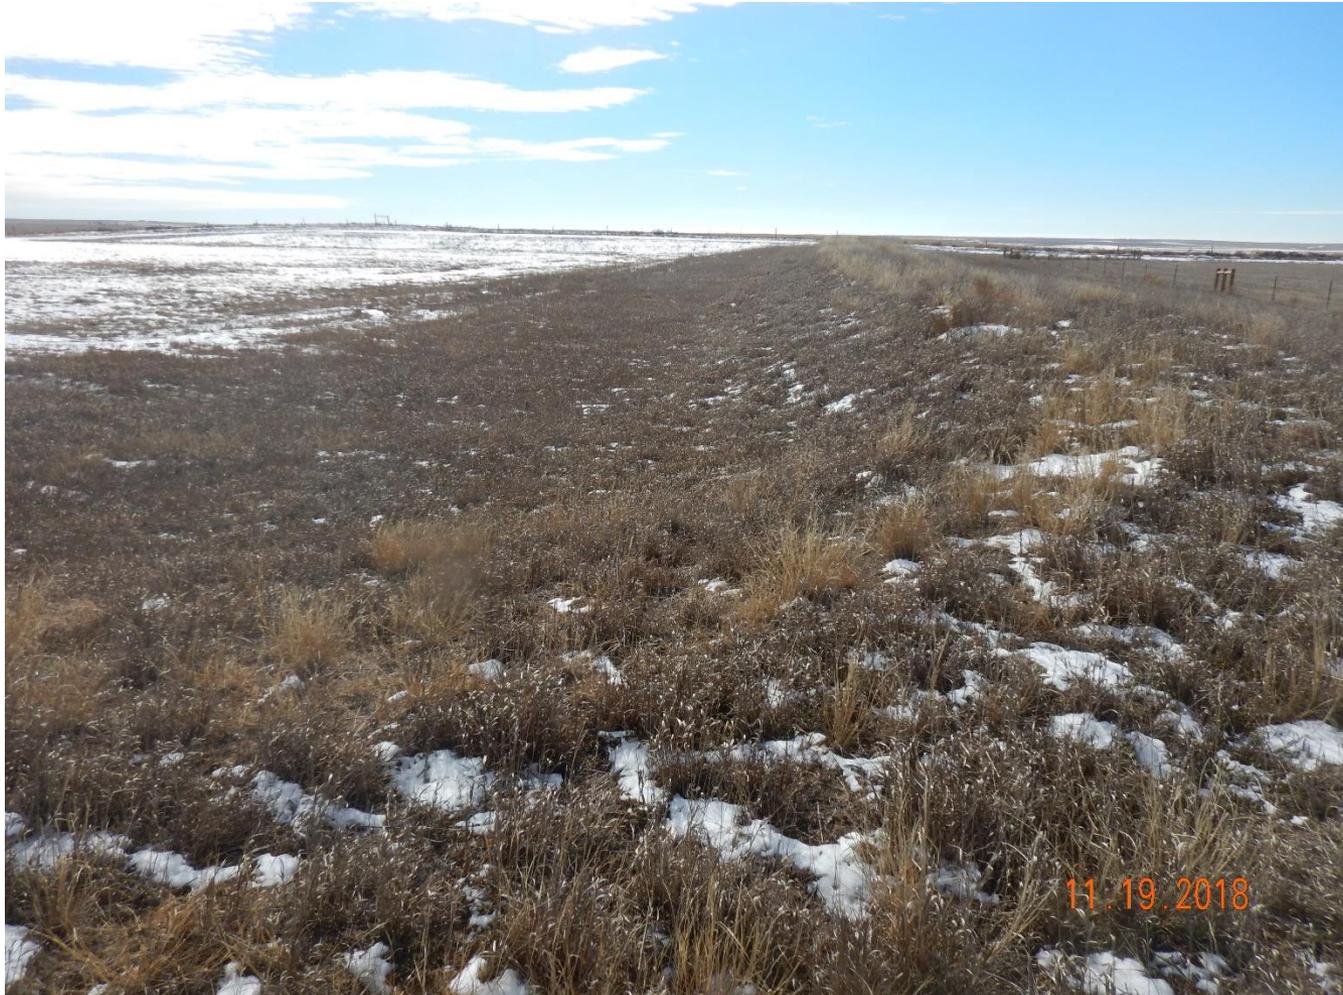
**Photo 5:** Photo taken from the northwestern end of the location, facing south. Photo shows no additional interim reclamation activities appear to have been conducted on areas not needed for production; location has not been reduced in size.

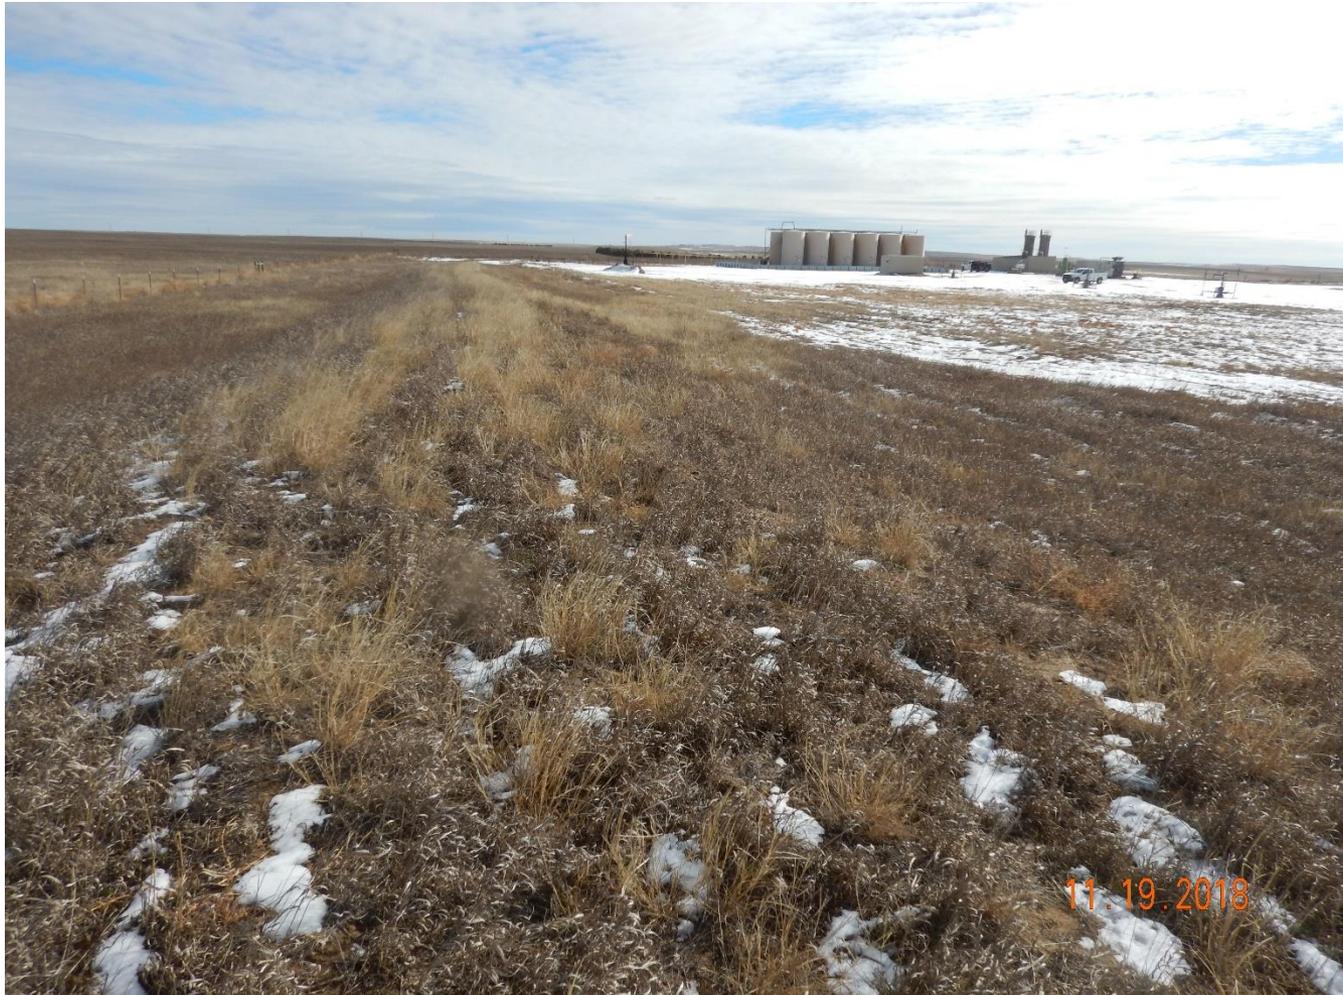
**Photo 6:** Photo taken from the northwestern end of the location, facing east. Photo shows no additional interim reclamation activities appear to have been conducted on areas not needed for production; location has not been reduced in size.

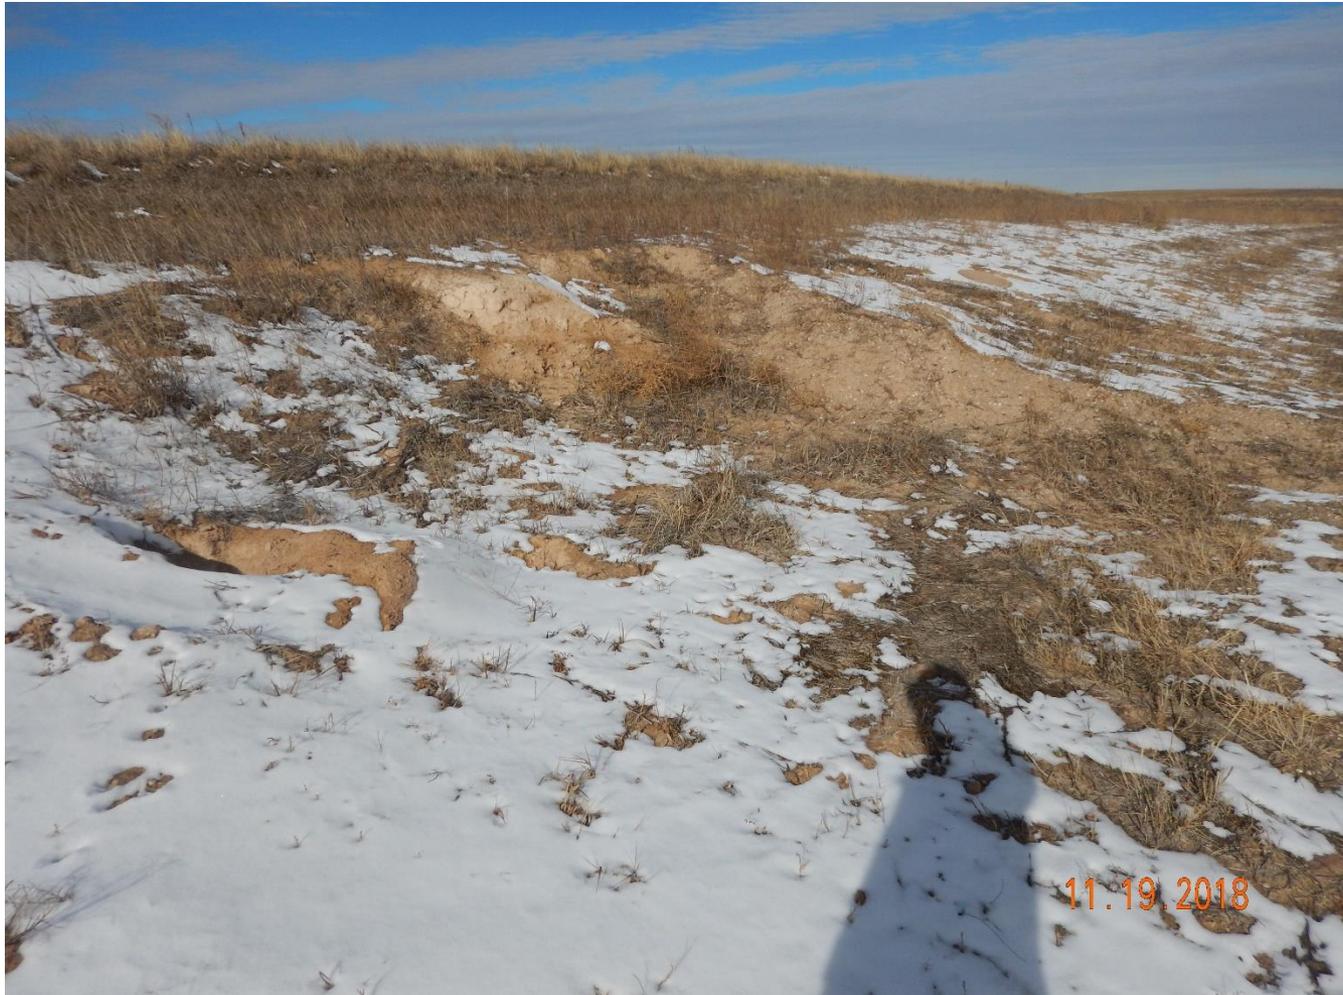
**Photo 7:** Photo taken from the west end of the location. Photo shows erosion degradation that has not been mitigated.

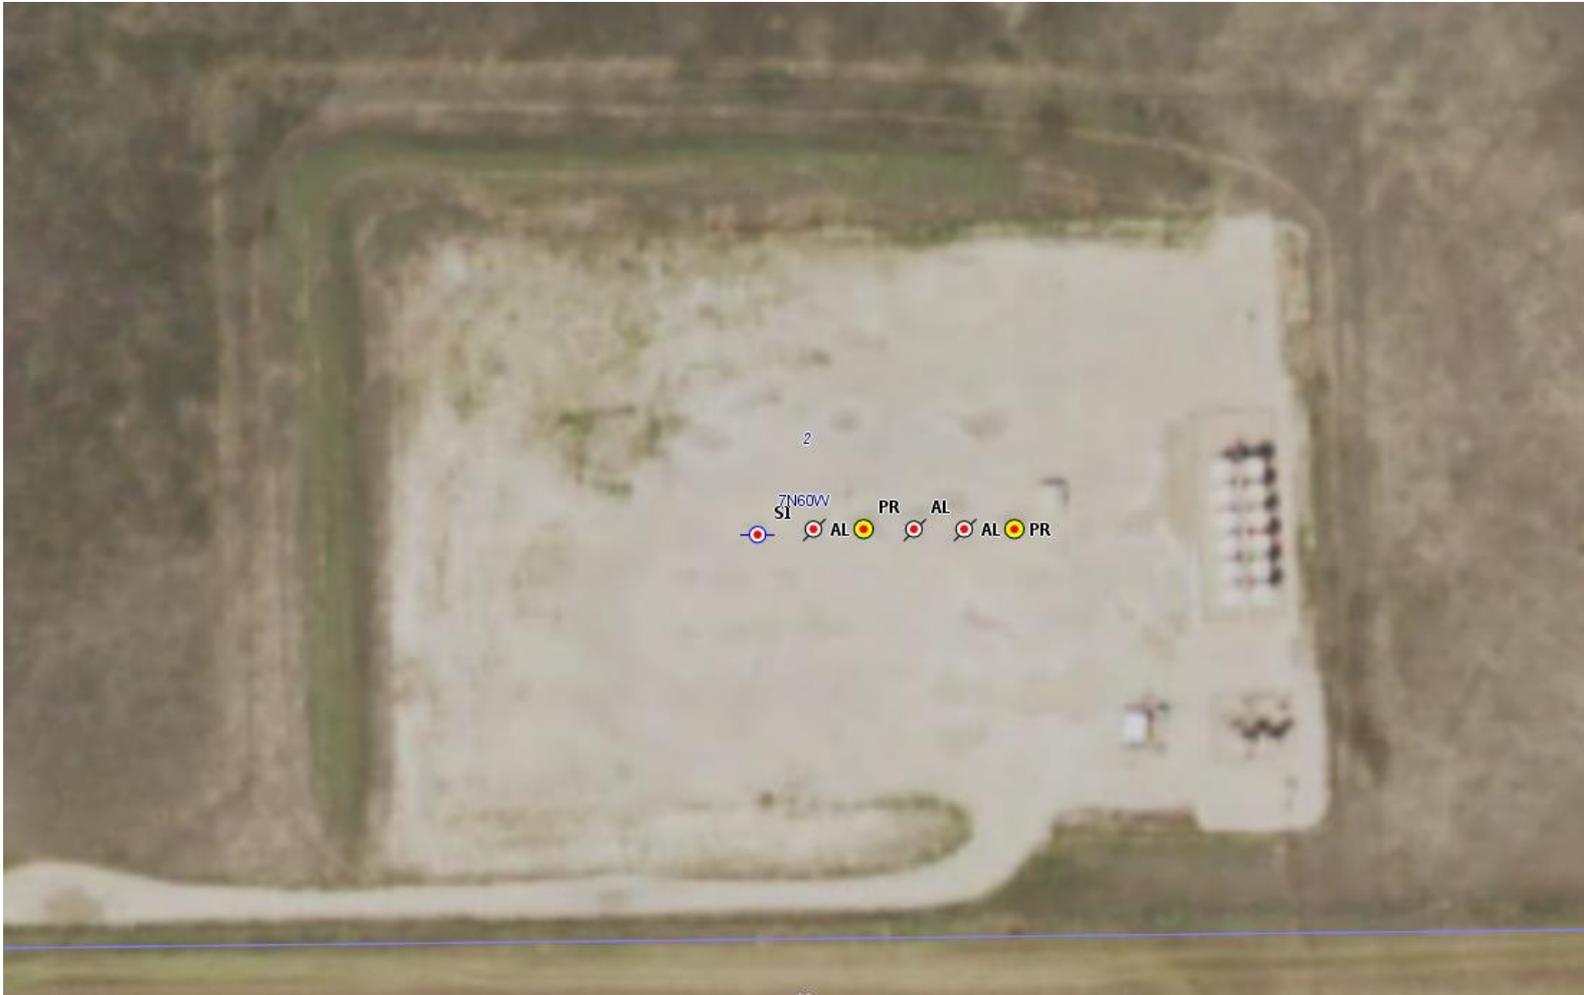
**Photo 8:** 2017 COGIS aerial imagery. Photo shows areas on the west end of the location that do not appear to be necessary for production operations. These areas need to be reclaimed in accordance with COGCC 1003 interim reclamation requirements.
