Final Reclamation Inspection

API: 05-123-31630

Weld County, CO

Location Name: STATE 16-9-66 #1H

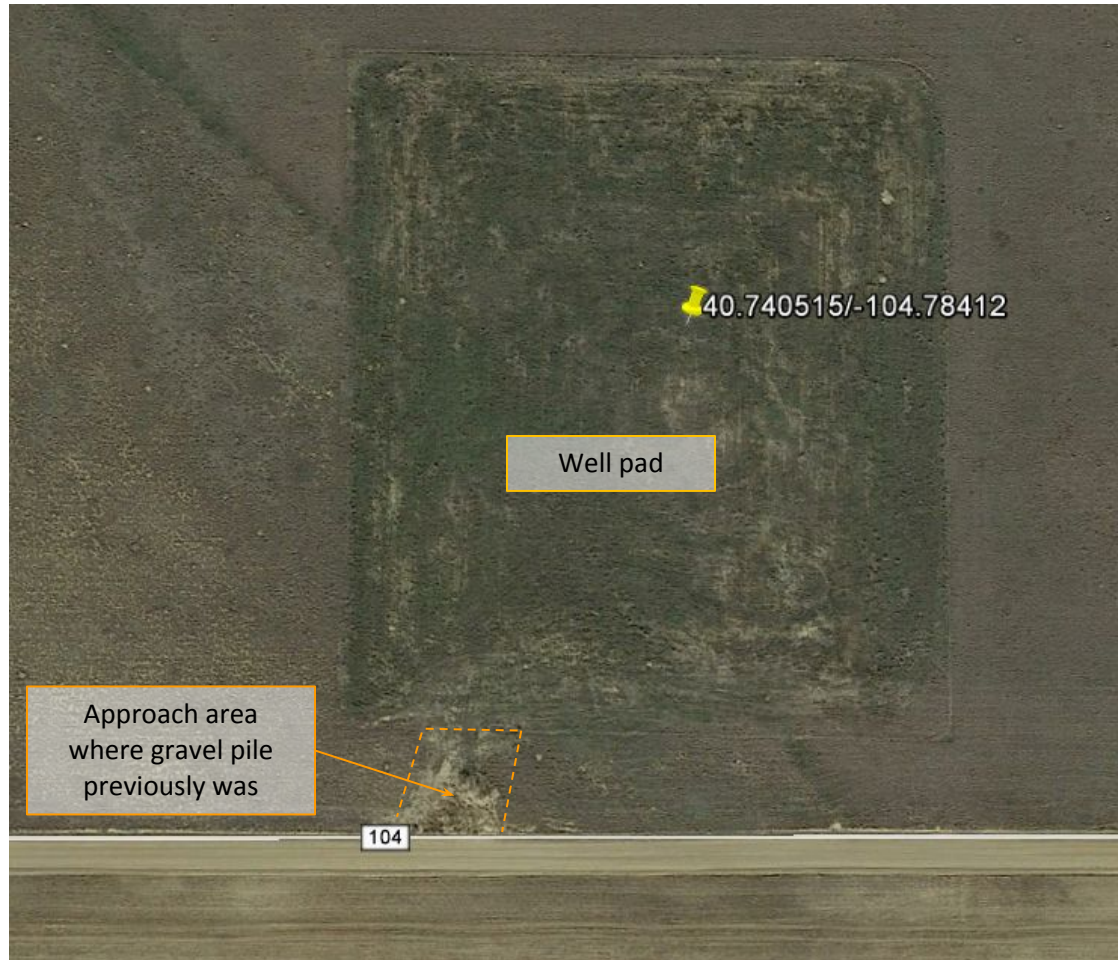
Google Earth imagery taken October 14, 2017. Photo illustrates the well pad location (~4.3 acres) in relation to adjacent reference areas. Surface owner, State Land Board, communicated that it was satisfactory to leave the vegetation as is, even though the vegetation is not similar to reference areas.

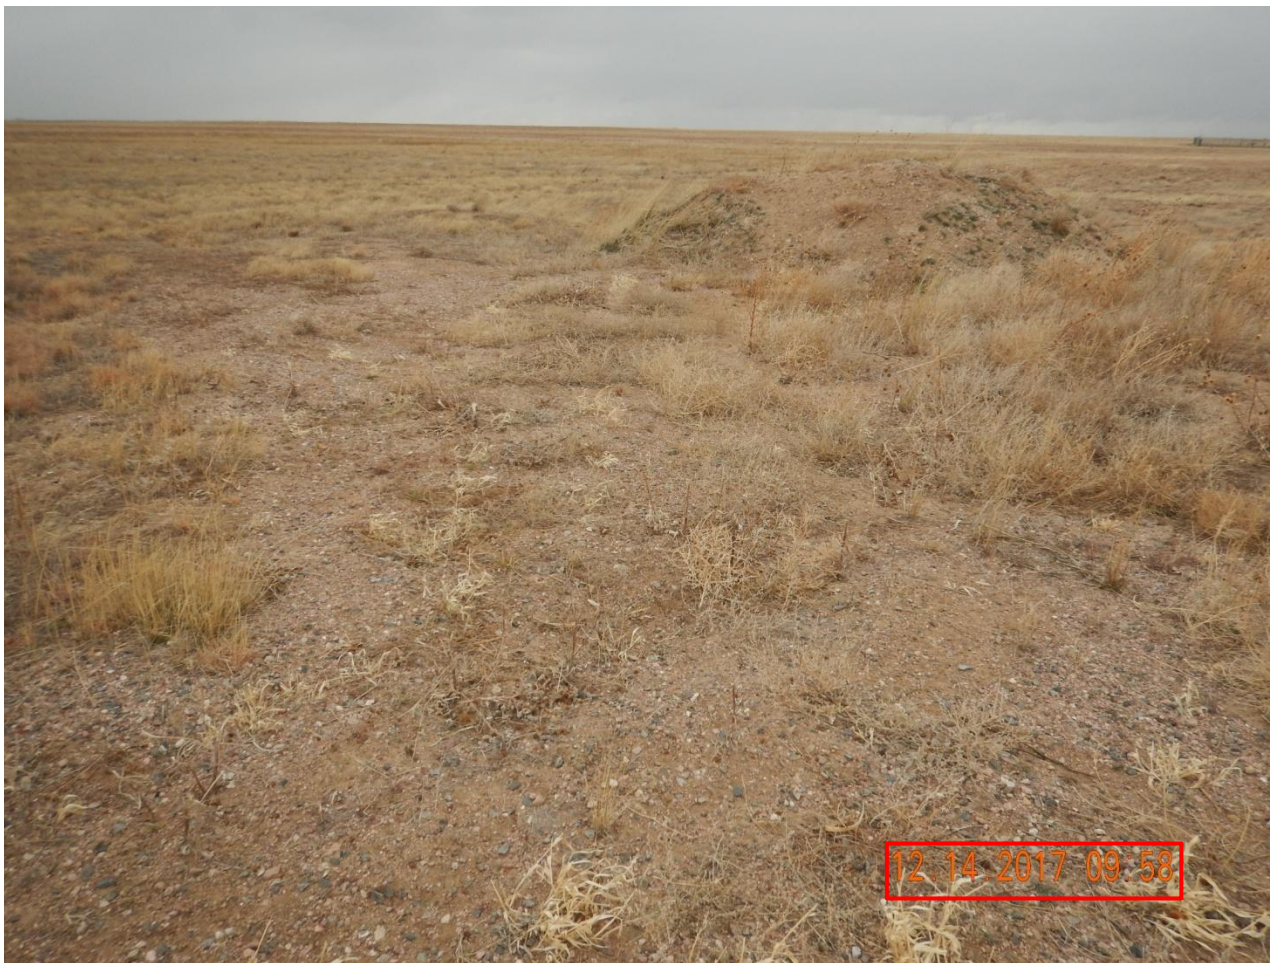
Photo 1. Photo taken December 14, 2017 from the entrance of the location, facing North. Approach and gravel pile left behind which has not been reclaimed per Rule 1004 standards.

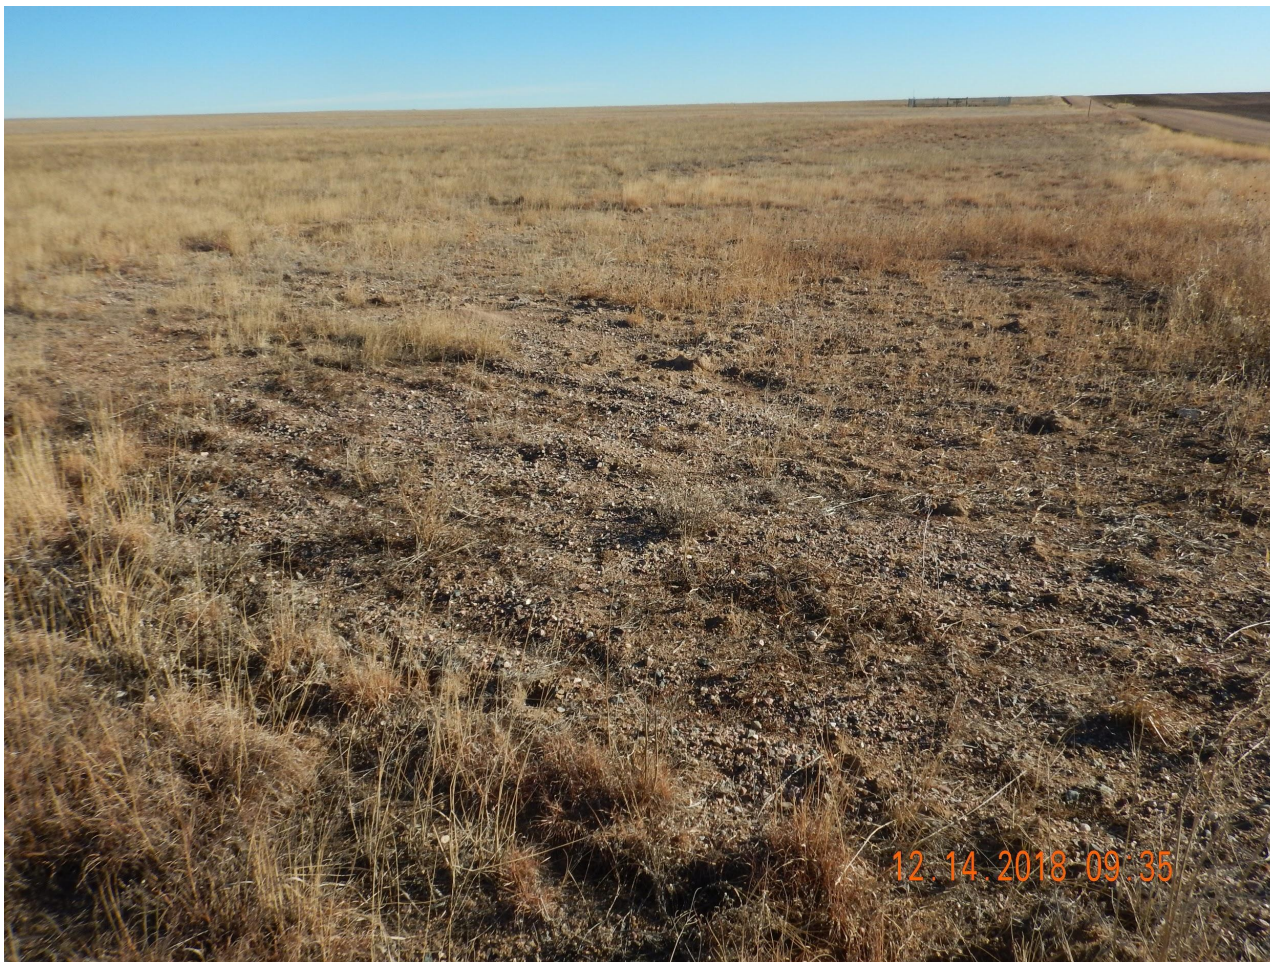
Photo 2. Photo taken from the entrance of the location, facing East. Gravel has been removed from the entrance. However, does not appear the Operator seeded the approach area as there was no apparent germination of desirable plant species.

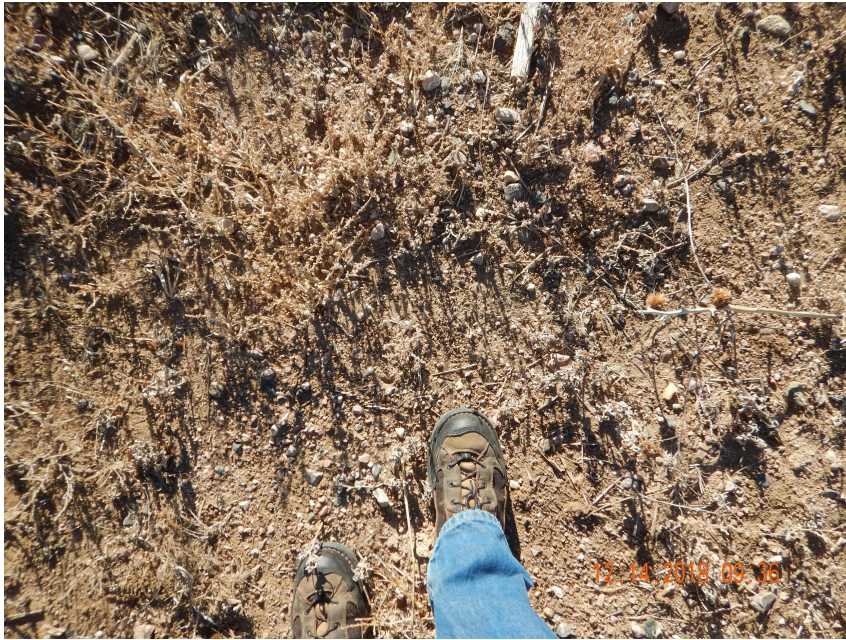
Photo 3. Close-up photo taken from the approach area. Photo illustrates no desirable vegetative growth.

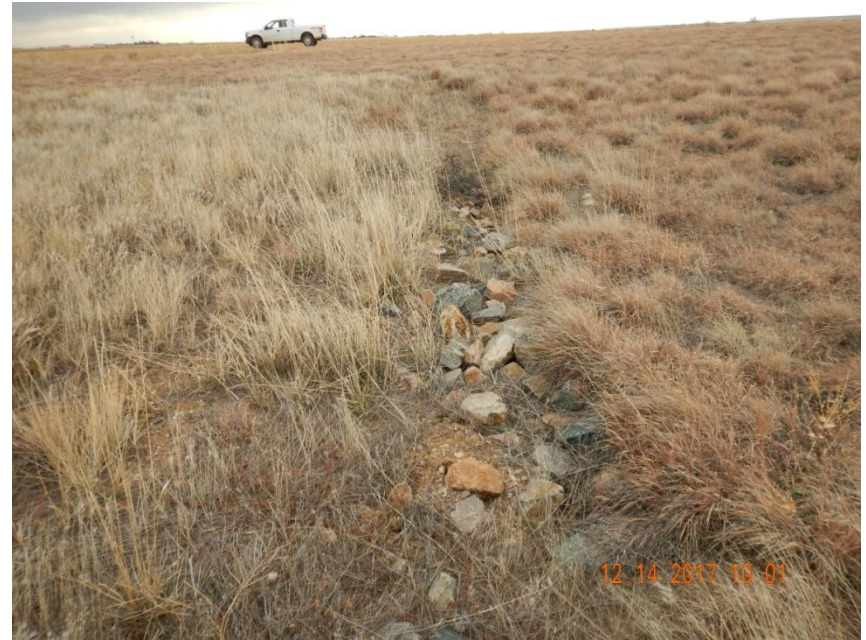
Photo 4. Photo taken December 14, 2017 from the southwest location, facing South. On December 14, 2018, rip-rap was still observed and was not removed.
