Inspection Photos

Operator: NOBLE ENERGY INC - 100322

Location ID: 326752

Inspection Doc. Number: 682504339

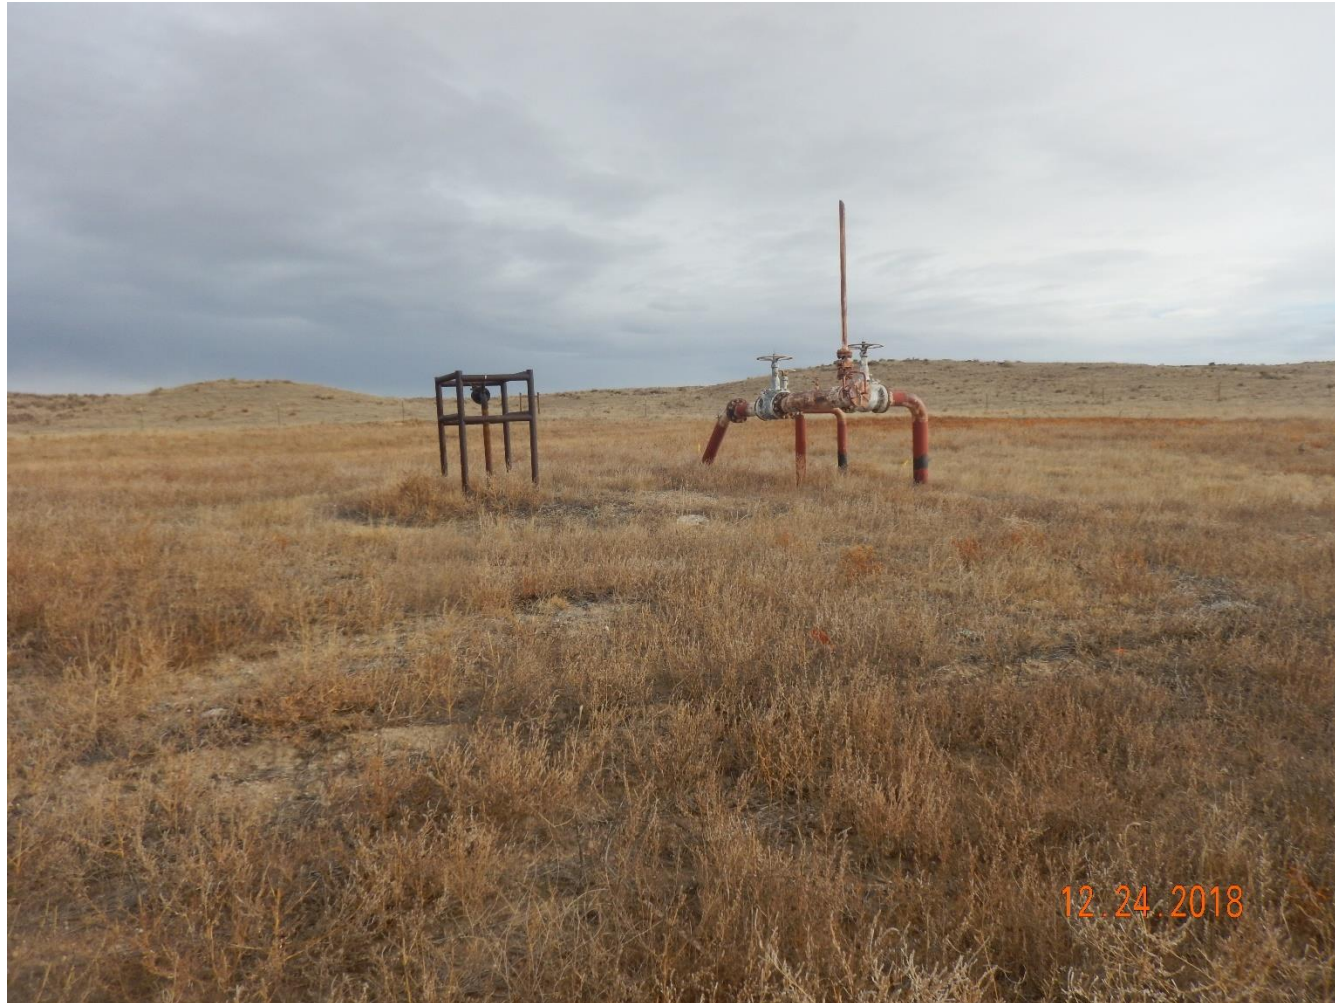
Photo 1: Photo taken from the location, facing east. Previous inspections required operator to remove risers/equipment from the location. Photo shows risers have not been removed.

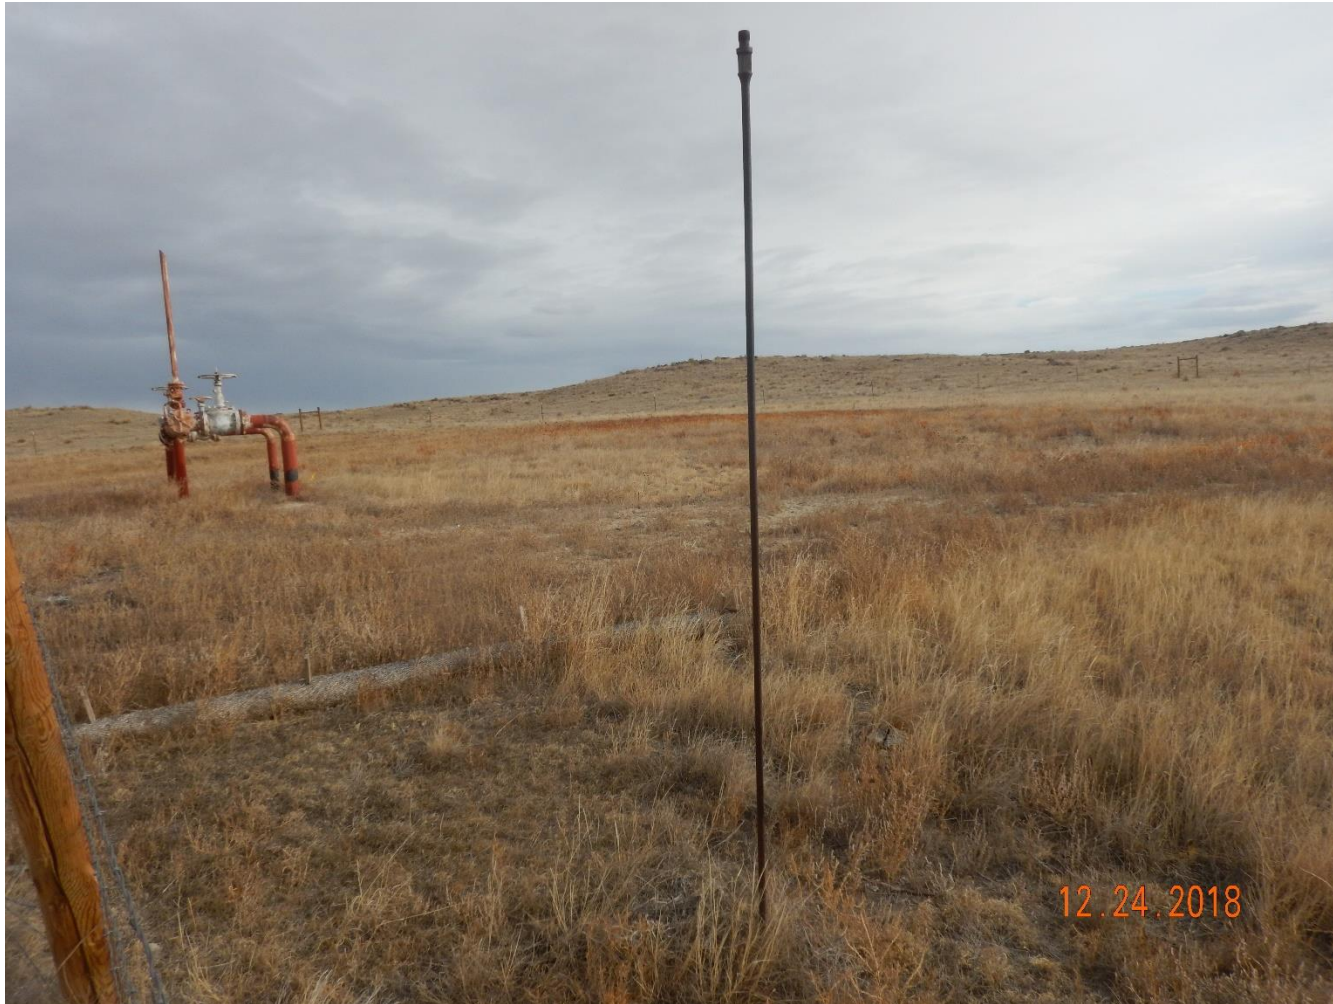
Photo 2: Photo taken from the location, facing southeast. Previous inspections required operator to remove pipe/risers/equipment from the location. Photo shows pipe/risers/equipment have not been removed.

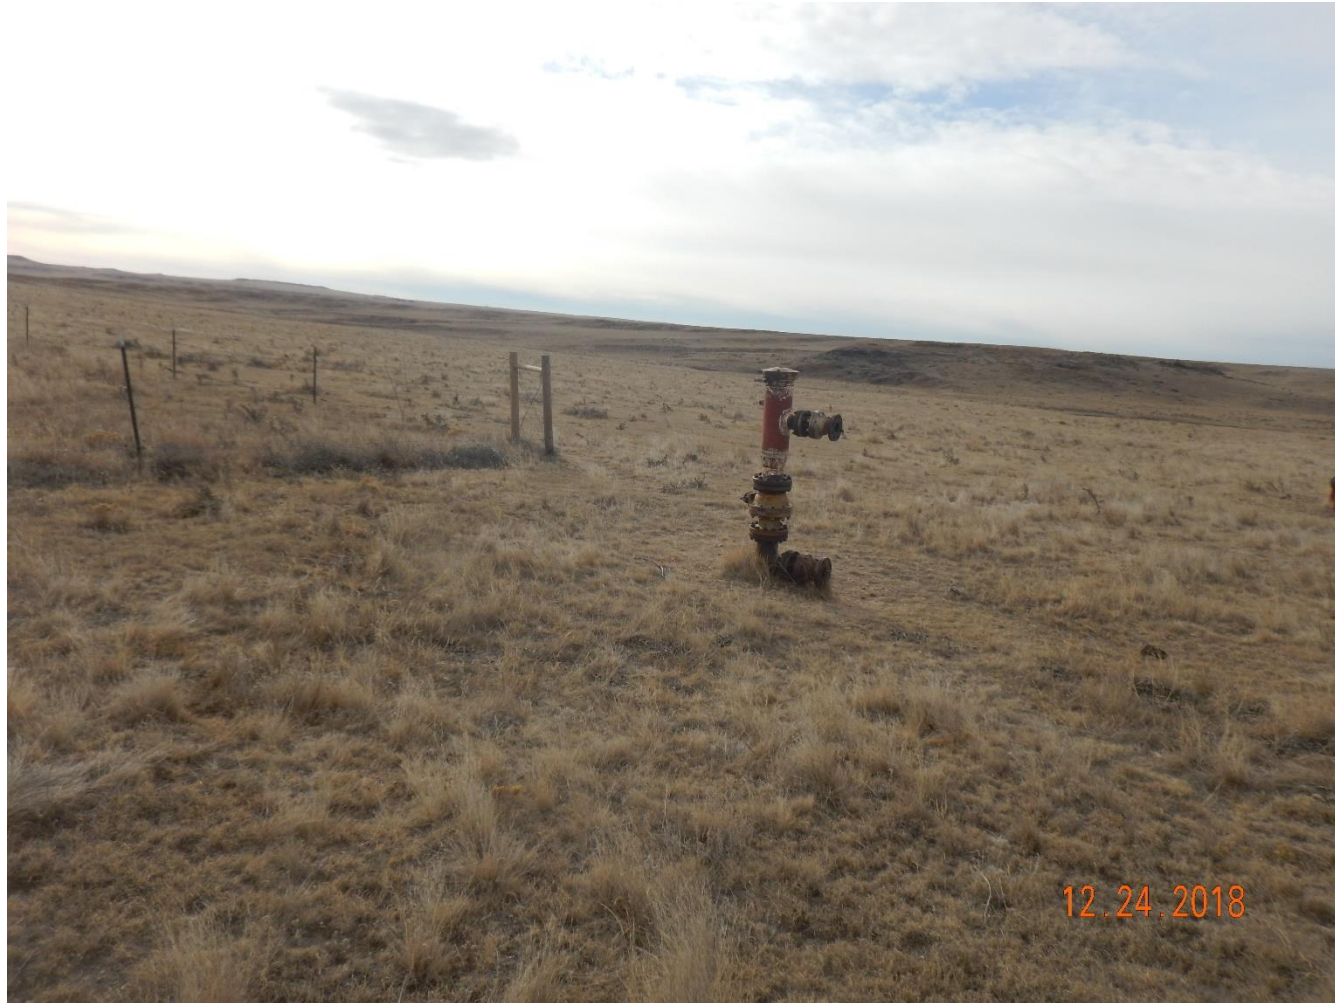
Photo 3: Photo taken from the location, facing southwest. Previous inspections required operator to remove risers/equipment from the location. Photo shows risers have not been removed.

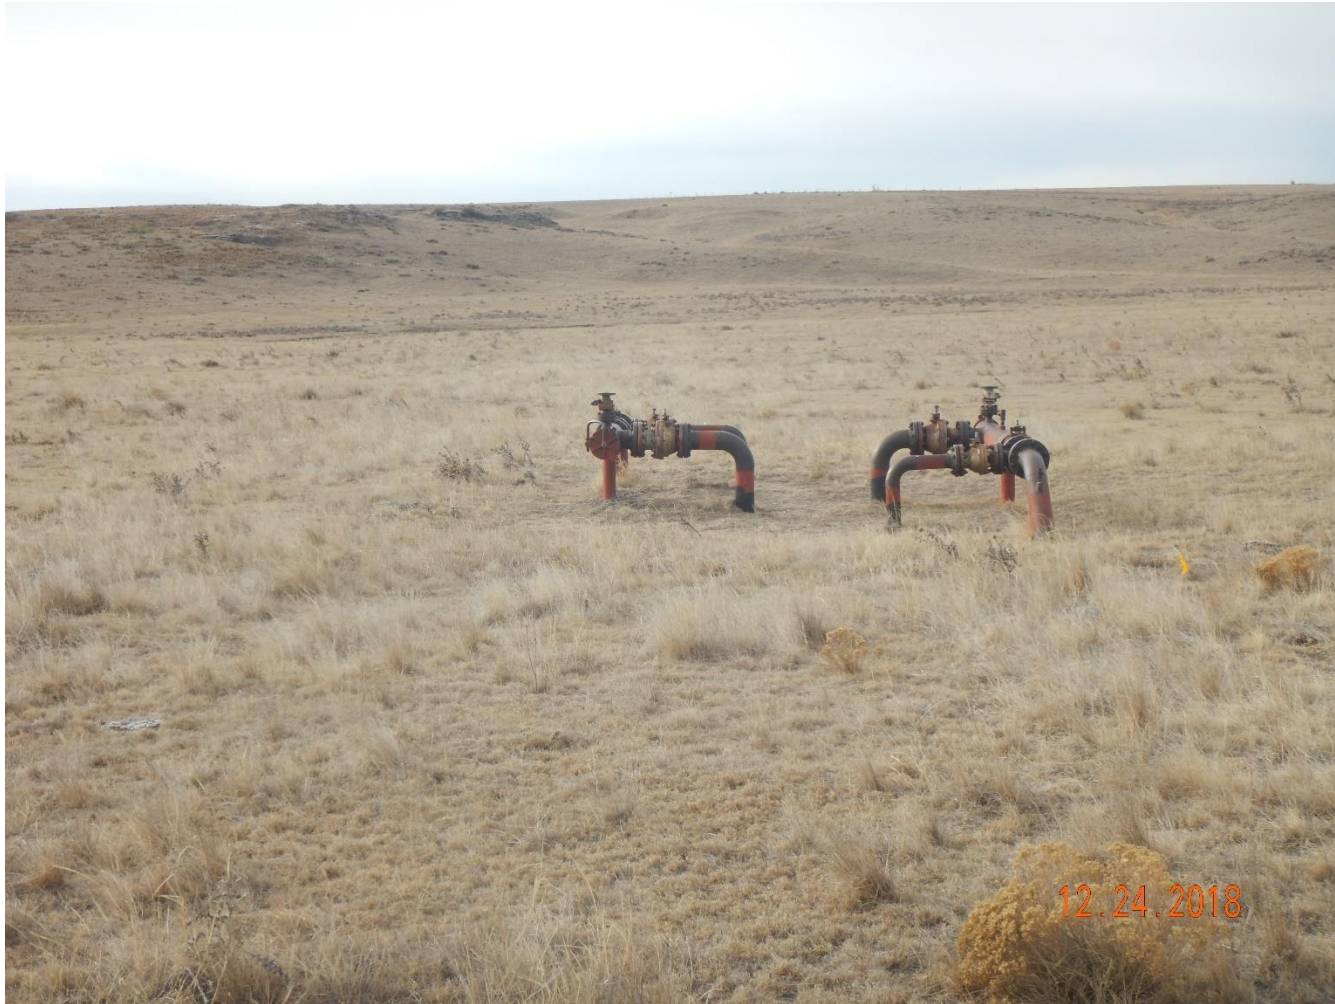
Photo 4: Photo taken from the location, facing west. Previous inspections required operator to remove risers/equipment from the location. Photo shows risers have not been removed.

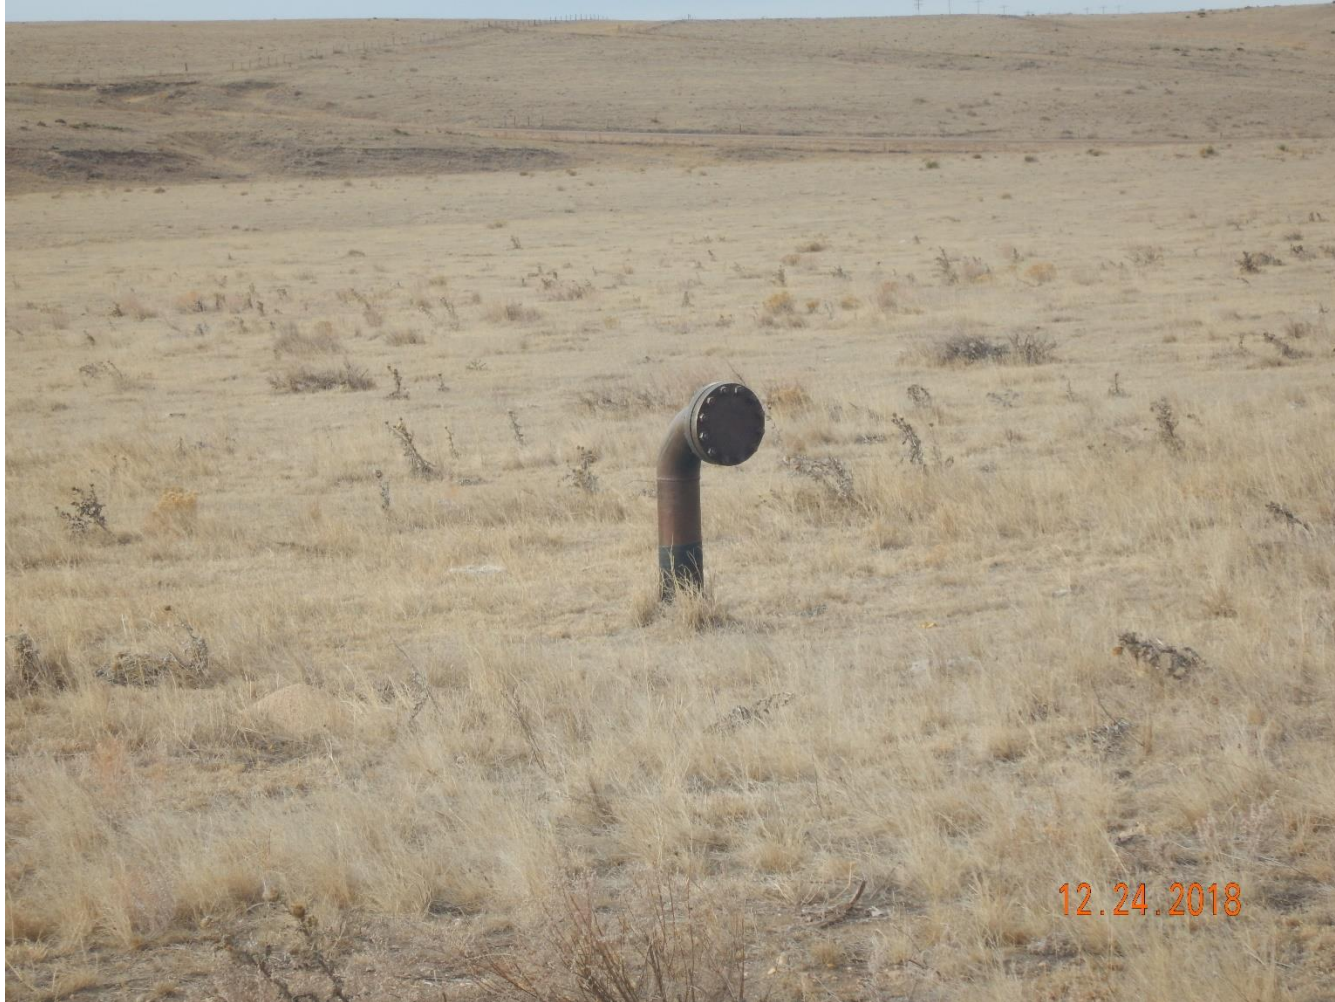
Photo 5: Photo taken from the location, facing west. Previous inspections required operator to remove risers/equipment from the location. Photo shows risers have not been removed.

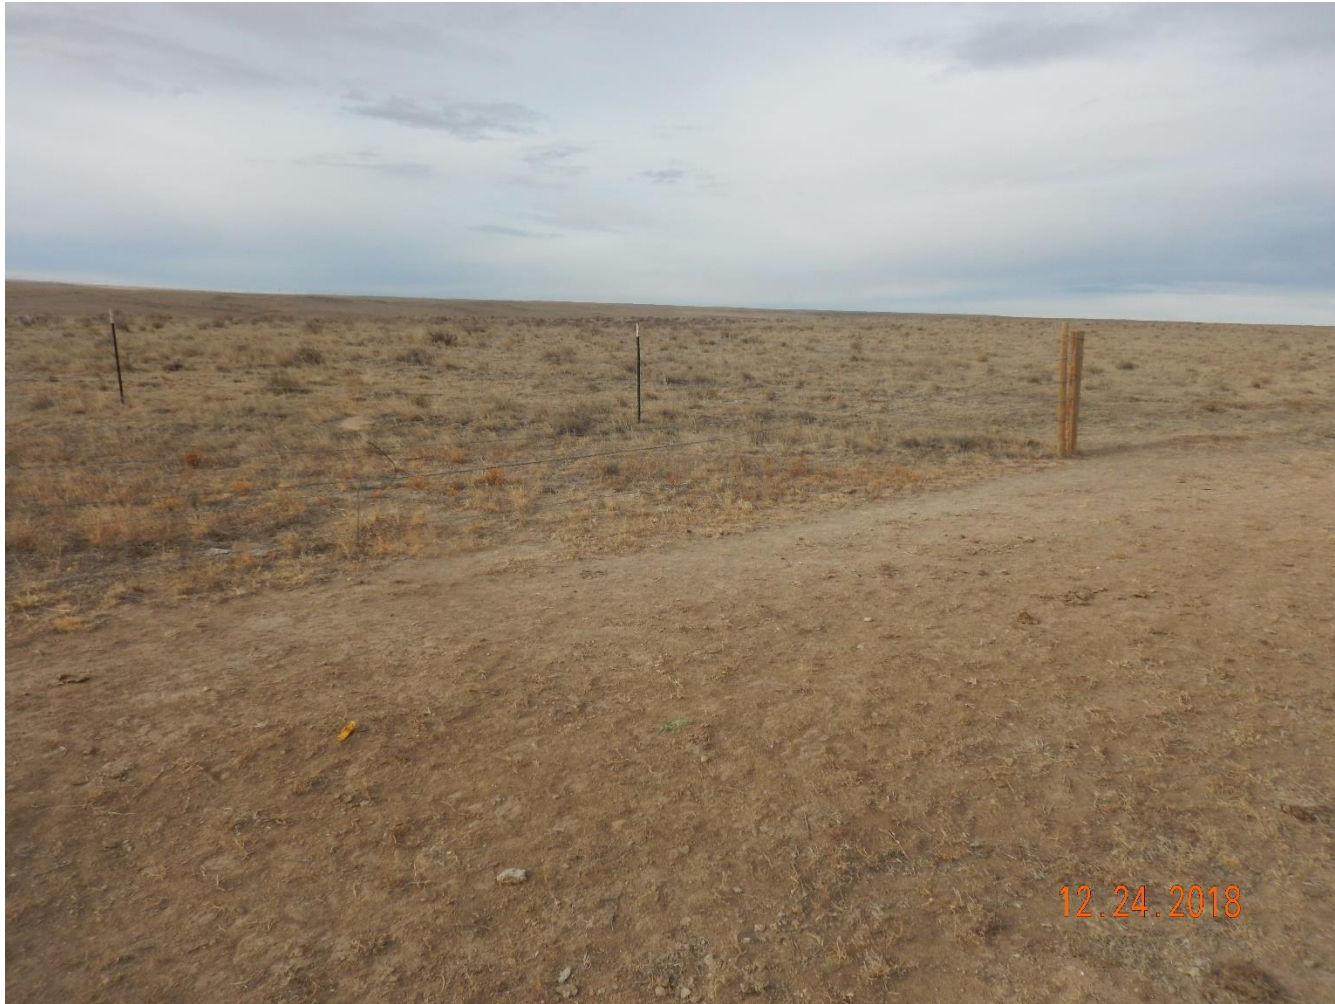
Photo 6: Photo taken from where the access road turns north. Previous inspections required operator to perform reclamation of the access road. Photo shows operator appears to only have conducted reclamation on a portion of the access road.

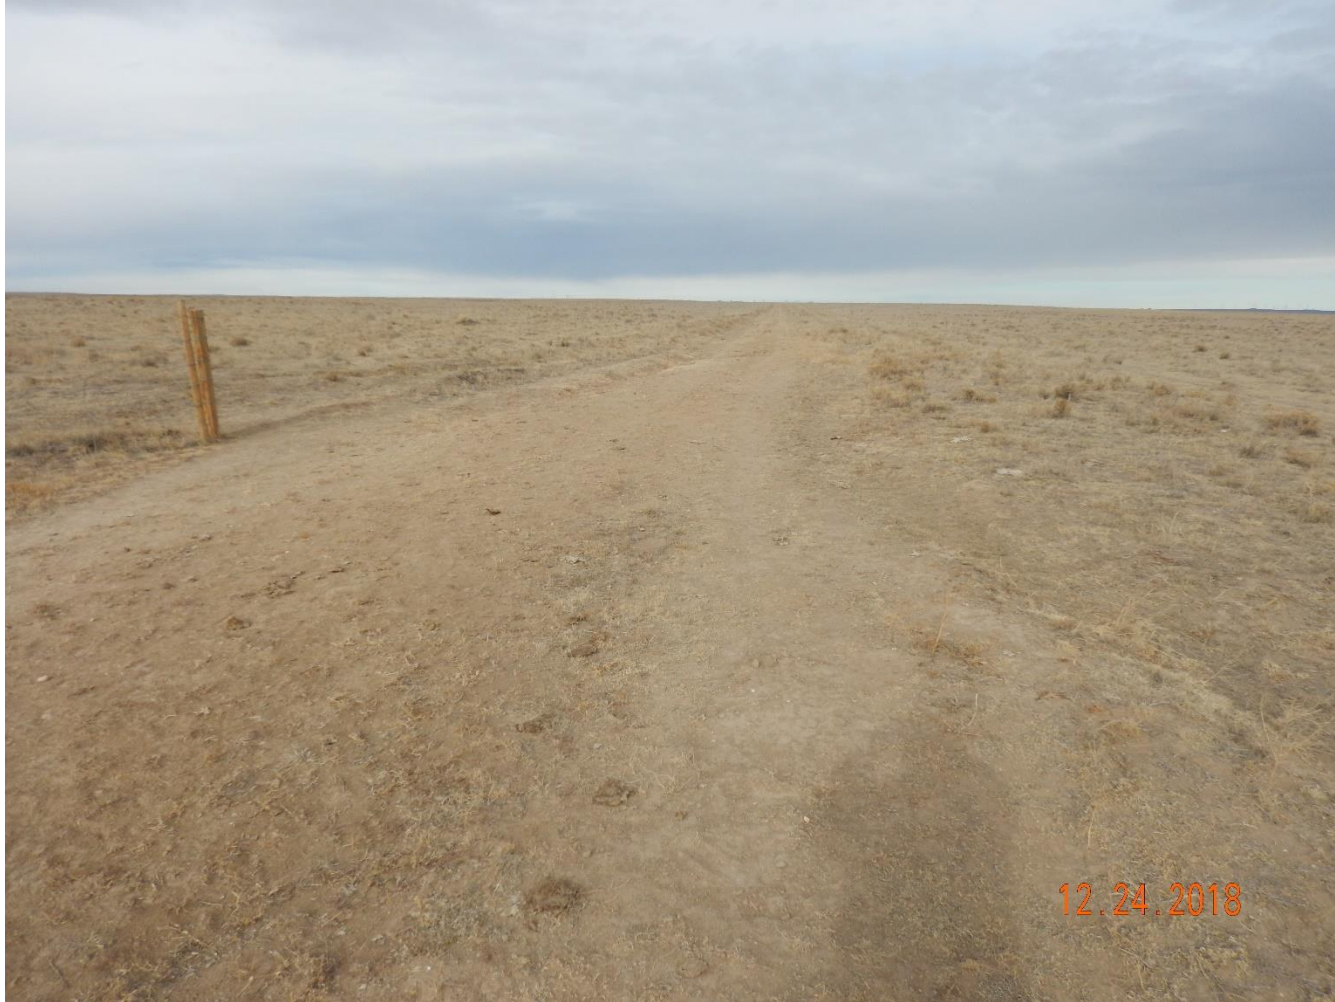
Photo 7: Photo taken from the access road, facing north. Photo shows access road has not been reclaimed.

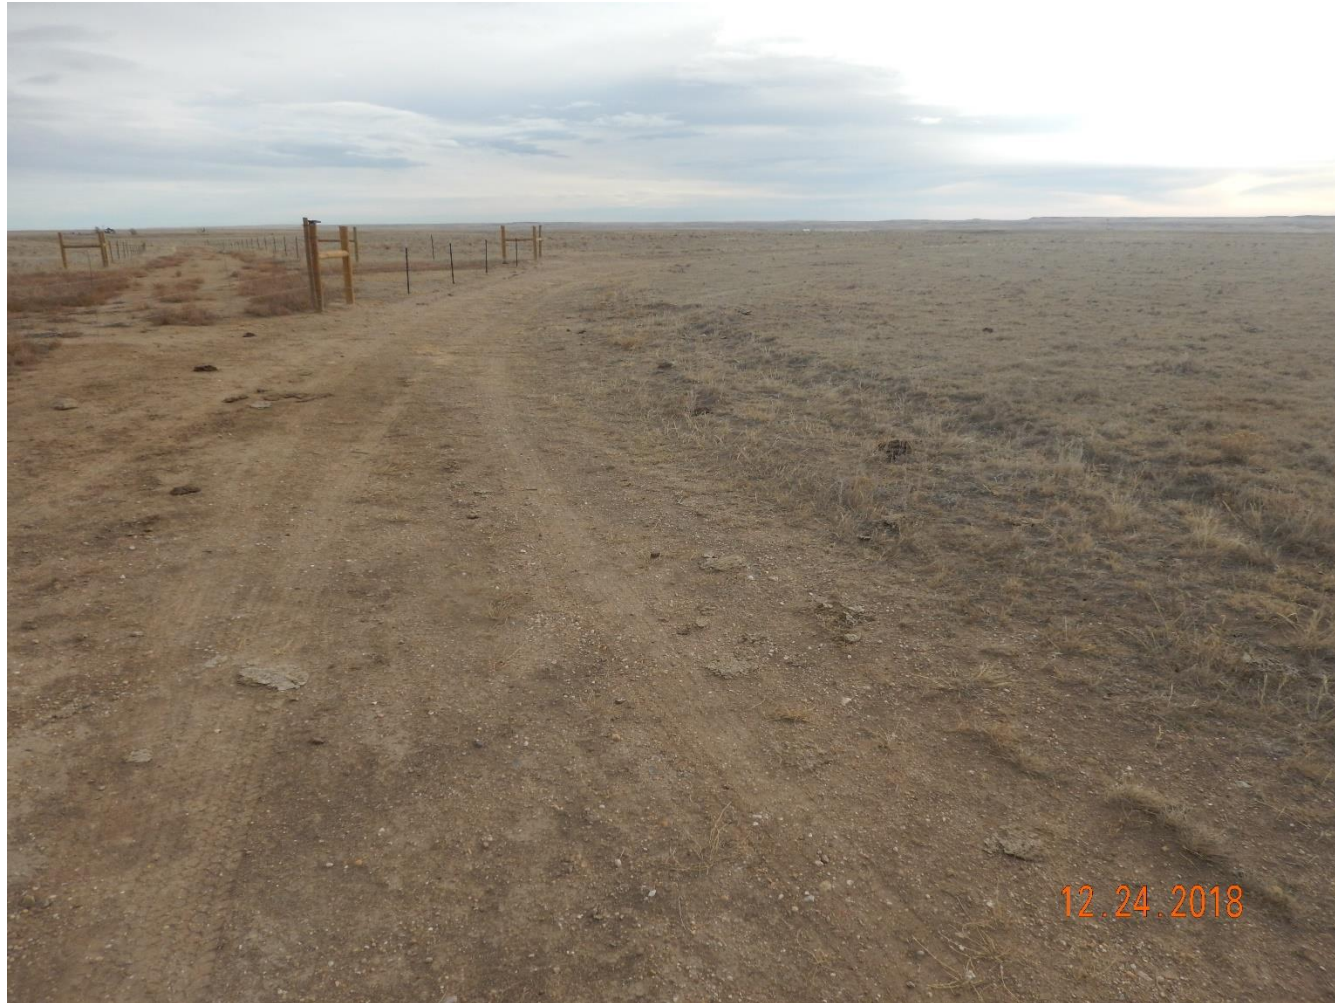
Photo 8: Photo taken from the access road, facing southeast. Photo shows access road has not been reclaimed. .

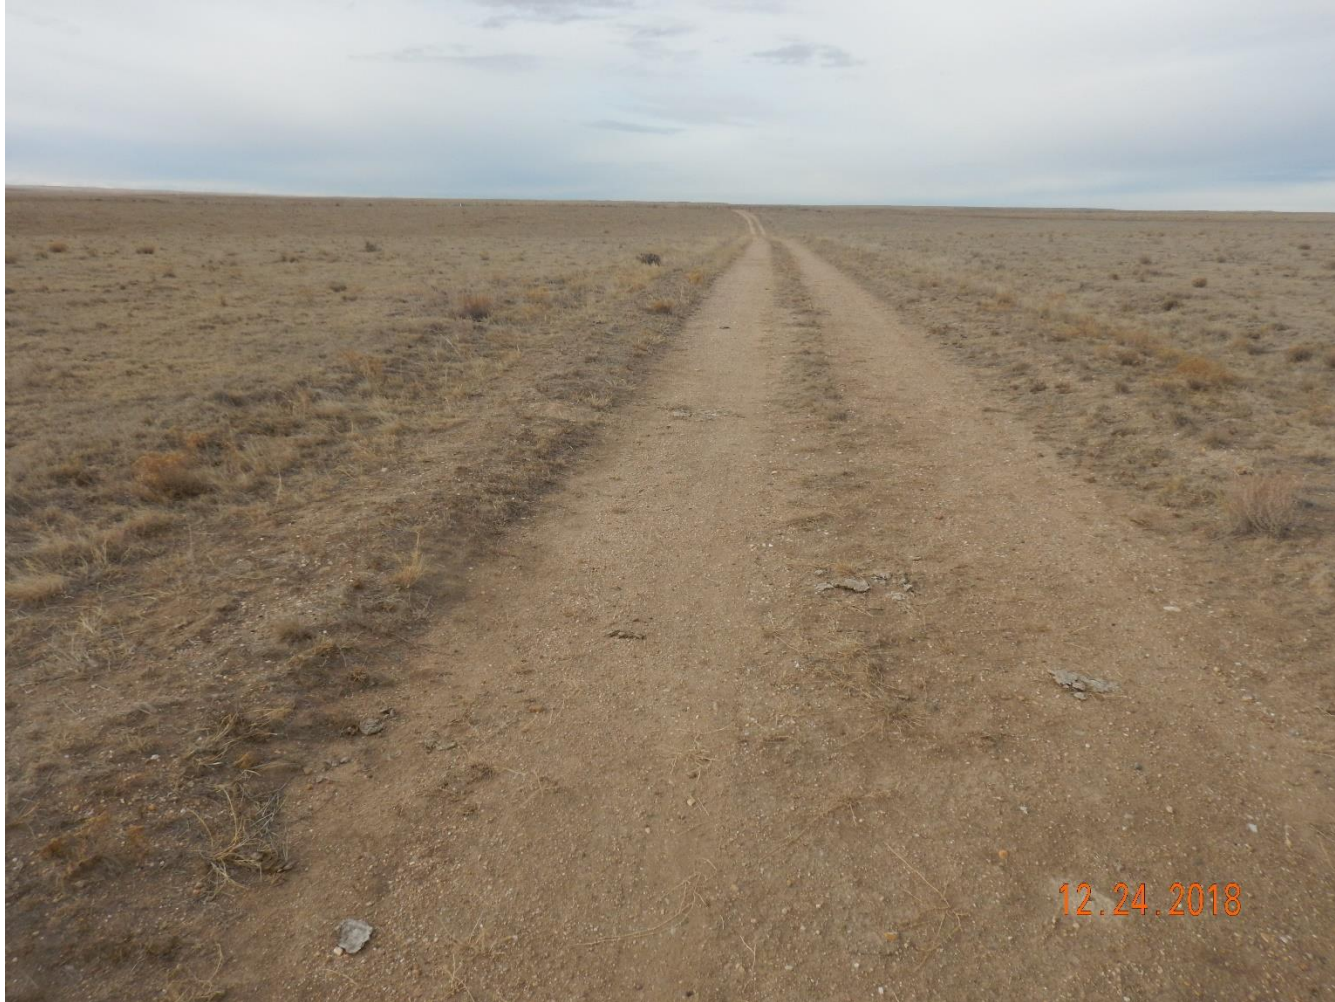
Photo 9: Photo taken from the access road, facing west towards the county road. Photo shows access road has not been reclaimed.

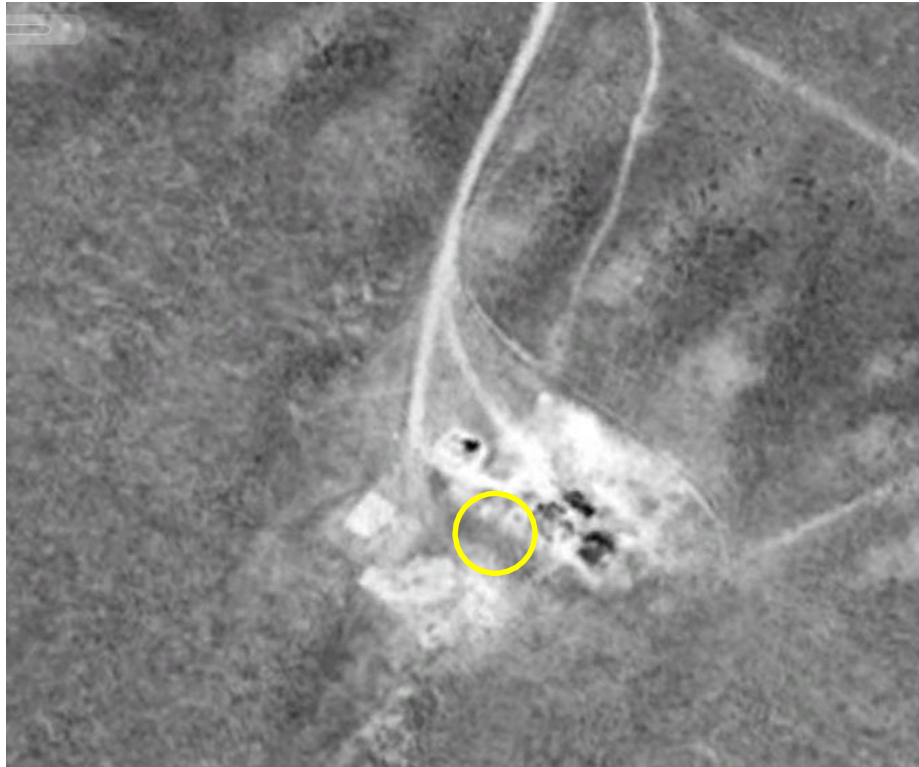
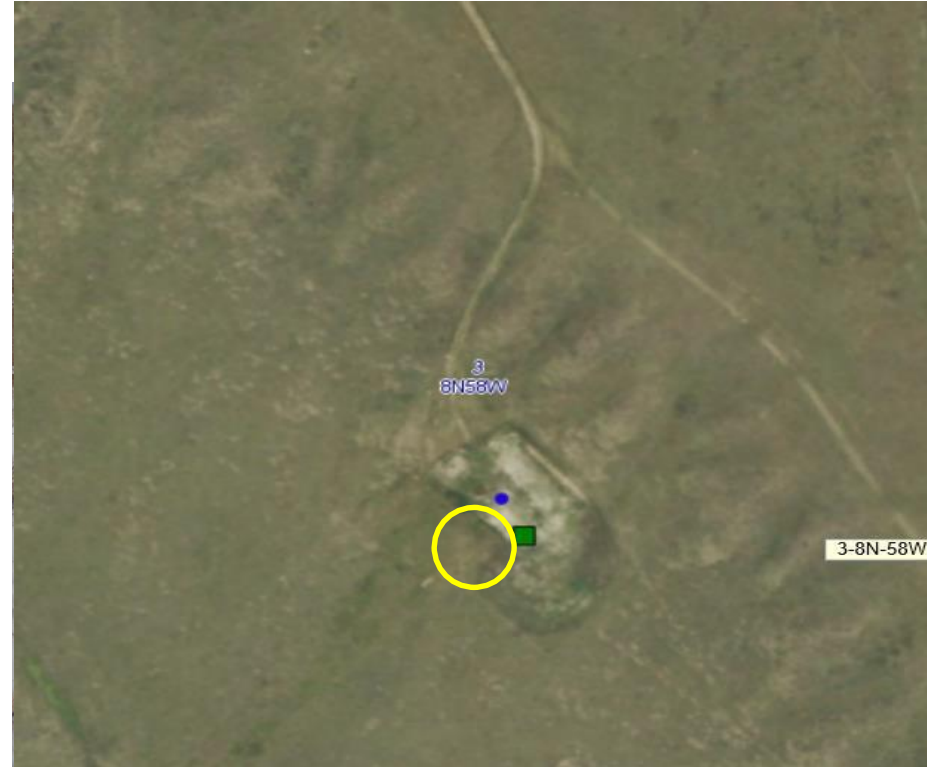
Photo 10: Historic aerial imagery (1999) seen on the left compared to current available aerial imagery (2015). Yellow circle indicates approximate areas where pipe equipment (seen in photos 3-5) remain.

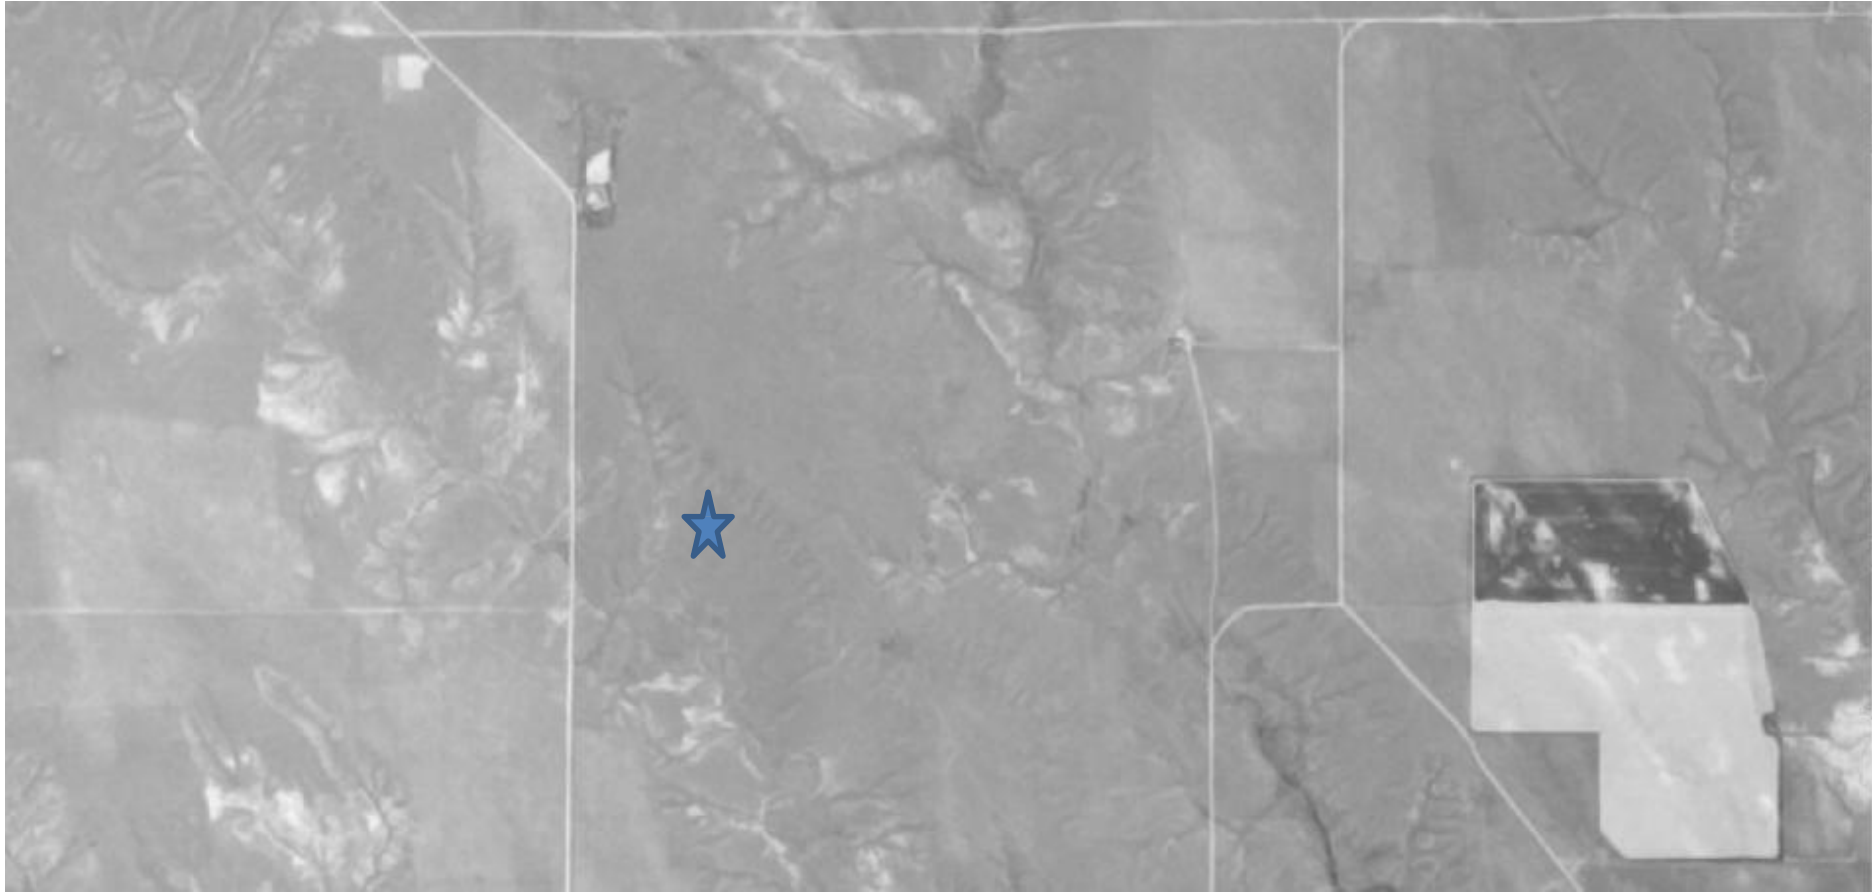
Photo 11: May 1985 aerial imagery. Star indicates location of the well. Well was spud 9/21/1987. Photo shows location and access road pre O&G disturbance. Photo shows access road was not been pre-existing and is subject to 1004 reclamation rules.
