Final Reclamation Inspection

Operator: NOBLE ENERGY INC- #100322

API: 05-123-12701

Inspection Photos
Location Name: SLW #2-12
API: 05-123-12701

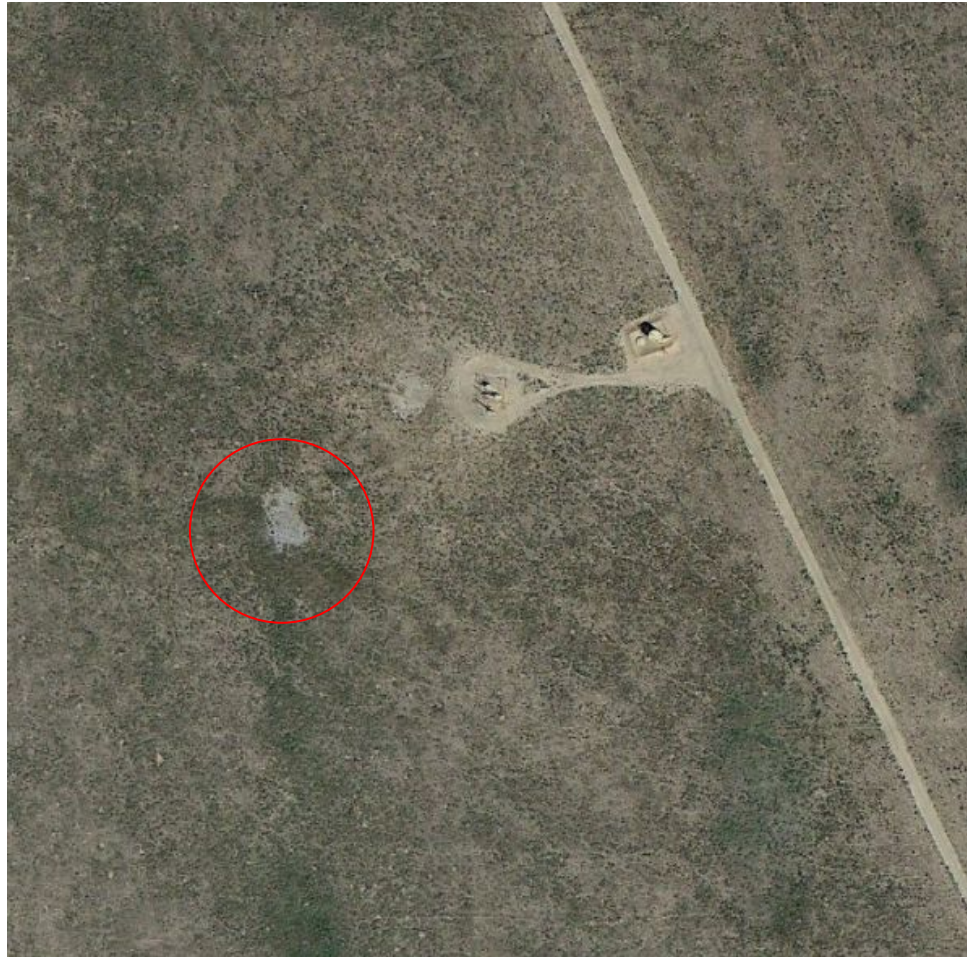
The most current Google Earth aerial imagery from 9/7/2013 illustrating the disturbance areas associated with the location during active operations. Bare patch is observed along the southwestern disturbance area. COGCC Staff will re-inspect this area on a future follow-up inspection to ensure compliance with Rule 1004 standards.

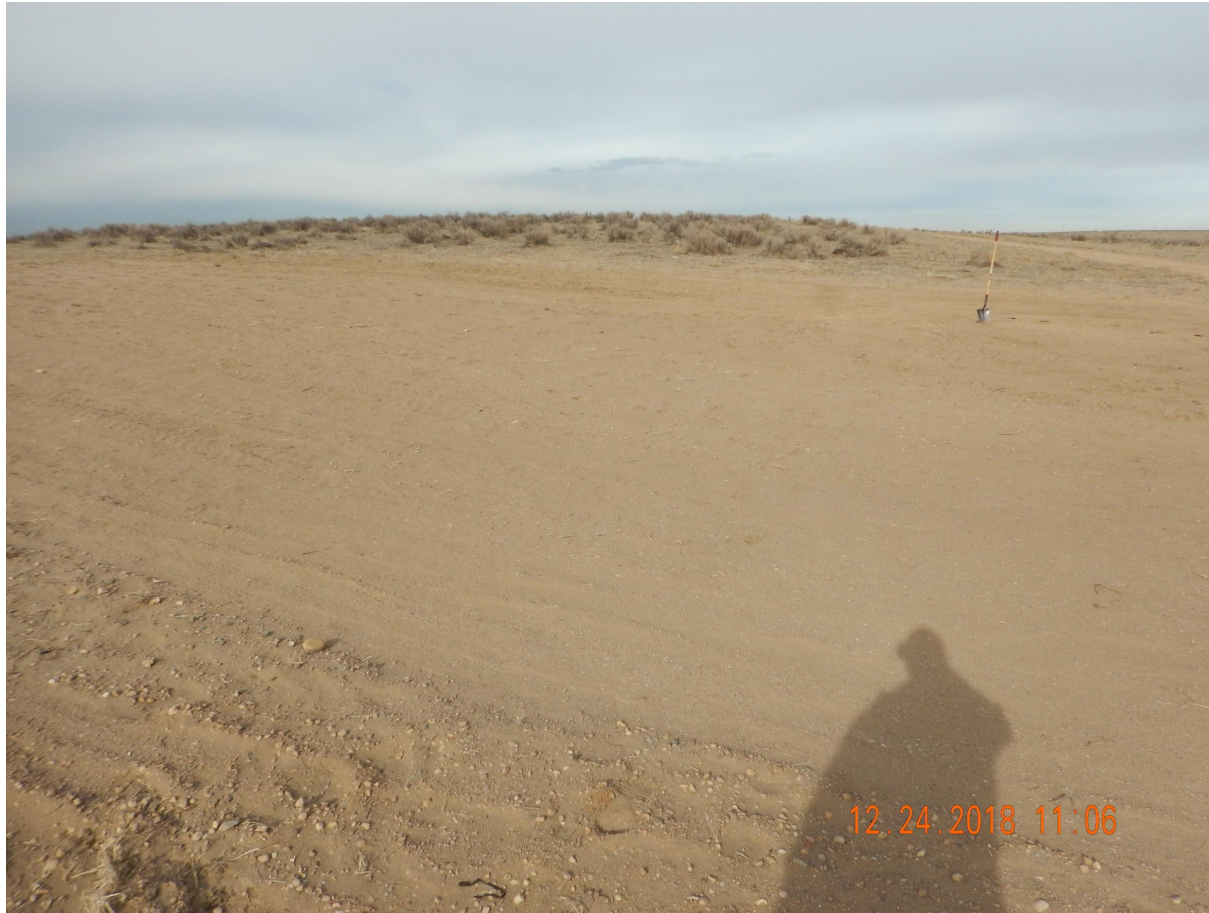
Photo 1. Photo taken from the eastern area of the former plugged and abandoned location, facing North. Well was plugged on 6/1/2015. Operator has failed to perform final reclamation activities (decompact, contour, remove gravel, etc.) per Rule 1004 standards.

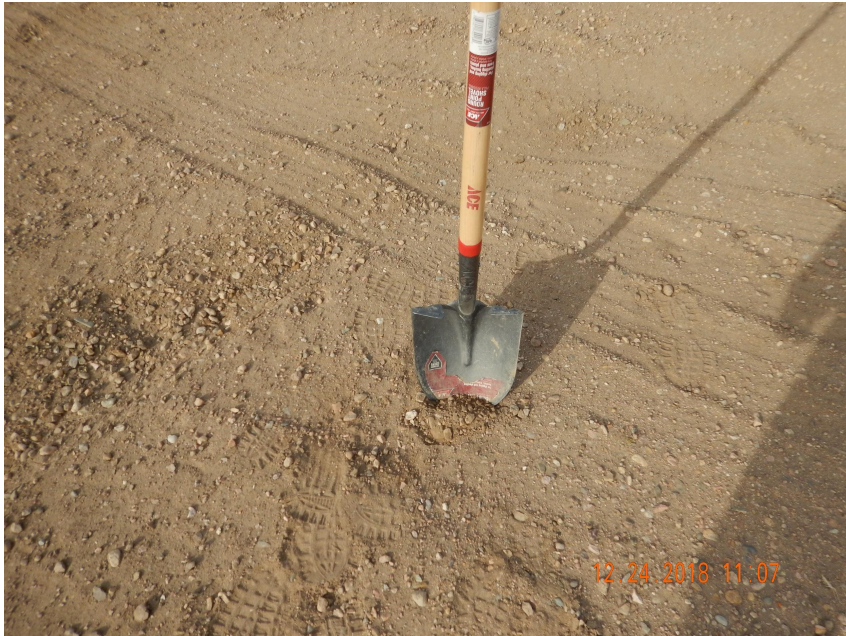
Photo 2. Photo taken from the former plugged and abandoned location. Photo illustrates gravel has not been removed and decompaction has not been performed. COGCC Staff could not penetrate the shovel more than a couple inches into the surface.

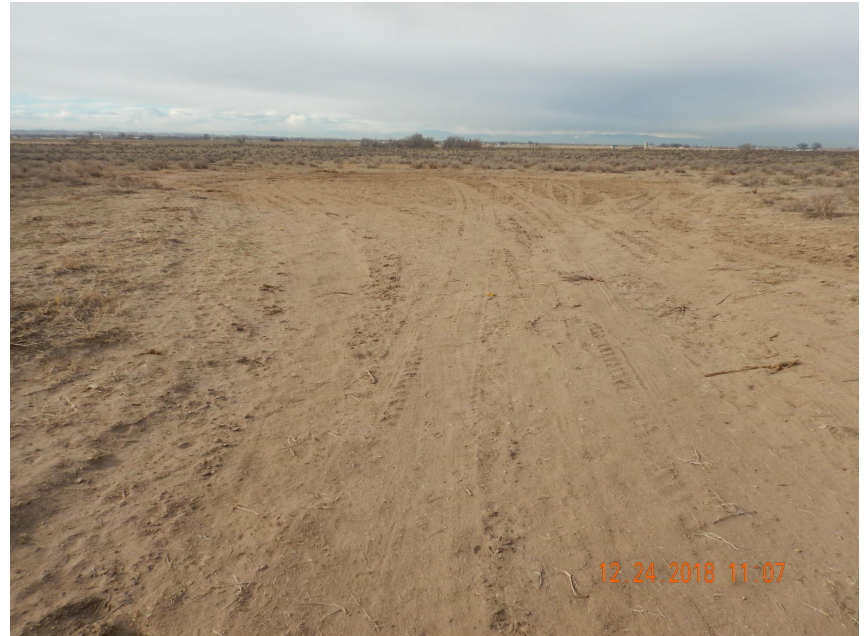
Photo 3. Photo taken from the eastern area of the former plugged and abandoned location, facing West. See comments under Photo 1.

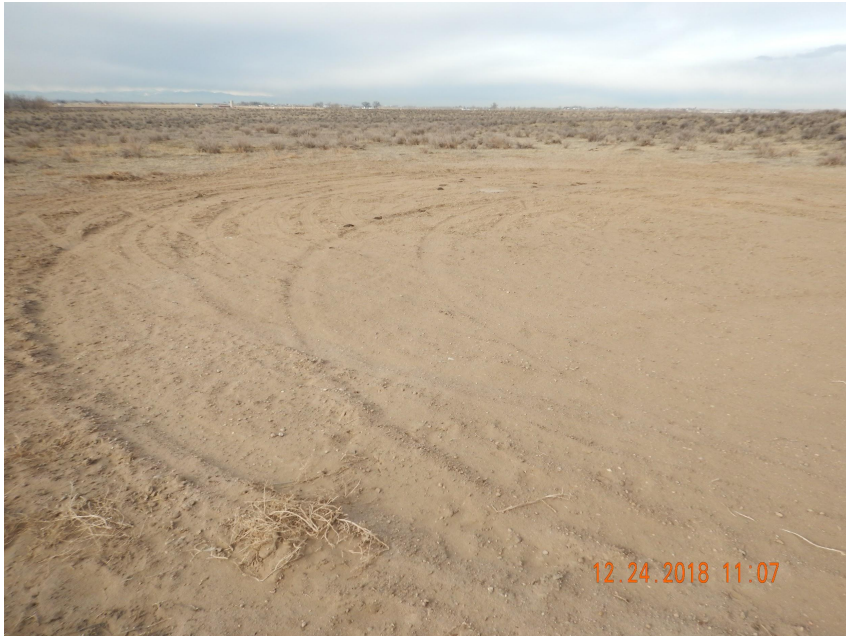
Photo 4. Photo taken from the western area of the former plugged and abandoned location, facing Northwest. See comments under Photo 1.

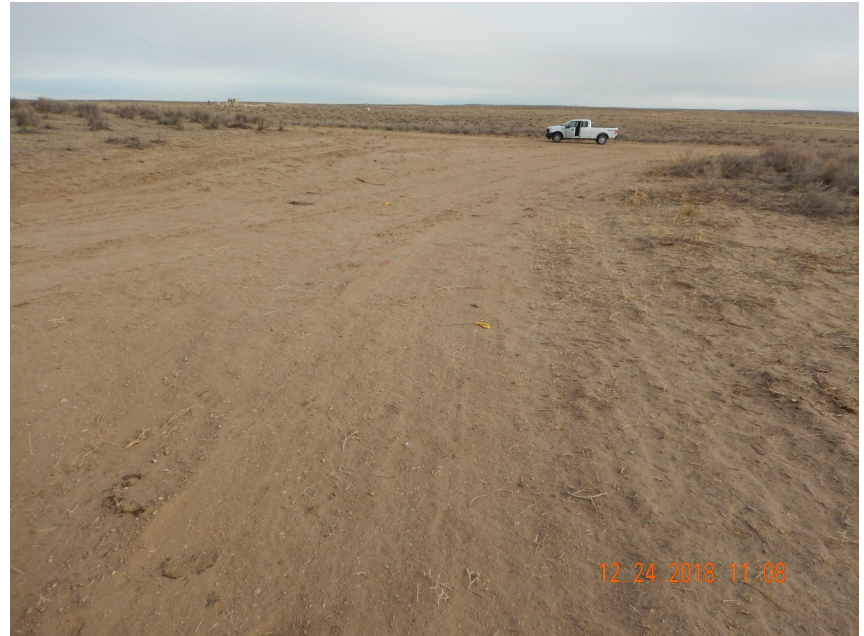
Photo 5. Photo taken from the western area of the former plugged and abandoned location, facing East. See comments under Photo 1.
