Final Reclamation and Stormwater Inspection

Operator: PELICAN HILL OIL & GAS INC – 10088

Location ID: 381289

Inspection Document #: 674902359

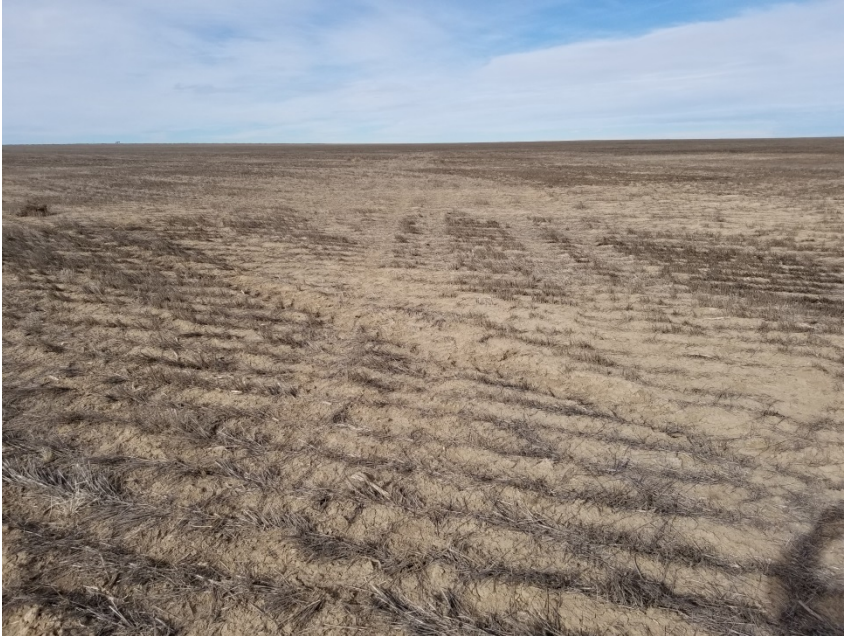
Photo 1. Photo taken from the location, facing North. Appears the Operator has performed final reclamation activities. However, the majority of the site has not been decompacted.

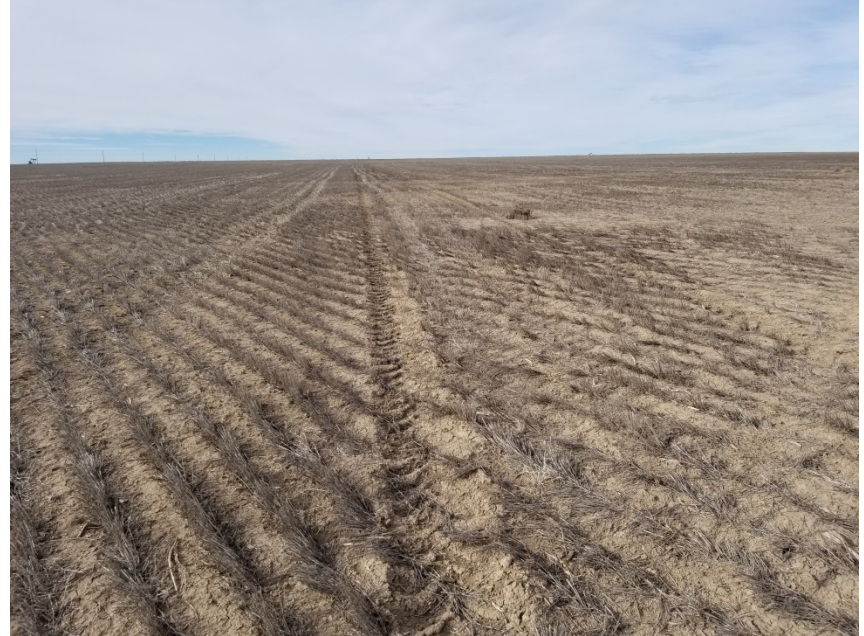
Photo 2. Photo taken from the location, facing West. Photo depicts compaction areas to the right of the Photo and decompacted areas to the left. See comments from Photo 1.

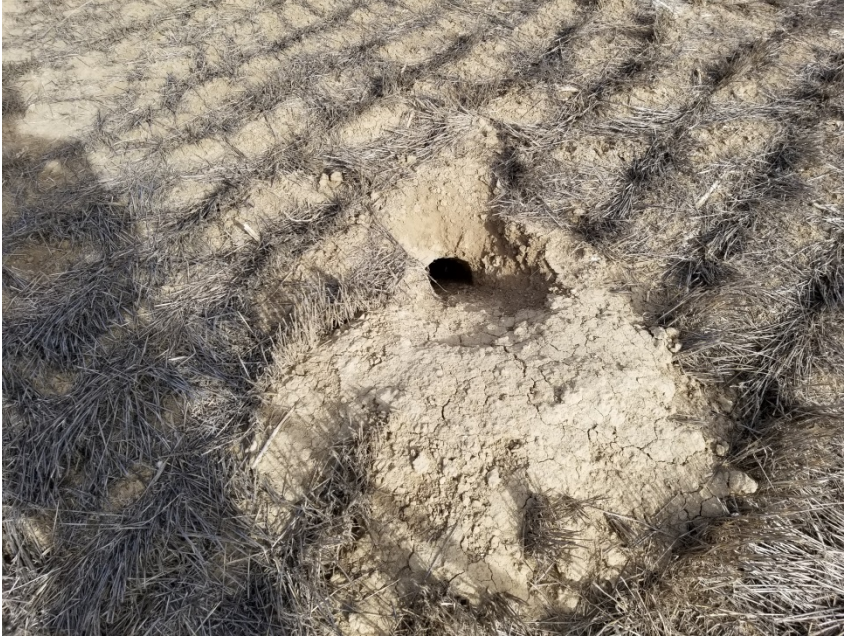
Photo 3. Photo taken from the location showing the test pit dug to check on decompaction. See comments from Photo 1.

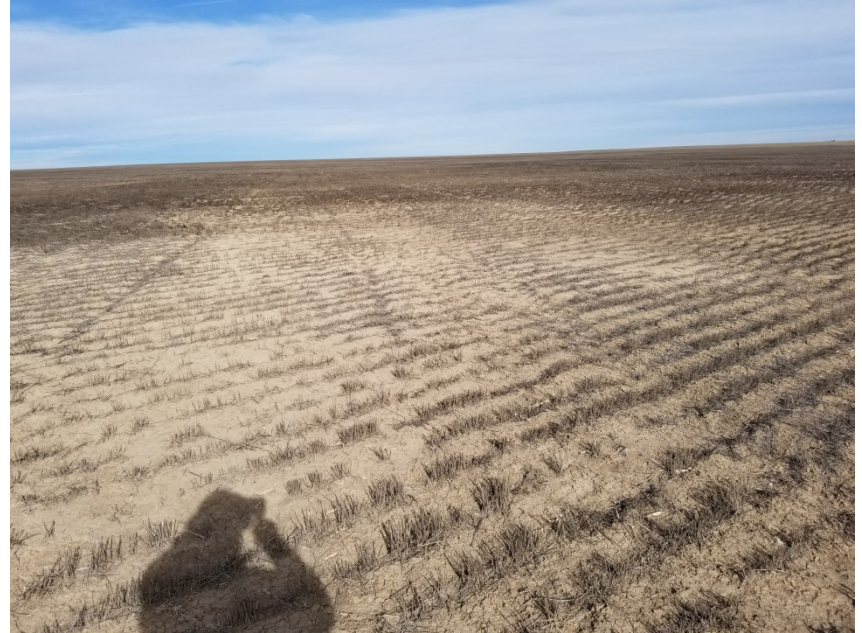
Photo 4. Photo taken from the location, facing North. Photo depicts compaction areas in the foreground of the Photo and decompacted areas in the background.
