Final Reclamation Inspection

Operator: NOBLE ENERGY INC- #100322

API: 05-123-18960

Location Name: ROBIN GREEN STATE #BB 18-4

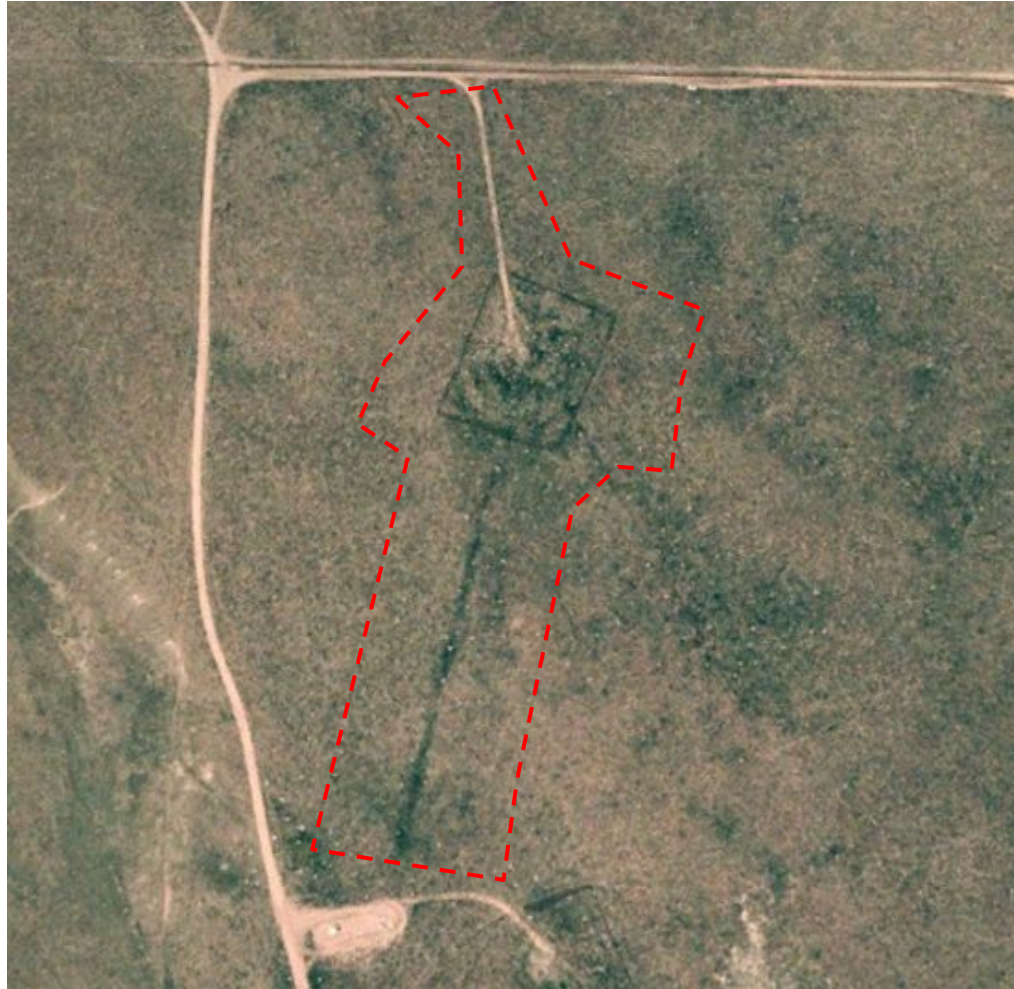
Google Earth aerial imagery from 6/16/2005 illustrating some of the disturbance areas associated with the location during active operations, including a flowline. Operator shall comply with Rule 1004 standards to reclaim all associated disturbance areas.

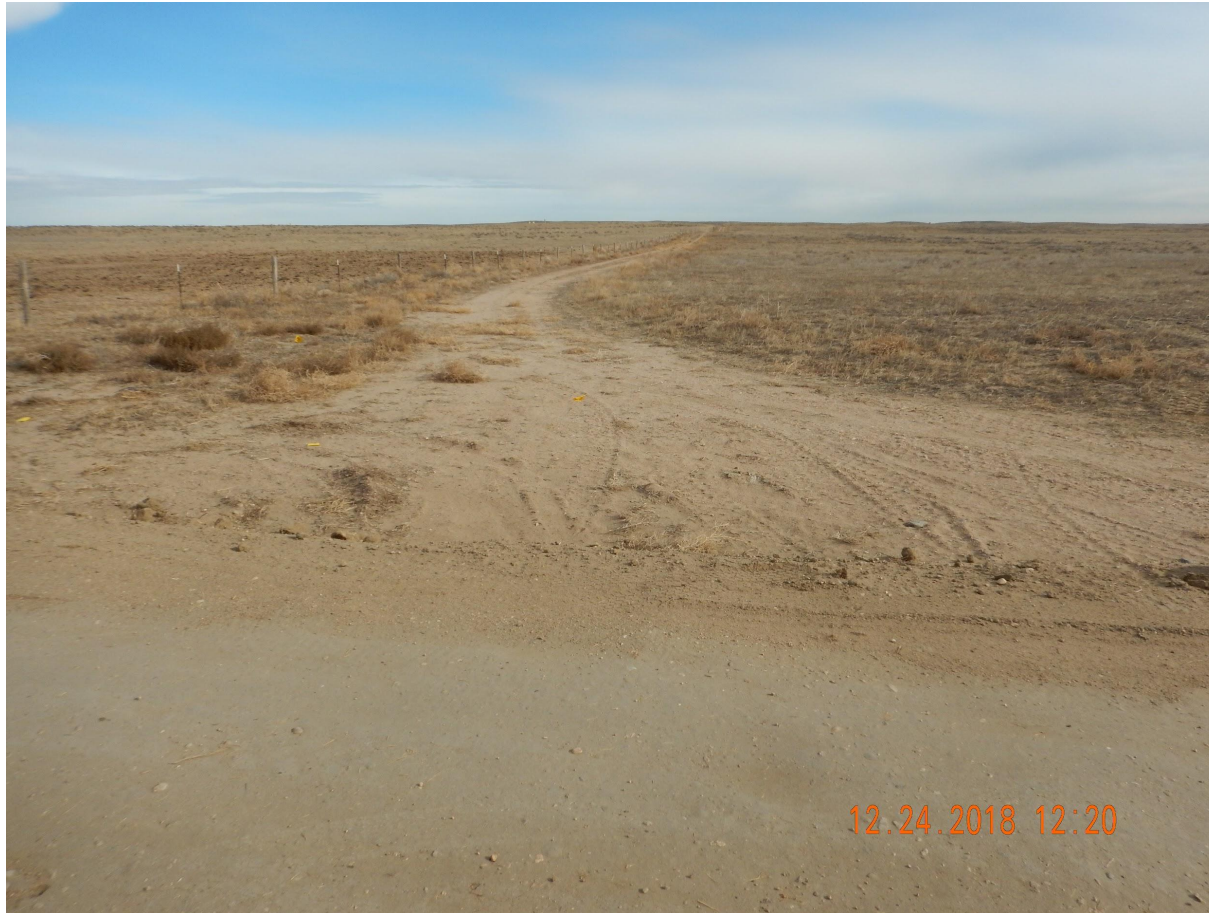
Photo 1. Photo taken from the northwestern main access road (shown in the first aerial image), facing East. Operator has failed to reclaim the access road per Rule 1004 standards (e.g., recontour, decompact, etc.). Wind erosion was observed along portions of the main access road.

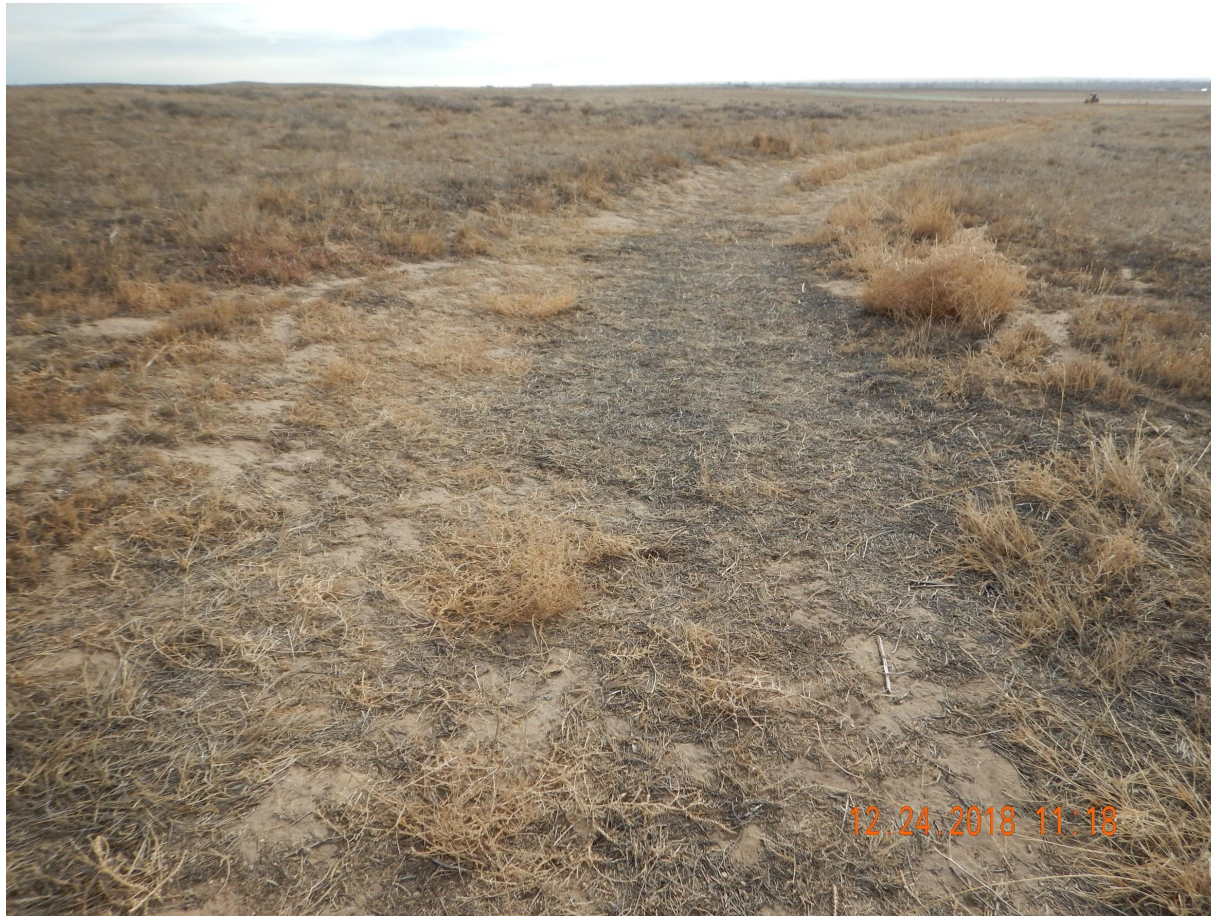
Photo 2. Photo taken from the entrance of the well location access road, facing South. Well was plugged on 3/4/2014. Operator has failed to properly reclaim the access road per Rule 1004 standards (e.g., recontour, decompact, etc.).

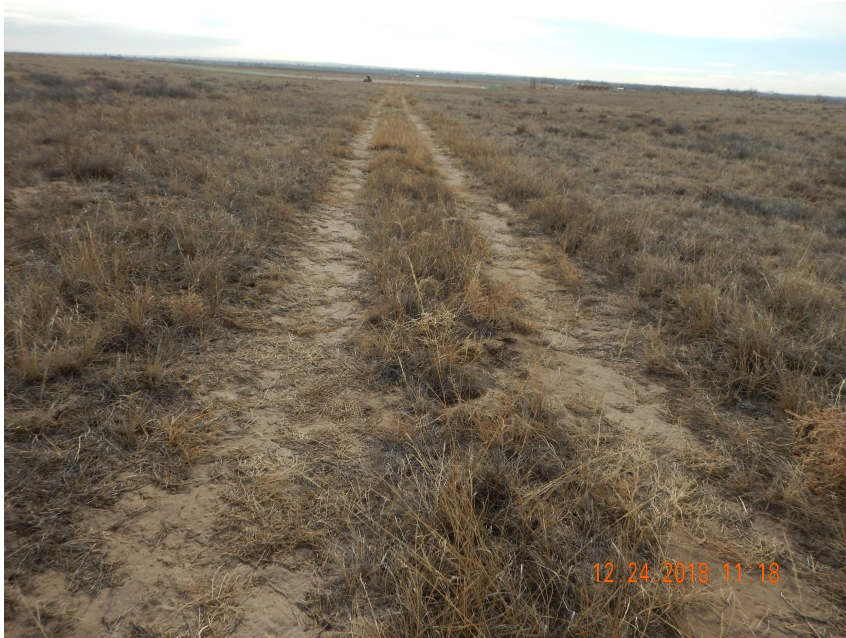
Photo 3. Photo taken from the northern well location access road, facing South. See comments under Photo 1.

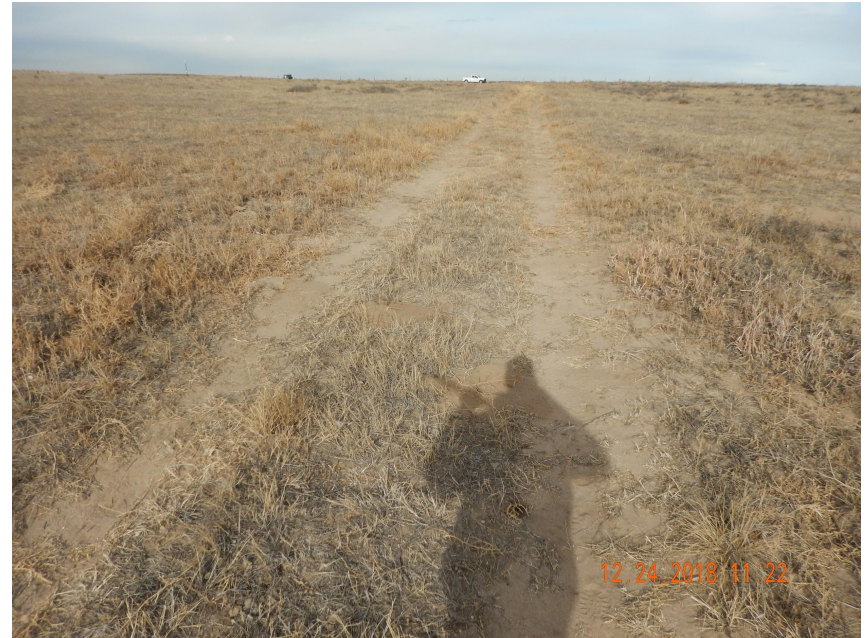
Photo 4. Photo taken from the southern well location access road, facing North. See comments under Photo 1.

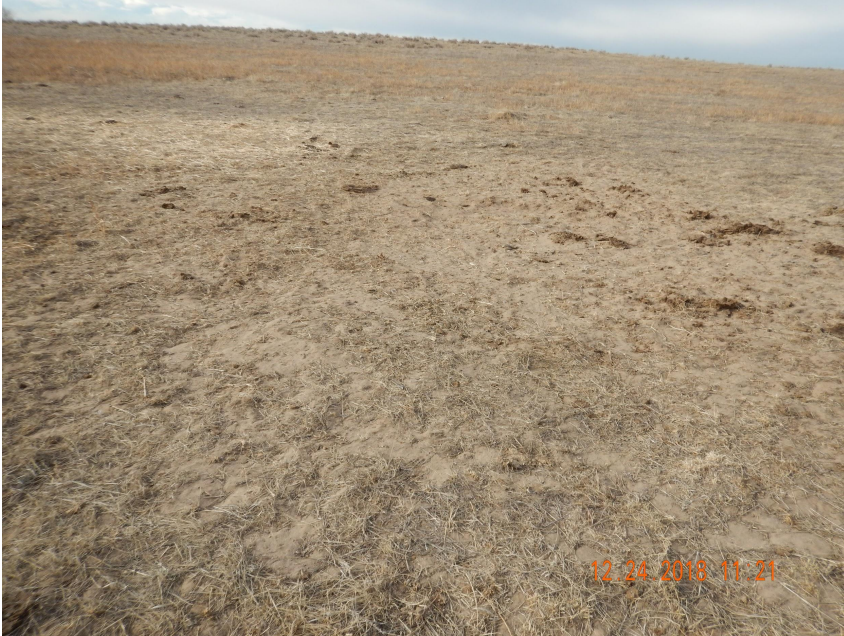
Photo 5. Photo taken from the approximate well location, facing West. Well location area is not reflective of reference area vegetation. Much of the well location is bare or has sparse vegetation establishment.

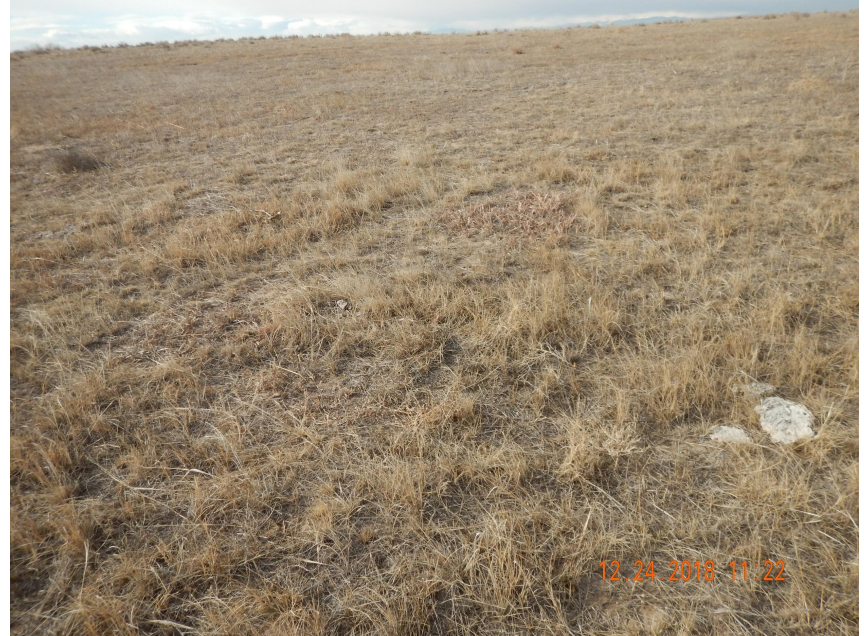
Photo 6. Reference photo taken west of the well location, facing West. See comments under Photo 4.
