Final Reclamation Inspection

Operator: NOBLE ENERGY INC- #100322

API: 05-123-14978

Inspection Photos
Location Name: STATE #18-1
API: 05-123-14978

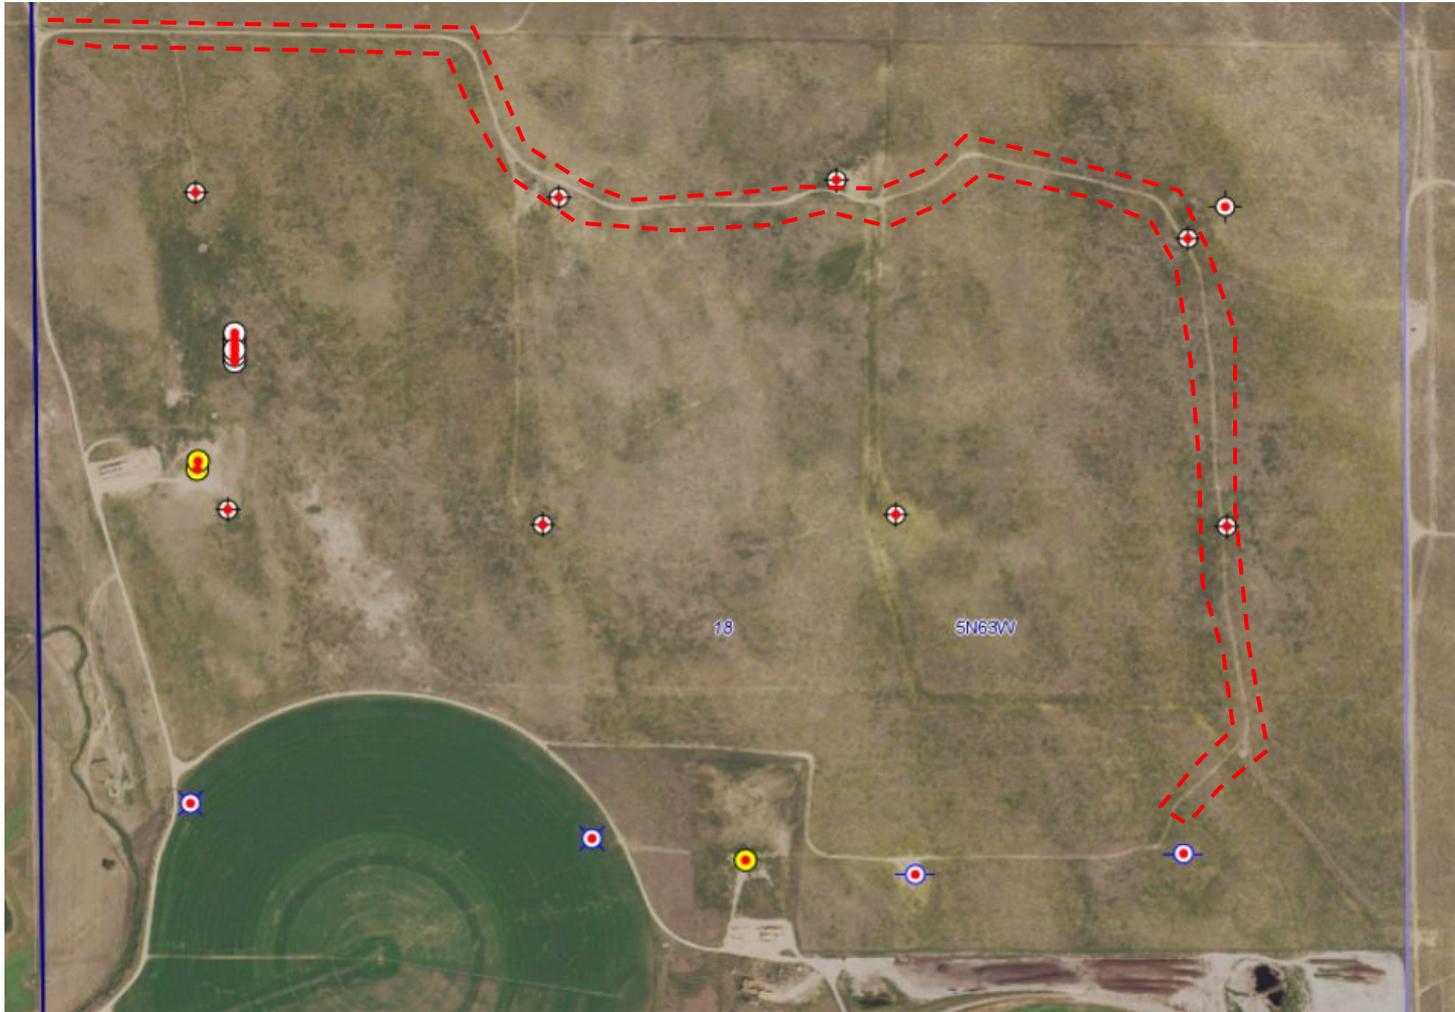
COGCC GISOnline aerial imagery from 2017. The main access road (highlighted in the red-dashed line) is no longer in need for oil and gas operations and historic imagery indicates this was not a pre-existing road. All associated wells and facilities have been plugged and abandoned along the main access road. Last well plugged along the main access road was 8/3/2015.

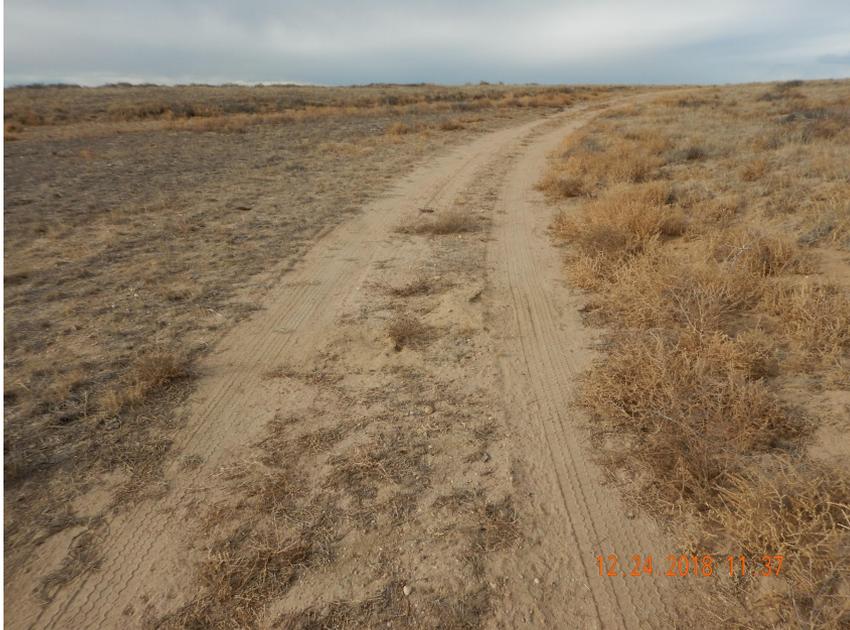
Photo 1. Photo taken from the main access road (shown in the aerial image), facing West. Operator has failed to reclaim the access road per Rule 1004 standards (e.g., recontour, decompact, etc.). Wind erosion was observed along portions of the main access road.

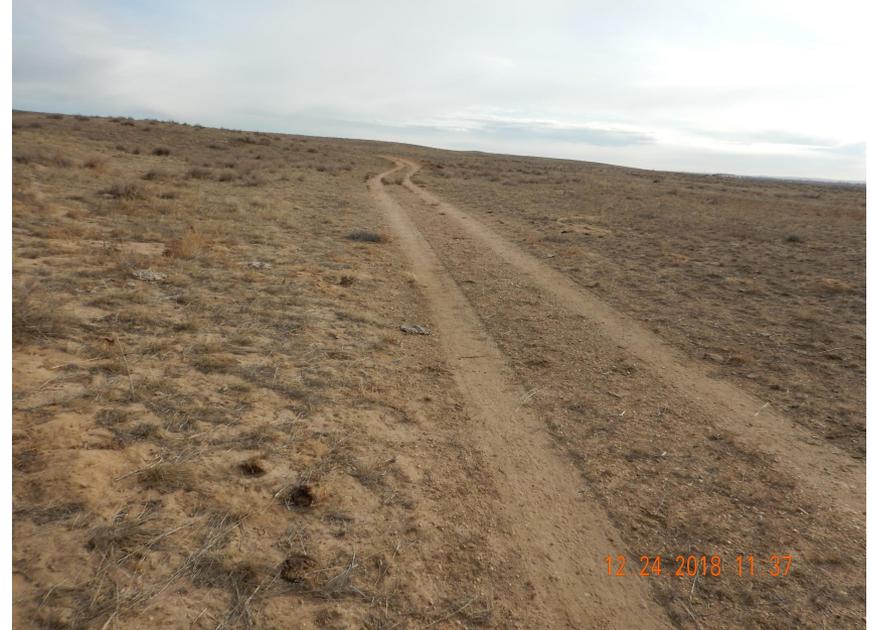
Photo 2. Photo taken from the main access road (shown in the aerial image), facing East. See comments under Photo 1.

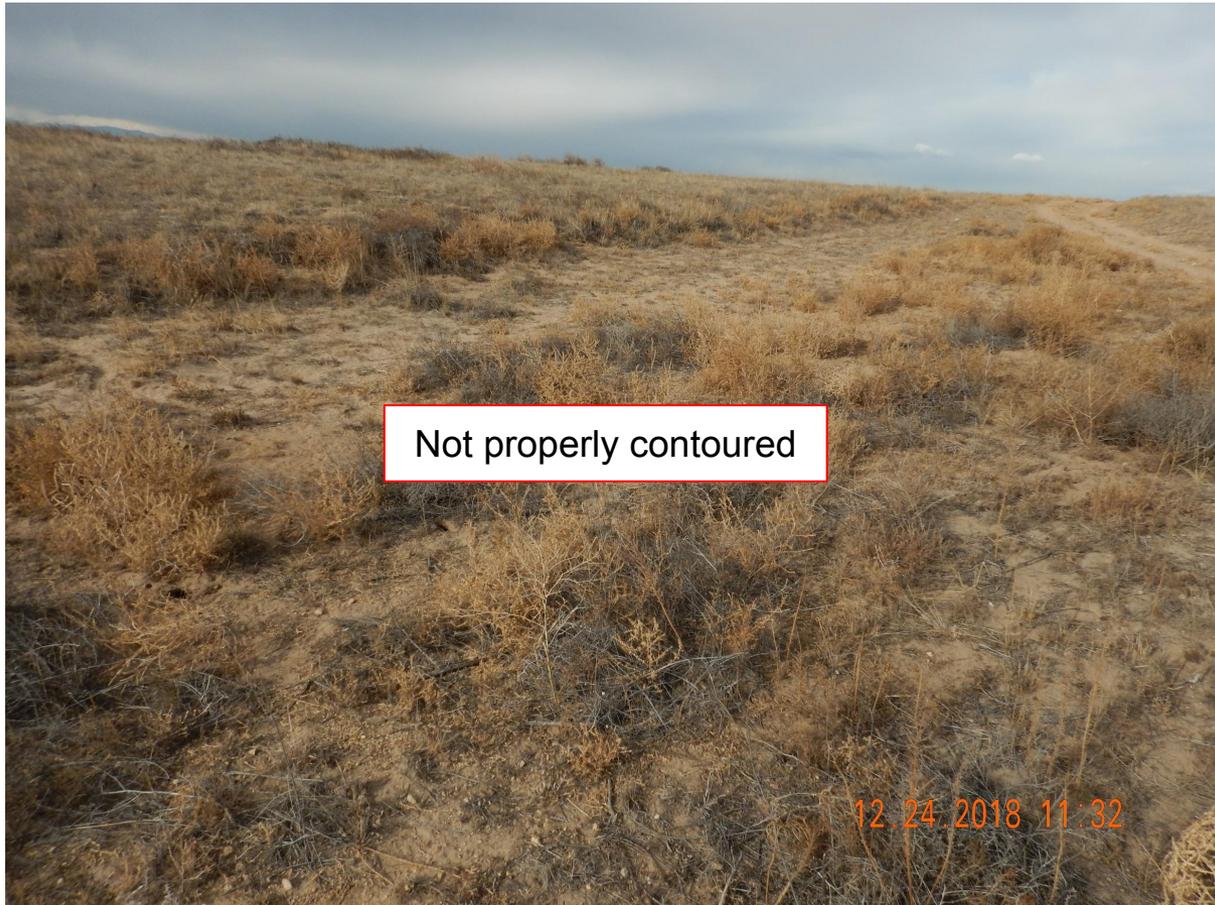
Photo 3. Photo taken from the northwestern location, facing East. Operator has failed to reclaim the location per Rule 1004 standards (e.g., recontour). Area is not reflective of reference area vegetation. Patches of Russian thistle, shown above, were observed.

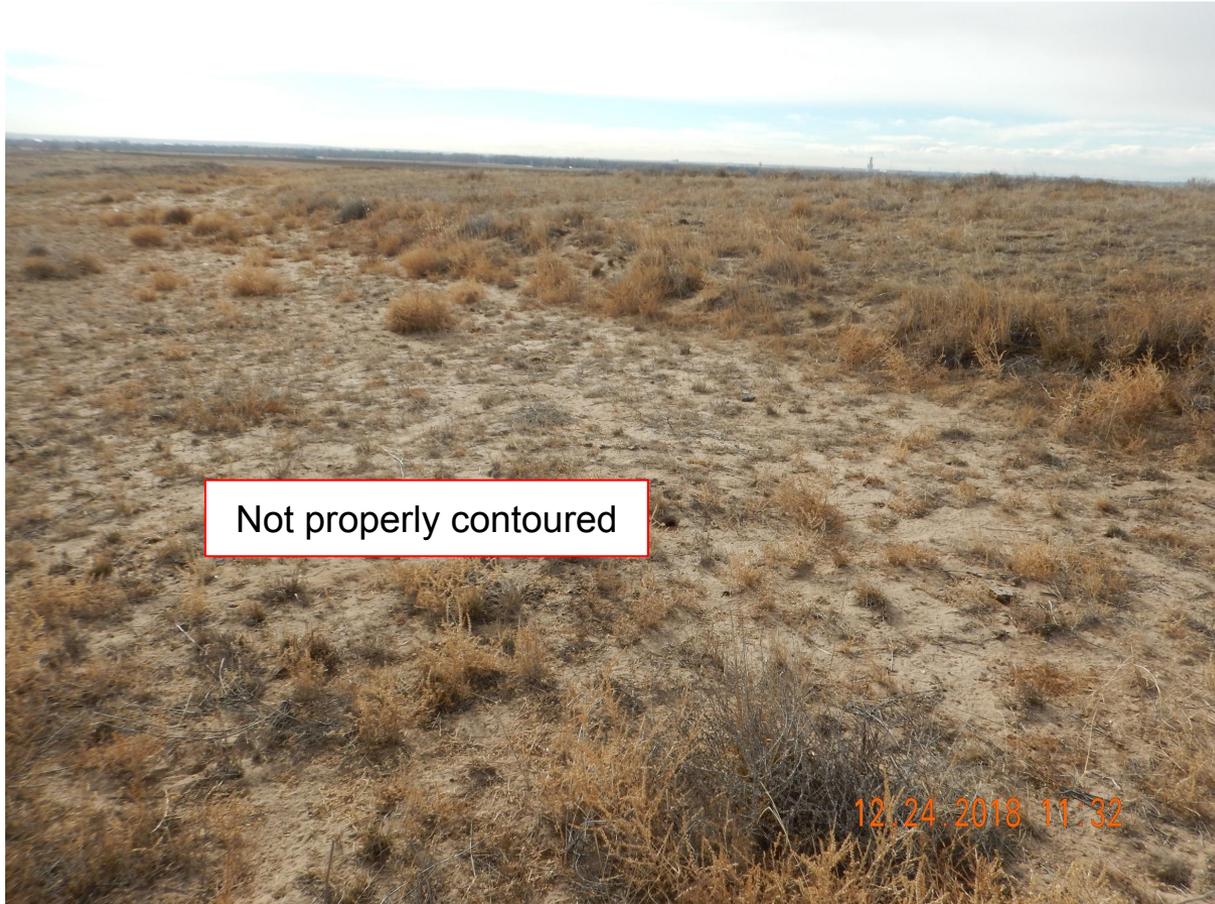
Photo 4. Photo taken from the northwestern location, facing South. See comments under Photo 3.

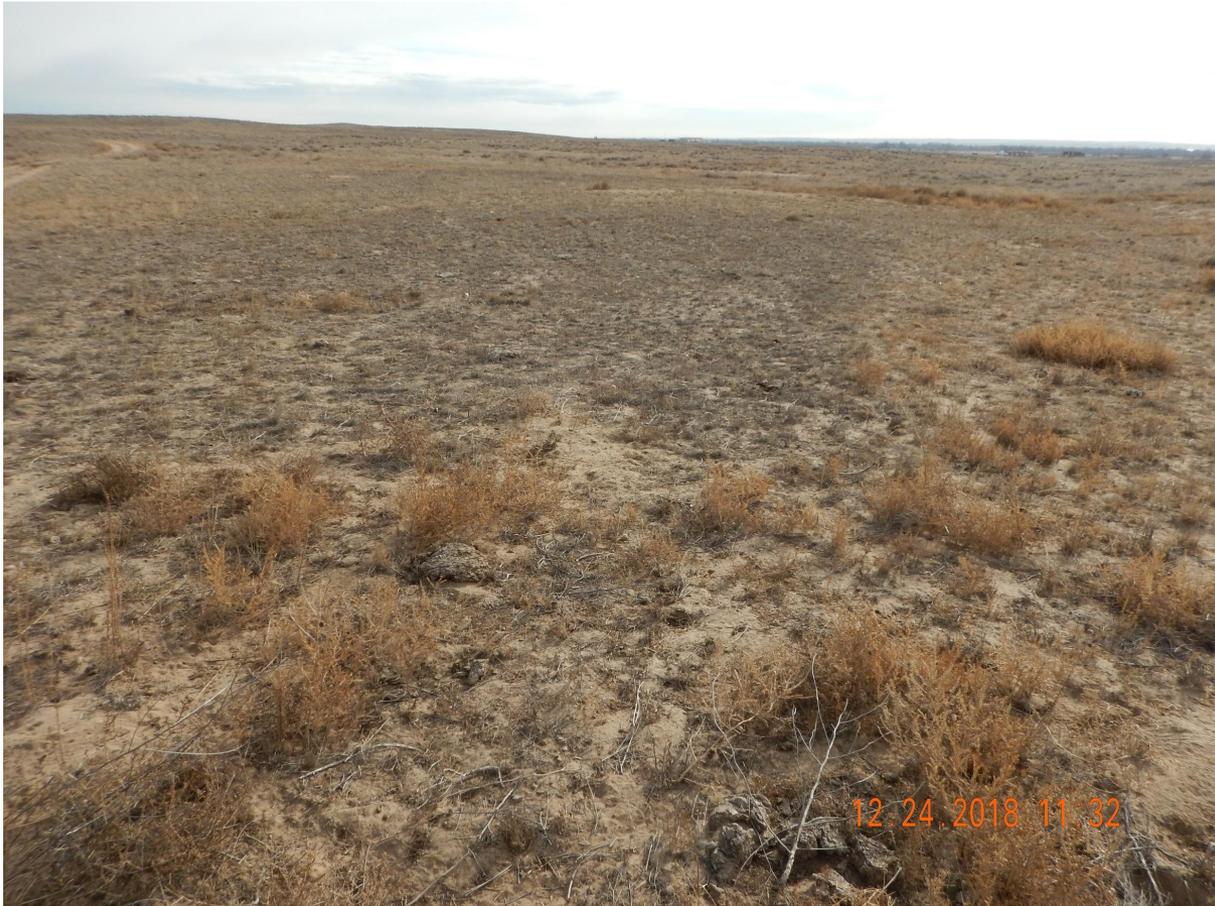
Photo 5. Photo taken from the northwestern location, facing East. Operator has seeded the disturbance area but the vegetation planted is not reflective of reference area vegetation- see Photos 6 & 7.

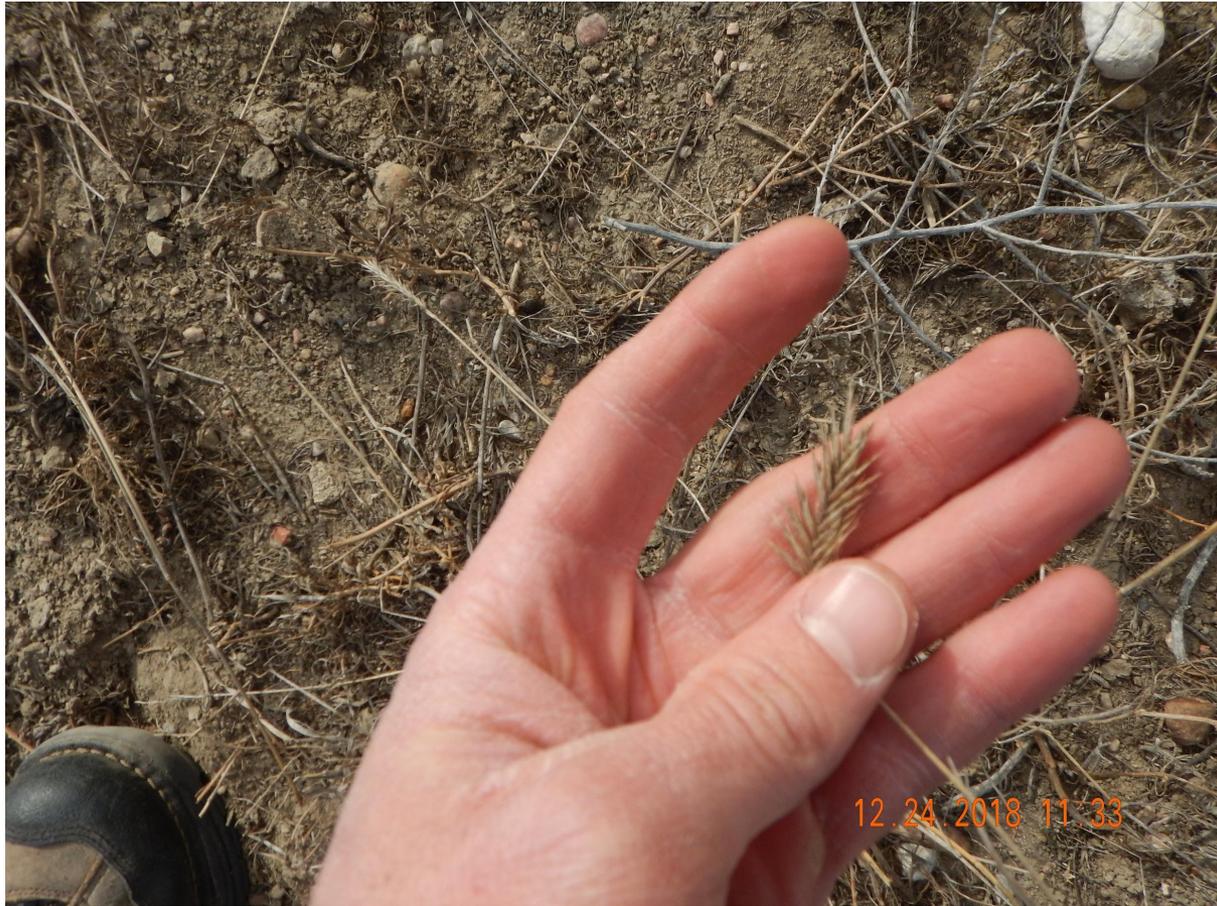
Photo 6. Photo taken from the location. Most of the vegetation appears to be Crested wheatgrass (*Agropyron cristatum*)- shown in the photo. Some Smooth brome (*Bromus inermis*) was also observed; both species are introduced not native. Reference area vegetation consists of the following, but not limited to, sand dropseed (*Sporobolus cryptandrus*), prairie sandreed (*Calamovilfa longifolia*), blue grama (*Bouteloua gracilis*) and sand sage (*Artemisia filifolia*).

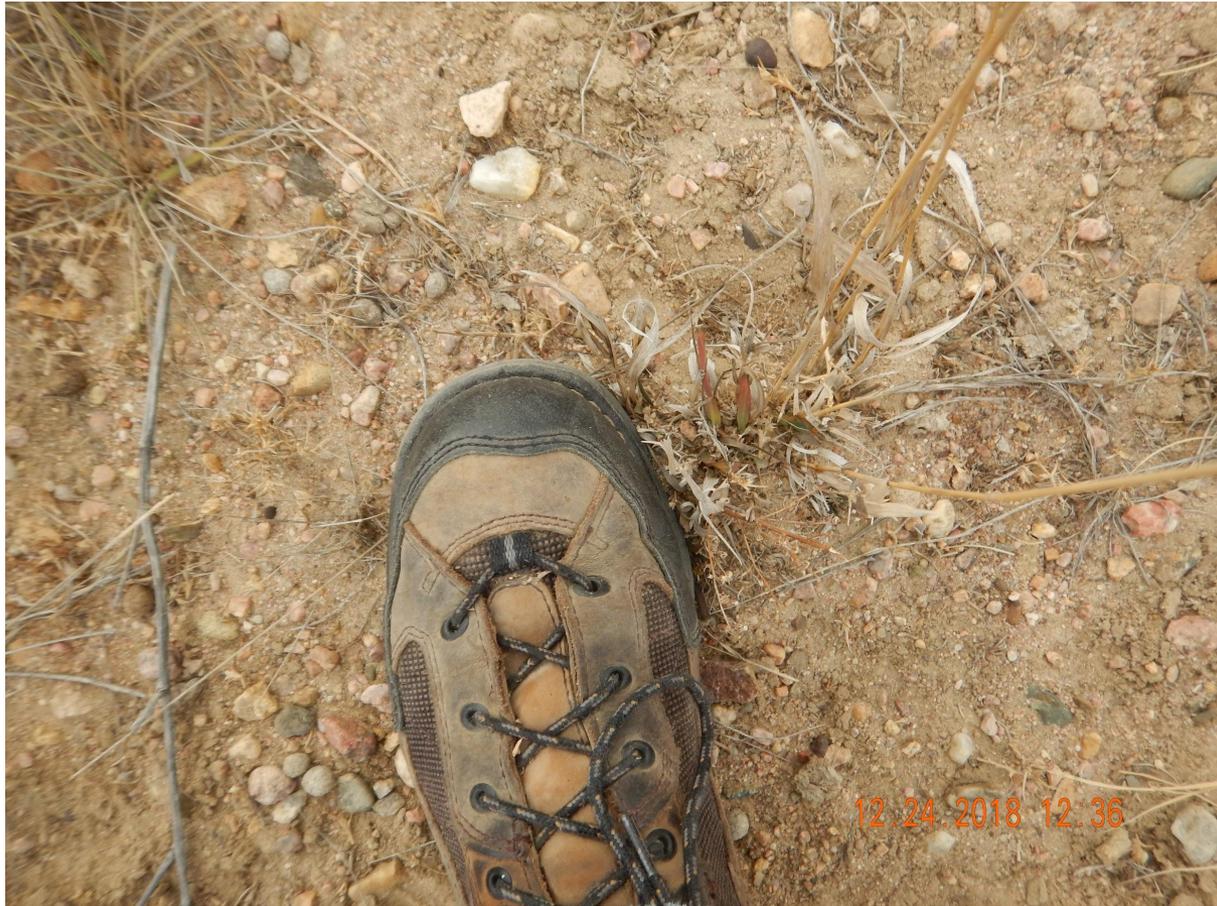
Photo 7. Photo taken from the location. Photo illustrates what appears to be Smooth brome (*Bromus inermis*).

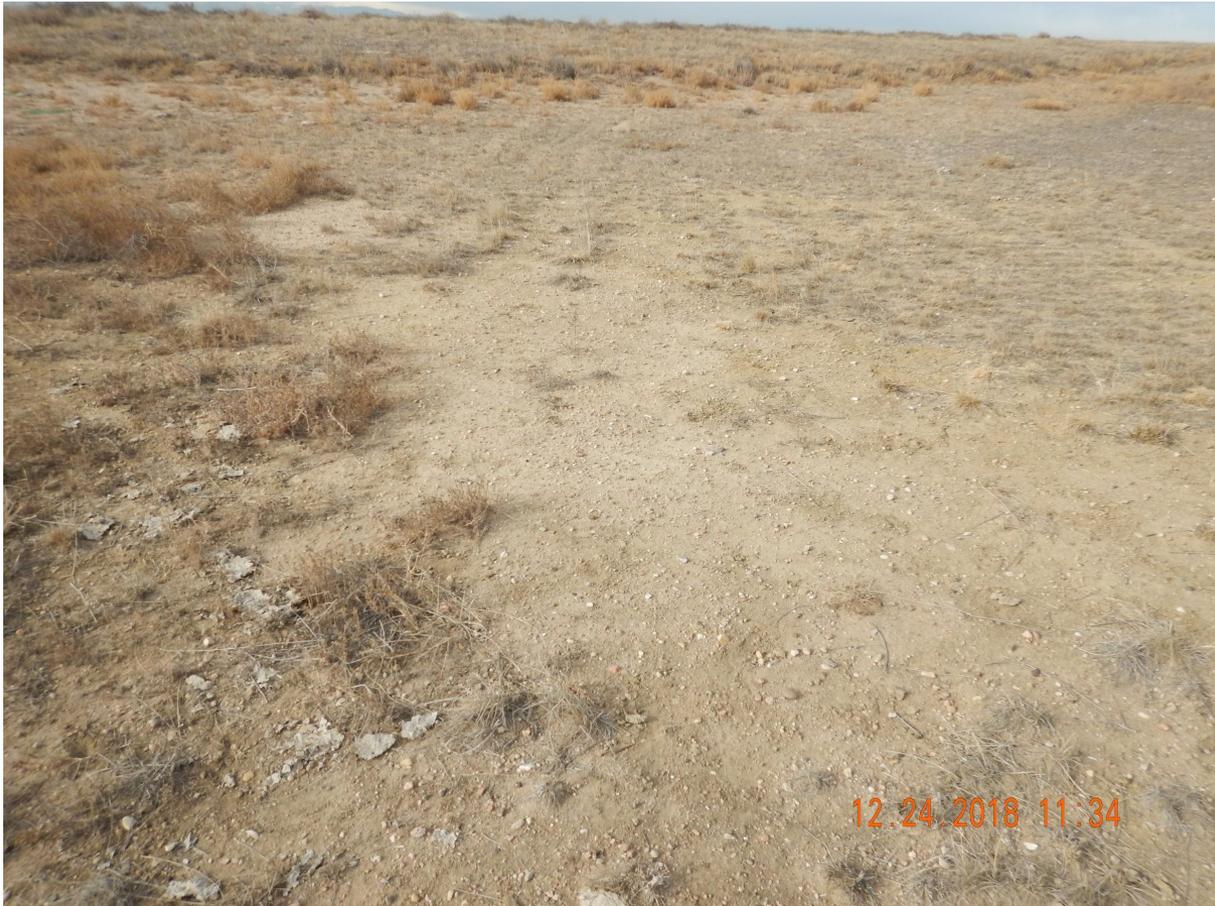
Photo 8. Photo taken from the southwestern location, facing West. Photo illustrates bare patches with no vegetation.

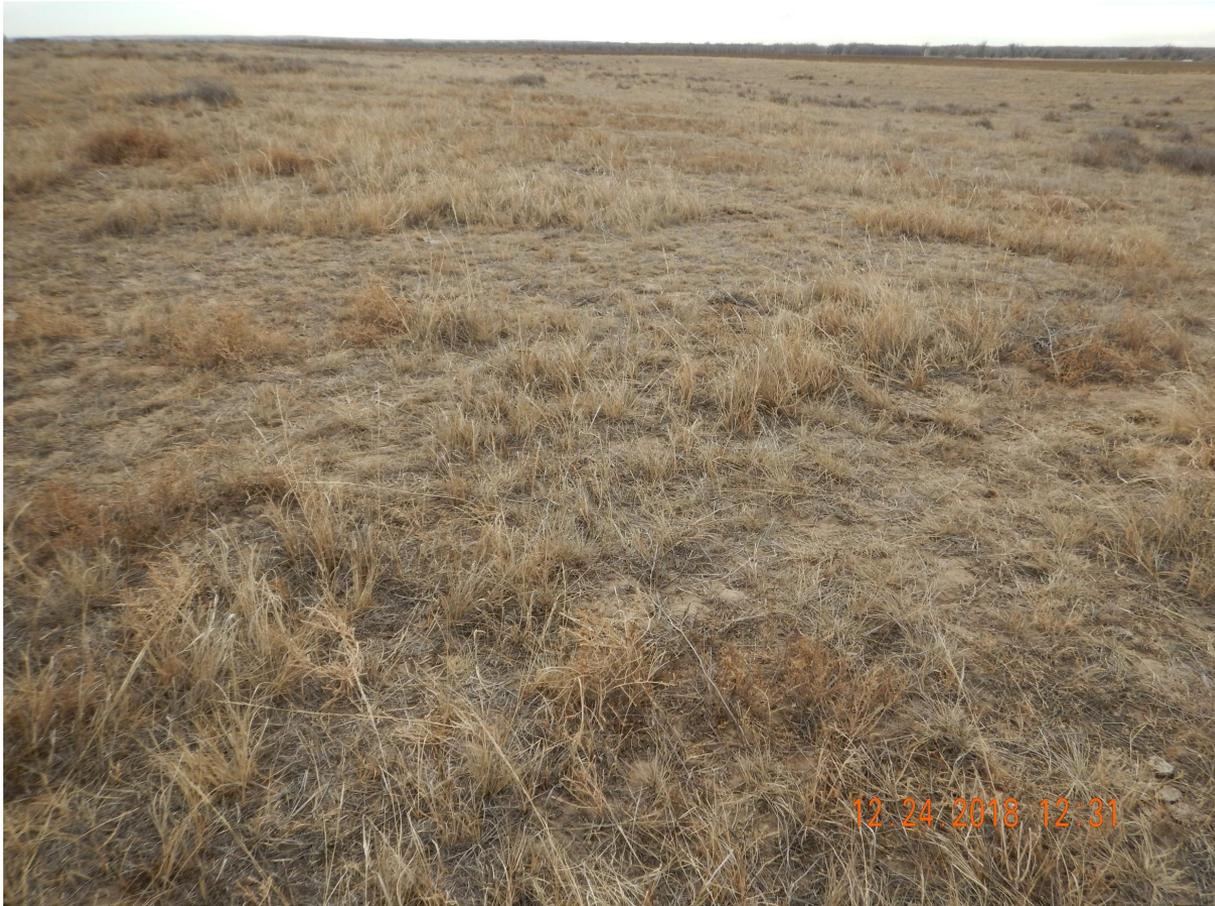
Photo 9. Reference photo taken south of the location, facing Southwest. Reference area vegetation consists of the following, but not limited to, sand dropseed (*Sporobolus cryptandrus*), prairie sandreed (*Calamovilfa longifolia*), blue grama (*Bouteloua gracilis*) and sand sage (*Artemisia filifolia*).
