# Final Reclamation Inspection

Operator: NOBLE ENERGY INC- #100322

API: 05-123-19279

Location Name: DKW GREEN STATE #BB 18-07

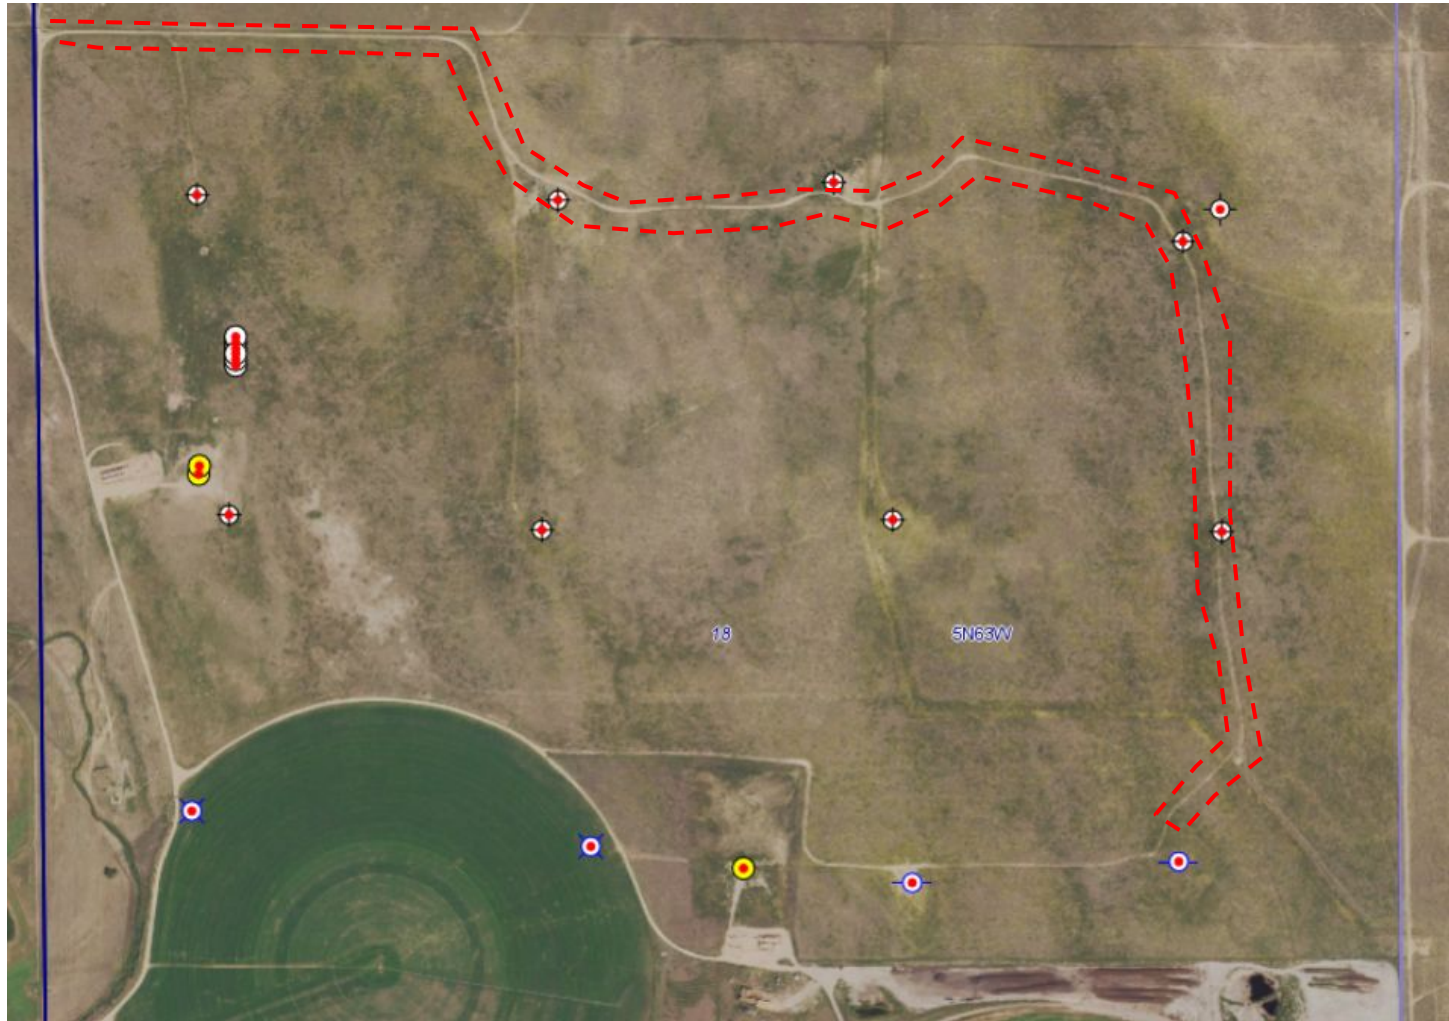
COGCC GISOnline aerial imagery from 2017. The main access road (highlighted in the red-dashed line) is no longer in need for oil and gas operations and historic imagery indicates this was not a pre-existing road. All associated wells and facilities have been plugged and abandoned along the main access road. Last well plugged along the main access road was 8/3/2015.

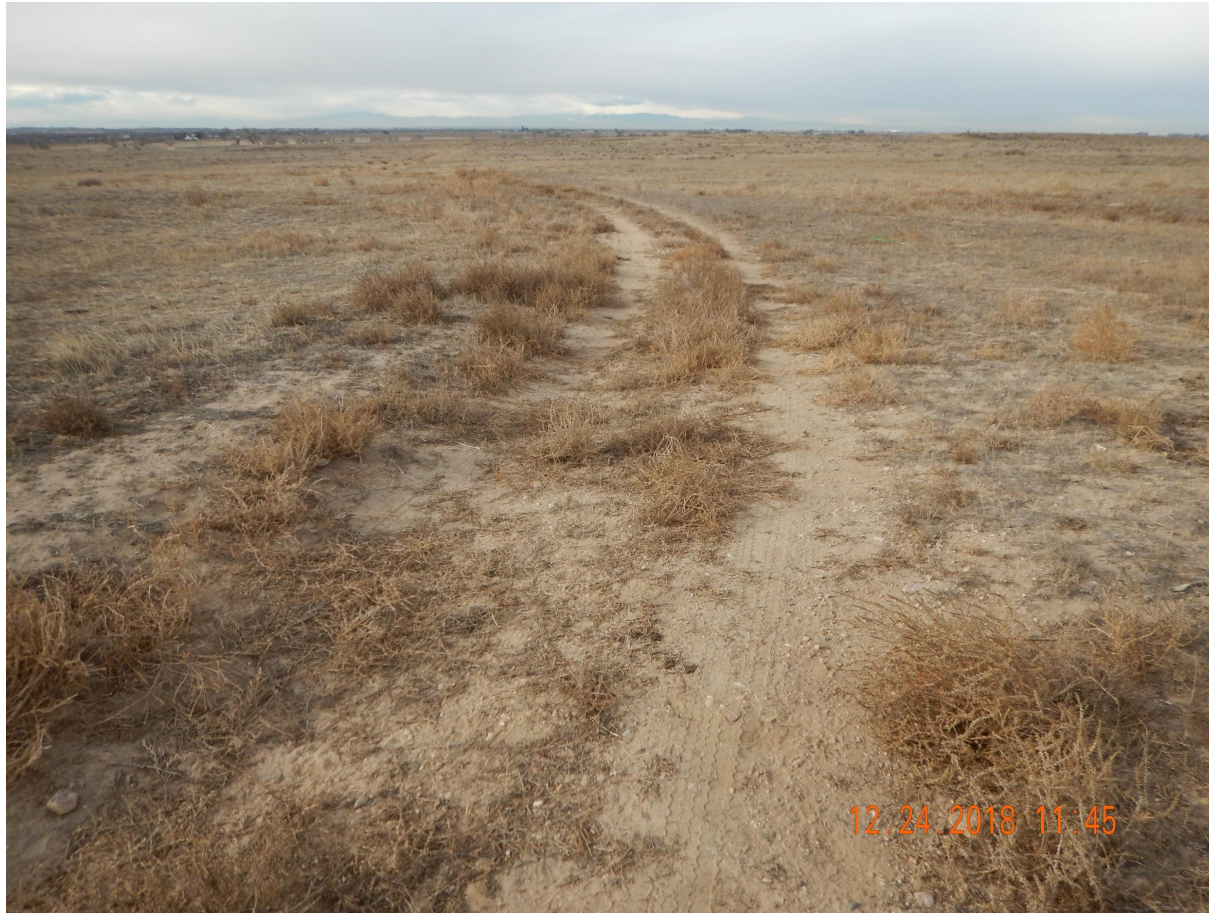
**Photo 1.** Photo taken from the main access road (shown in the aerial image), facing West. Operator has failed to reclaim the access road per Rule 1004 standards (e.g., recontour, decompact, etc.). Wind erosion and Russian thistle, annual weed, was observed along portions of the main access road.

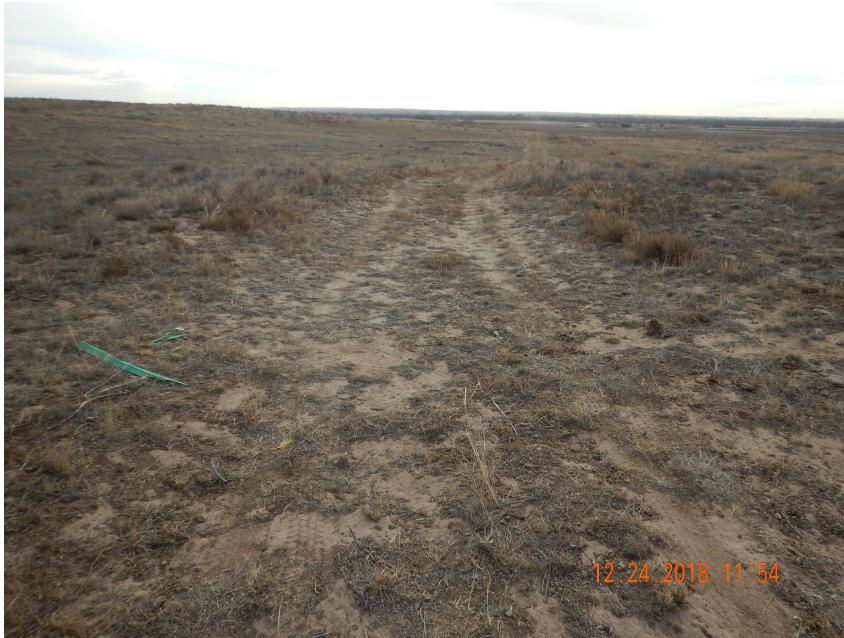
**Photo 2.** Photo taken from the northern well location access road, facing South. Operator has failed to reclaim the well location access road per Rule 1004 standards (e.g., recontour). Patches of Russian thistle were observed along portions of the access road and bare patches with no vegetation.

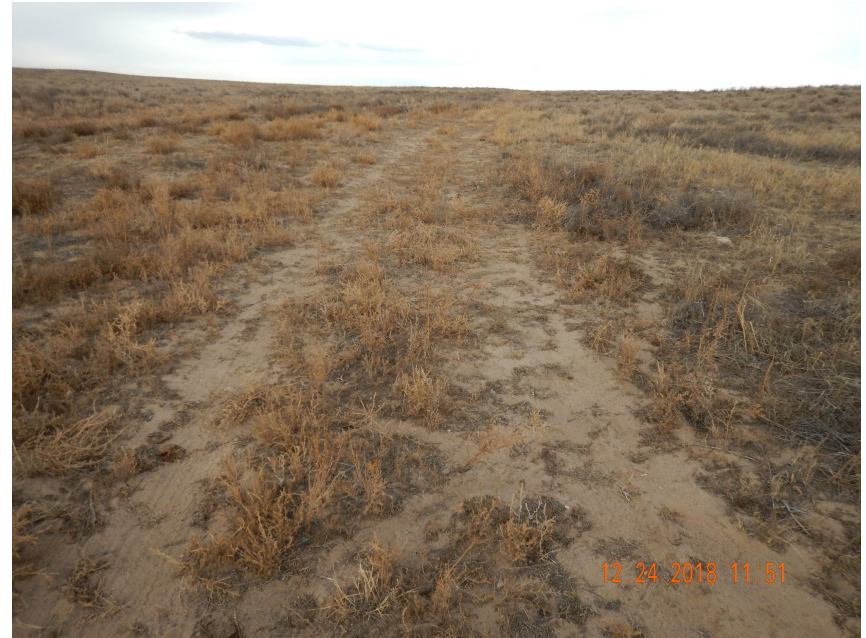
**Photo 3.** Photo taken from the central well location access road, facing North. See comments under Photo 2.

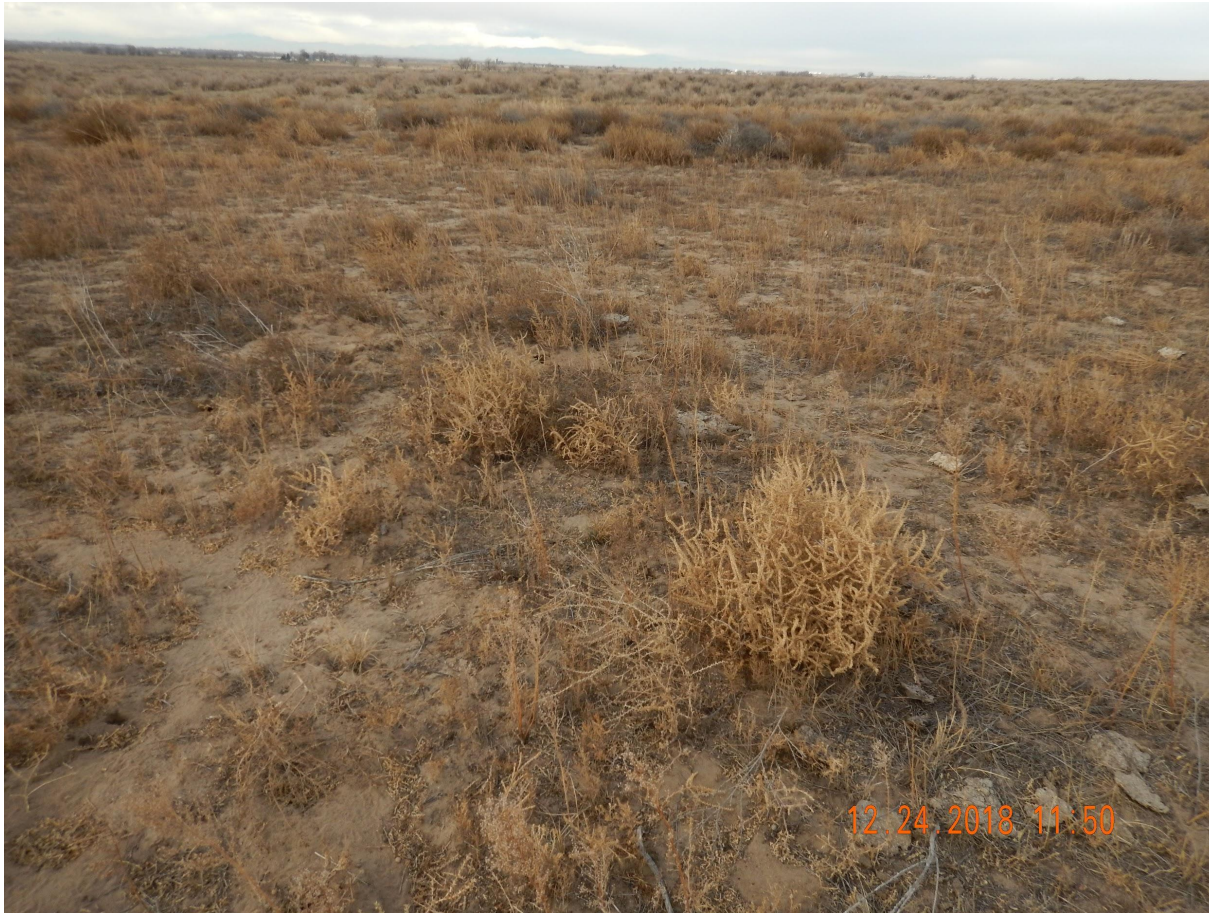
**Photo 4.** Photo taken from the central well location, facing West. Patches of Russian thistle were observed throughout the location and little to no desirable vegetation which is not reflective of reference areas.

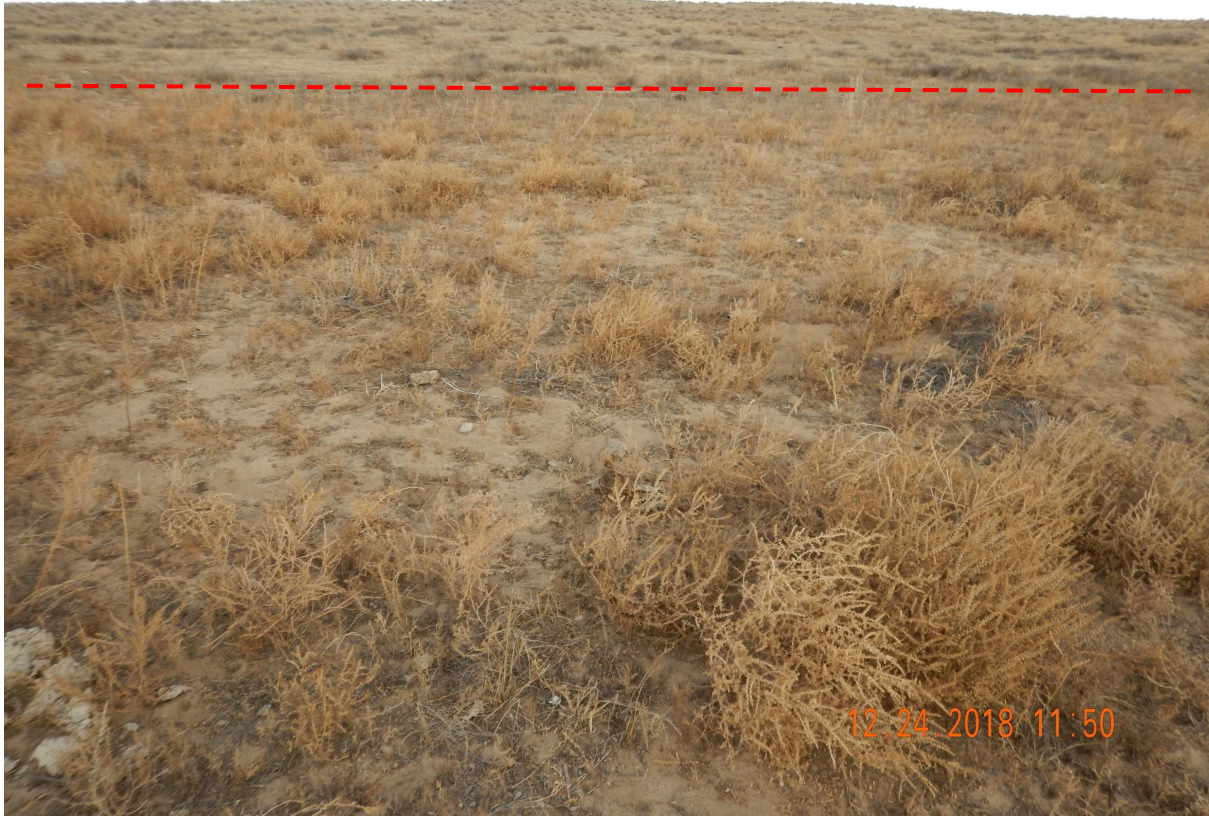
**Photo 5.** Photo taken from the central well location, facing East. See comments under Photo 4.

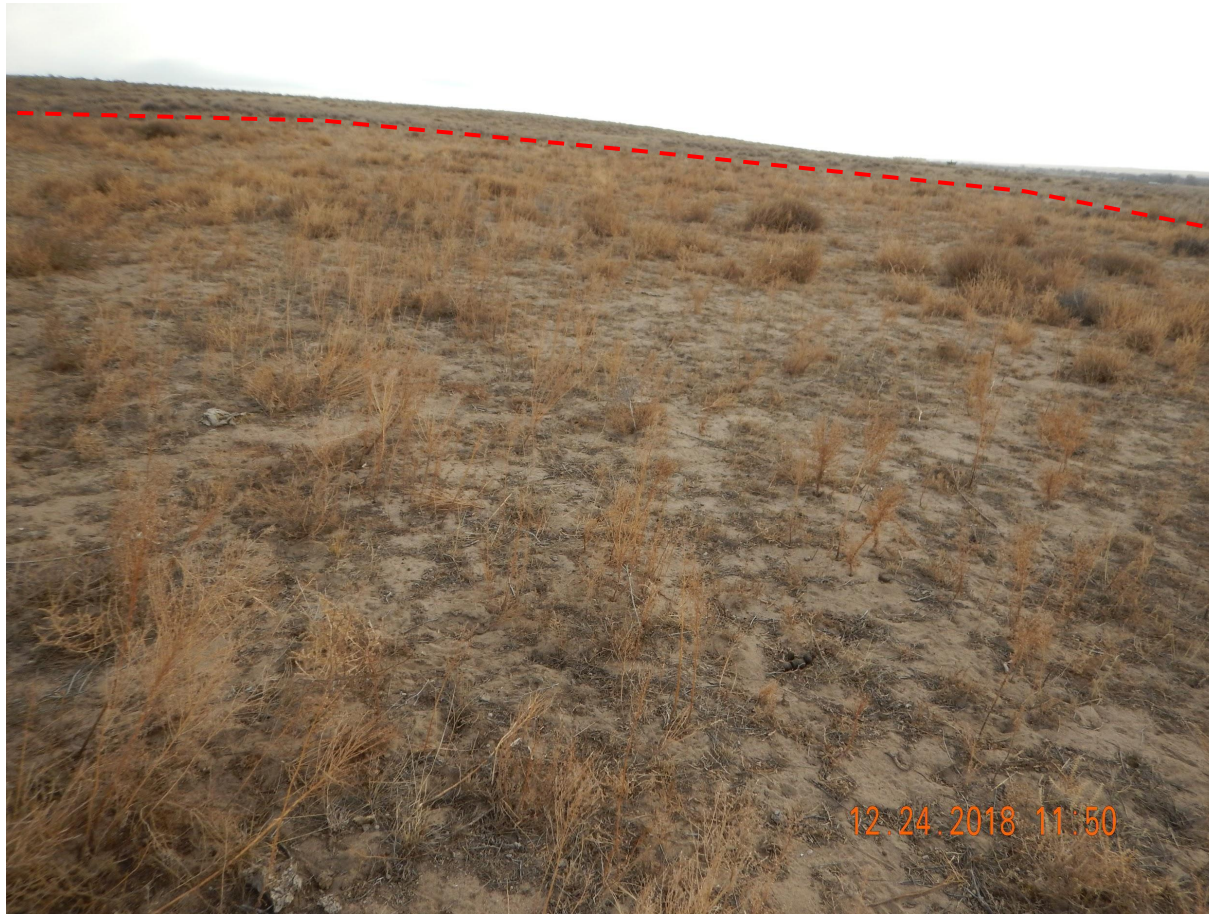
**Photo 6.** Photo taken from the central well location, facing South. See comments under Photo 4.
