Location Name: Champlin 205 Amoco A-1    API: 017-06248    Inspection Date: 12/26/2018

**COLORADO**  
Oil & Gas Conservation  
Commission  
Department of Natural Resources

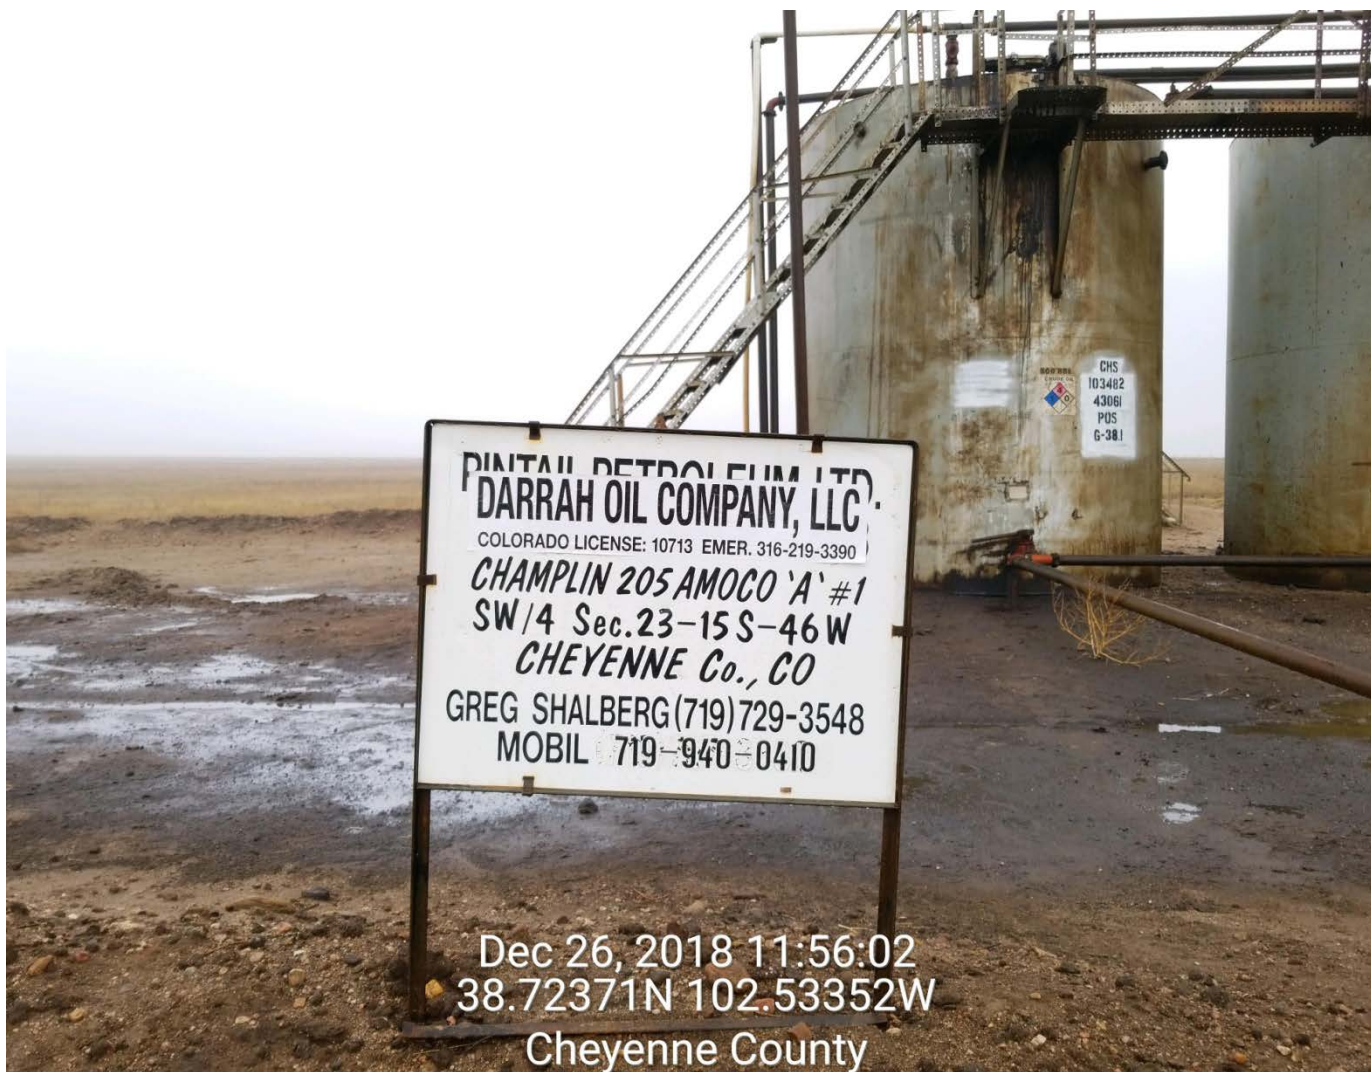
Dec 26, 2018 11:56:02  
38.72371N 102.53352W  
Cheyenne County

Containment berm wet from stormwater. Localized stained soil found in the northwest corner of containment.

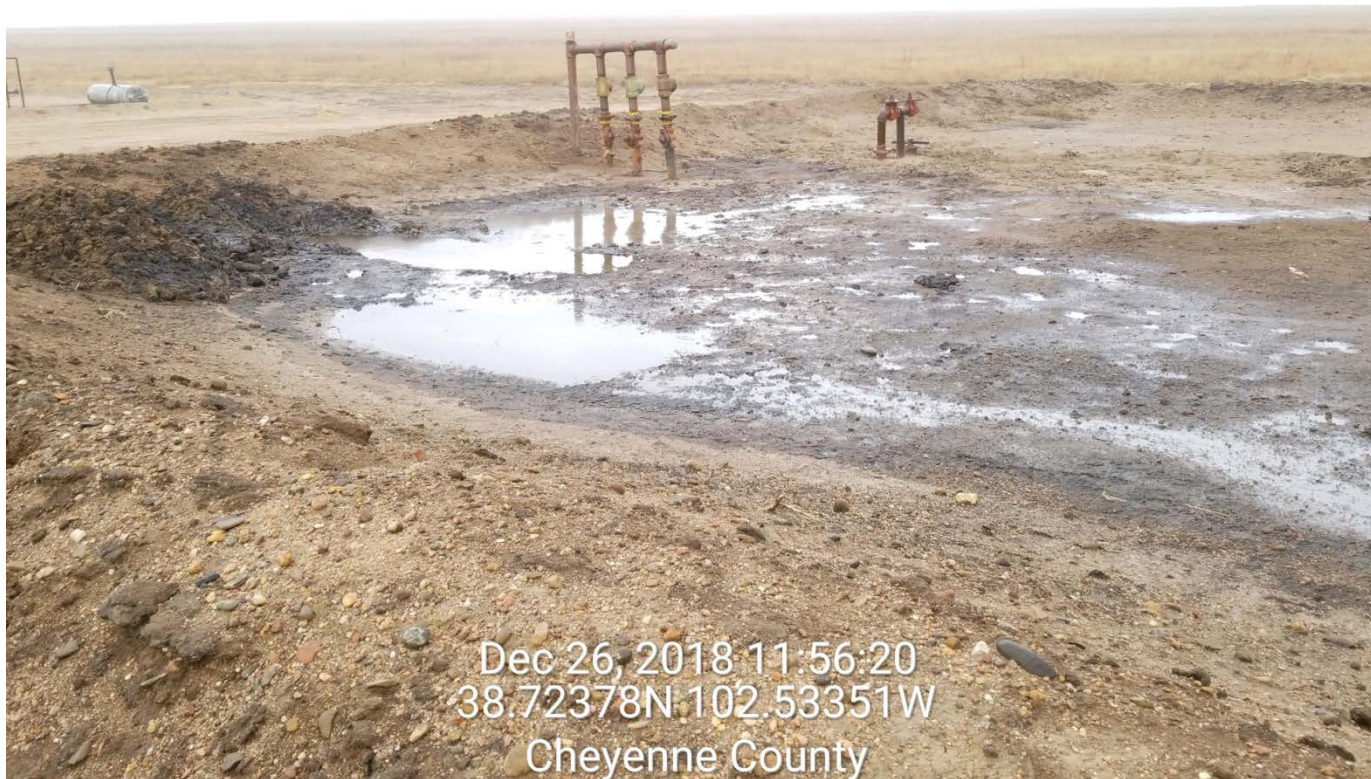
Dec 26, 2018 11:56:20  
38.72378N 102.53351W  
Cheyenne County

Containment berm wet from stormwater. Localized stained soil found in the northwest corner of containment.

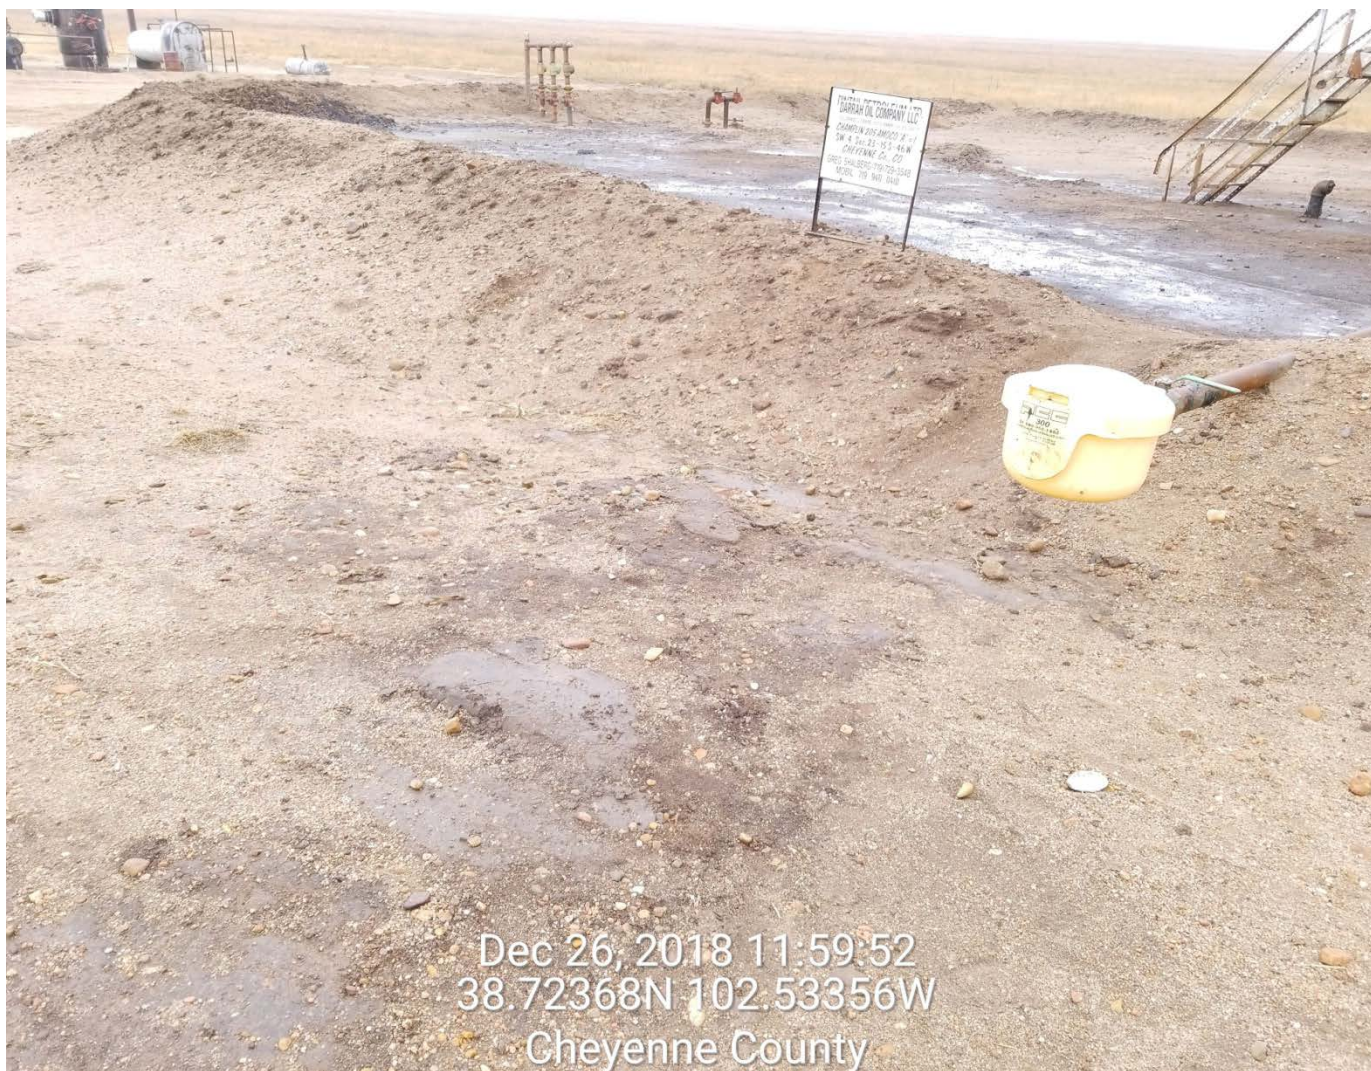
Dec 26, 2018 11:59:52  
38.72368N 102.53356W  
Cheyenne County

Stained soil near loadout.

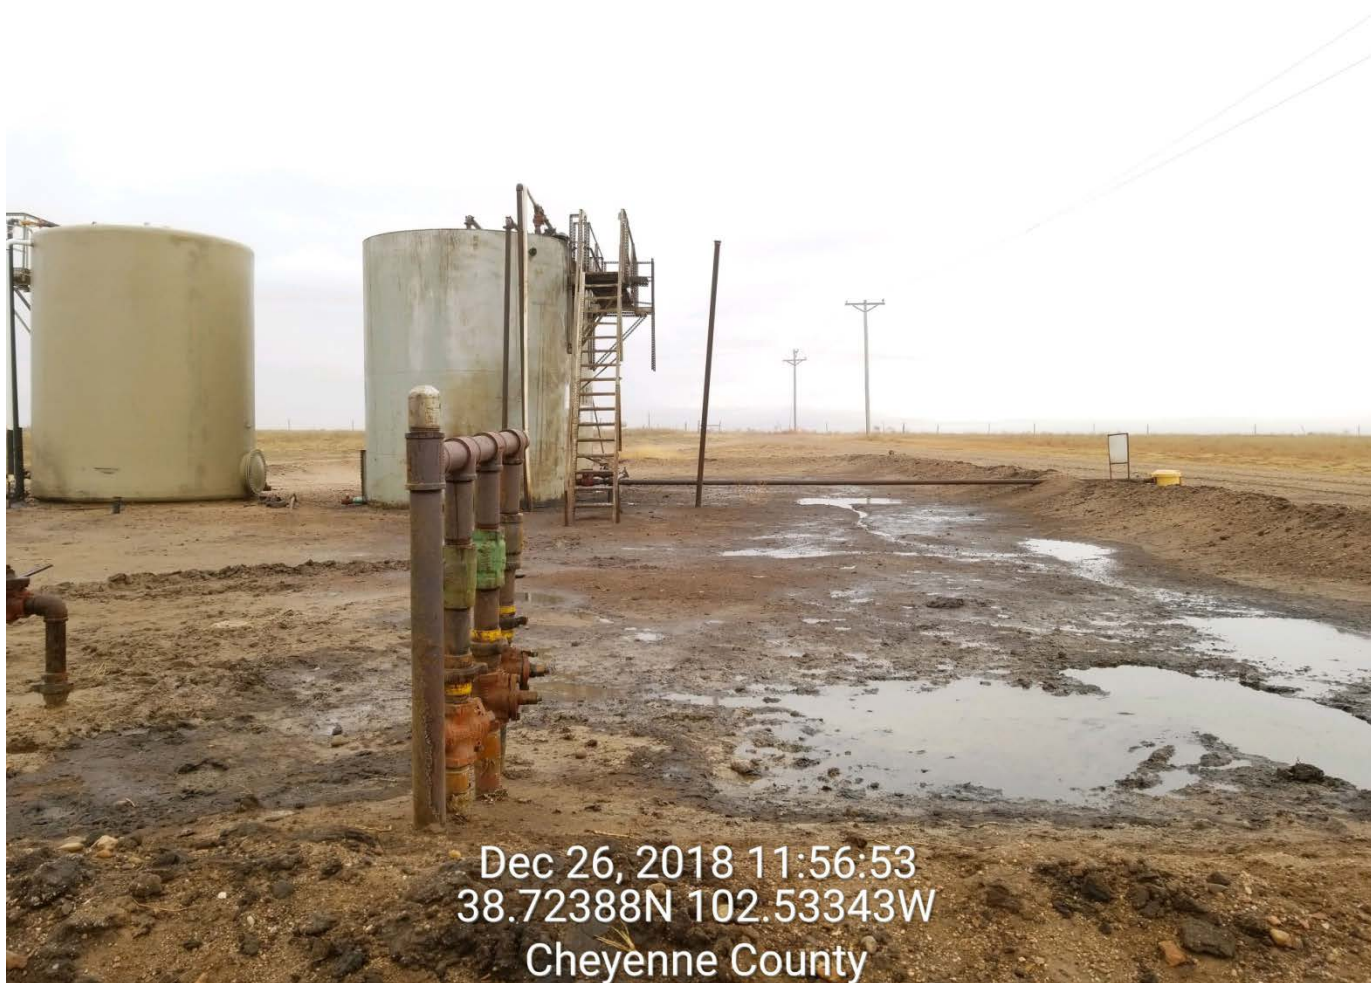
Dec 26, 2018 11:56:53  
38.72388N 102.53343W  
Cheyenne County

Containment berm wet from stormwater. Localized stained soil found in the northwest corner of containment.

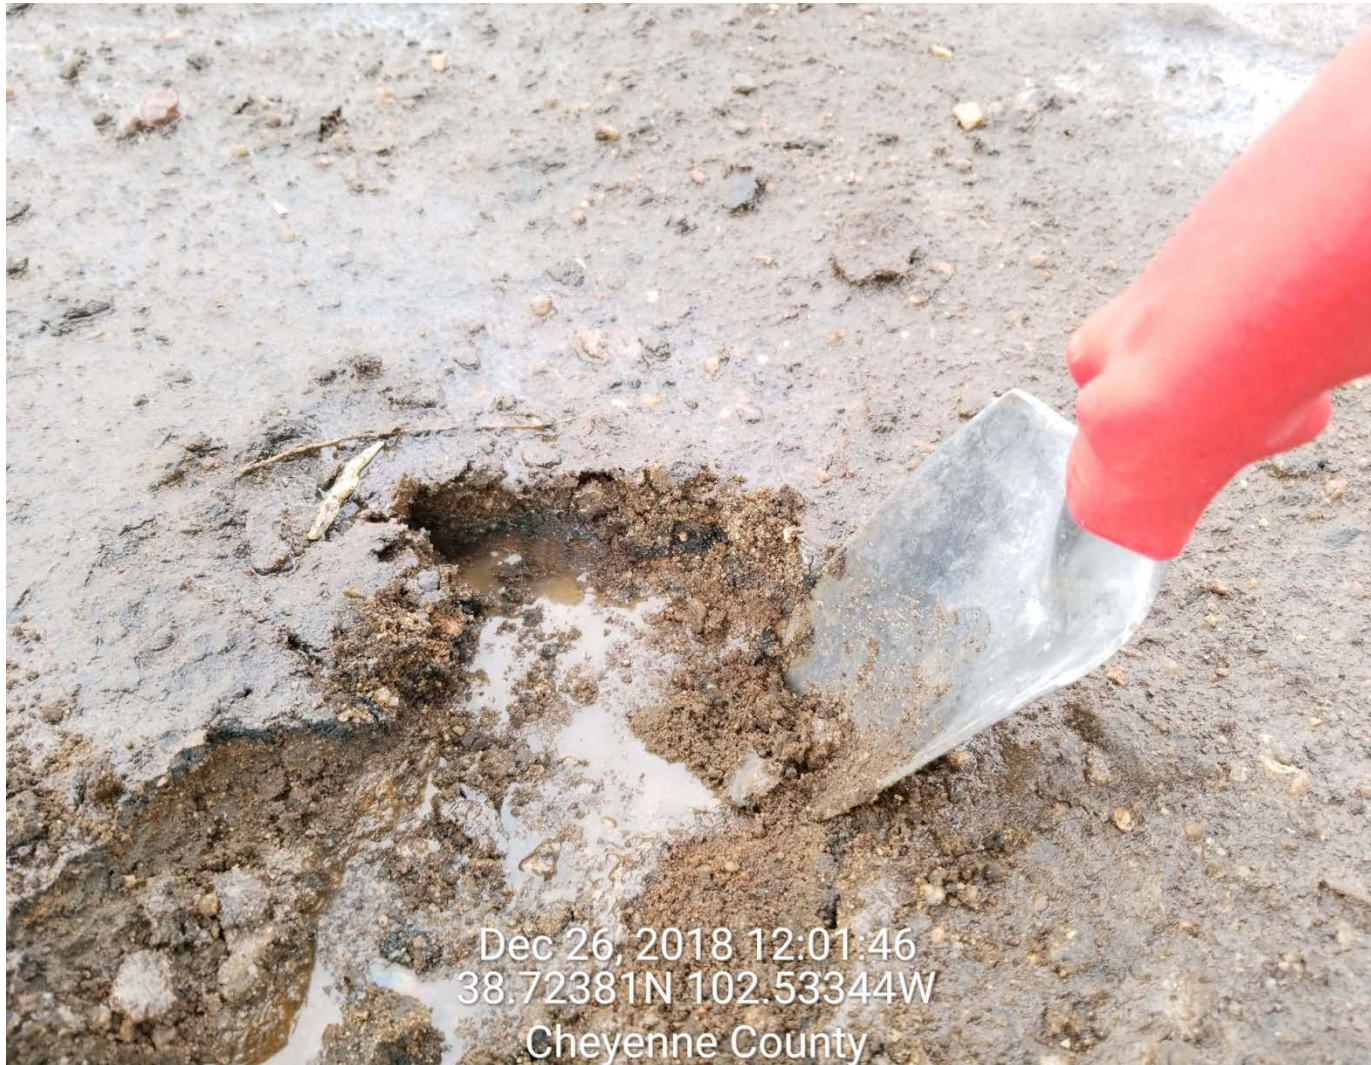
Dec 26, 2018 12:01:46  
38.72381N 102.53344W  
Cheyenne County

Oil saturation in top half inch of soil in the stained soil found in the northeast corner of containment.

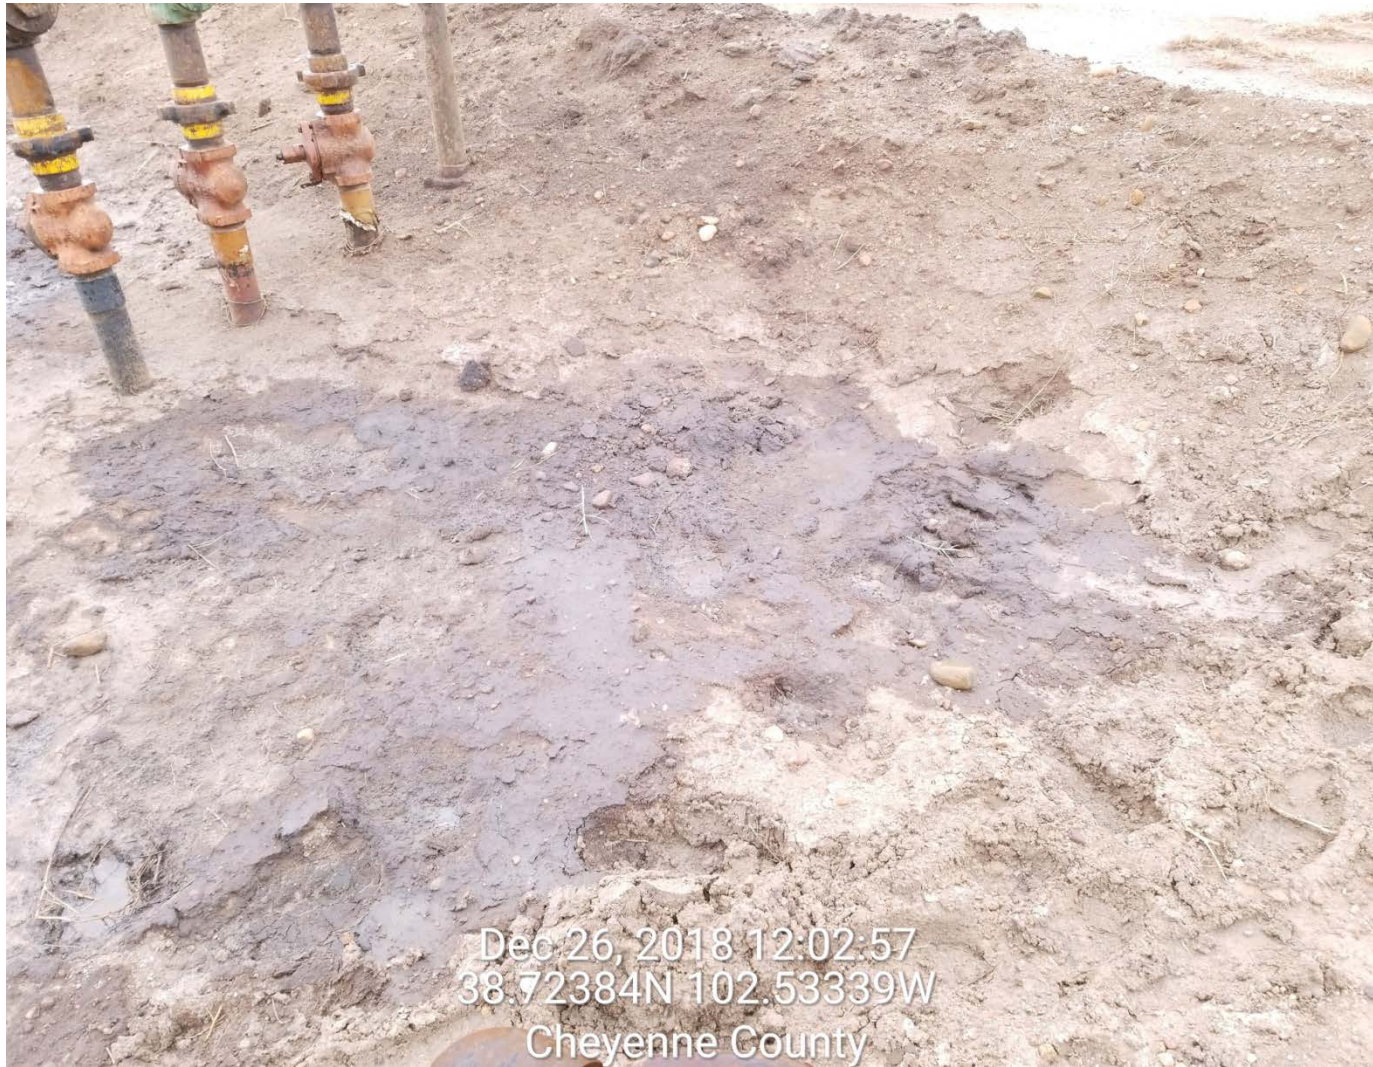
Stained soil in containment.

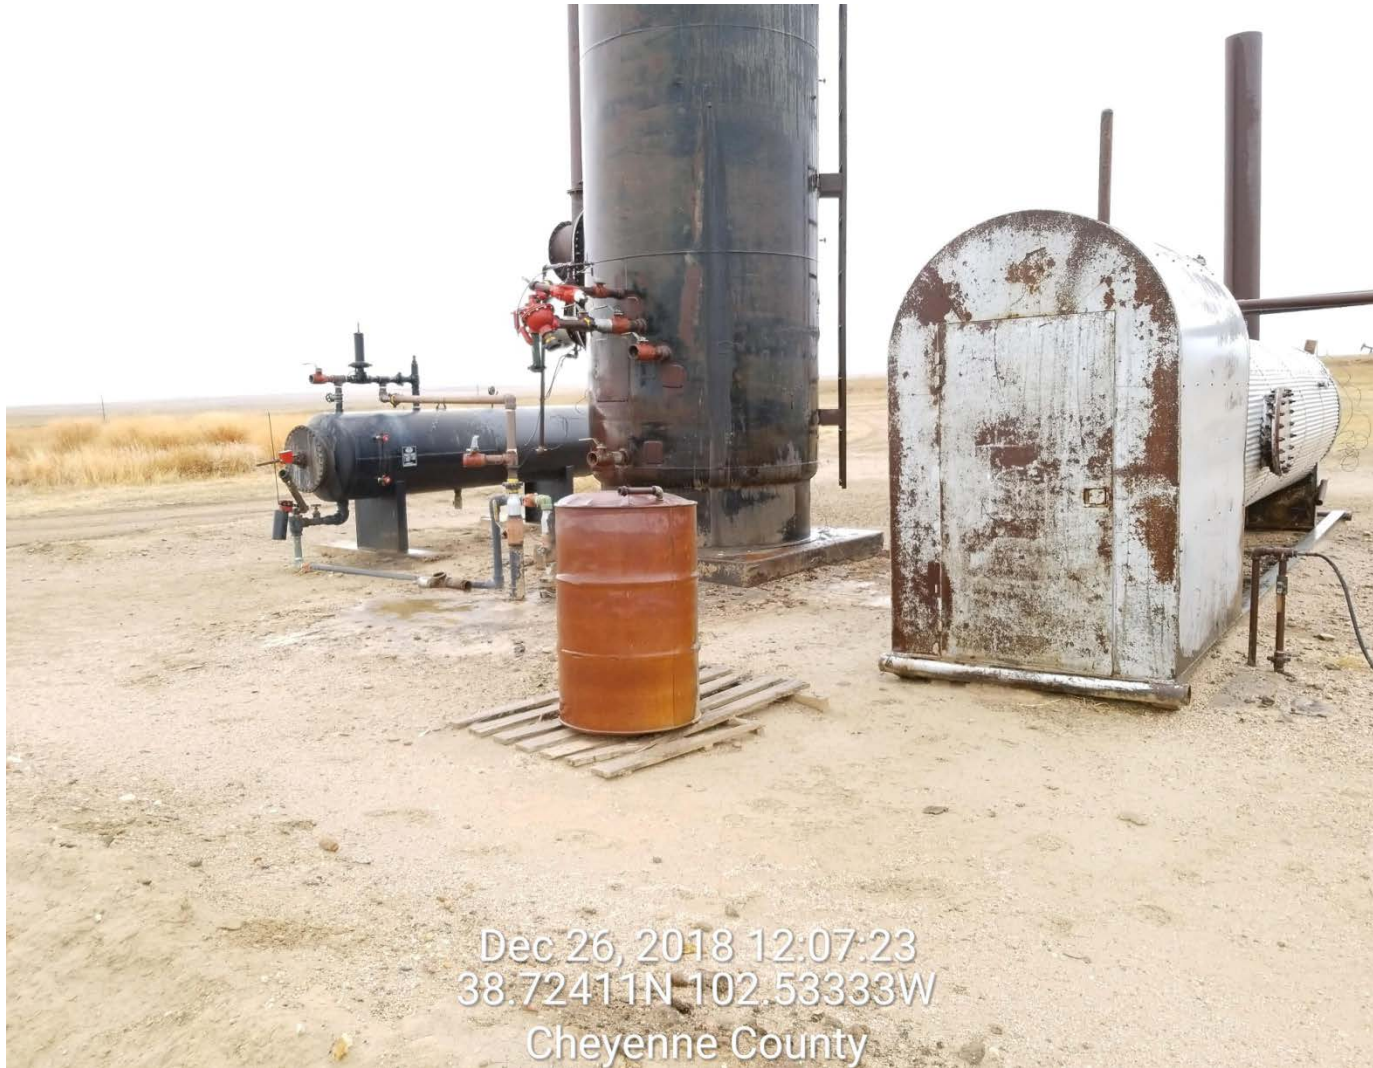
Dec 26, 2018 12:07:23  
38.72411N 102.53333W  
Cheyenne County

Unmarked open barrel that appeared to contain crude oil.

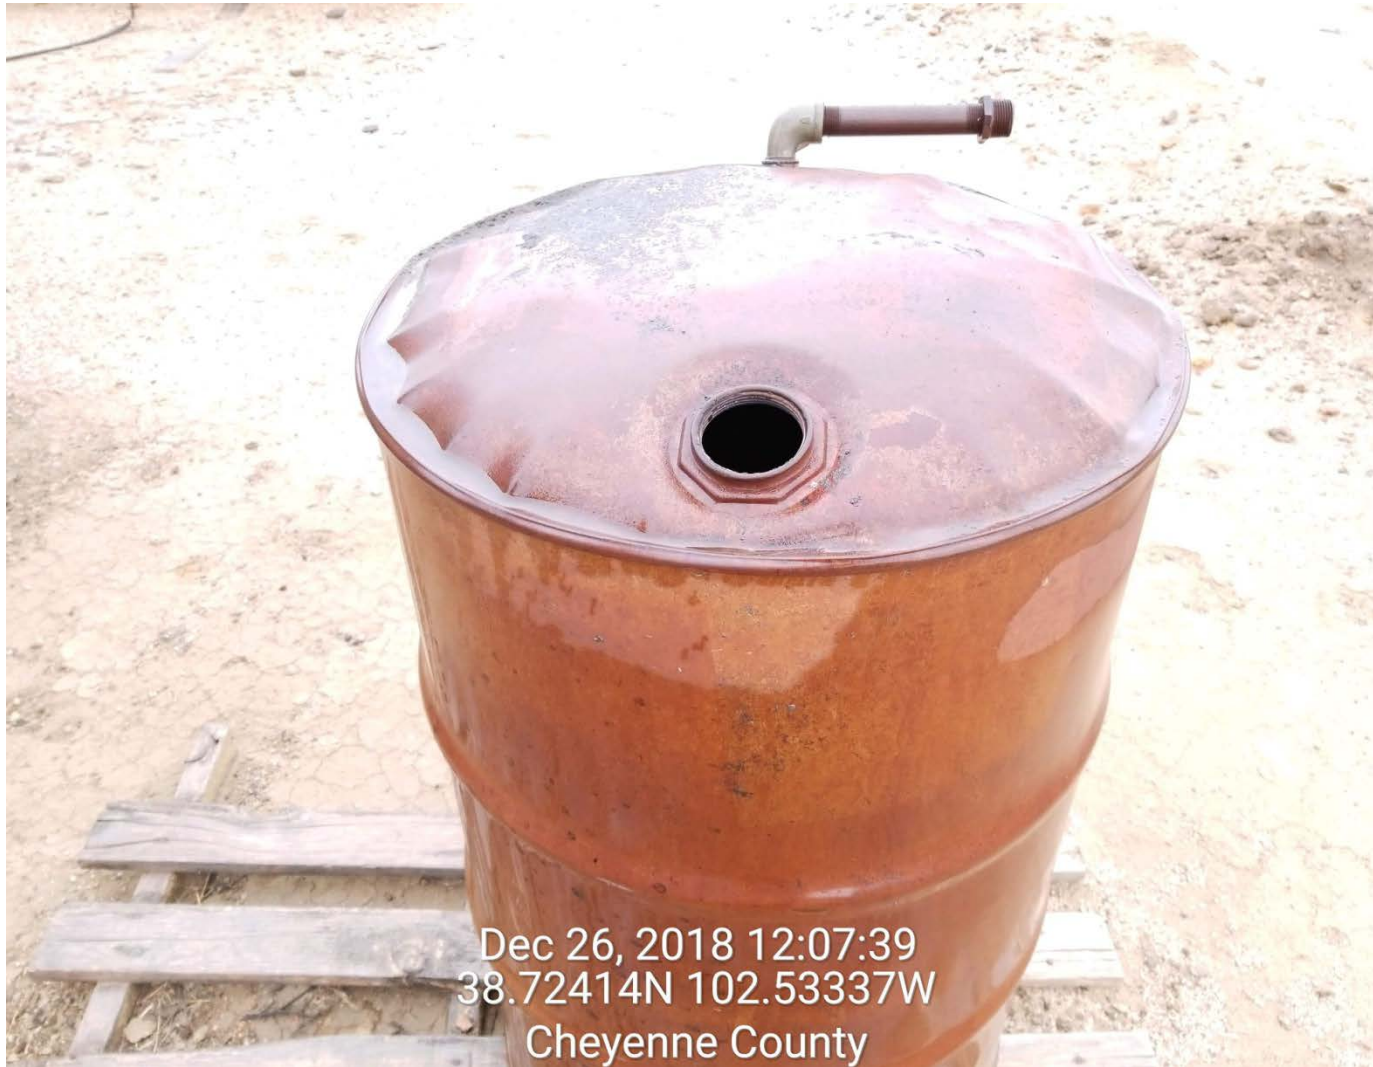
Dec 26, 2018 12:07:39  
38.7241N 102.53337W  
Cheyenne County

Unmarked open barrel that appeared to contain crude oil.

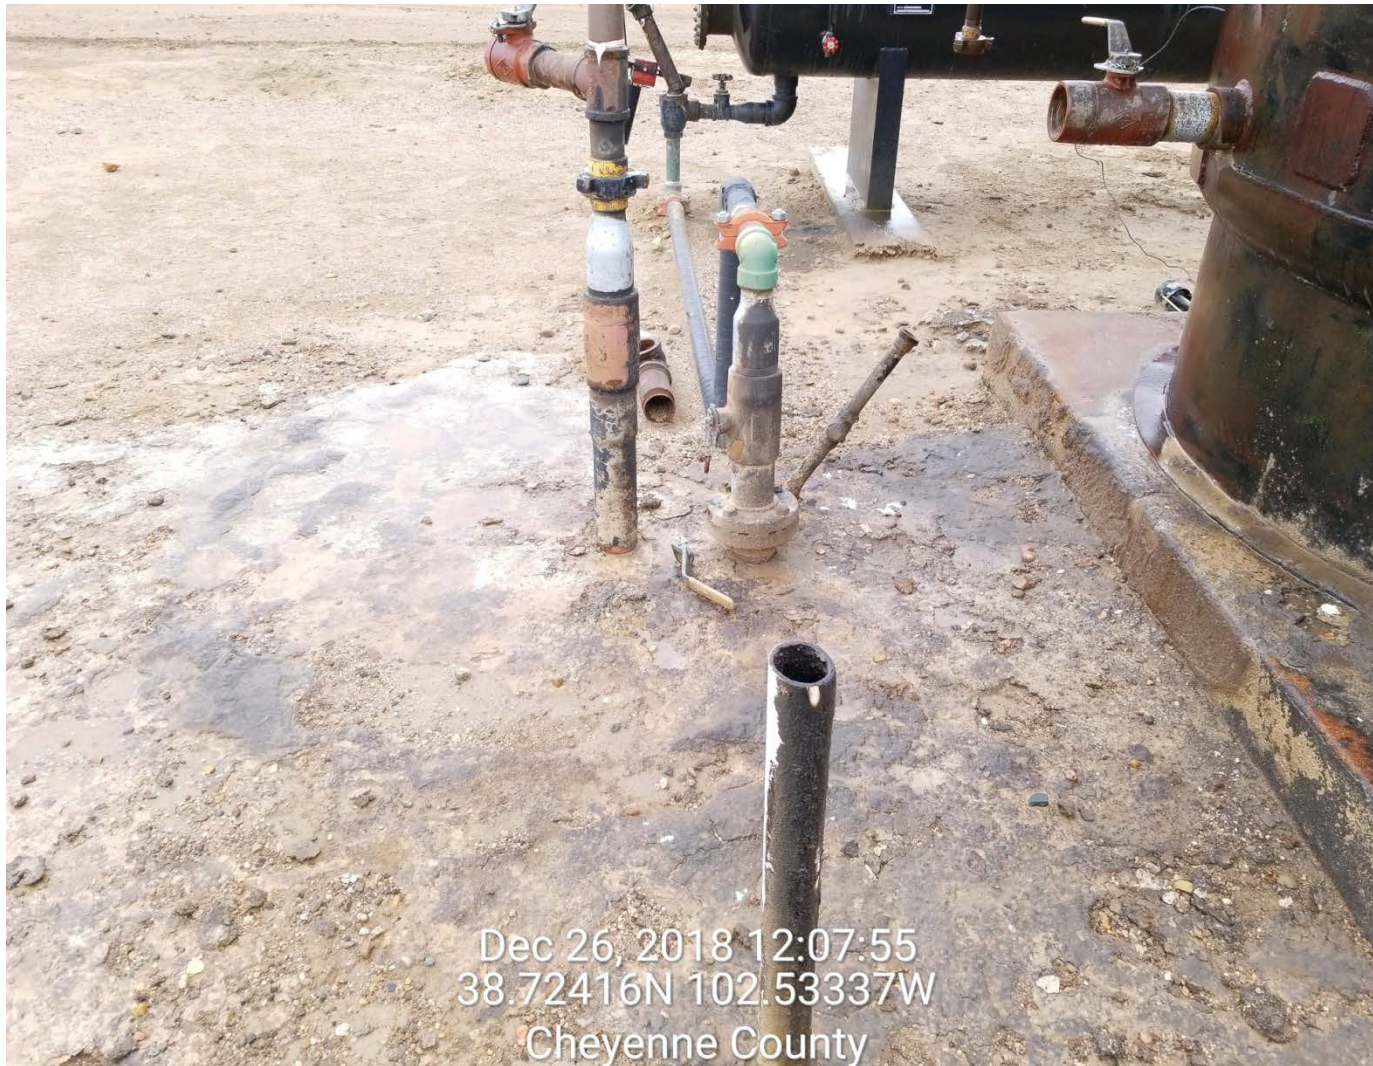
Dec 26, 2018 12:07:55  
38.72416N 102.53337W  
Cheyenne County

**Improperly abandoned pipeline. Pipe contained crude oil 8-10 inches below top of pipe.**

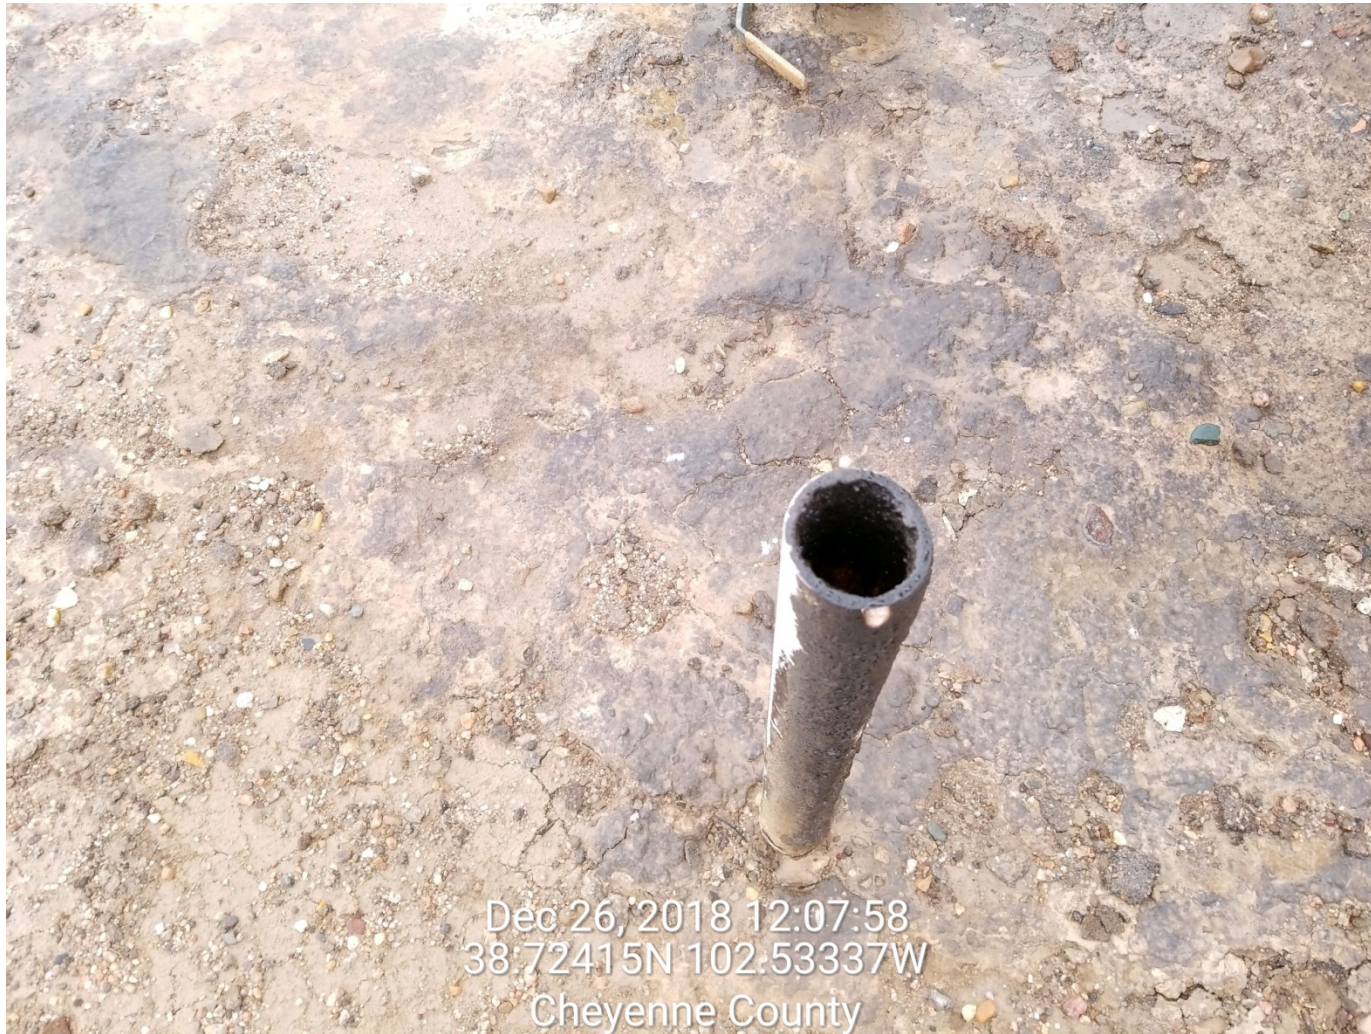
**Improperly abandoned pipeline. Pipe contained crude oil 8-10 inched below top of pipe.**

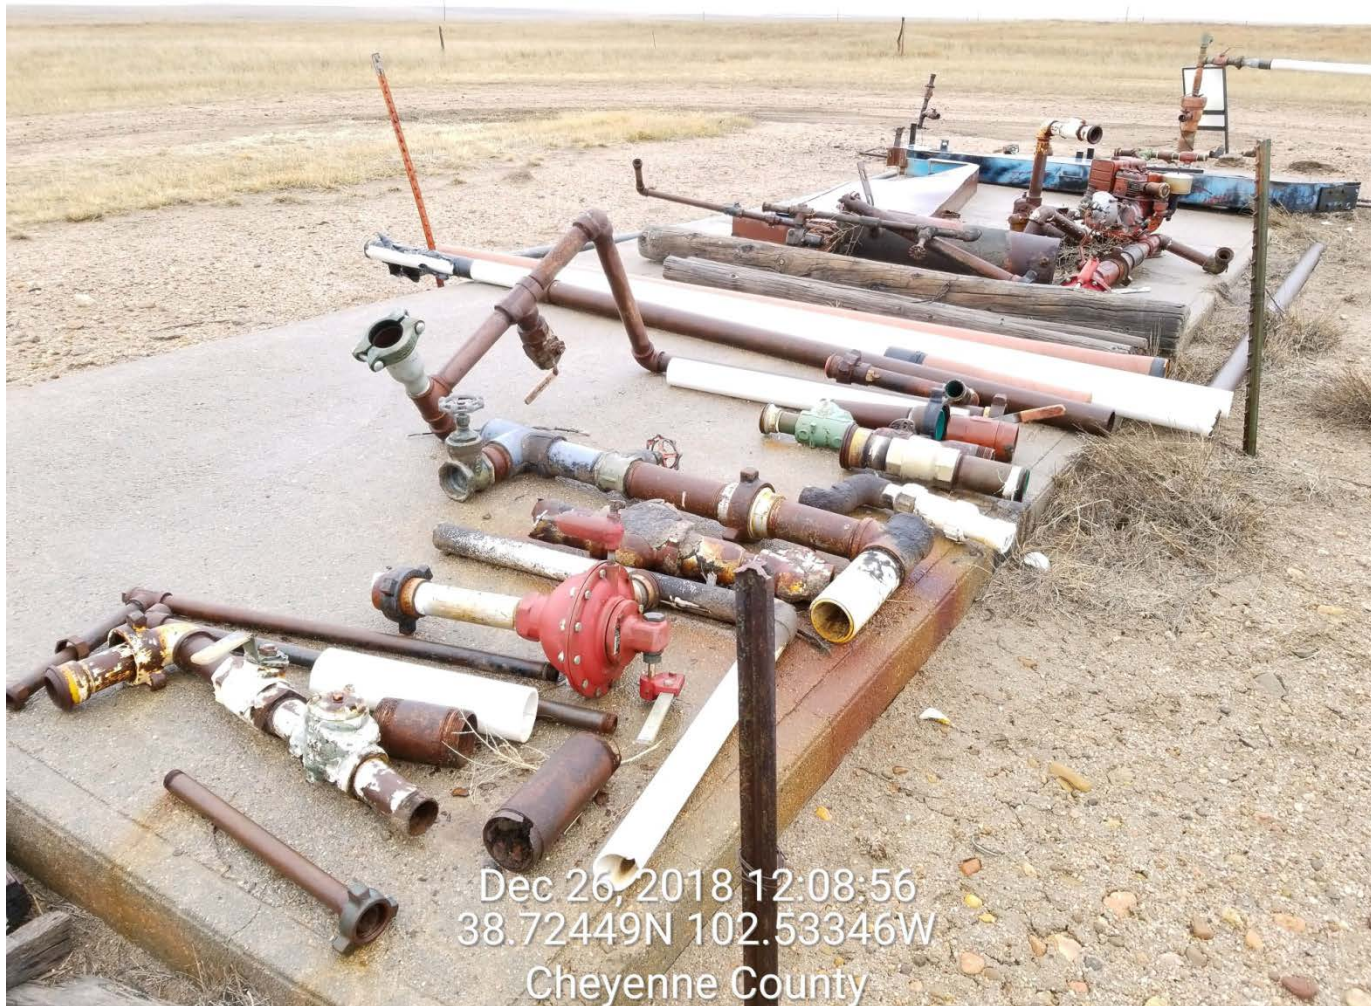
Unused equipment on location.

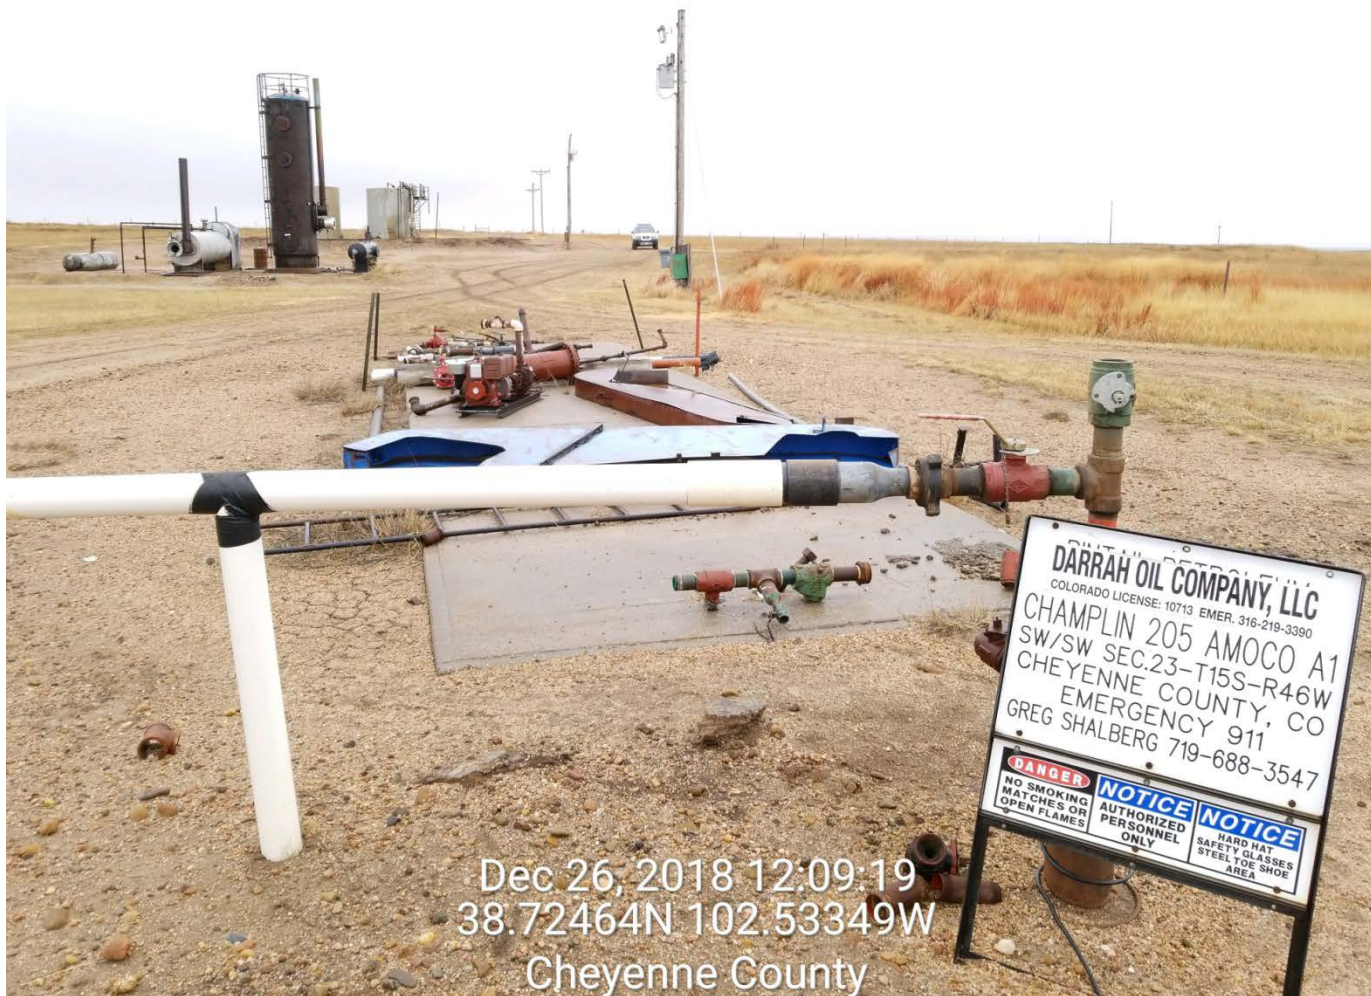
Unused equipment on location.

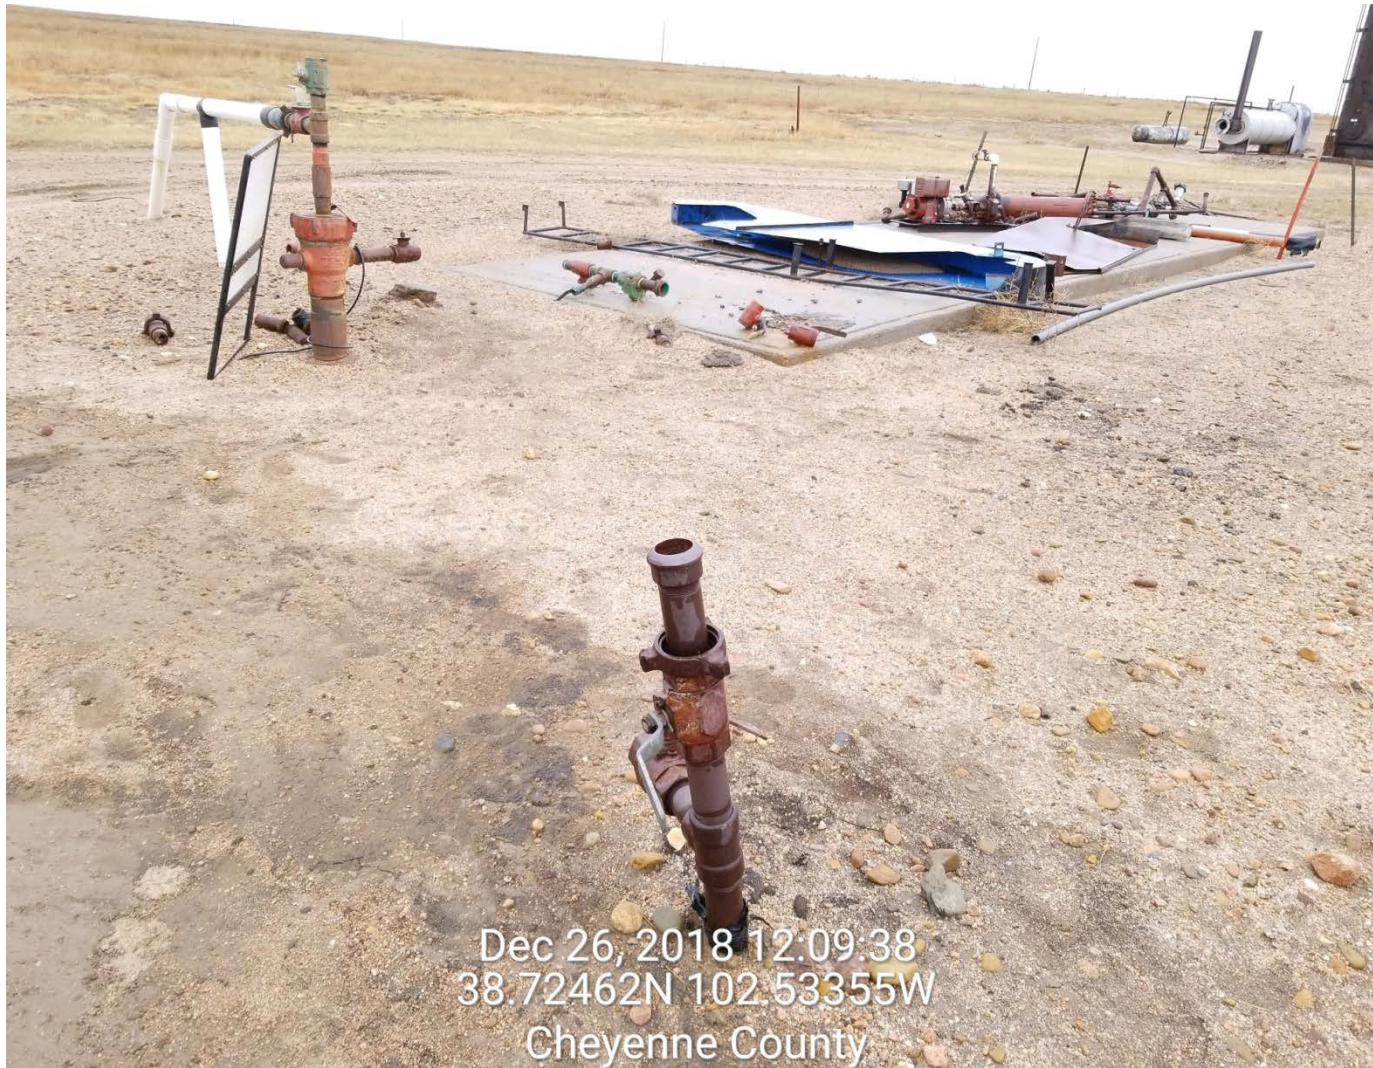
Dec 26, 2018 12:09:38  
38.72462N 102.53355W  
Cheyenne County

**Improperly abandoned flowline. Disconnected flowline risers not Lock Out Tag Out**
