Final Reclamation and Stormwater Inspection

Operator: NOBLE ENERGY INC – 100322

Location ID: 328452

Weld County, CO

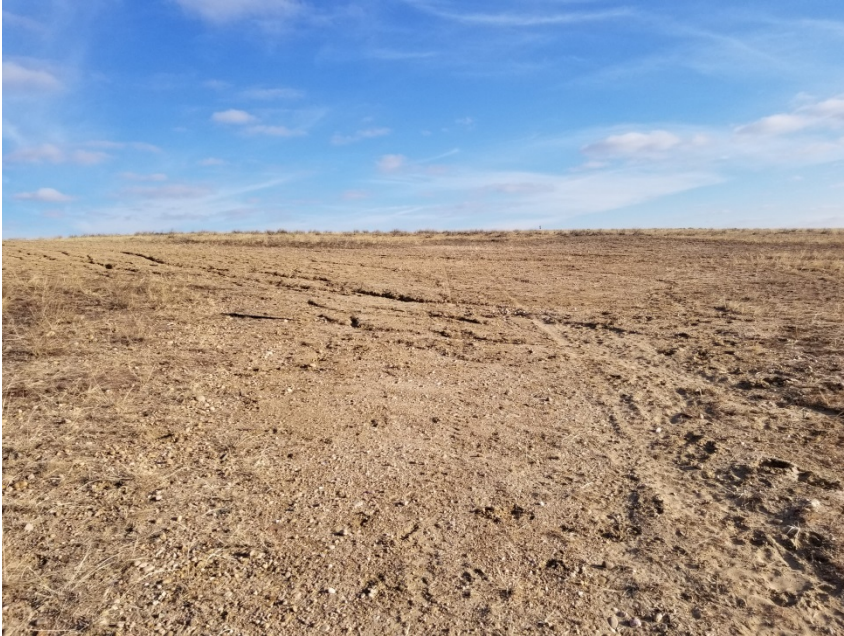
Photo 1. Photo taken from the access road and facility, facing Northeast. Appears the Operator has performed final reclamation activities. However, the majority of the site is barren or covered in weedy, annual vegetation which includes but not limited to kochia, with little perennial grass cover establishment.

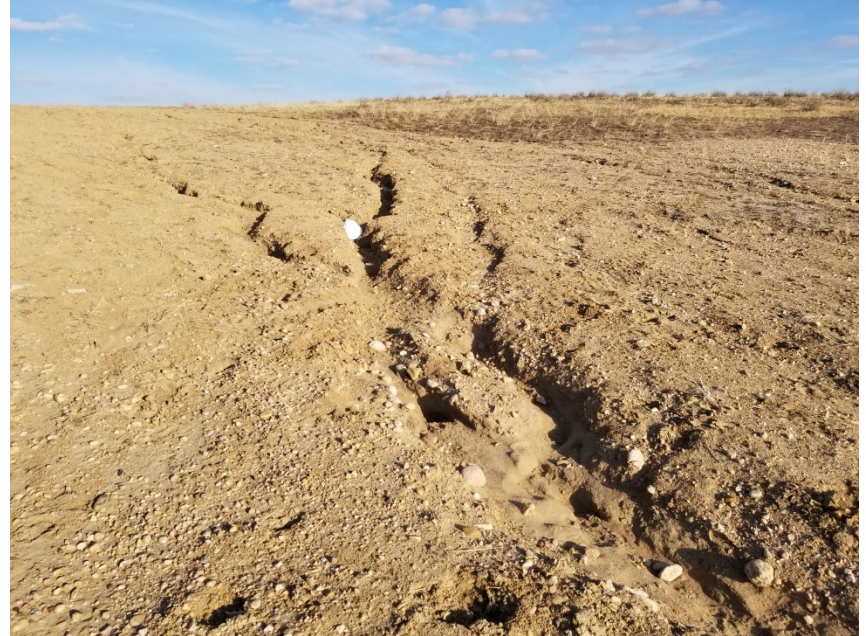
Photo 2. Photo taken from the access road and facility, facing Northeast. Photo depicts rill erosion along access road and facility location.

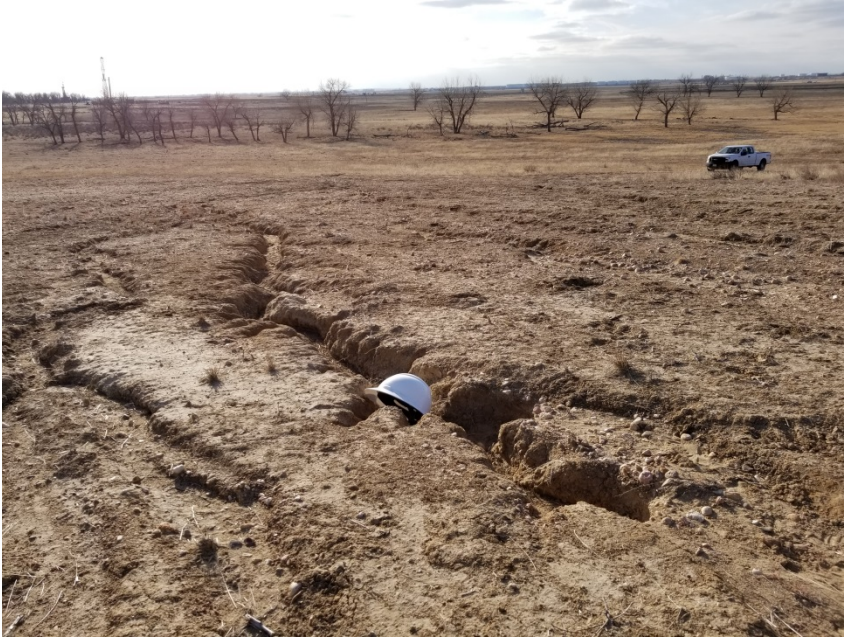
Photo 3. Photo taken from the access road and facility, facing Southwest. See comments from Photo 2.

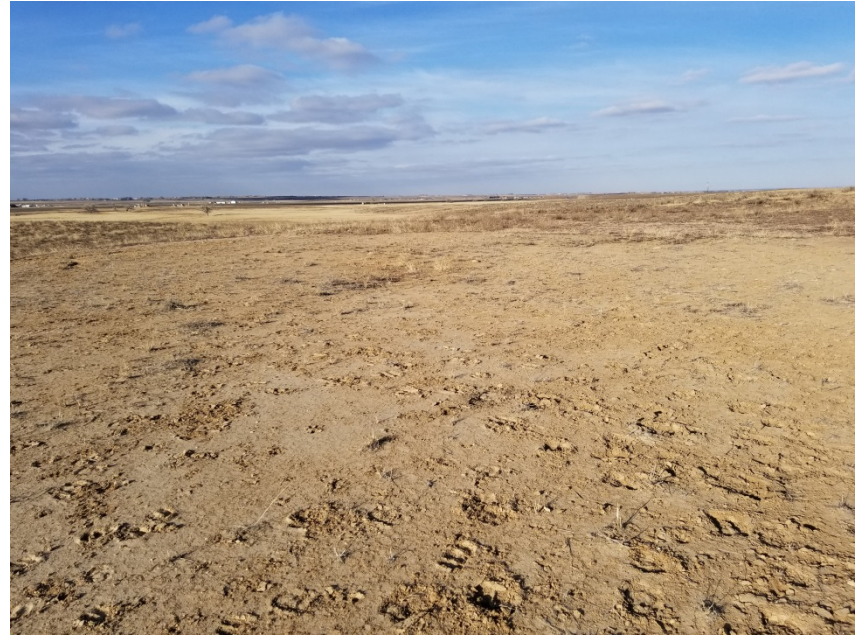
Photo 4. Photo taken from the location, facing West. See comments from Photo 1.

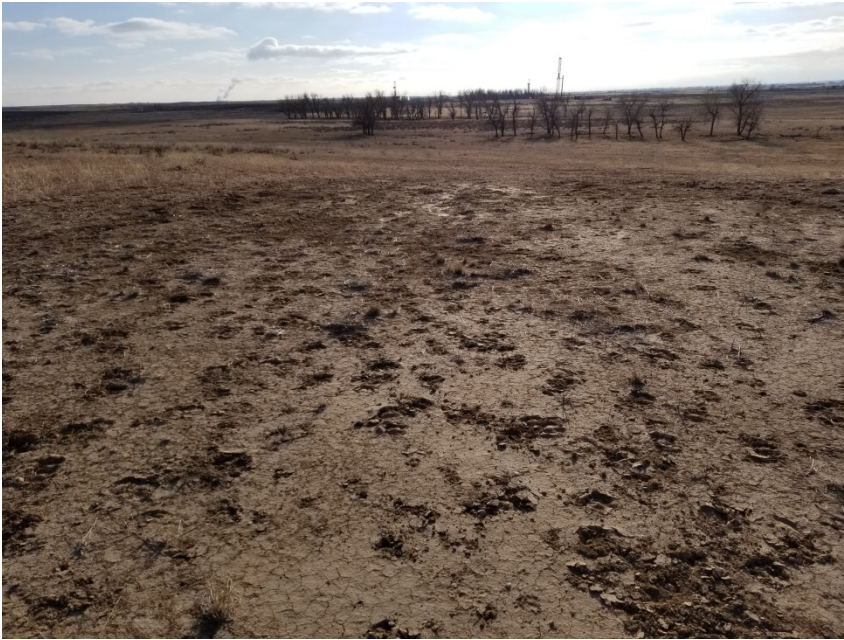
Photo 5. Photo taken from the location, facing South. See comments from Photo 1.

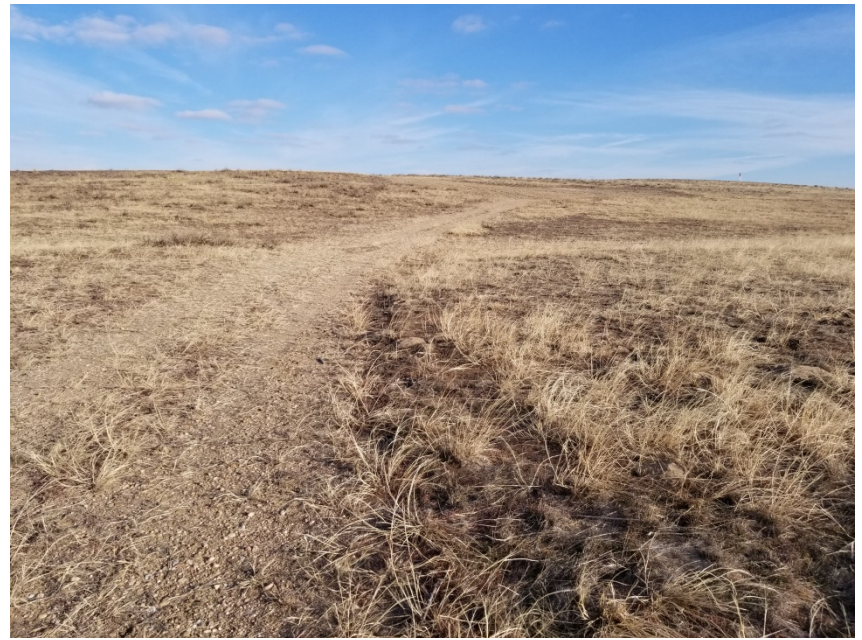
Photo 6. Photo taken from the access road, facing East. Note the gravel and access road remain and have not been reclaimed.
