Final Reclamation Inspection

Operator: PDC ENERGY INC - #69175

API: 05-123-12572

Inspection Photos
Location Name: FRICK #32-18
API: 05-123-12572

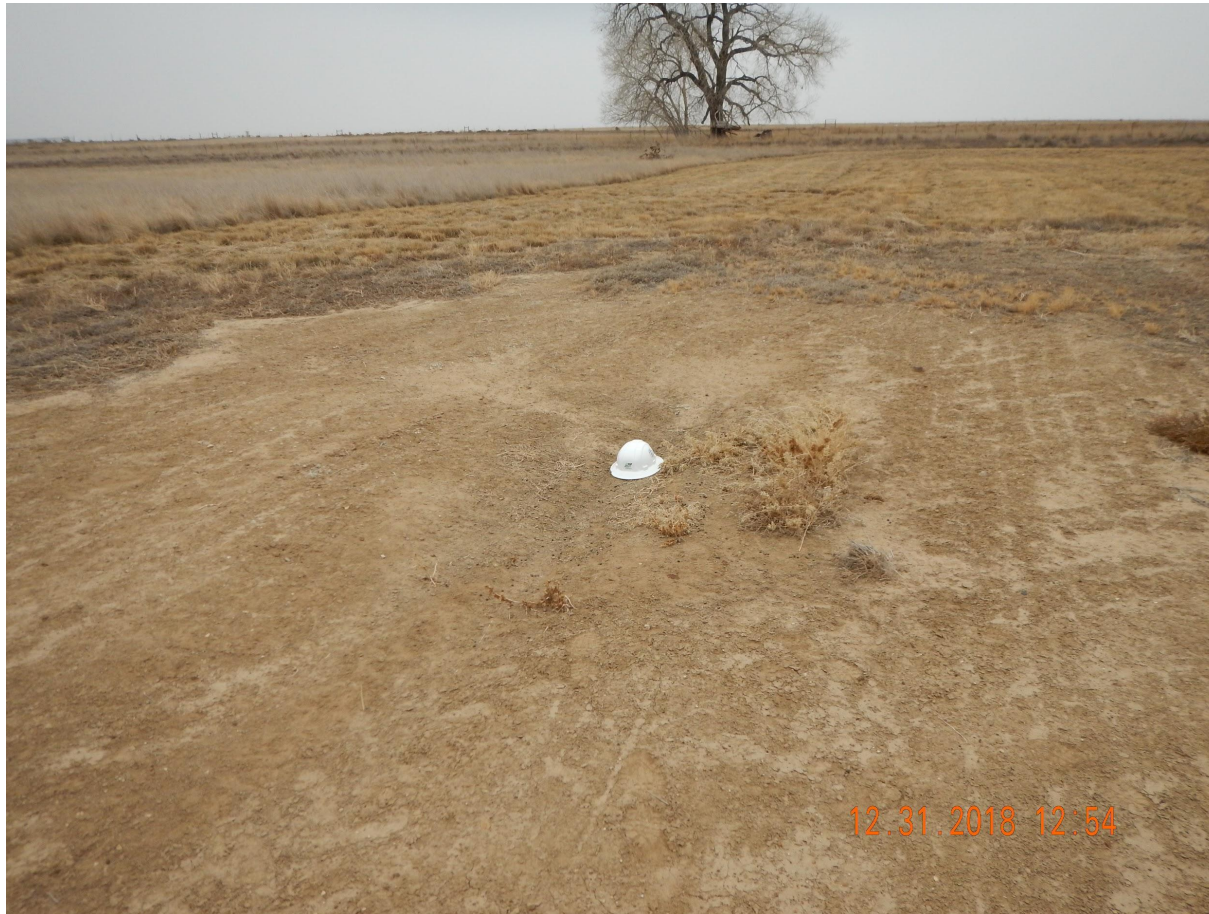
Photo 1. Photo taken from the well location, facing West. No equipment observed at the well location. Photo illustrates subsidence at the PA well location with no vegetative growth.

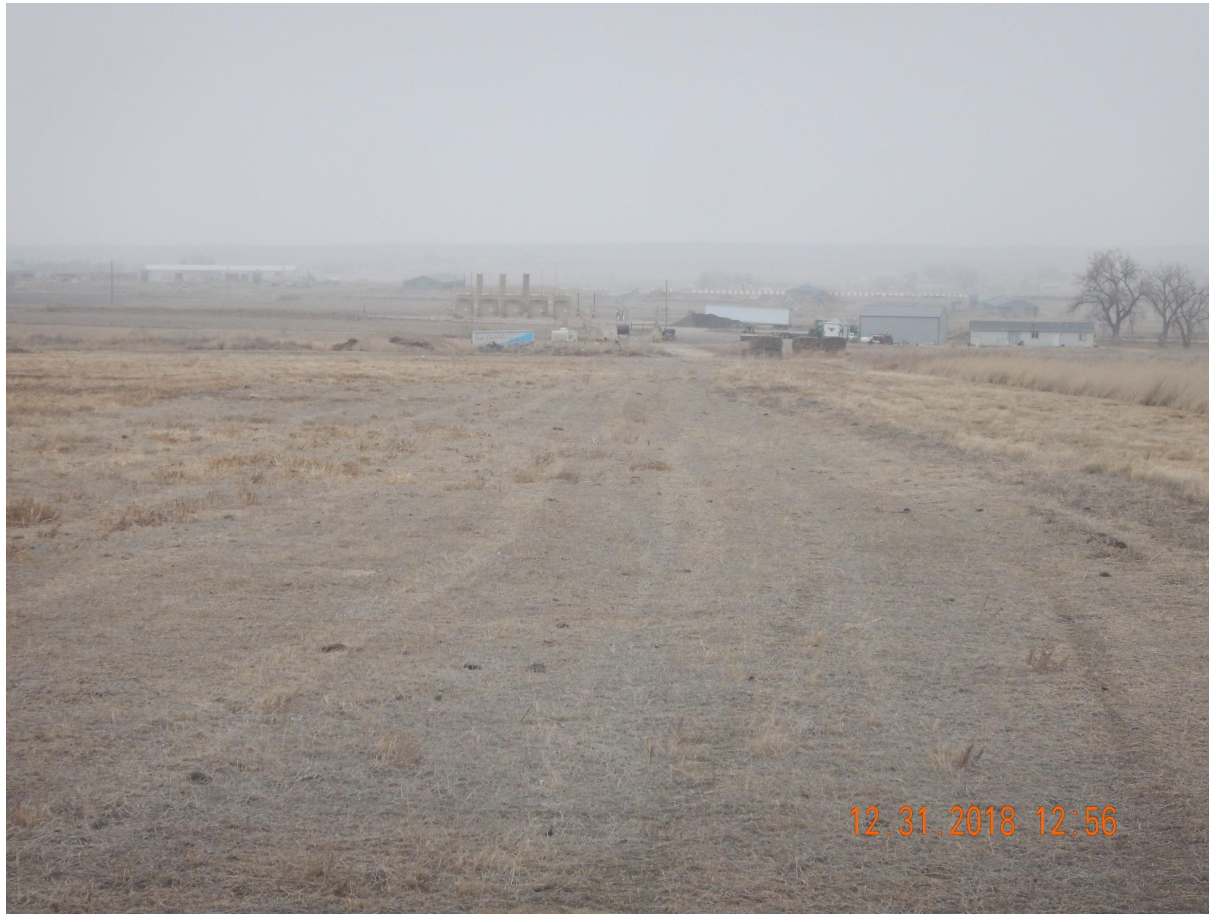
Photo 2. Photo taken from the well location, facing East. Photo illustrates puncture vine throughout the entire access road which also appears to have spread off the access road.
