Inspection Photos

Operator: RITCHIE EXPLORATION INC - 74770

Location ID: 387057

Inspection Doc. Number: 682504359

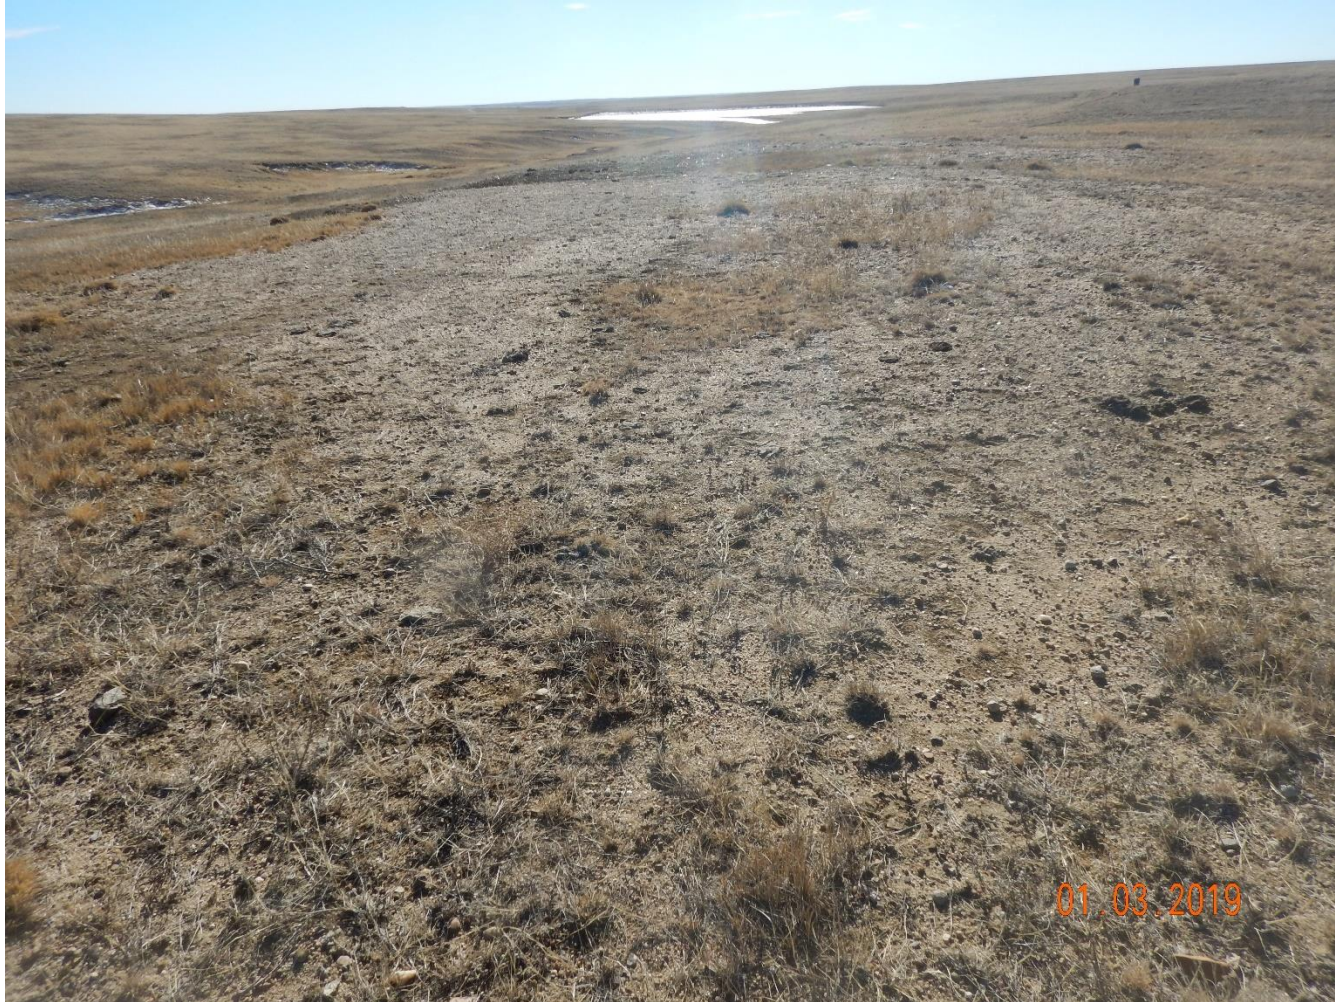
Photo 1: Photo taken from the north end of the location, facing south. Photo shows areas of the location/well remains predominantly bare and exposed soil. Location does not meet reclamation requirements.

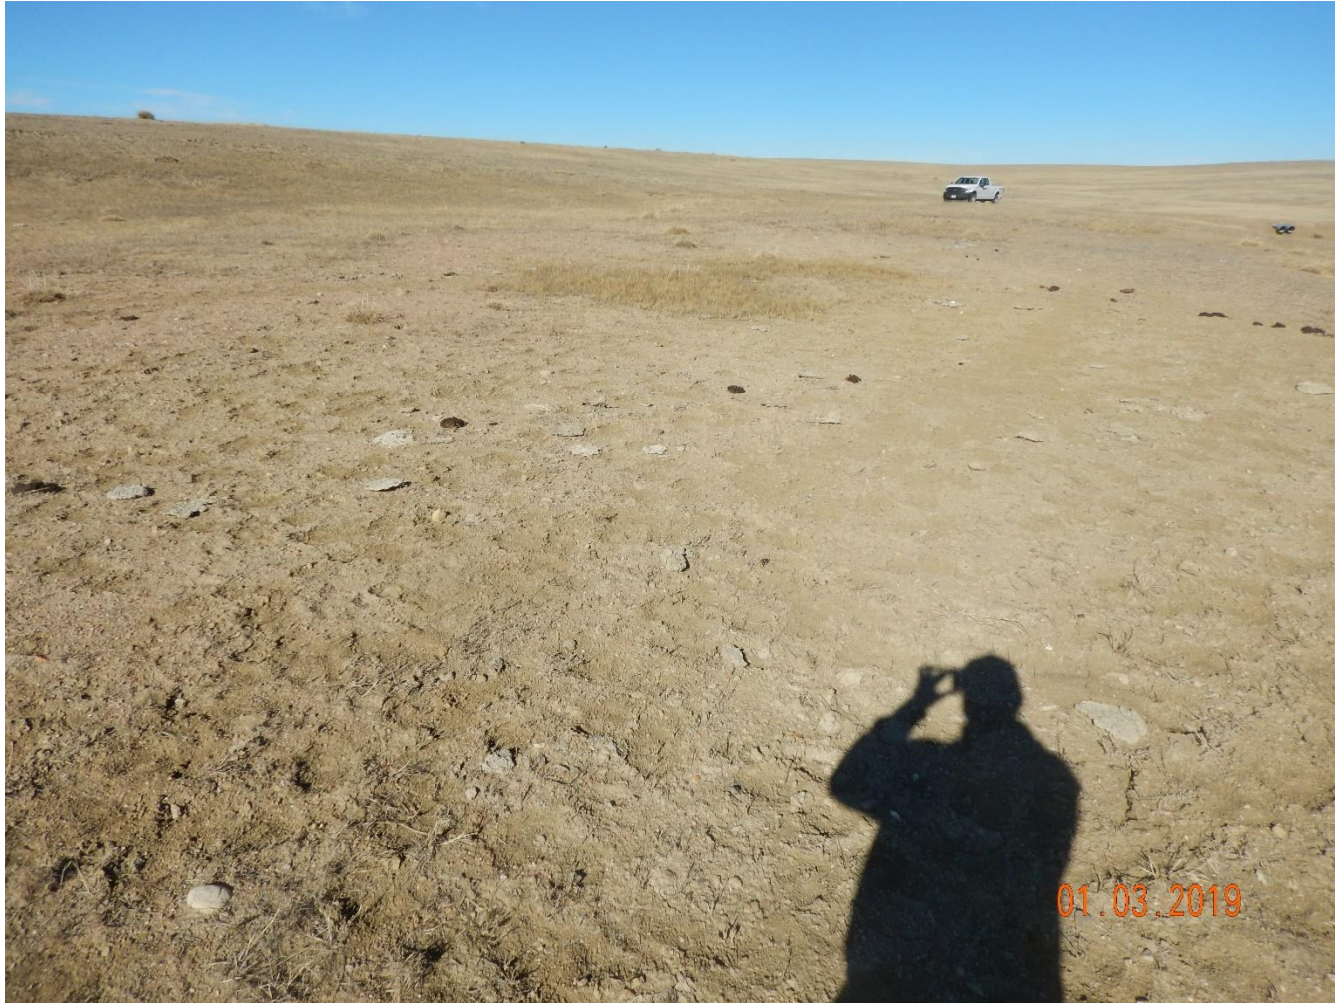
Photo 2: Photo taken from the south end of the location, facing north. Photo shows areas of the location/well remains predominantly bare and exposed soil. Location does not meet reclamation requirements.

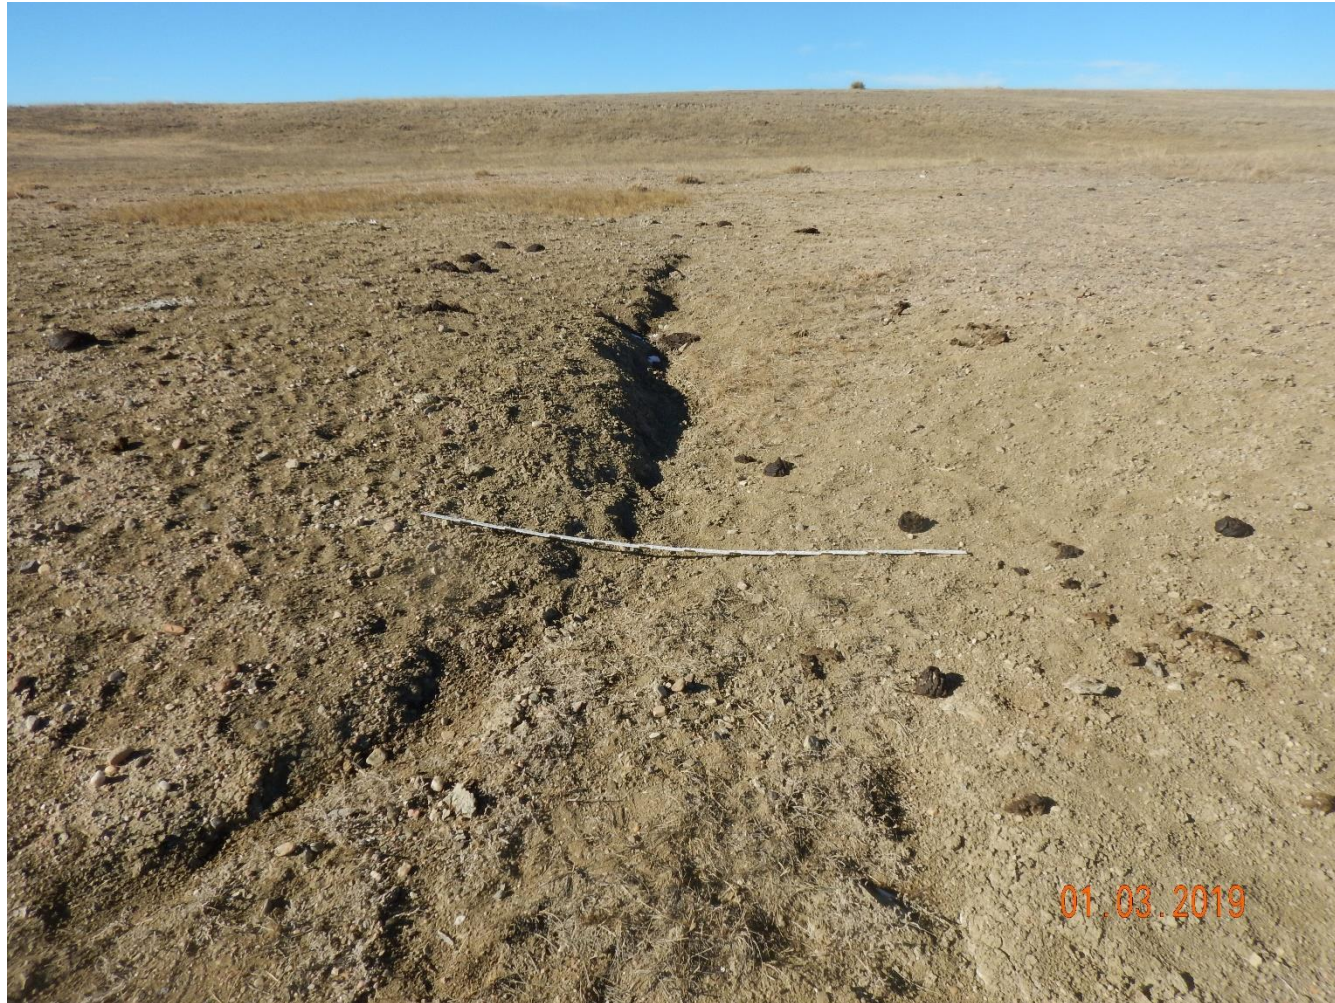
Photo 3: Photo taken from the east end of the location, facing west. Photo shows erosion degradation due to stormwater runoff from the location. 6 foot measuring stock for reference.

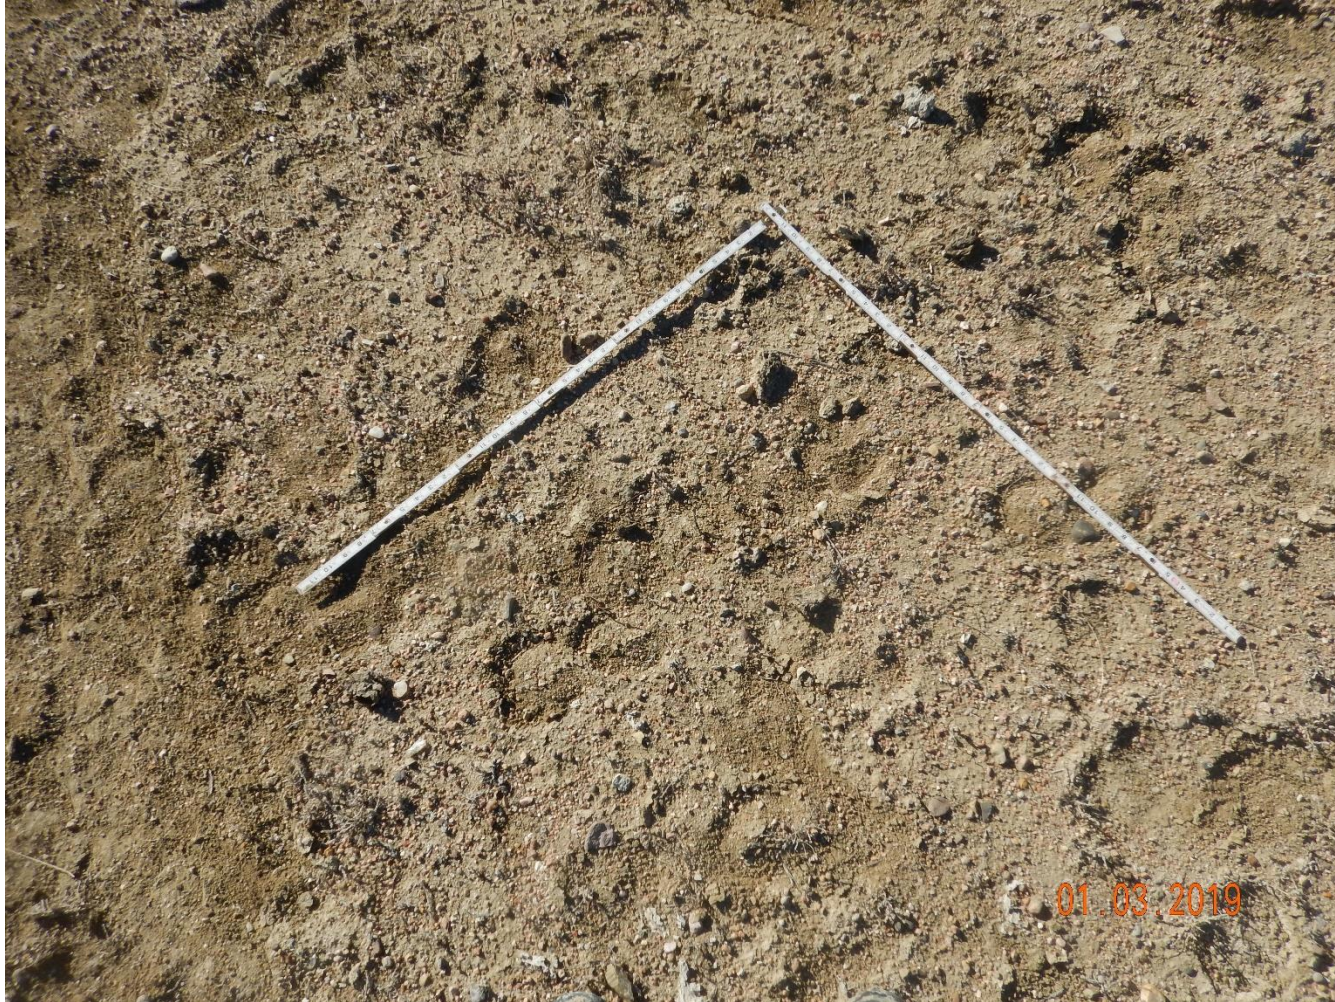
Photo 4: Photo taken from the location. Photo shows location remains predominantly bare and exposed soil. 3x3 foot measuring stick for reference.

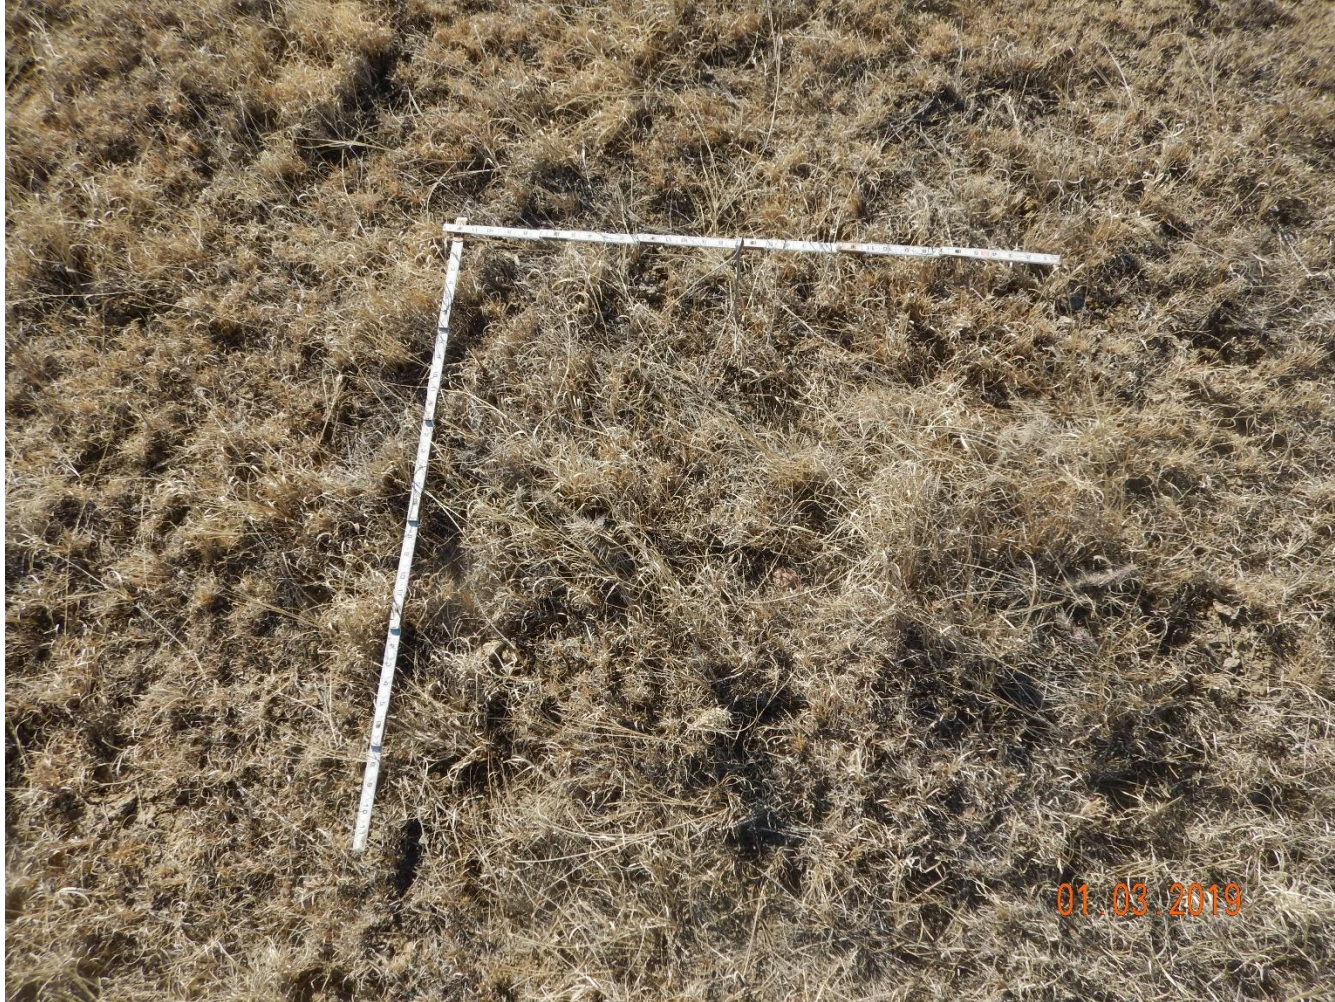
Photo 5: Photo taken from the adjacent reference area. Photo shows reference vegetation. Vegetation observed includes Blue grama, Buffalo grass, Wester wheat, Purple threeawn, sand dropseed, etc... 3x3 foot measuring stick for reference.

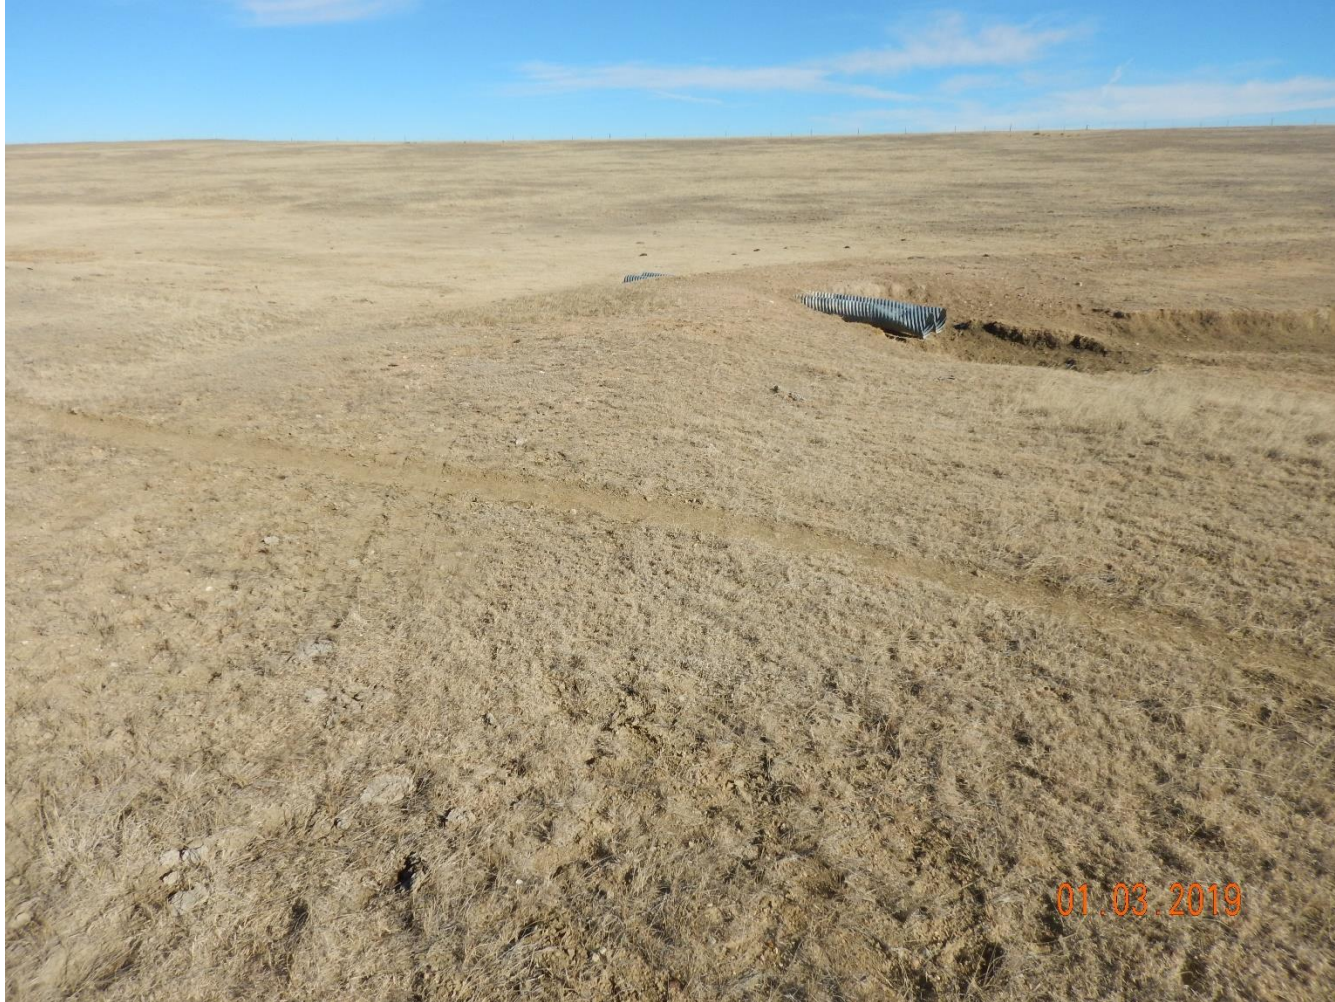
Photo 6: Photo taken from the north end of the location, facing east. Photo shows a section of access road/culvert that was constructed to cross a drainage. Access road requires reclamation including removal of culvert and restoration of the drainage.

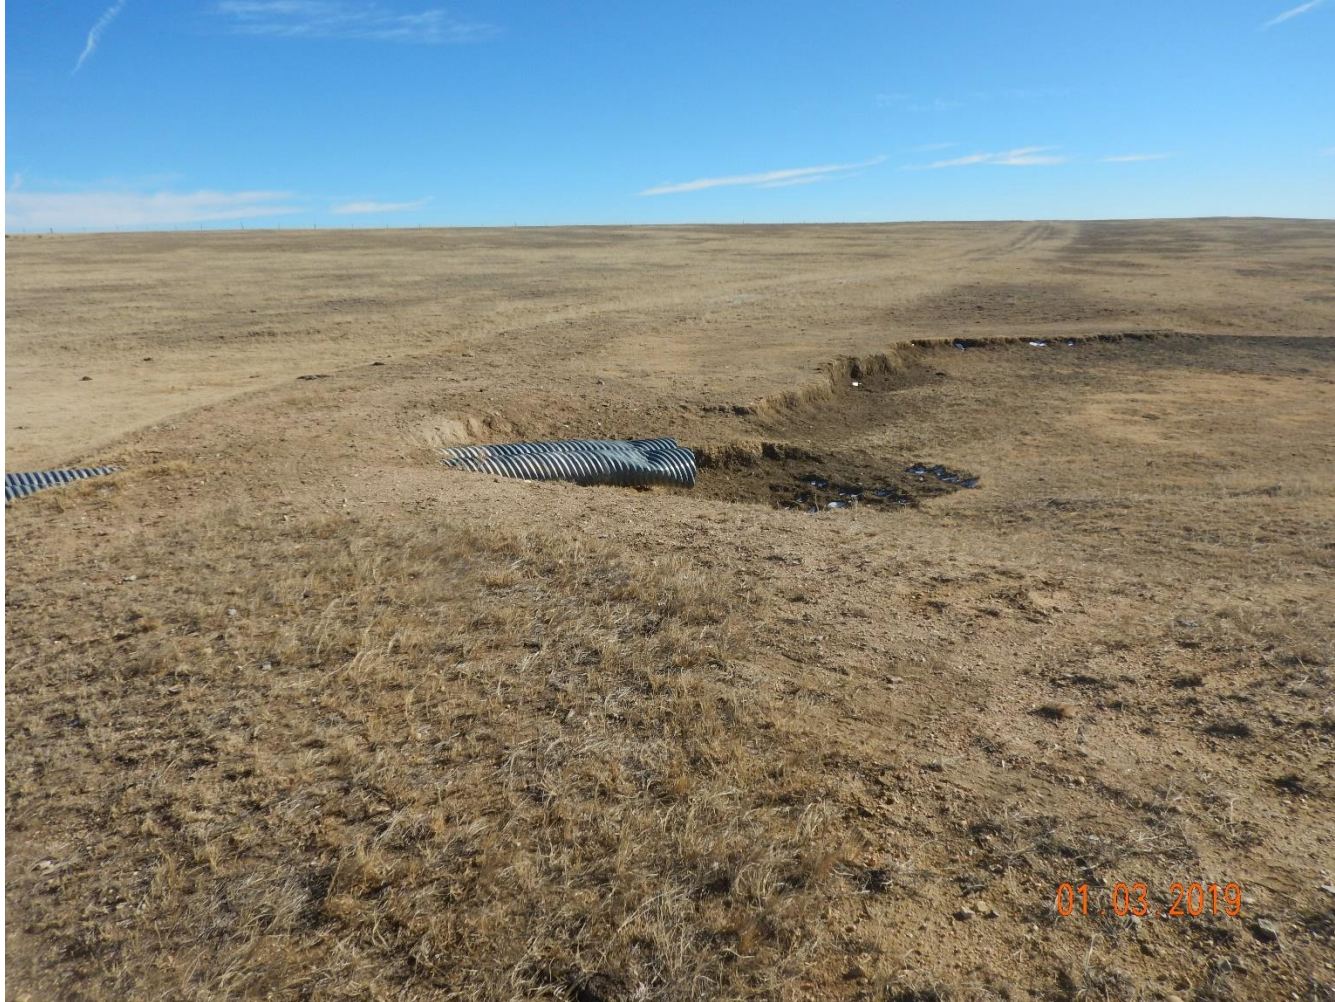
Photo 7: Photo taken from the north end of the location, facing east. Photo shows a section of access road/culvert that was constructed to cross a drainage. Access road requires reclamation including removal of culvert and restoration of the drainage.

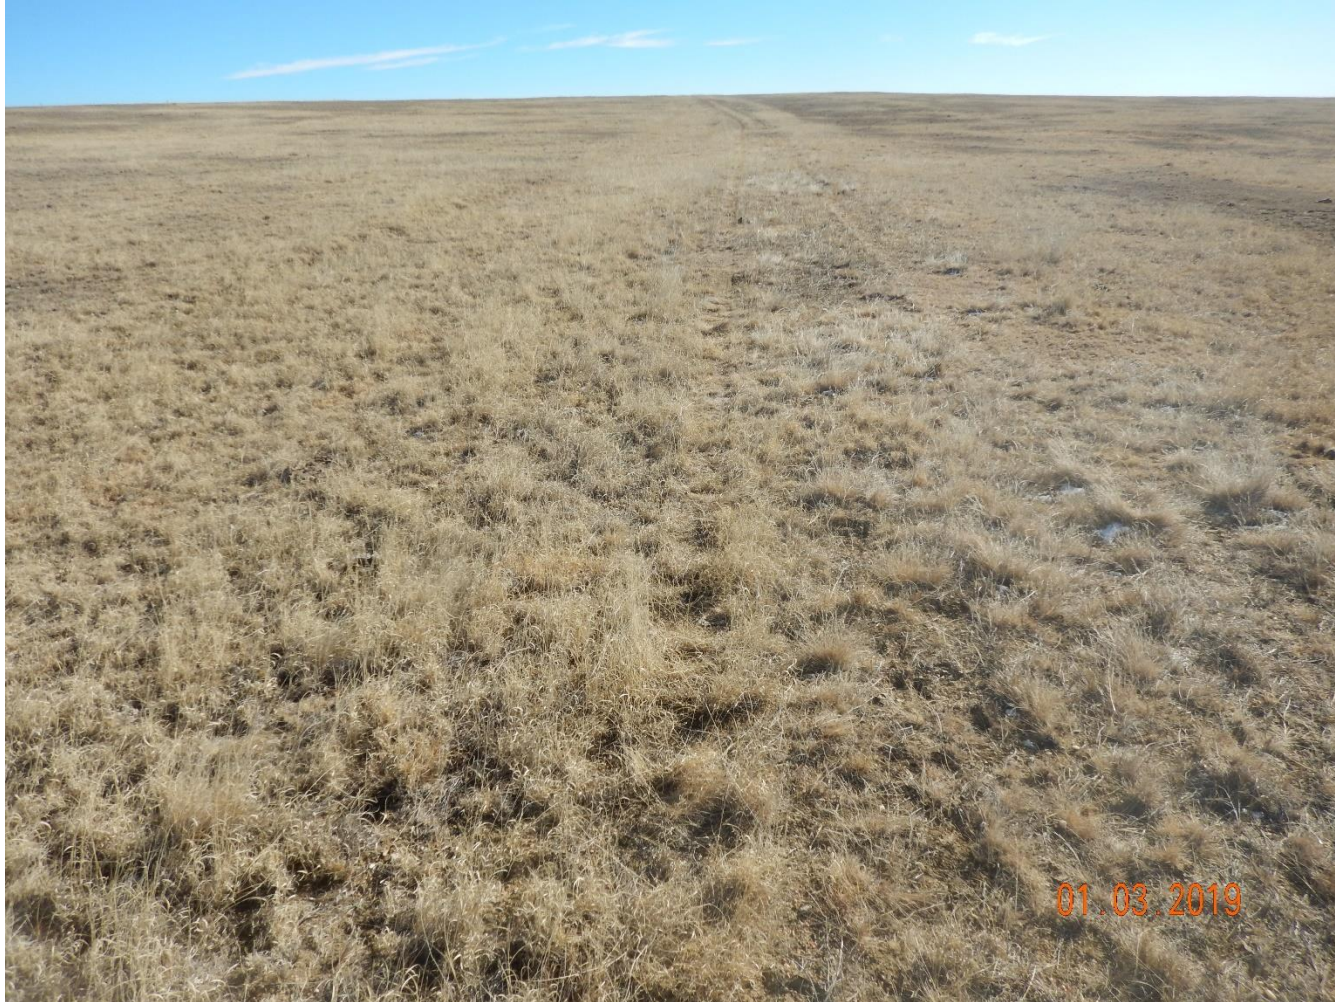
Photo 8: Photo taken from the access road, east of the location. Vegetation appears to have achieved uniform establishment on access road.
