Interim Reclamation and Stormwater Inspection

Operator: CRESTONE PEAK RESOURCES OPERATING LLC - 10633

Location ID: 335763

Inspection Photos
Location Name: VESSELS MINERALS A UNIT #2
Location ID: 335763

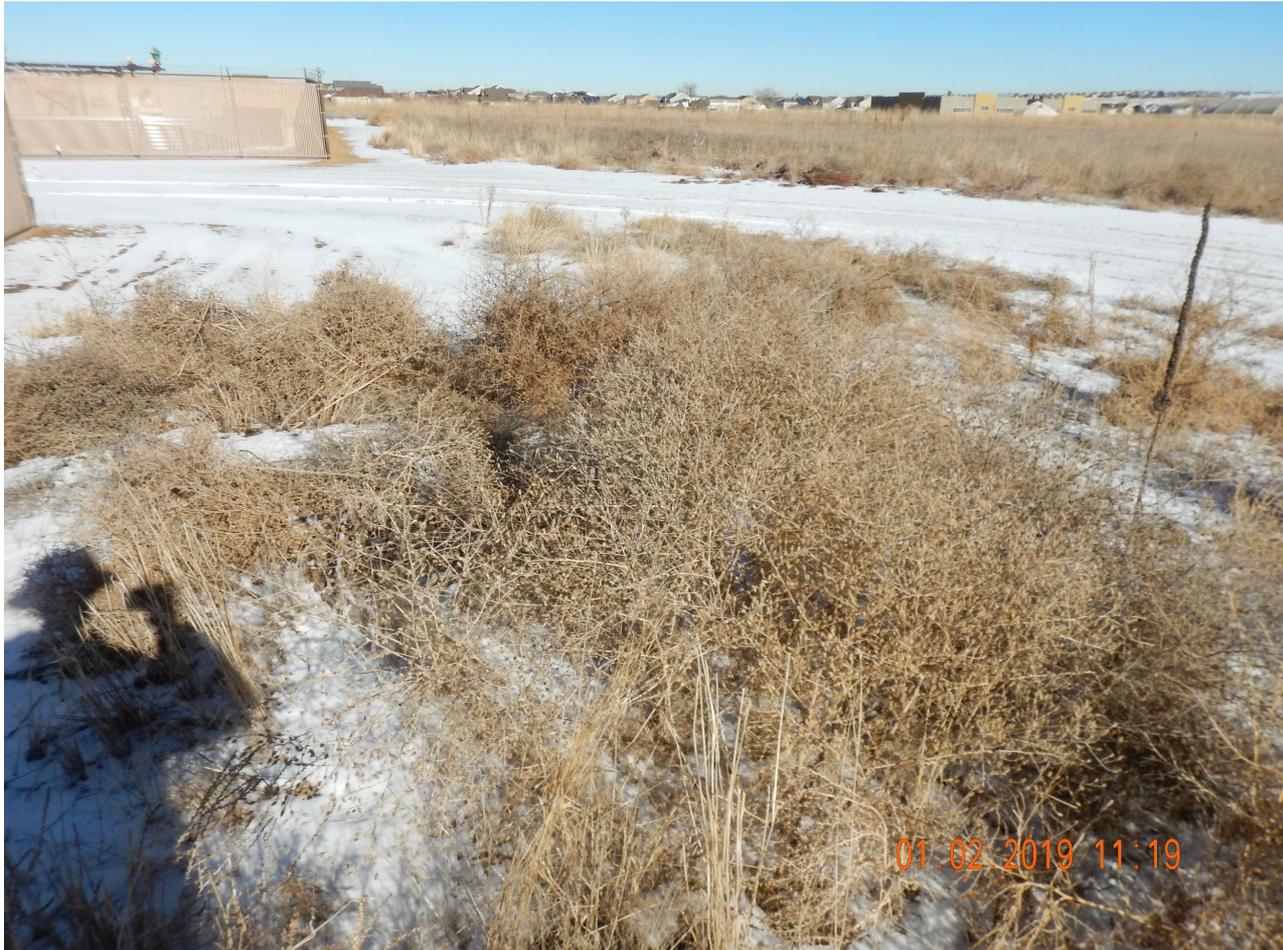
Photo 1. Photo taken from the eastern well location, facing North. Photo illustrates unmanaged Diffuse knapweed (*Centaurea diffusa*), a List B CO noxious weed. Operator shall properly remove the noxious weed.

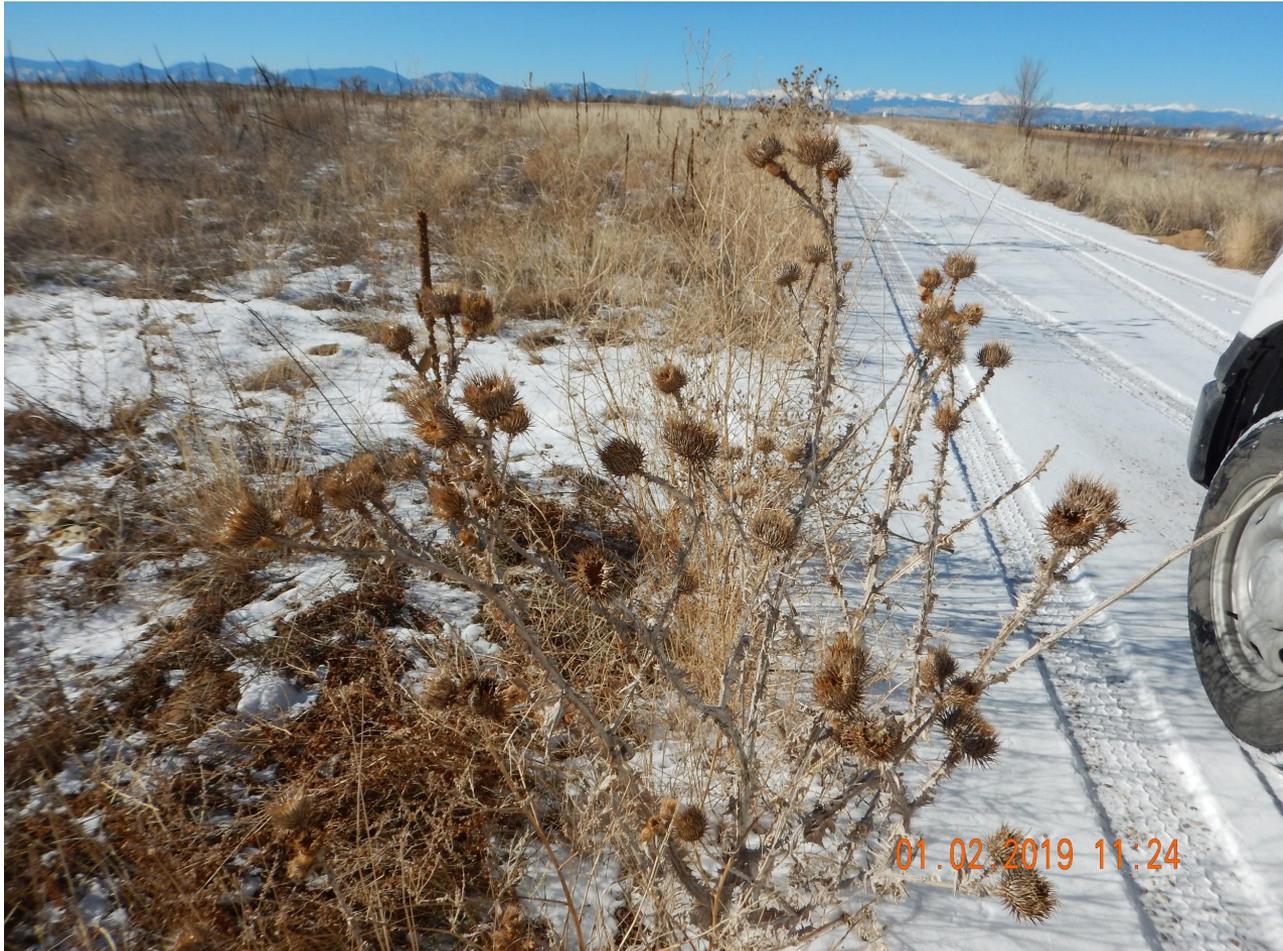
Photo 2. Photo taken along a portion of well location access road, facing West. Photo illustrates unmanaged Scotch thistle (*Onopordum acanthium*), a List B CO noxious weed. Operator shall properly remove the noxious weed.

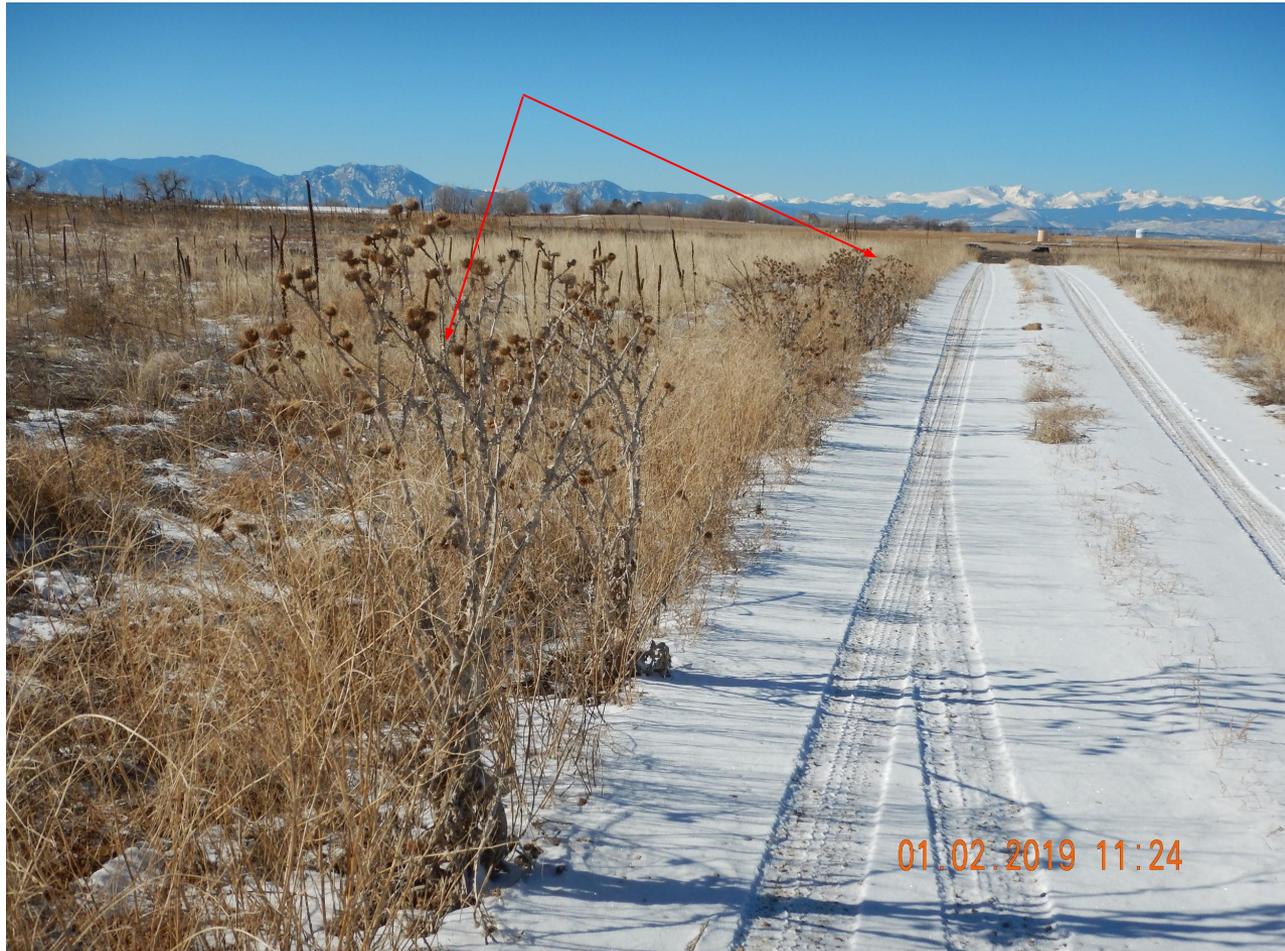
Photo 3. Photo taken along a portion of well location access road, facing West. See comments under Photo 2.
