Interim Reclamation and Stormwater Inspection

January 3, 2019

Operator: NOBLE ENERGY INC- #100322

Location ID: 445237

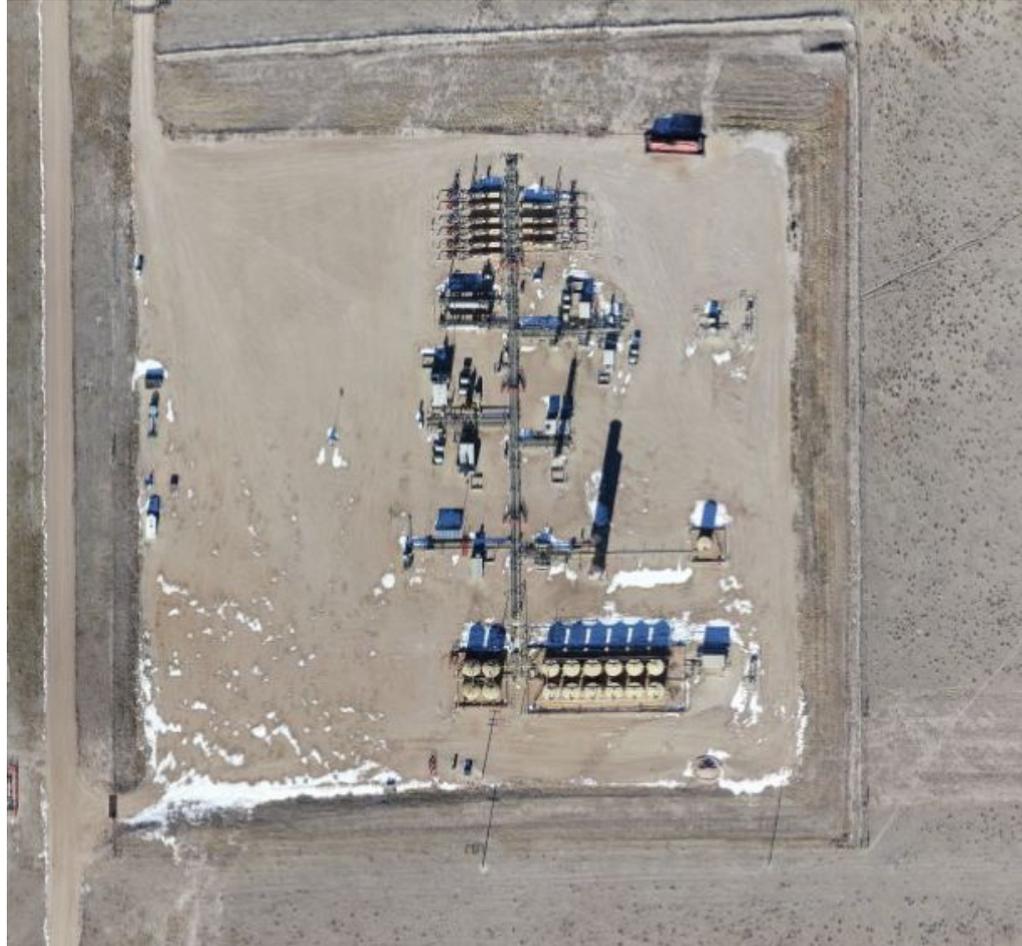
Aerial imagery taken on January 3, 2019 illustrates the western Production Facility area does not appear to be needed for production operations. Operator shall comply with Rules 1002 and 1003.

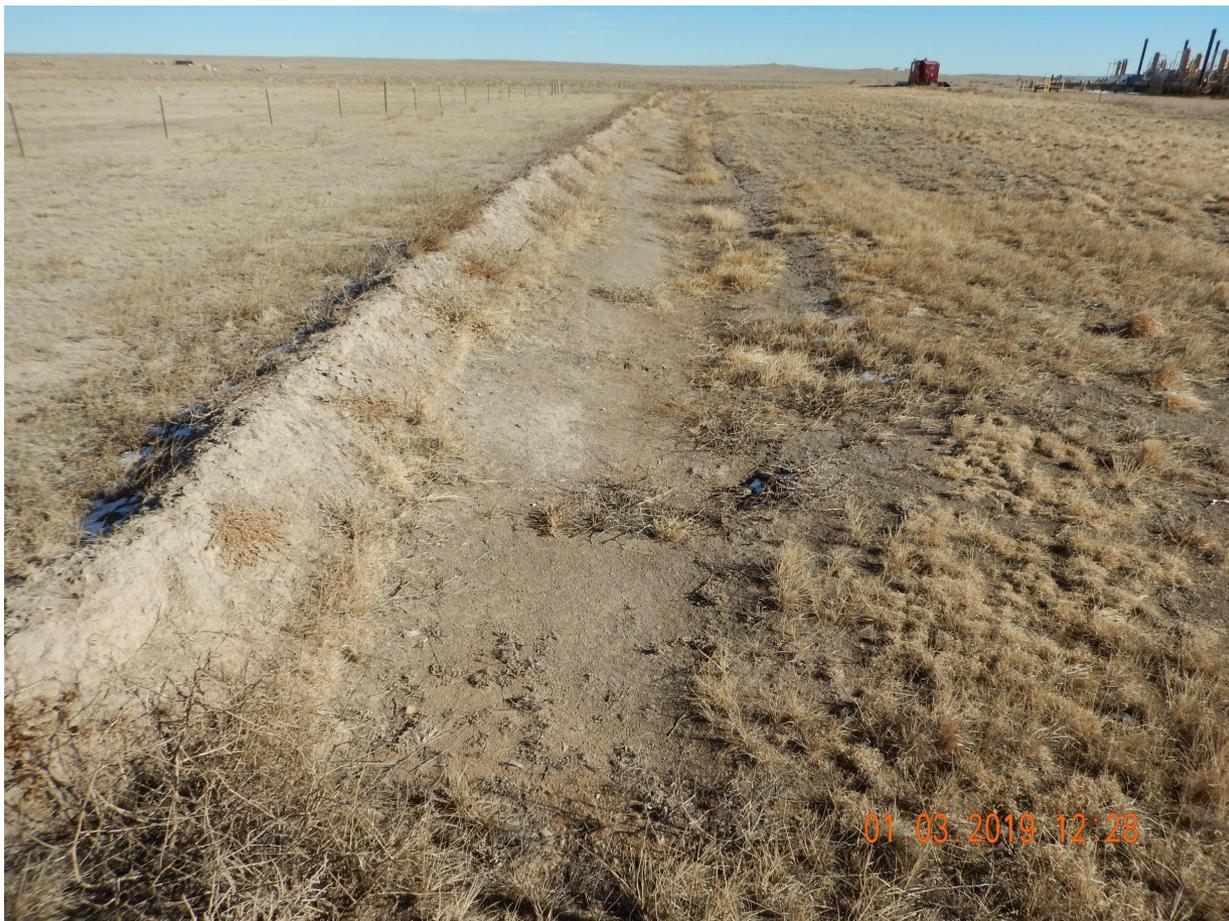
Photo 1. Photo taken from the northwestern location, facing East. Appears the Operator has ditch and berm BMP along the northern location which is directed to a stabilized outlet (sediment trap).

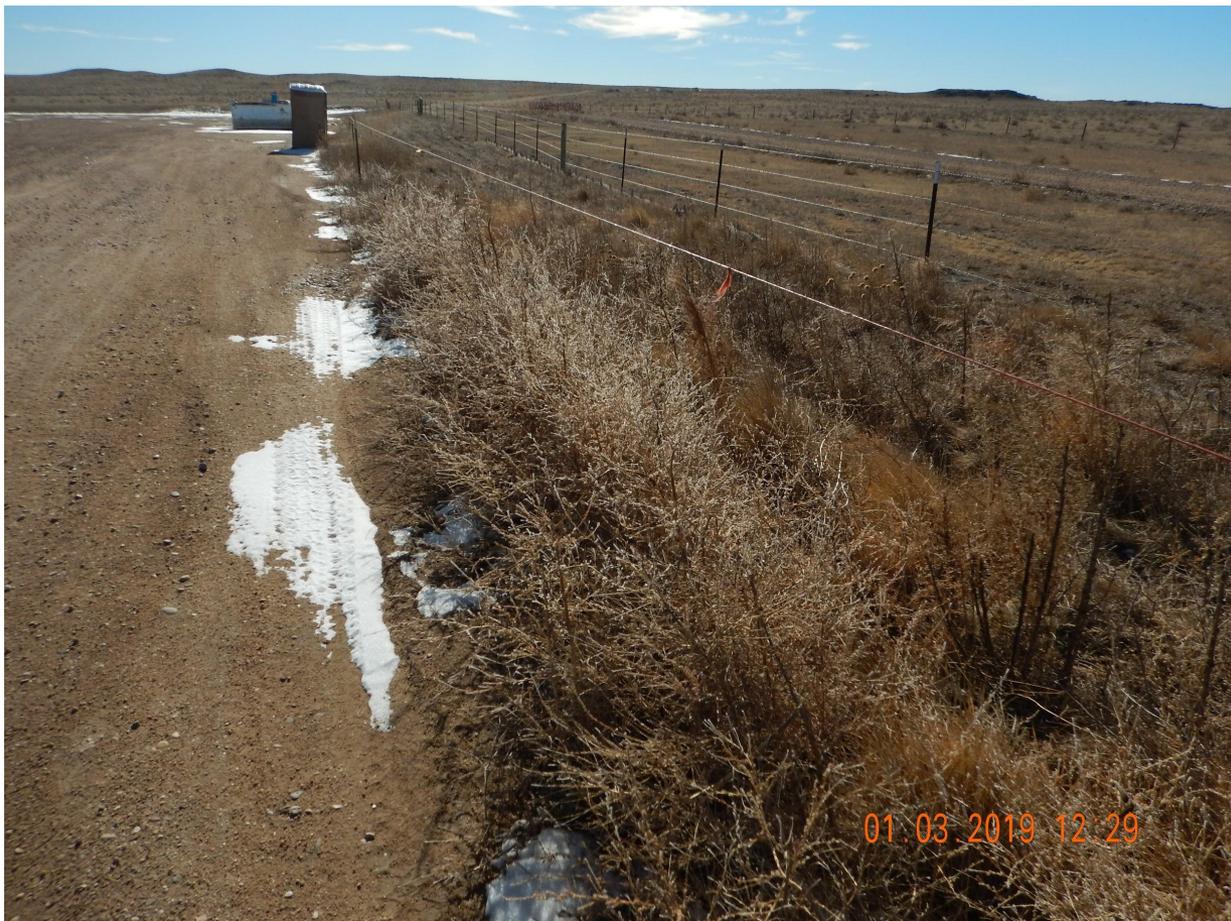
Photo 2. Photo taken from the northwestern location, facing South. Photo illustrates unmanaged Kochia weeds along the western perimeter of the location.
