Inspection Photos

Operator: BAYHORSE PETROLEUM LLC - 10234

Location ID: 440889

Inspection Doc. Number: 682504443

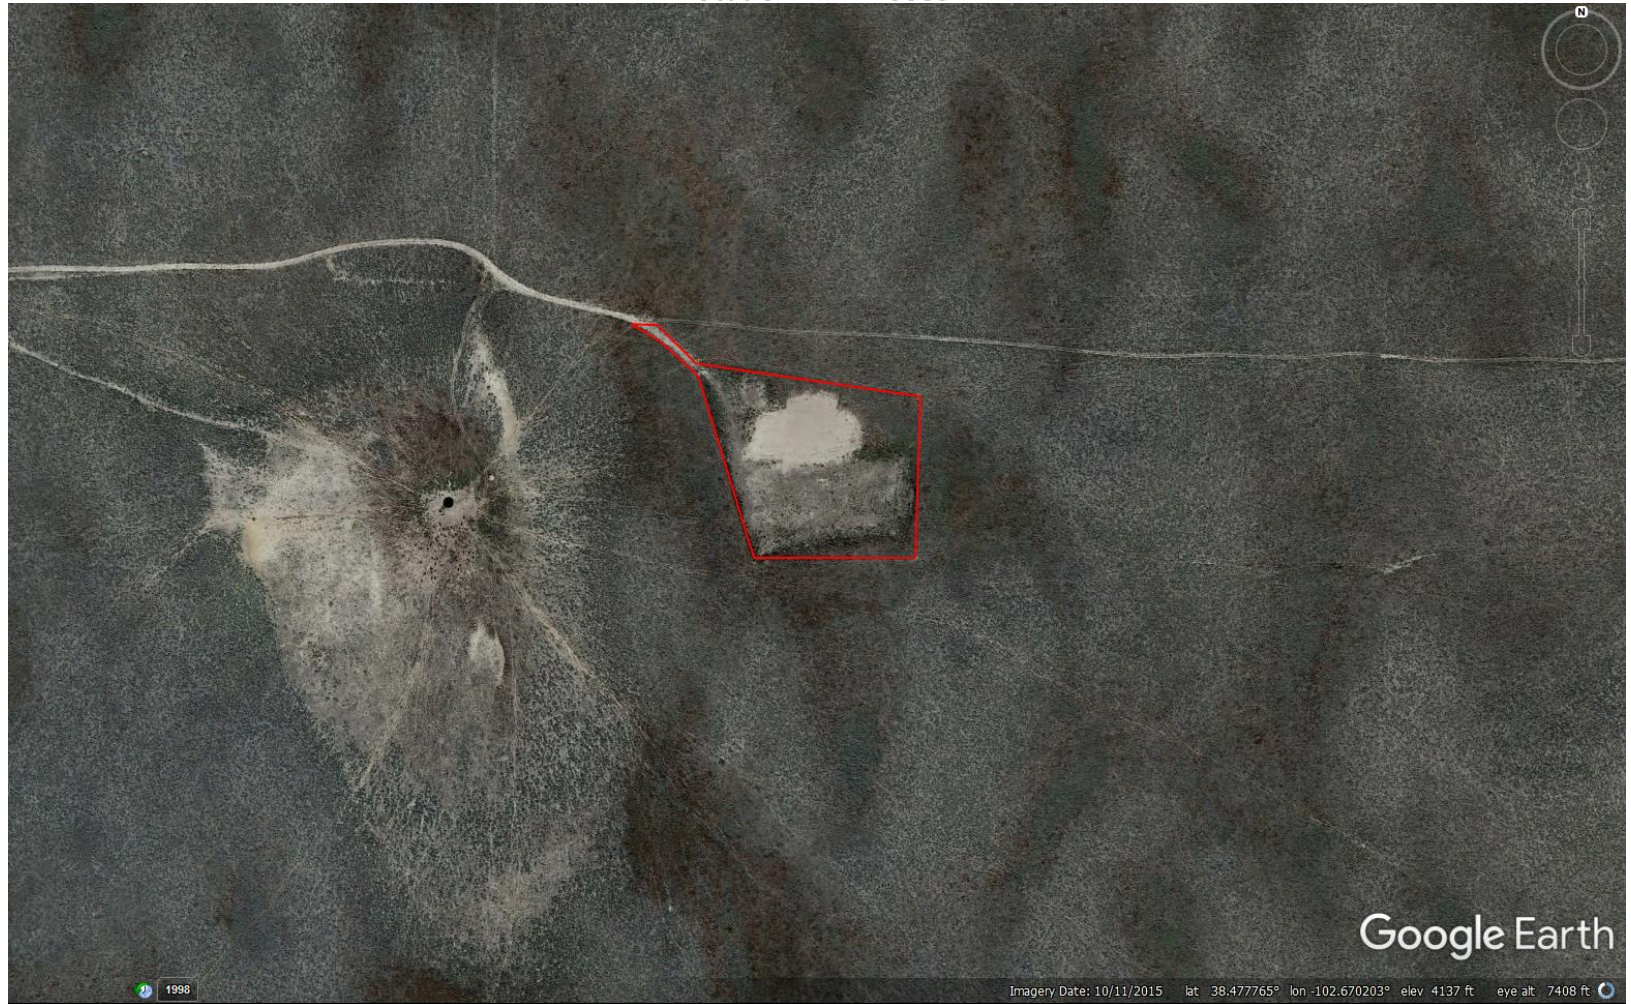
Photo 1: 2015 google earth aerial image. Photo shows area of the location where vegetation is not progressing towards reclamation requirements. Disturbance ~4.3 acres in size.

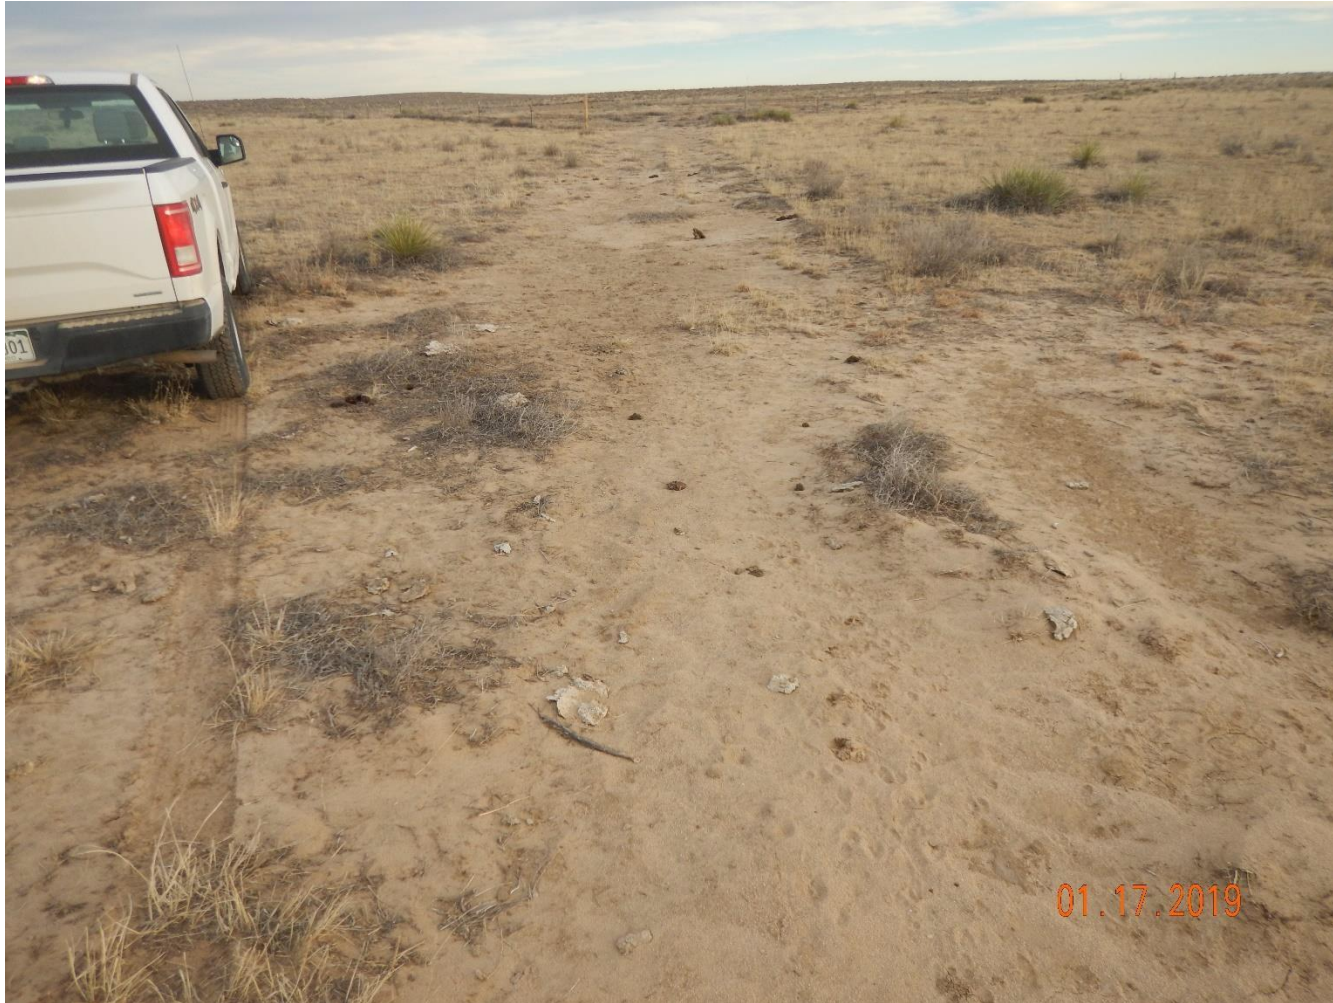
Photo 2: Photo taken from the access road on the north end of the location, facing south. Photo shows road remains predominantly bare and exposed soil. Desirable vegetative establishment does not appear to be progressing towards reclamation standards.

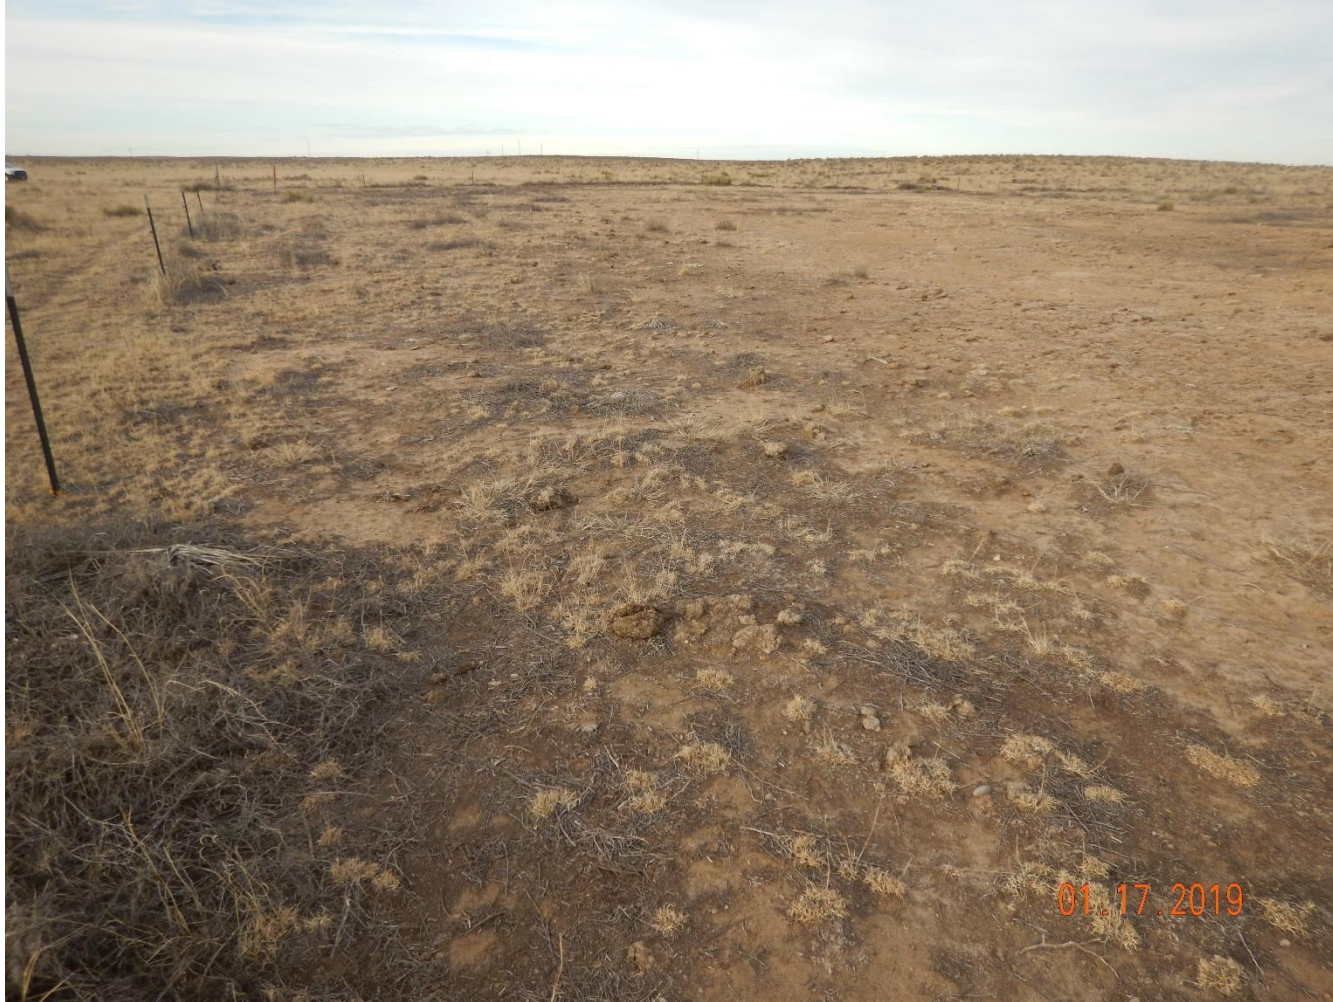
Photo 3: Photo taken from the west end of the location , facing north. Photo shows location remains predominantly bare and exposed soil. Desirable vegetative establishment does not appear to be progressing towards reclamation standards.

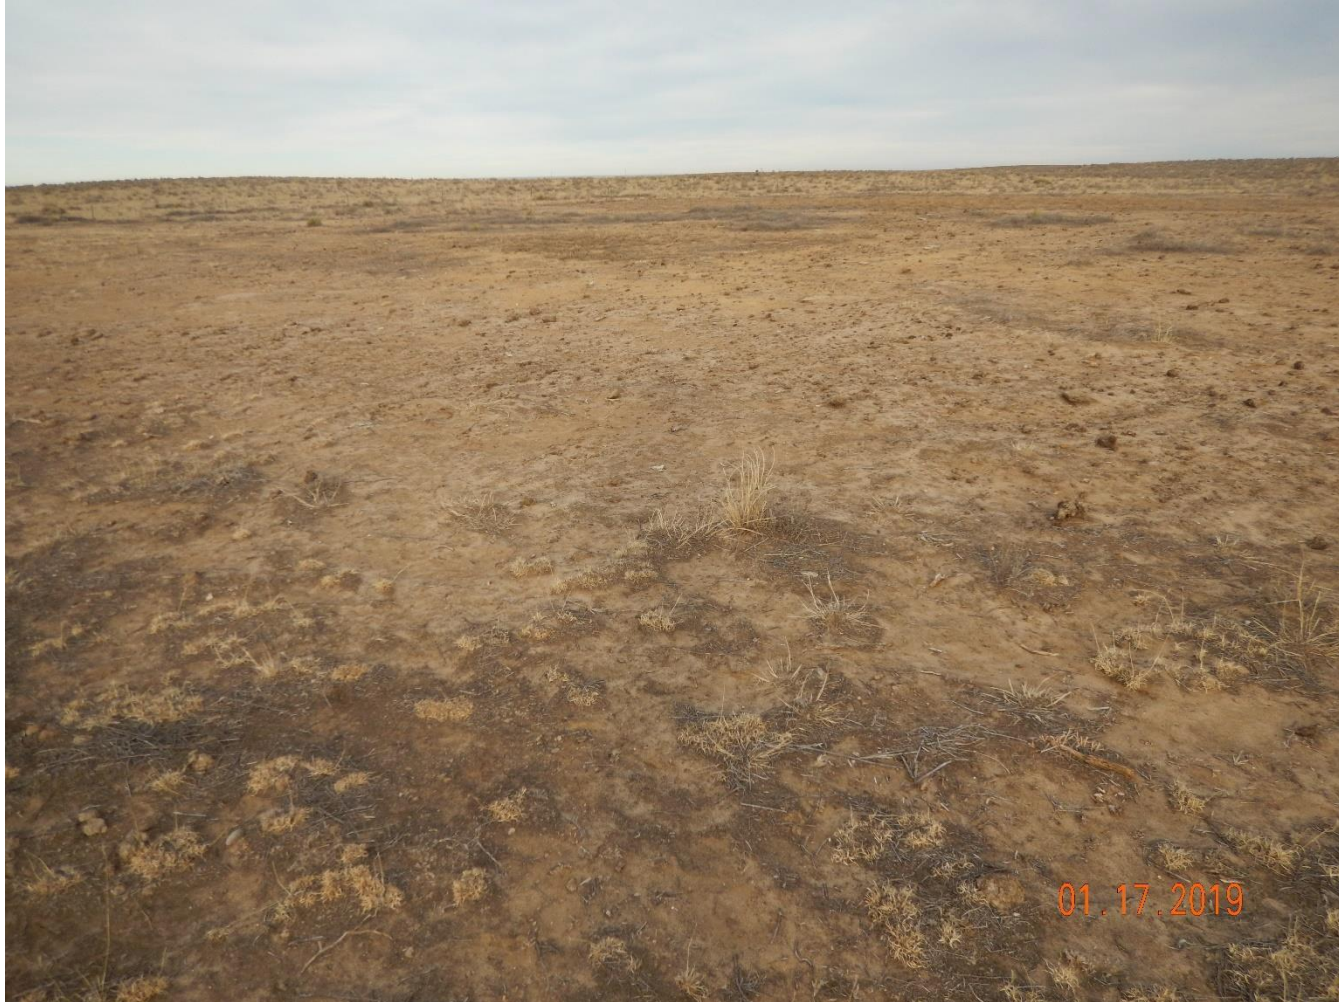
Photo 4: Photo taken from the west end of the location, facing northeast. Photo shows location remains predominantly bare and exposed soil. See comments under photo 4.

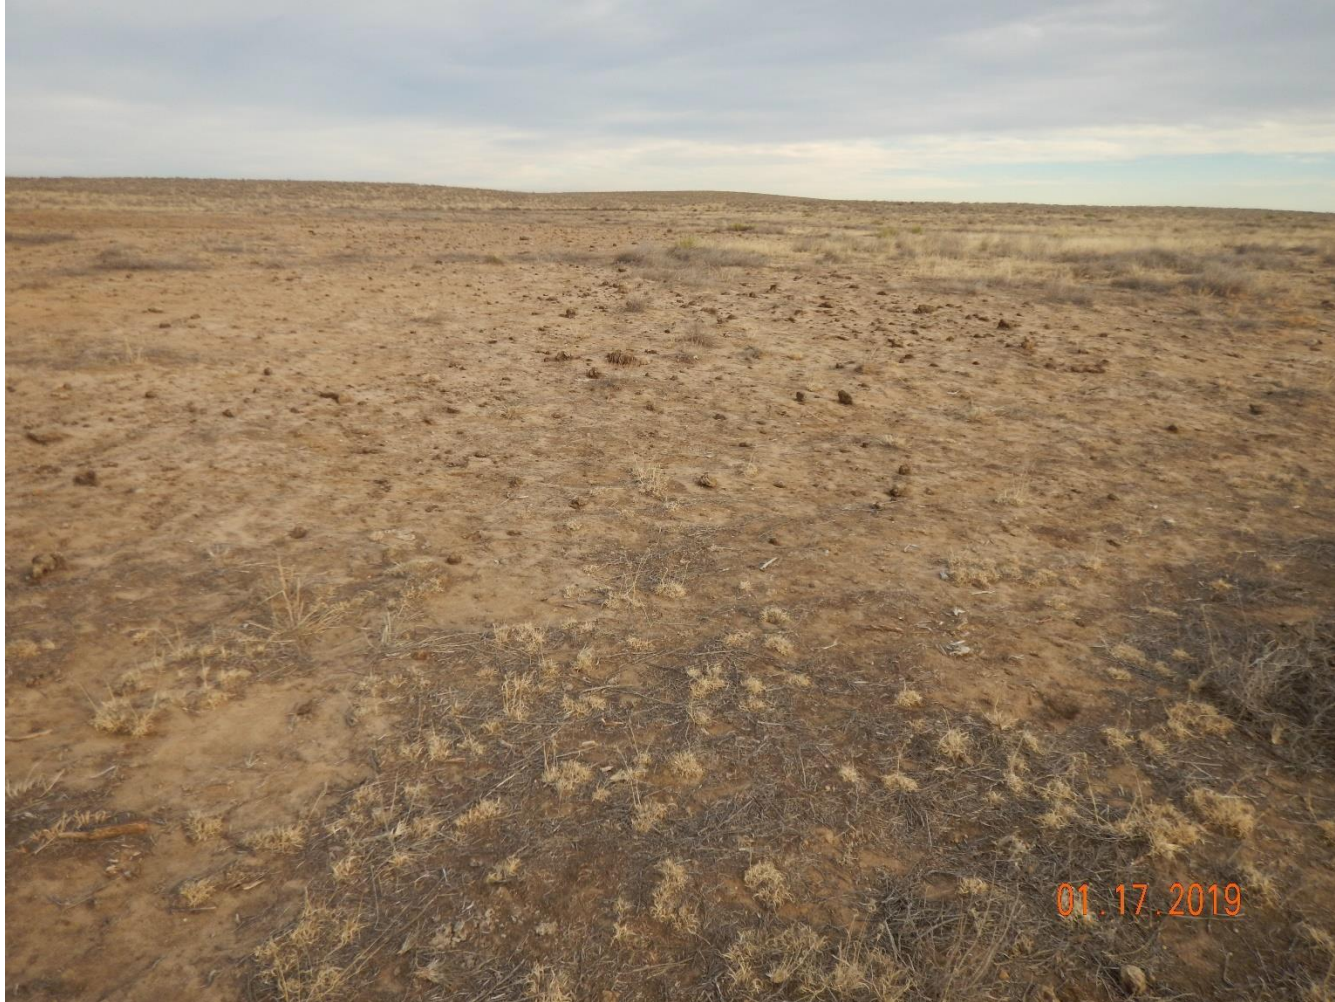
Photo 5: Photo taken from the west end of the location, facing southeast. Photo shows location remains predominantly bare and exposed soil. See comments under photo 4.

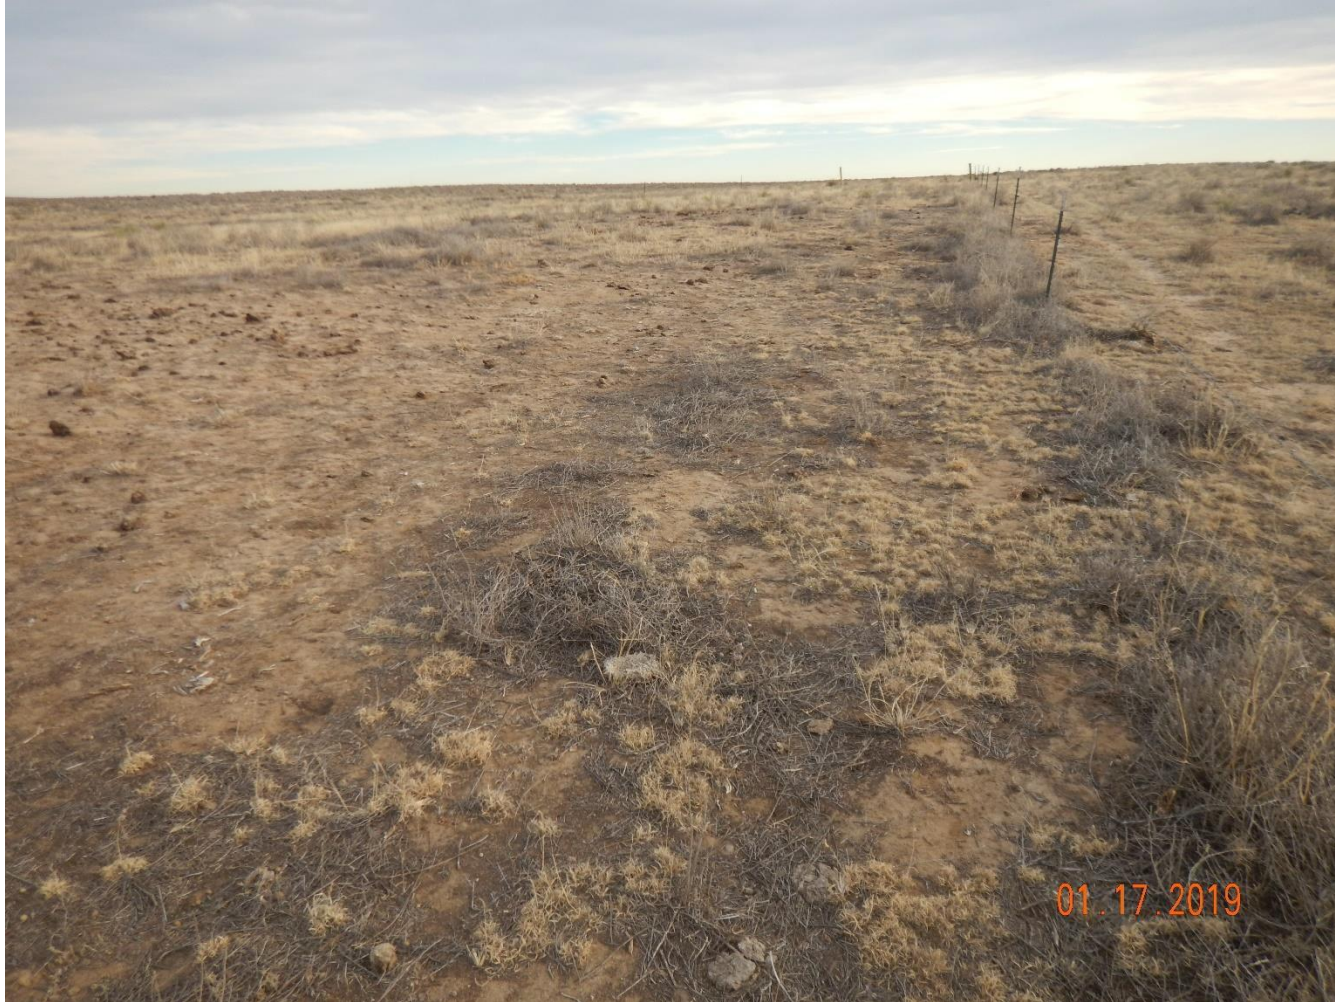
Photo 6: Photo taken from the west end of the location, facing nsouth. Photo shows location remains predominantly bare and exposed soil. See comments under photo 4.
