# Construction and Storm Water Inspection

Operator: CRESTONE PEAK RESOURCES OPERATING LLC – 10633

Location ID: 451044

Weld County, CO

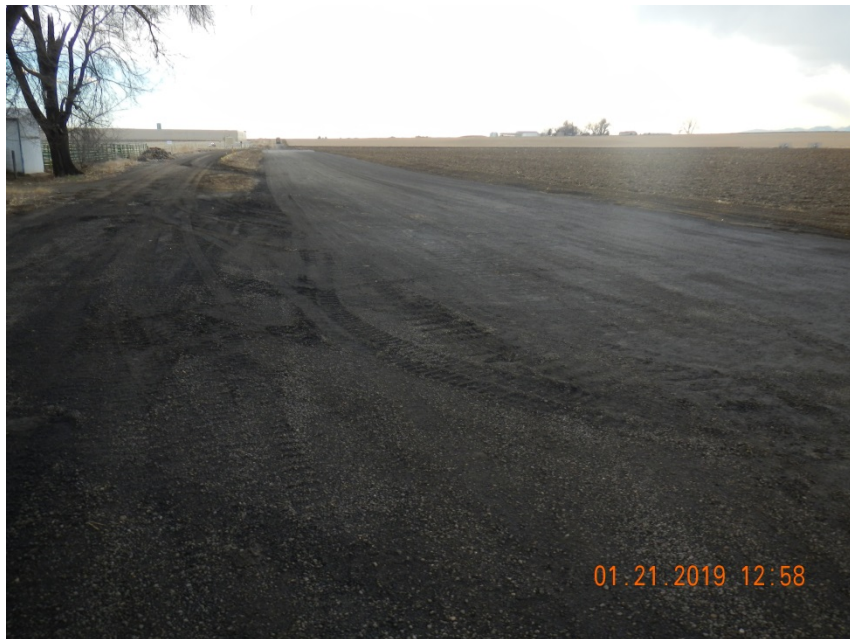
**Photo 1.** Photo taken from the entrance of the location off CR 205, facing North. Operator has installed gravel potentially to limit tracking onto the county road. BMPs in proper functioning condition at the time of this inspection.

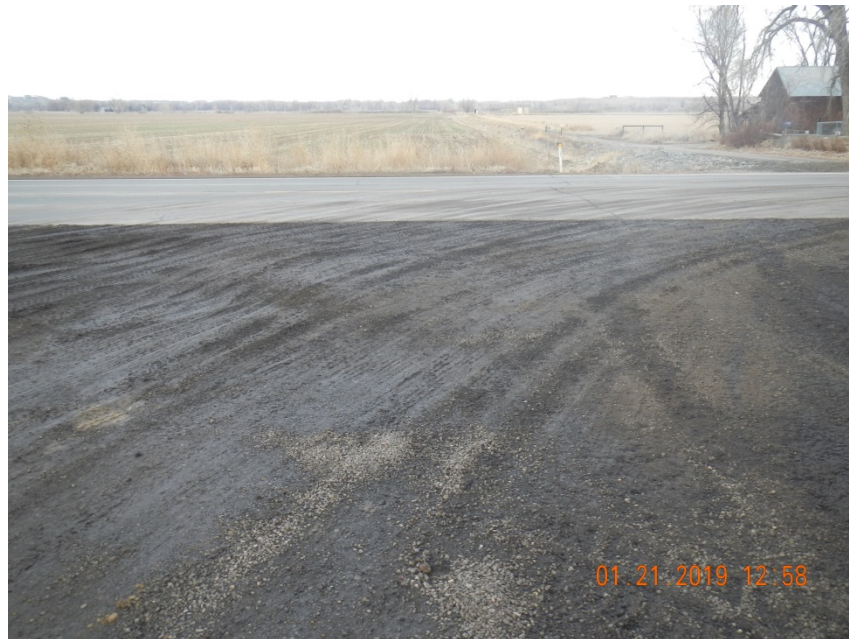
**Photo 2.** Photo taken from the entrance of the location off CR 20.5, facing South. See comments from Photo 1.
