Inspection Photos
Location Name: IGO-65N66W /28NENW
Location #: 330085

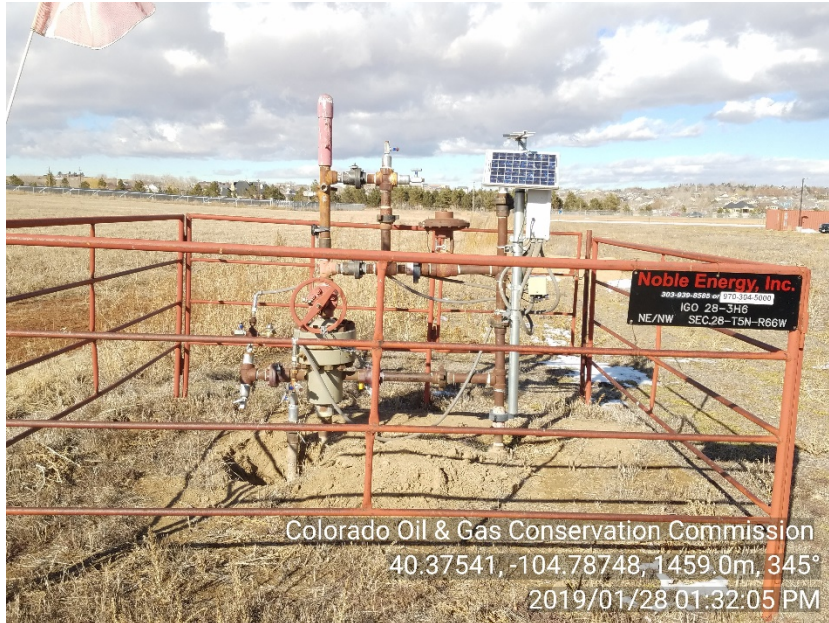
Photo #1
Igo 28-3H6 (05-123-18373) wellsite
Shut-In | LOTO
Weeds appear to be mitigated
No Orange SI / TA tag per agreement

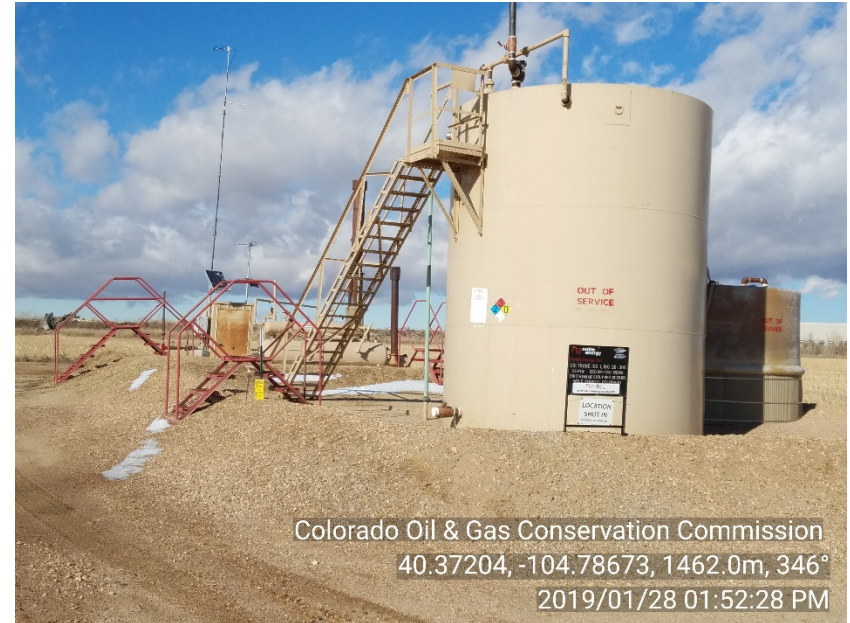
Photo #2
Coltrane-Igo # 1, Igo 28-3H6 Battery
Shut-down
Contents / Capacity not posted on crude oil tank
