# Interim Reclamation and Stormwater Inspection

Operator: VERDAD RESOURCES LLC - #10651

Location ID: 428592

Inspection Photos  
Location Name: Pergamos /8-41-7-60  
Location ID: 428592

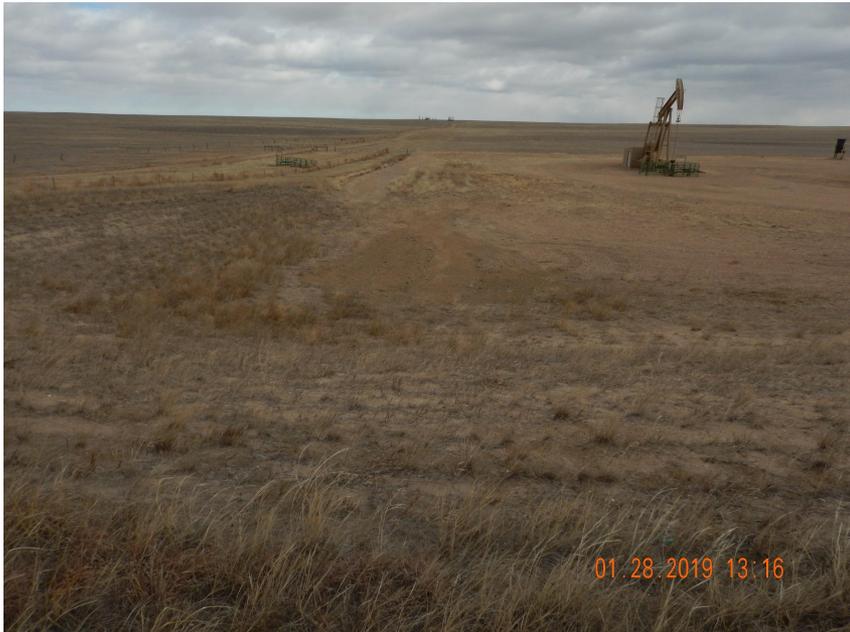
**Photo 1.** Photo taken from the entrance of the location, facing East. Photo illustrates the northern well pad. Operator has failed to perform interim reclamation.

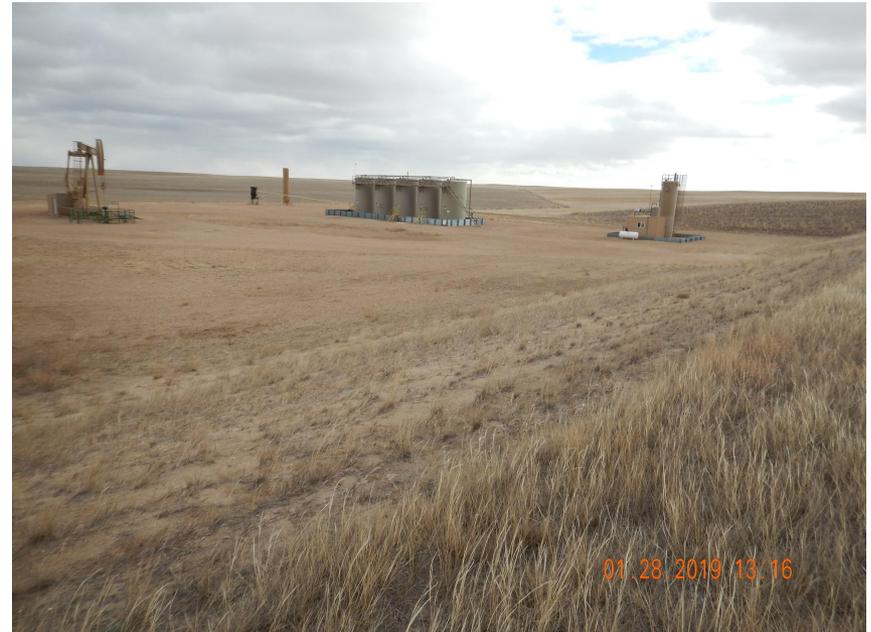
**Photo 2.** Photo taken from the entrance of the location, facing South. See comments under Photo 1.

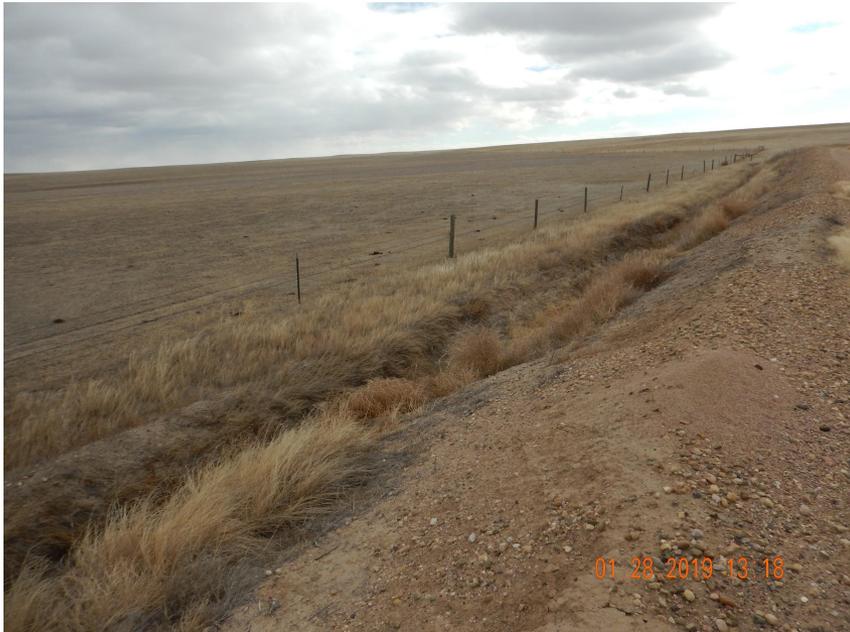
**Photo 3.** Photo taken from the eastern well pad, facing South. Photo illustrates unmanaged weeds along the fill slope. Operator shall control weeds and weed debris per Rule 603.f.

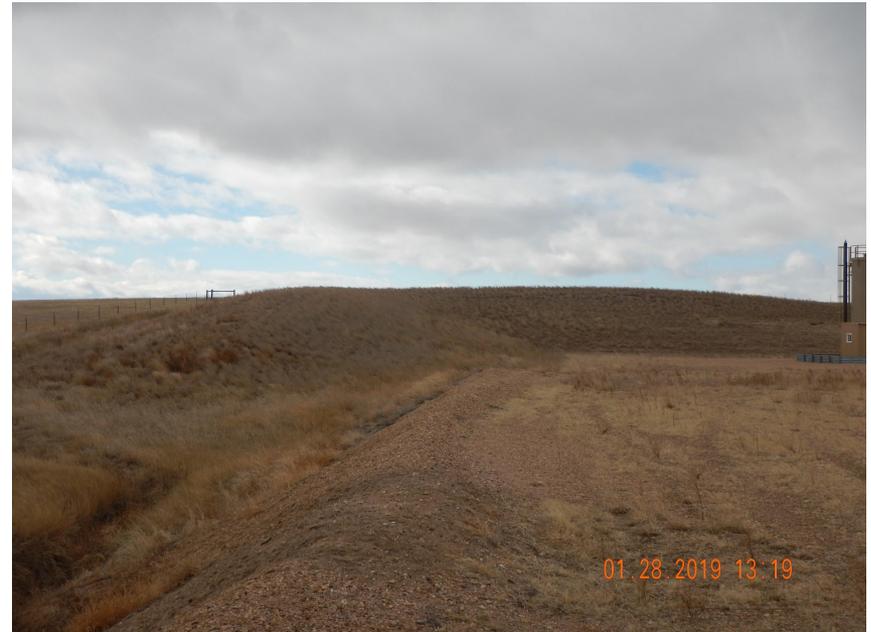
**Photo 4.** Photo taken from the southern well pad, facing West. See comments under Photo 1.
