Interim Reclamation and Stormwater Inspection

Operator: EXTRACTION OIL & GAS INC #10459

Location ID: 450197

Inspection Photos
Location Name: McGirr /26-L
Location ID: 450197

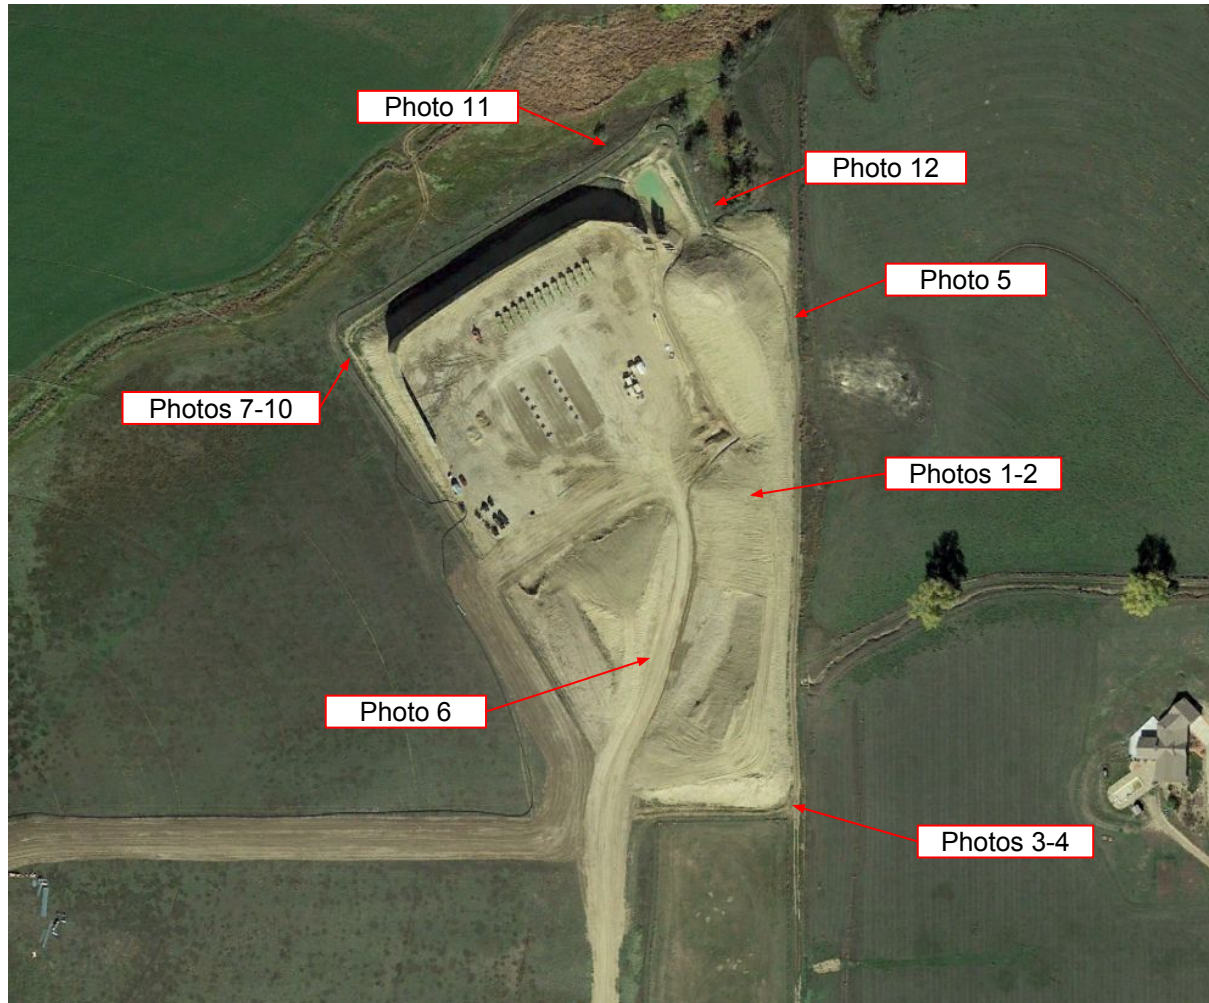
Google Earth aerial imagery taken on 10/14/2017. Photo reference points to help illustrate approximate locations of the subject photo during the January 30, 2019 inspection.

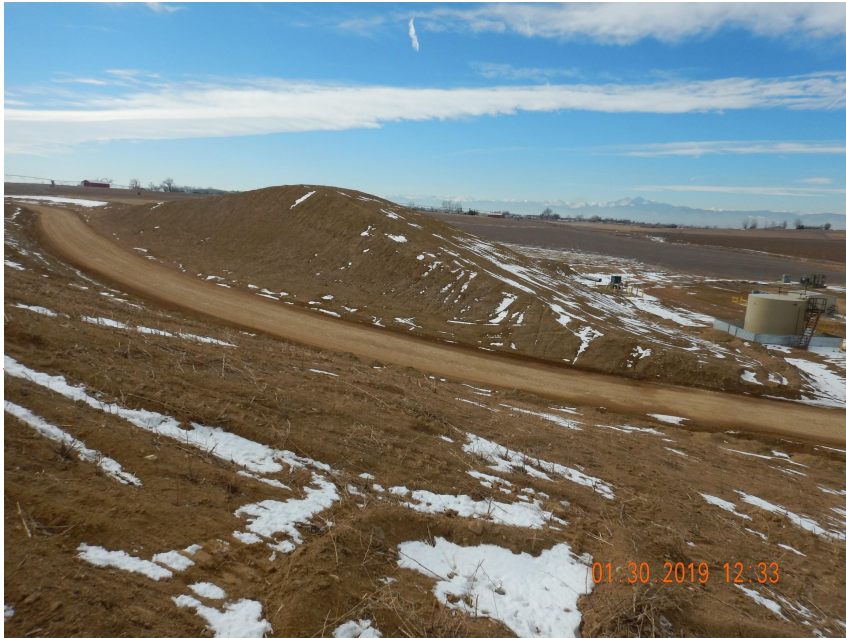
Photo 1. Photo taken from the eastern stockpile, facing West. Photo illustrates that no interim reclamation has been performed.

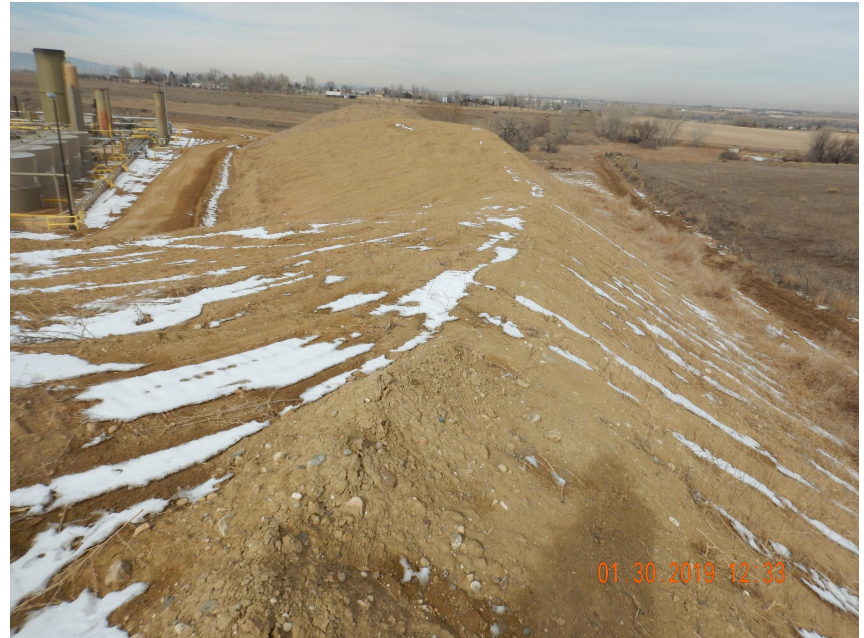
Photo 2. Photo taken from the eastern stockpile, facing North. See comments under Photo 1.

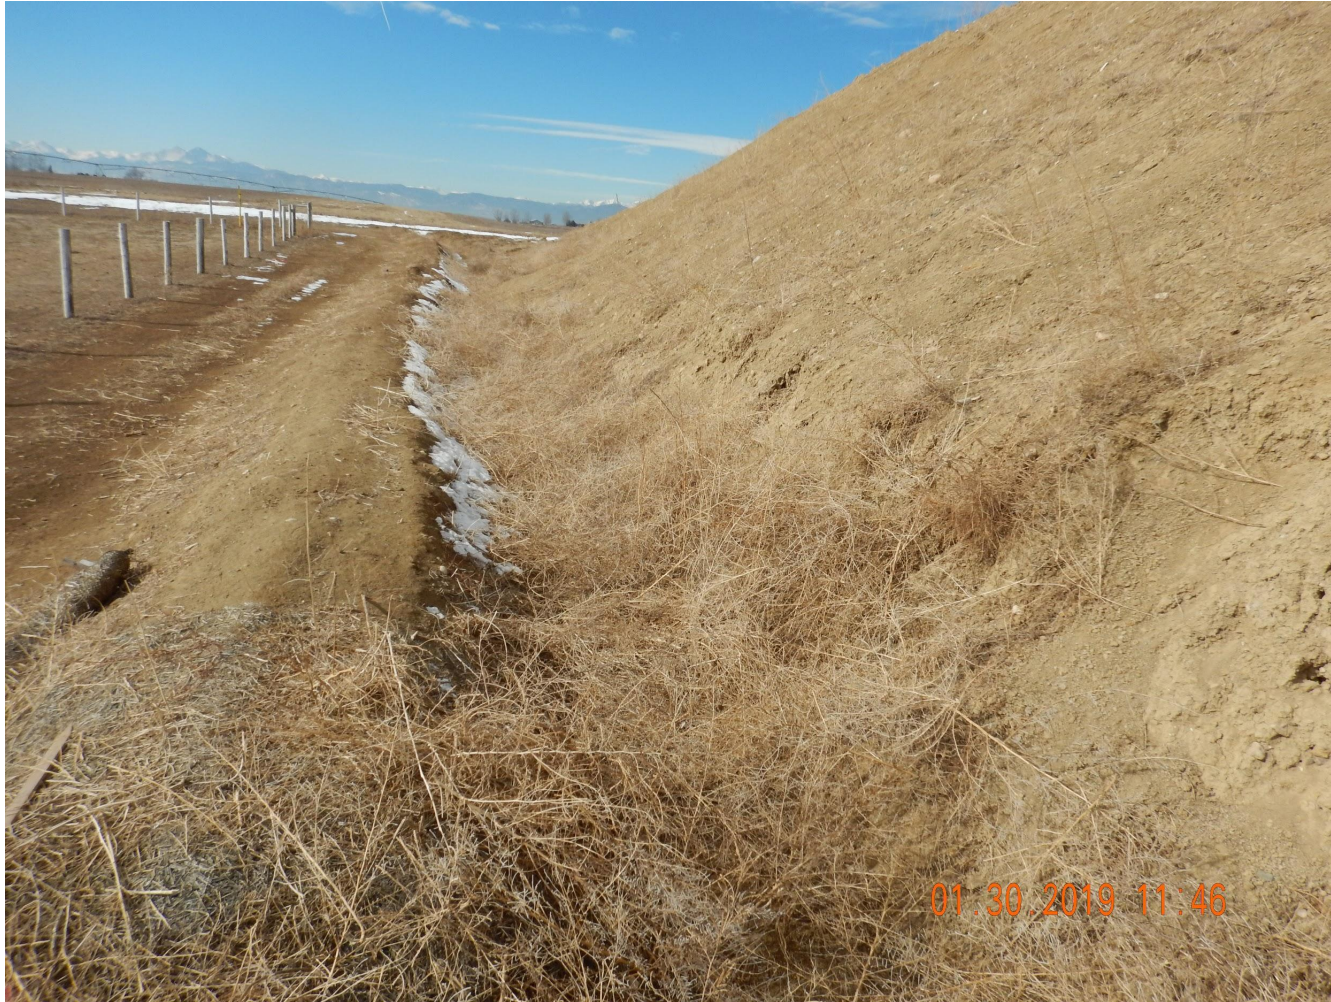
Photo 3. Photo taken from the southern perimeter of location, facing West. Photo illustrates unmanaged weeds and weed debris. Operator failed to control and manage weeds to prevent weed waste and prevent the spread of seeds onto adjacent lands per Rule 603.f.

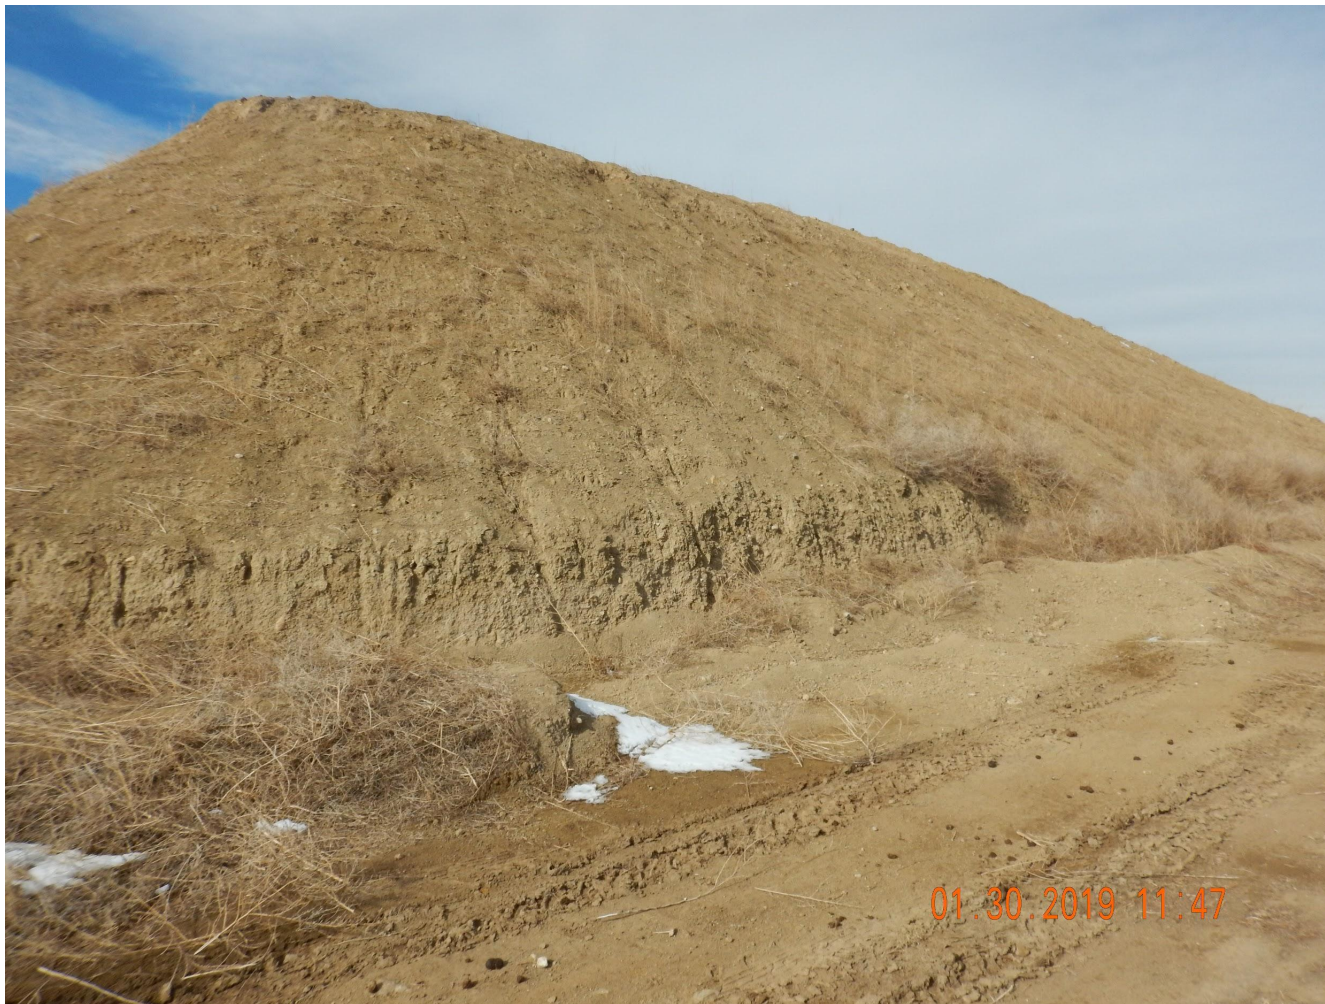
Photo 4. Photo taken from the southeast perimeter of location, facing Northwest. Photo illustrates rill erosion along the southern slope of the stockpile and unmanaged weeds. Rill erosion was observed throughout most of the location. Operator has failed to adequately stabilize stockpiles and fill slopes to minimize erosion and site degradation per Rule 1002.f.

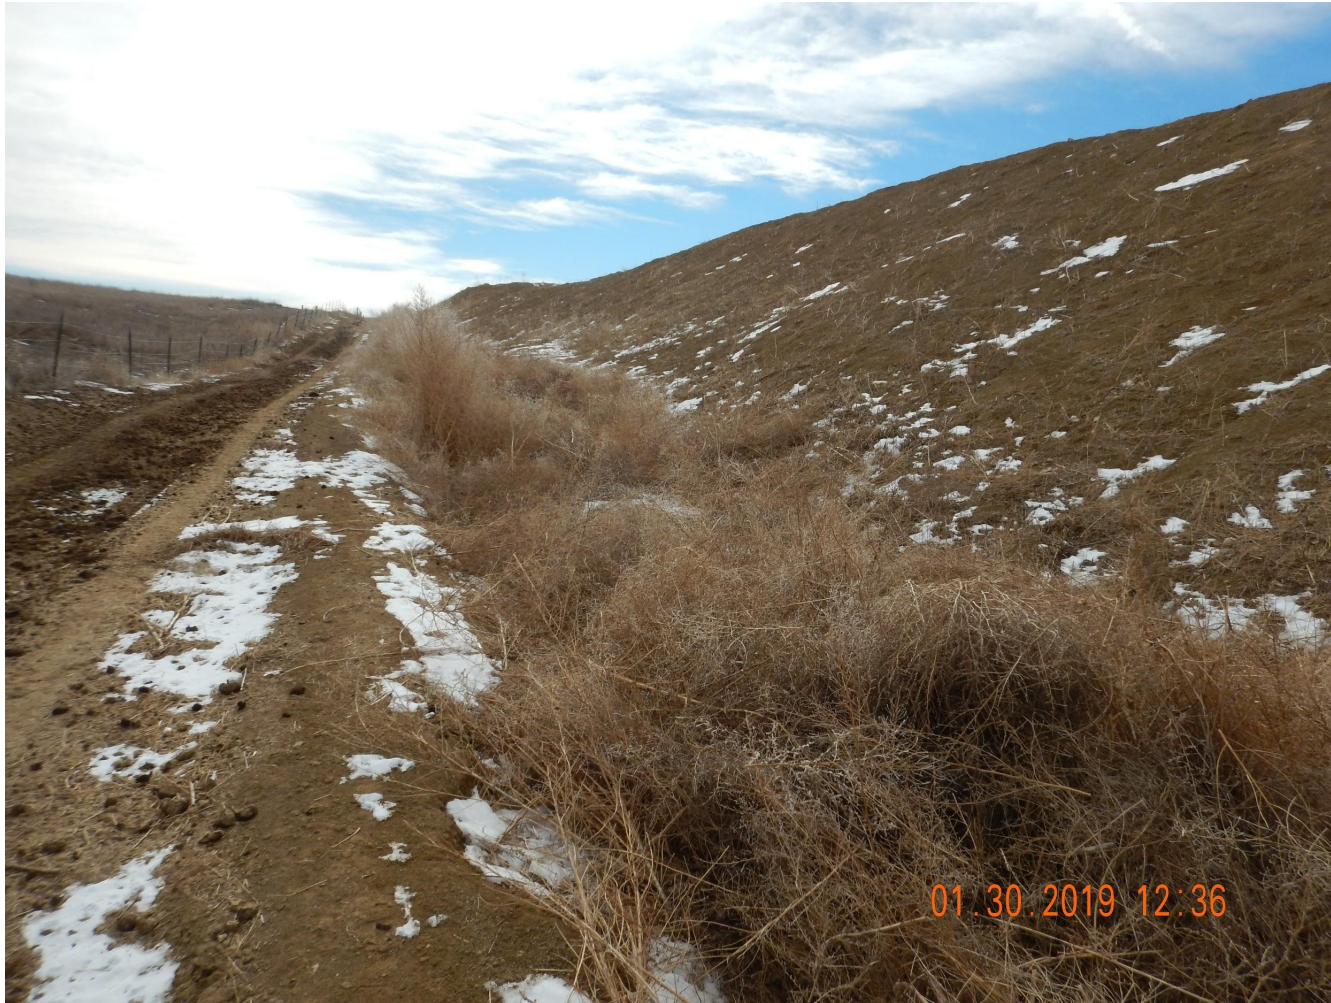
Photo 5. Photo taken from the eastern perimeter of location, facing South. See comments under Photo 3. Note: Weeds were in excess of 6 feet tall along portions of the eastern perimeter.

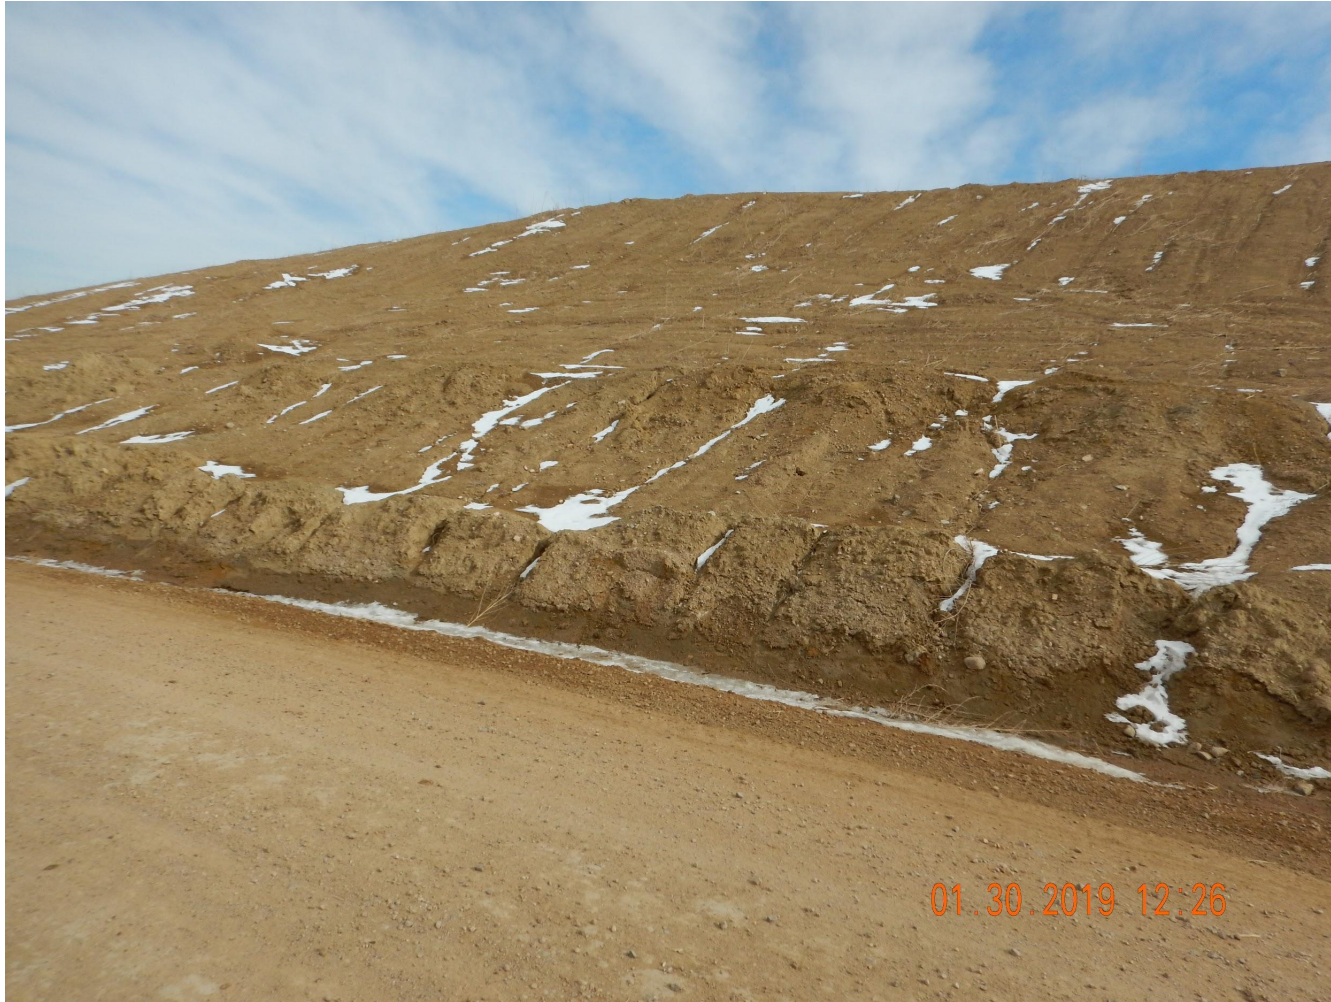
Photo 6. Photo taken along a portion of the access road, facing East. See comments under Photo 4.

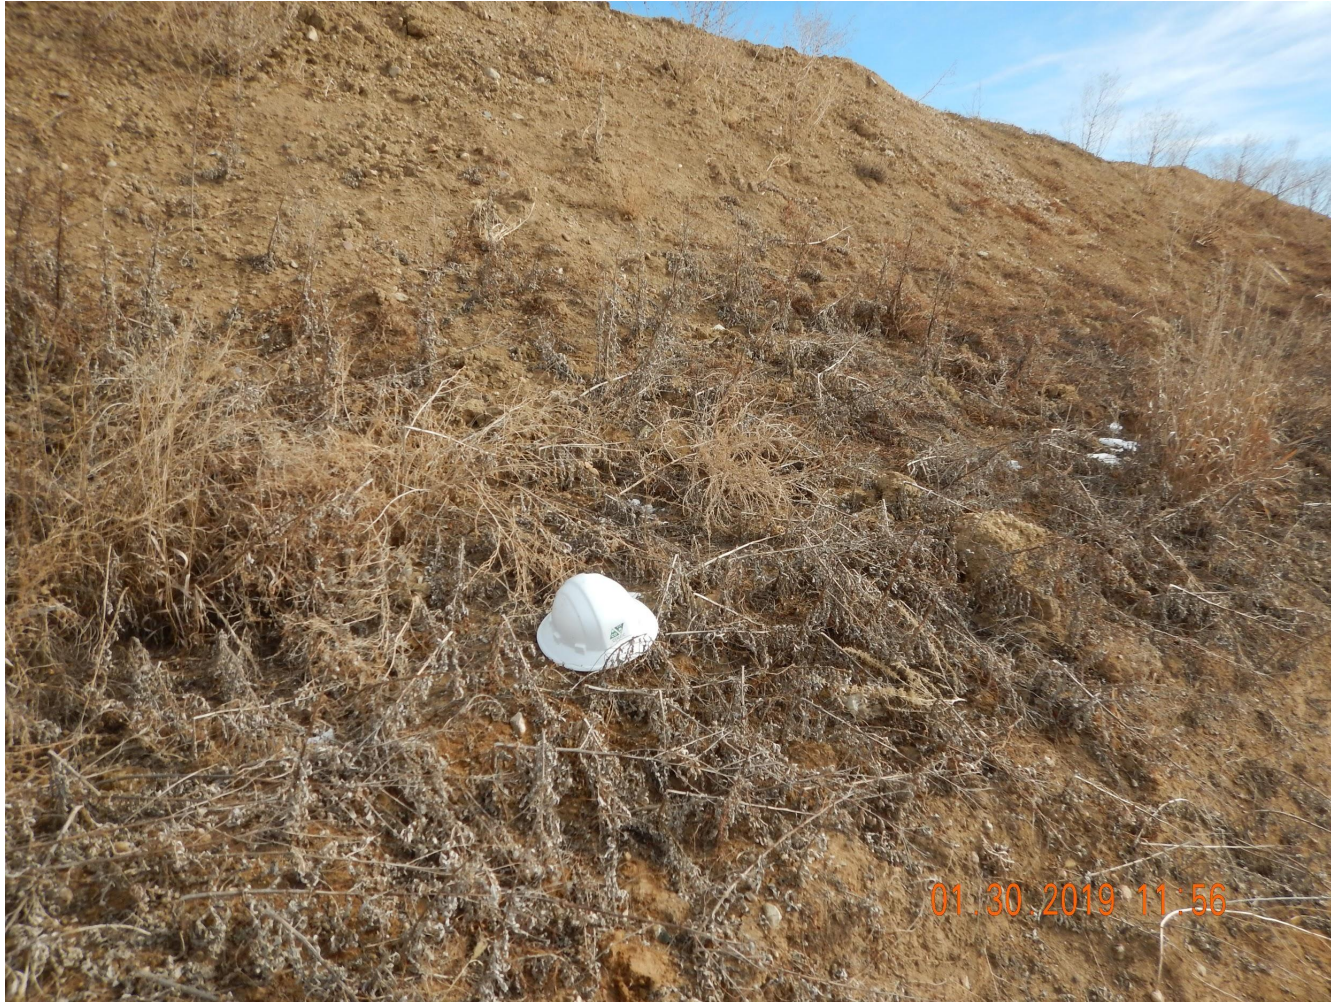
Photo 7. Photo taken from the northwestern perimeter of location, facing Southeast. Photo illustrates unmanaged Canada thistle (*Cirsium arvense*), a List B Colorado Noxious weed. Operator has failed to control and manage noxious weeds.

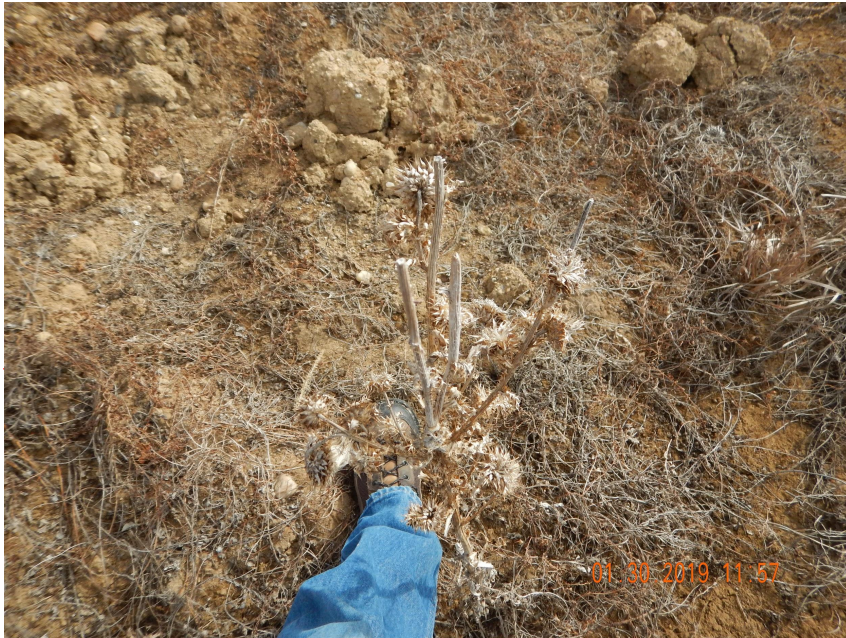
Photo 8. Photo taken from the northwestern perimeter of location. Photo illustrates unmanaged Musk thistle (*Carduus nutans*), a List B Colorado Noxious weed. Operator has failed to control and manage noxious weeds.

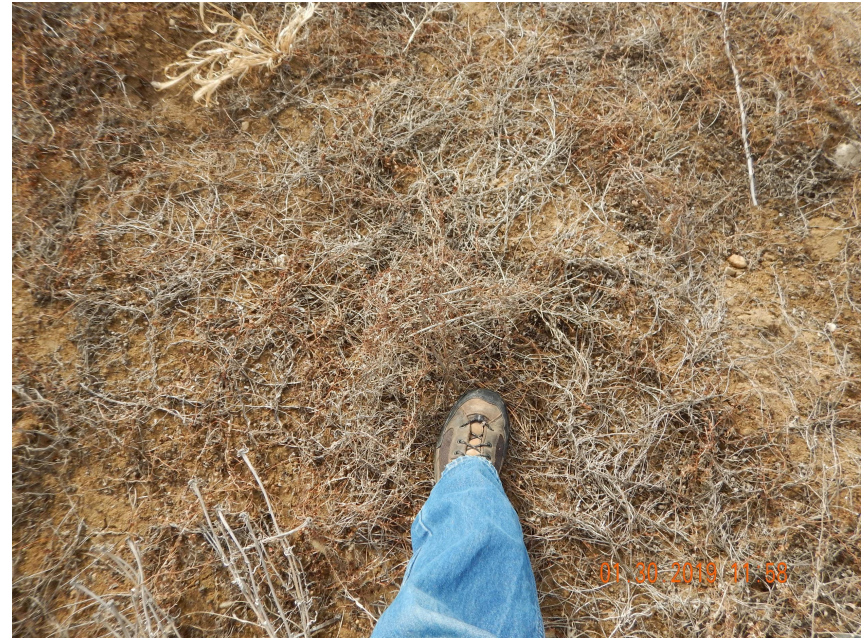
Photo 9. Photo taken from the northwestern perimeter of location. Photo illustrates unmanaged Field bindweed (*Convolvulus arvensis*), a List C Colorado Noxious weed. Operator has failed to control and manage noxious weeds.

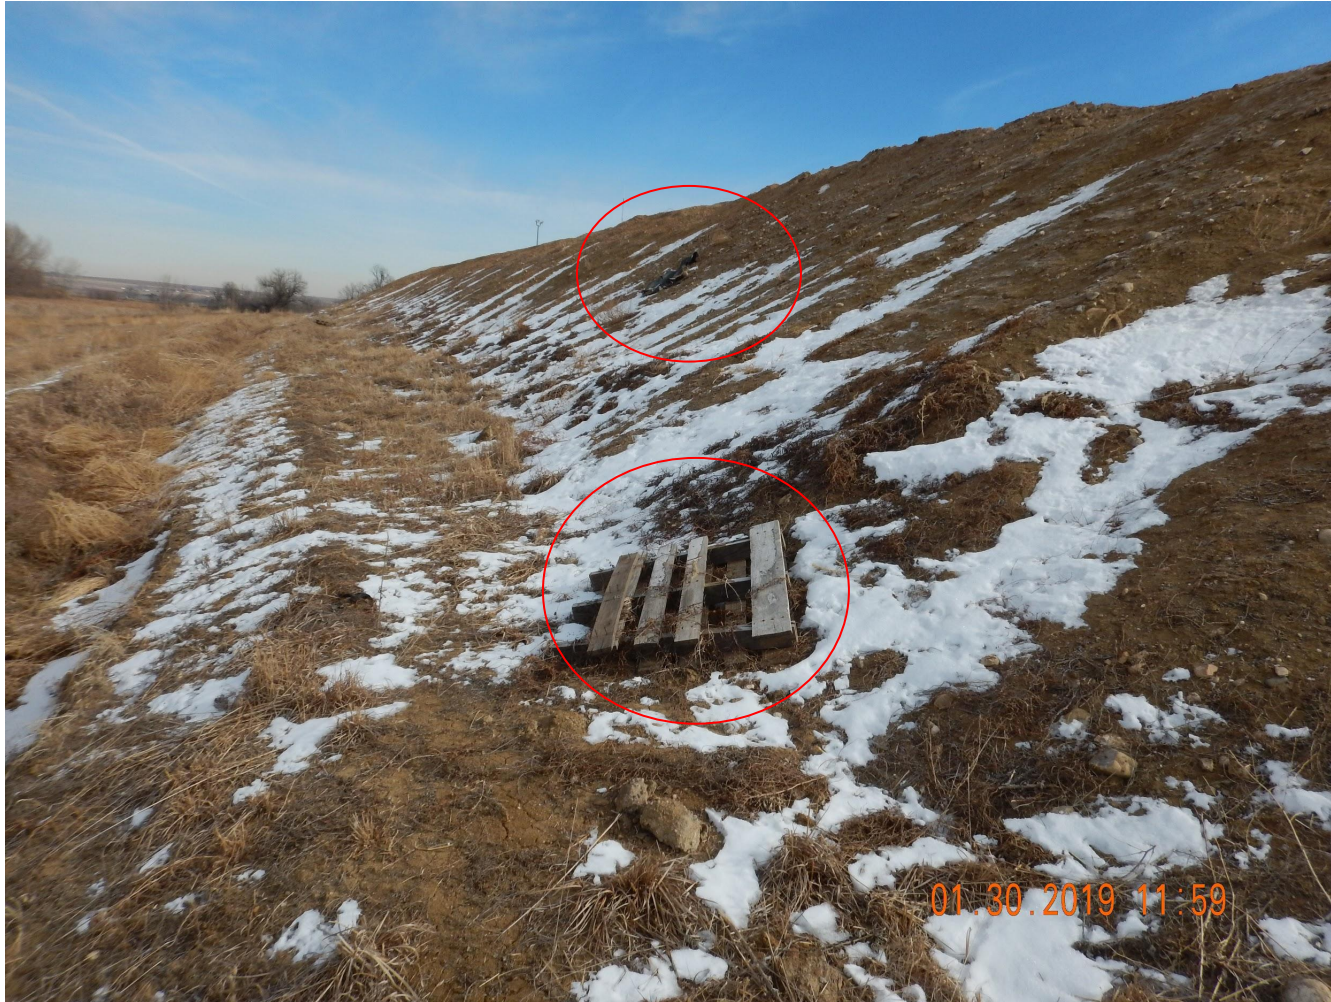
Photo 10. Photo taken from the northwest perimeter of location, facing East. Photo illustrates trash along the northern fill slope. Operator has failed to comply with Rule 603.f.

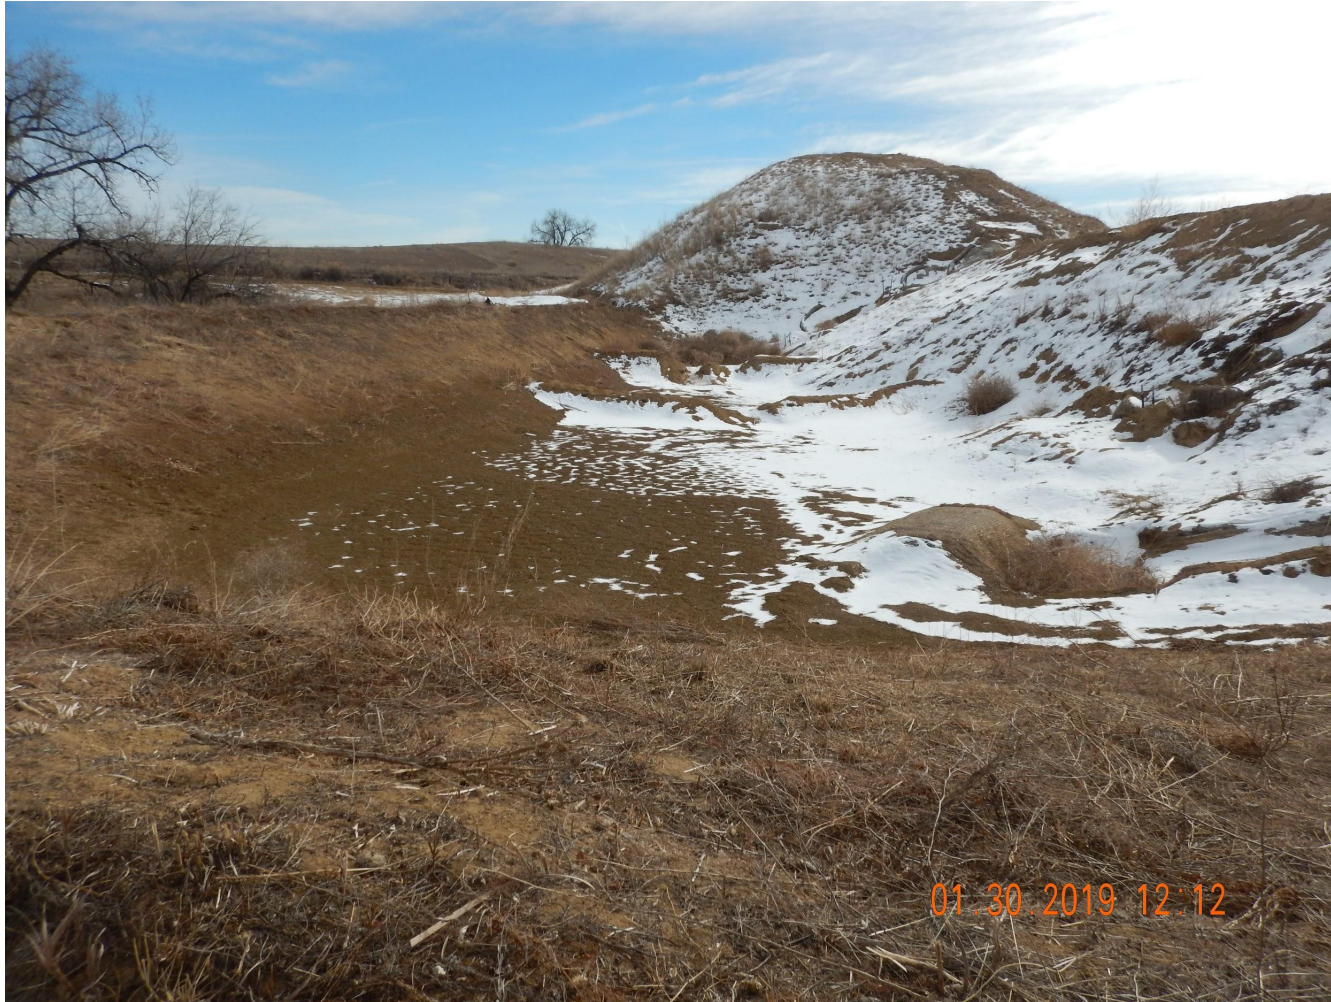
Photo 11. Photo taken from the northeast perimeter of location, facing South. Photo illustrates the sediment basin. Maintenance is needed, as gully erosion was observed along portions of the inlet- see following photo.

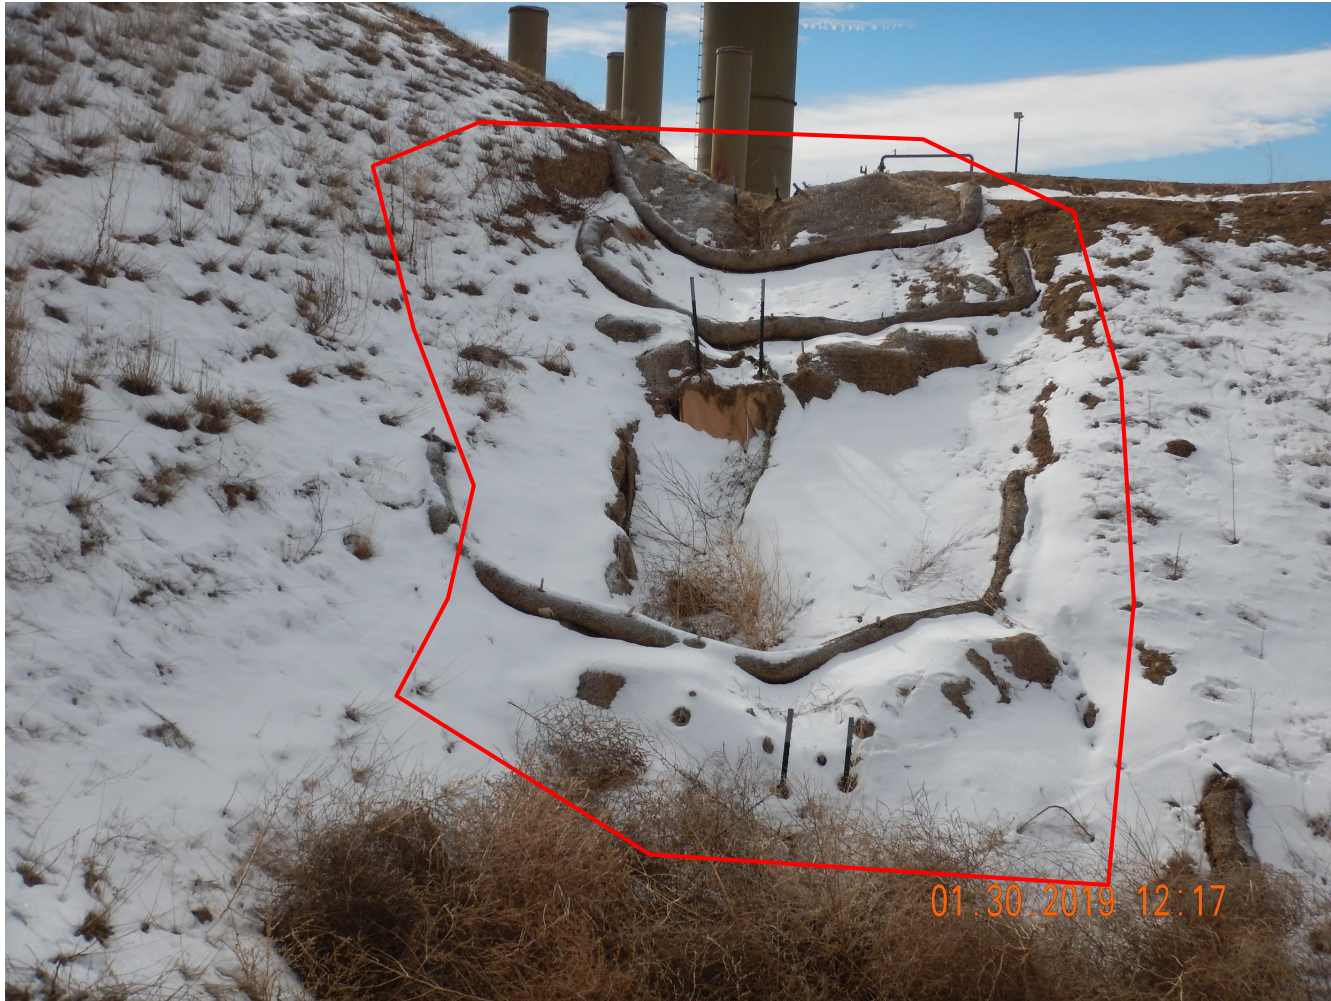
Photo 12. Photo taken from the southern inlet for the sediment basin, facing West. Photo illustrates maintenance is needed, as gully erosion was observed. Operator has failed to maintain BMPs per Rule 1002.f.
