Inspection Photos

Operator: VERDAD RESOURCES LLC - 10651

Location ID: 425596

Inspection Doc. Number: 682504457

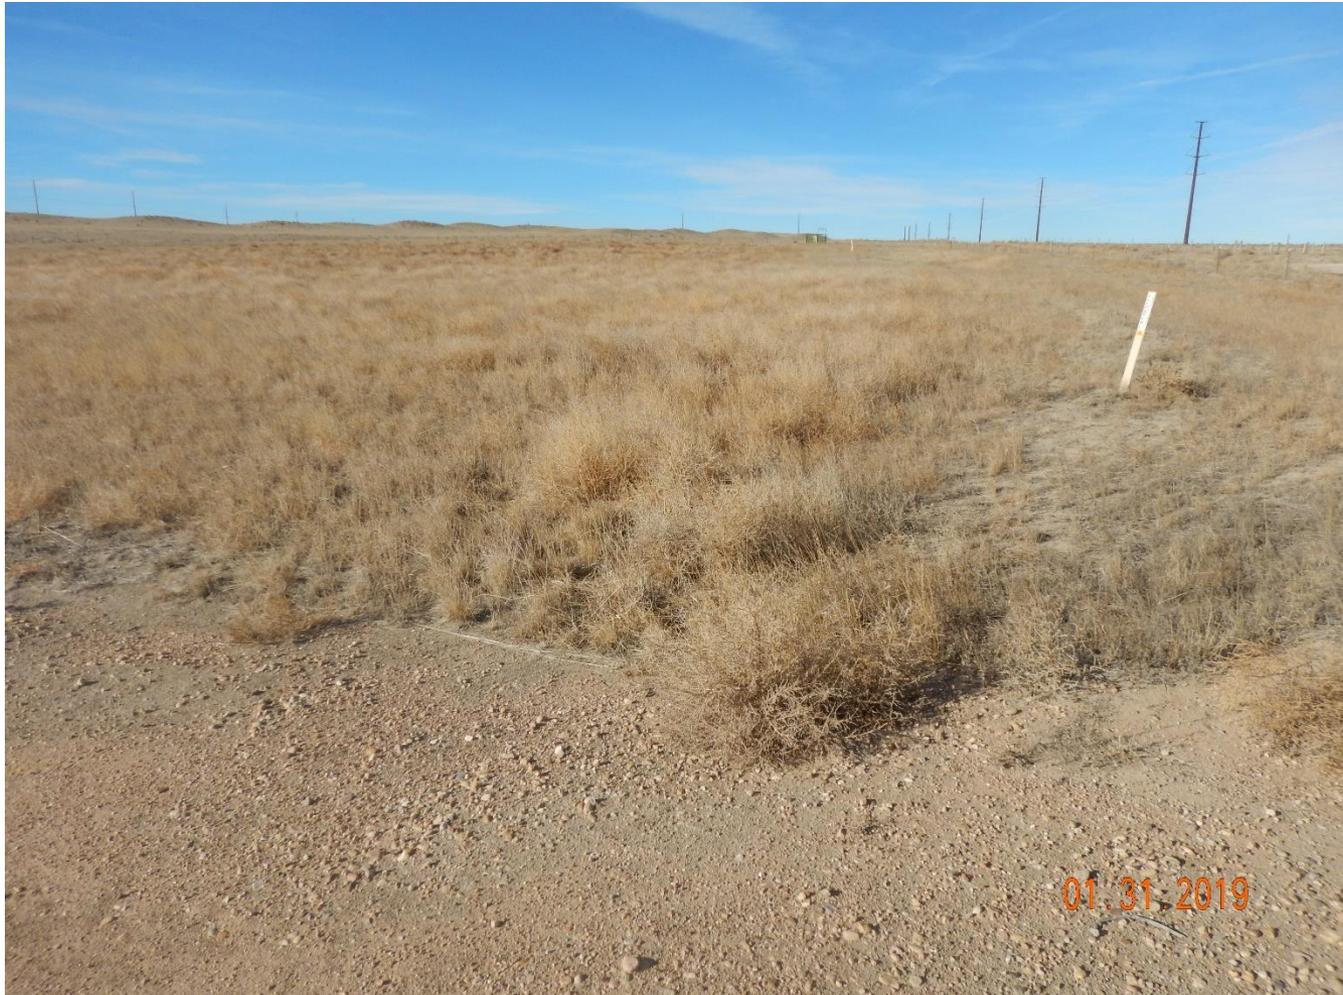
Photo 1: Photo taken from the north end of the location facing west. Photos 1-5 provide an overview of the location (interim and production areas) from west, southwest, southeast, to east.

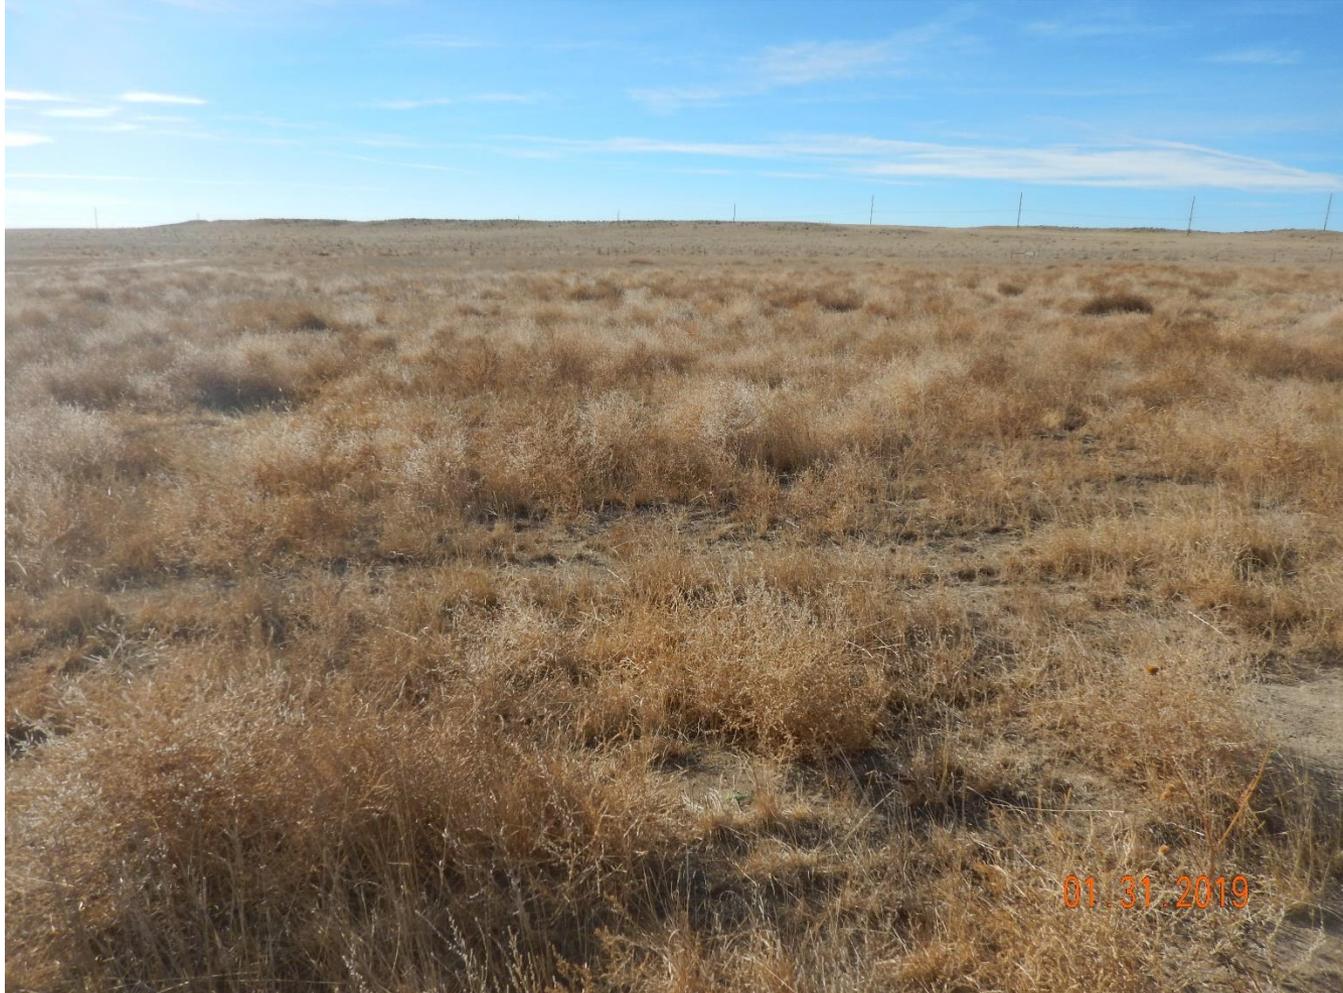
Photo 6: Photo taken from the northwestern area of the location, facing south. Photo shows area where freshwater pit existed. Pit appears to have been closed. Photo shows interim reclamation in process.

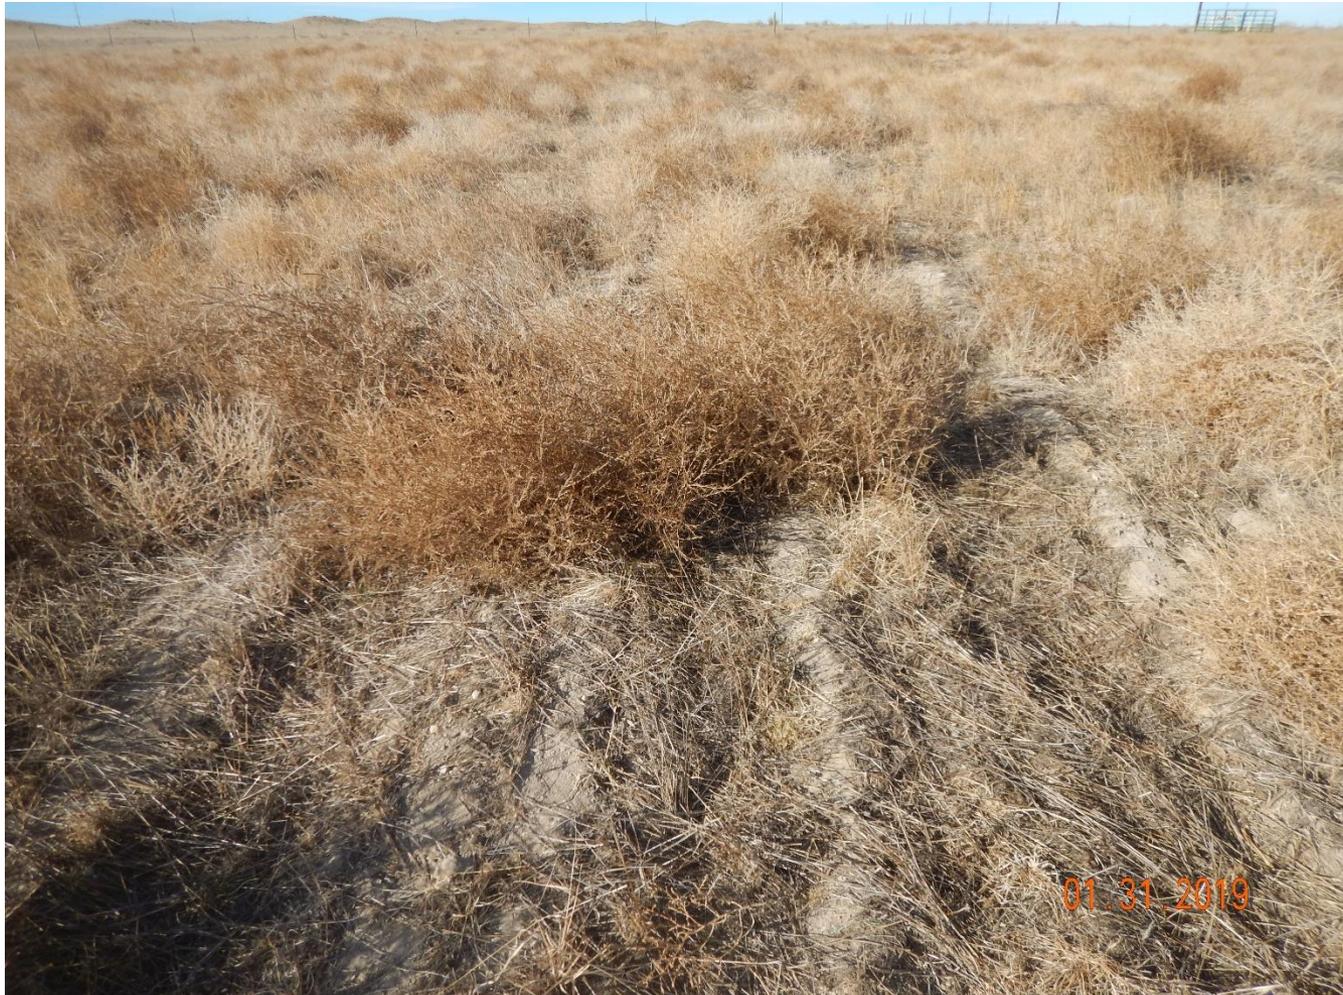
Photo 7: Photo taken from the interim areas on the west end of the location, facing west. Desirable perennial germination evident, however interim areas predominantly undesirable weedy plant species such as Russian thistle.
