Inspection Photos

Operator: VERDAD RESOURCES LLC - 10651

Location ID: 437190

Inspection Doc. Number: 682504463

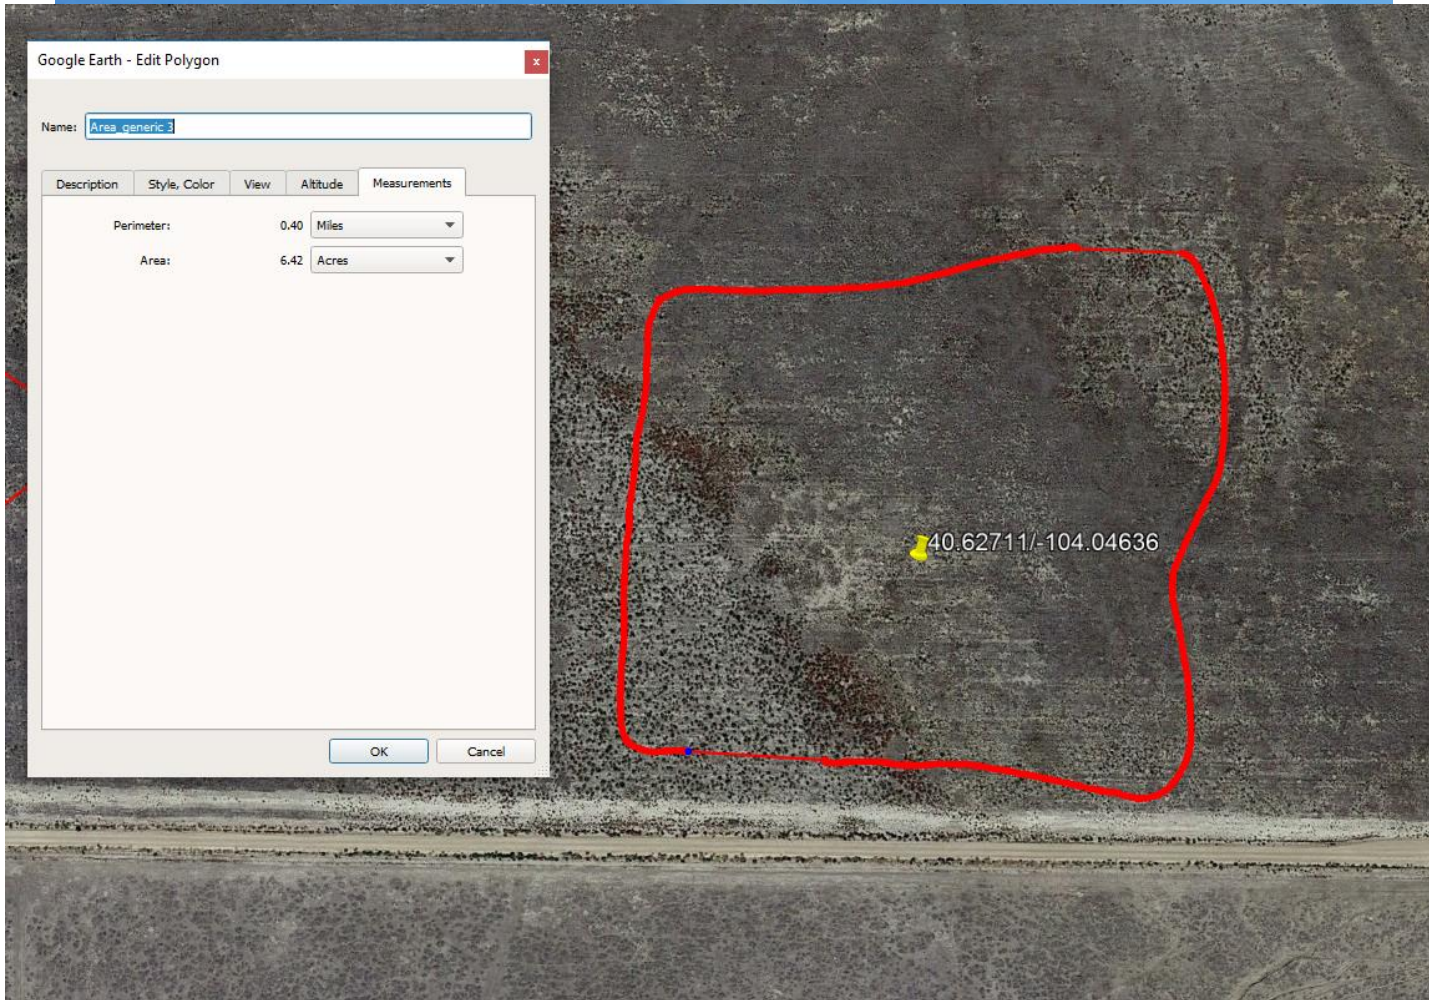
Photo 1: 2013 Google earth aerial imagery. Photo shows disturbance area for the location. A disturbance area of 6.42 acres was measured using a Trimble Juno 3B handheld device

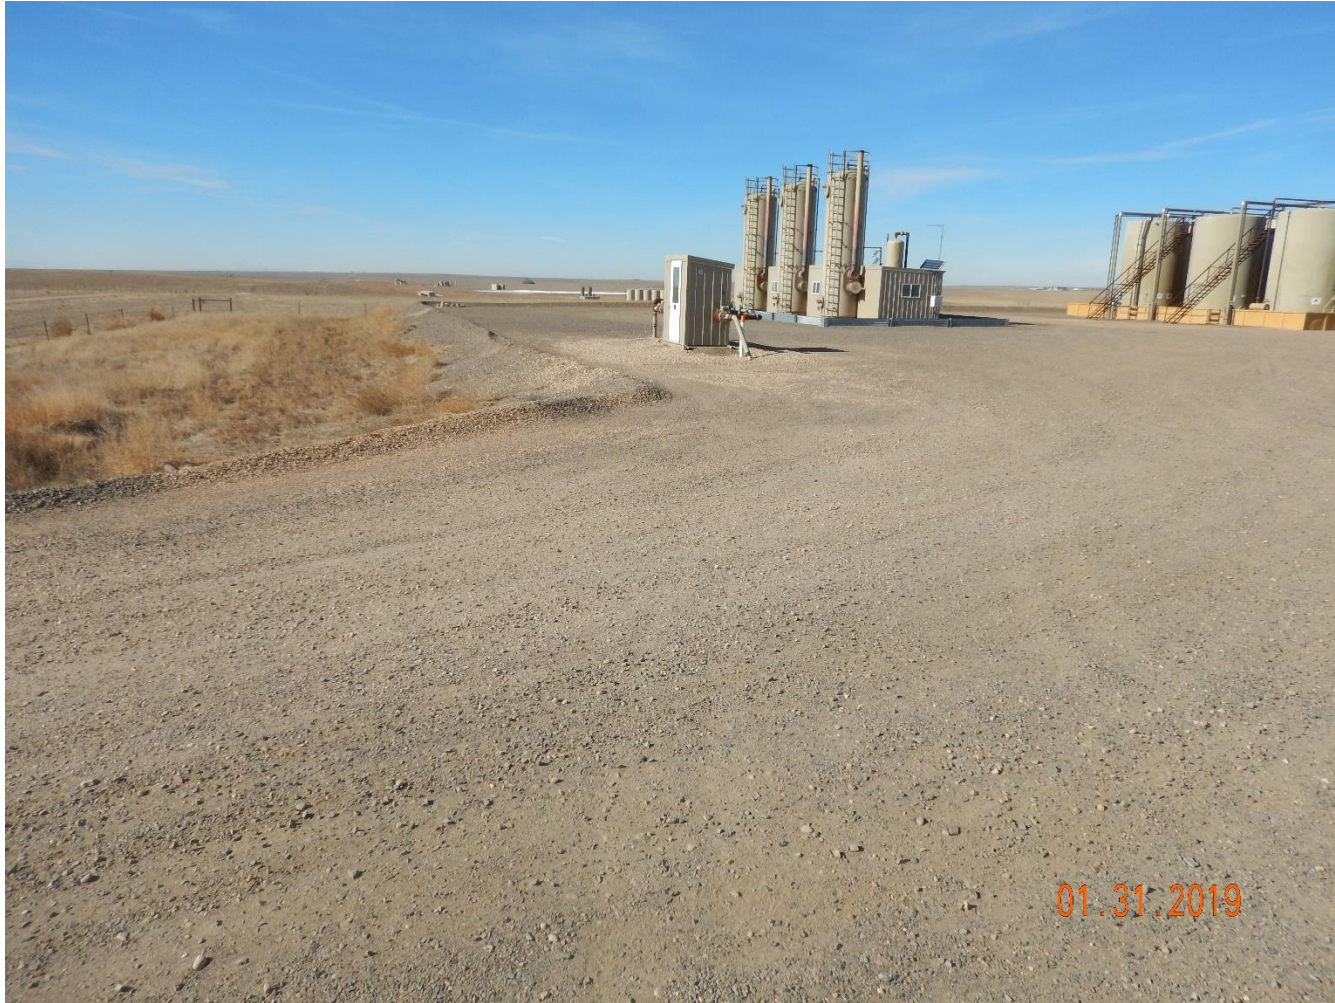
Photo 2: Photo taken from the south end of the location, facing west. Photos 2- 5 provide and overview of the location from west, northwest, northeast to east. Photos also show interim reclamation has not been conducted in accordance with COGCC rule 1003.

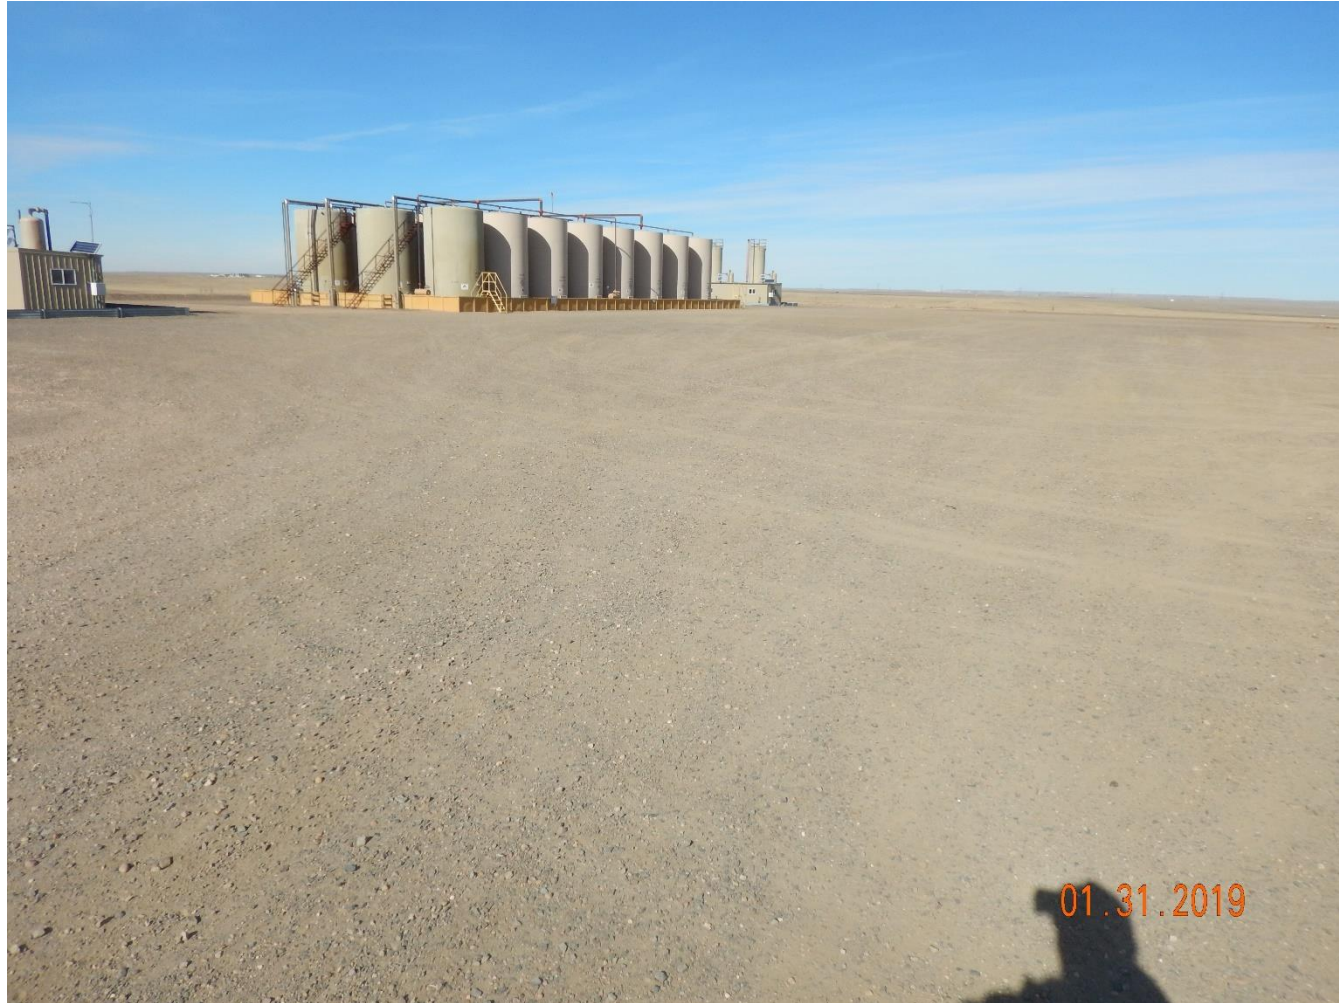
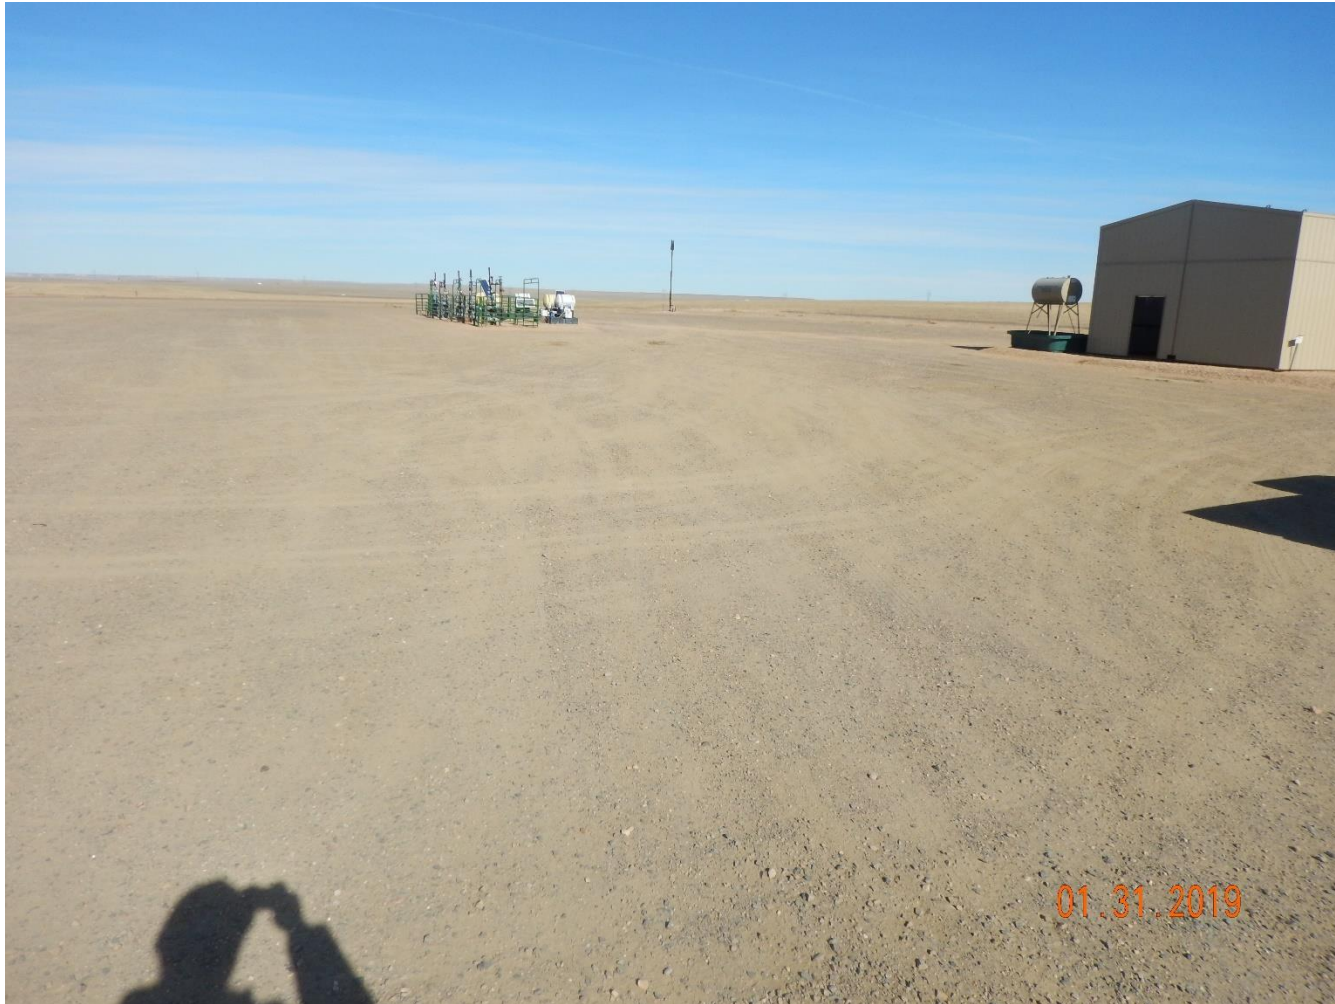
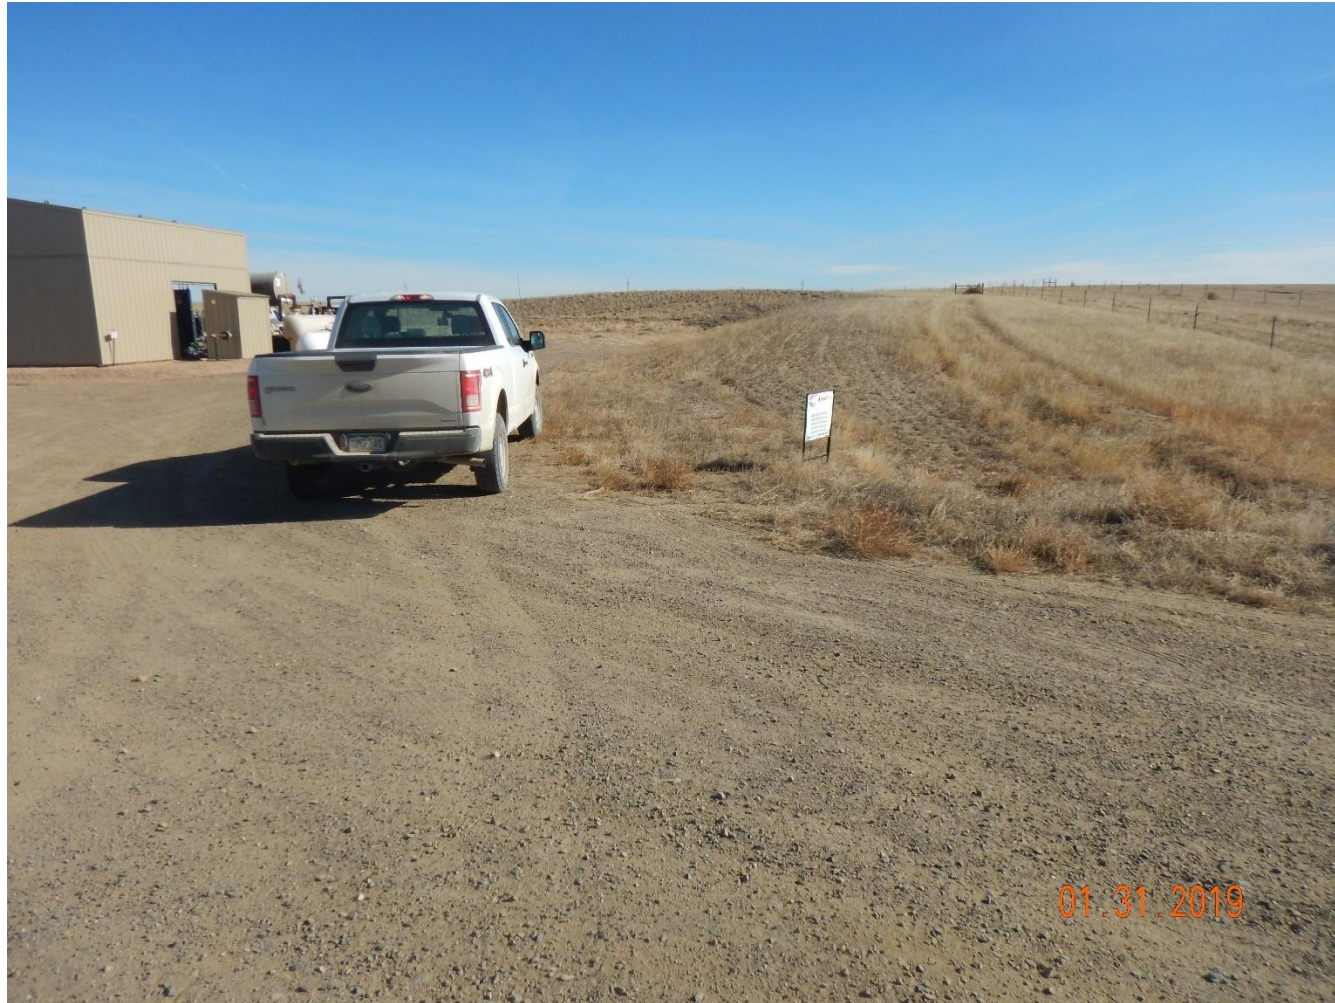
Photo 3: See comments under photo 2.

Photo 4: See comments under photo 2.

Photo 5: See comments under photo 2.

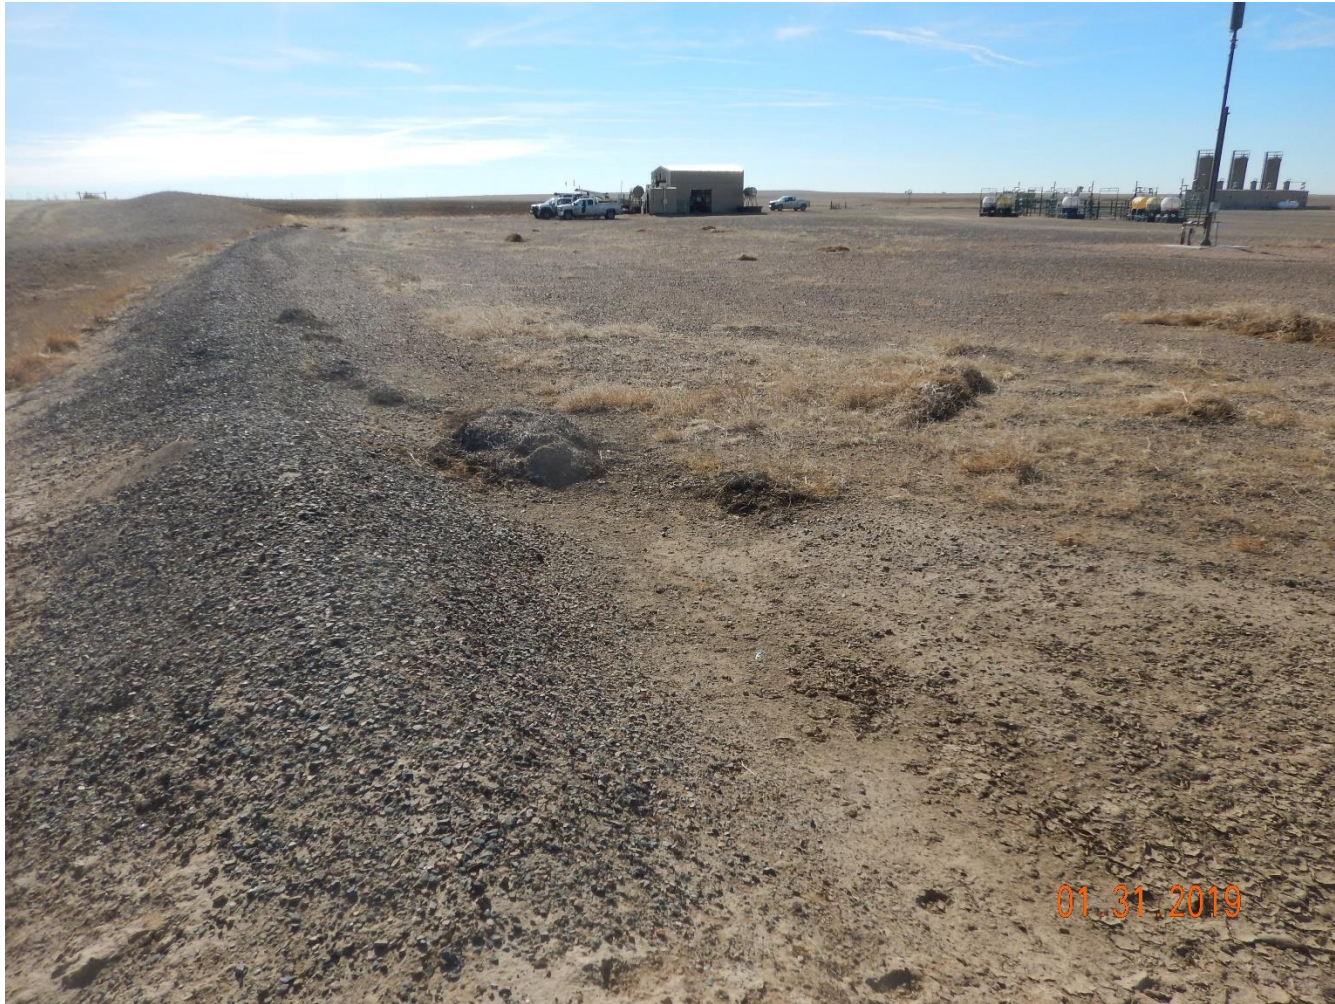
Photo 6: Photo taken from the northeast corner of the location, facing south. Photo shows interim reclamation has not been conducted in accordance with COGCC rule 1003

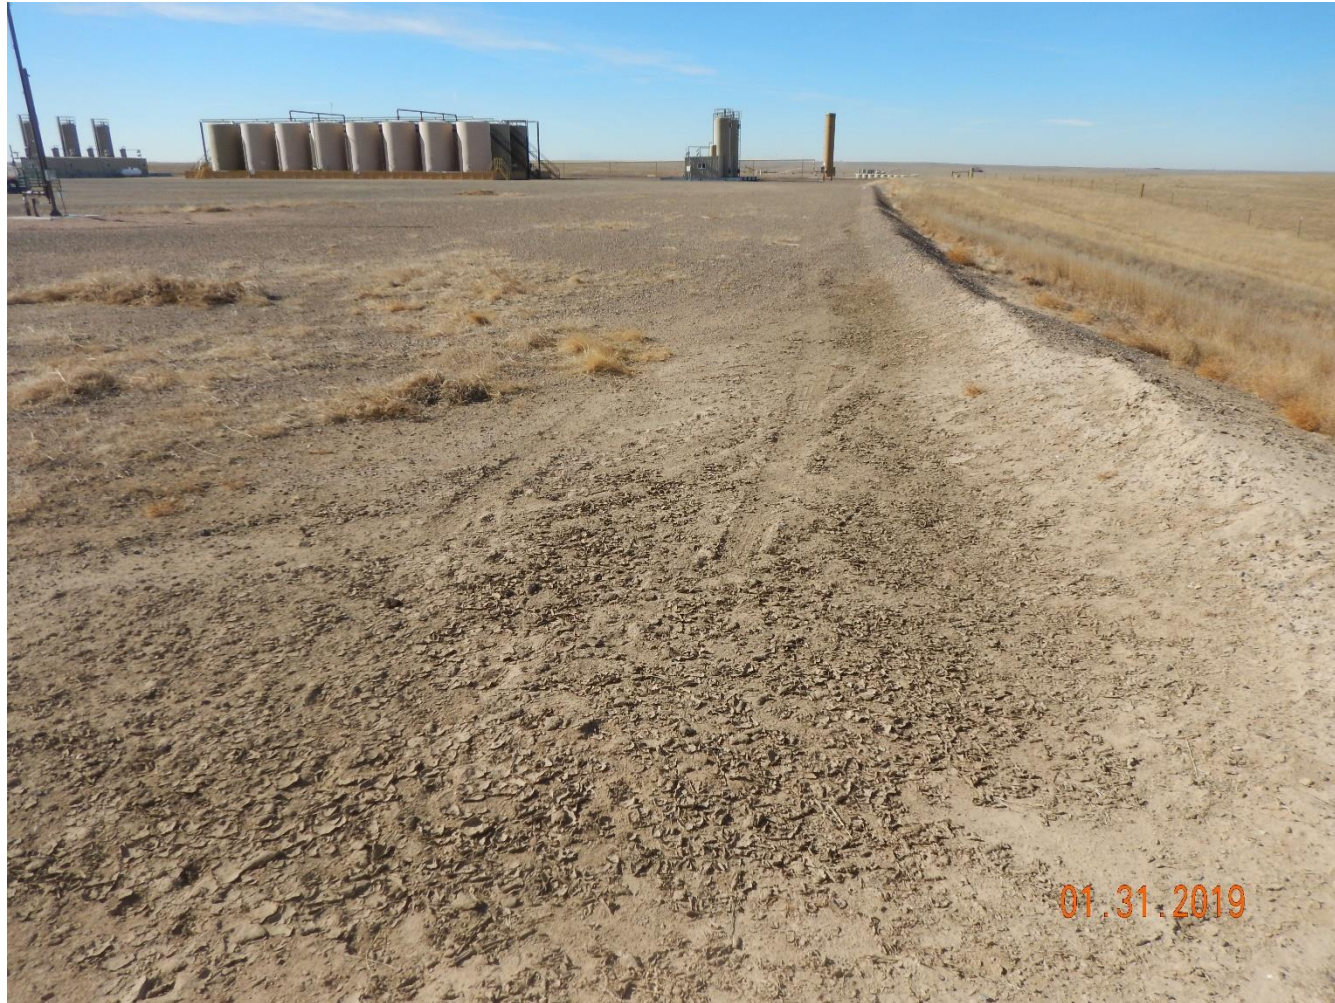
Photo 7: Photo taken from the northeast corner of the location, facing west. Photo shows interim reclamation has not been conducted in accordance with COGCC rule 1003

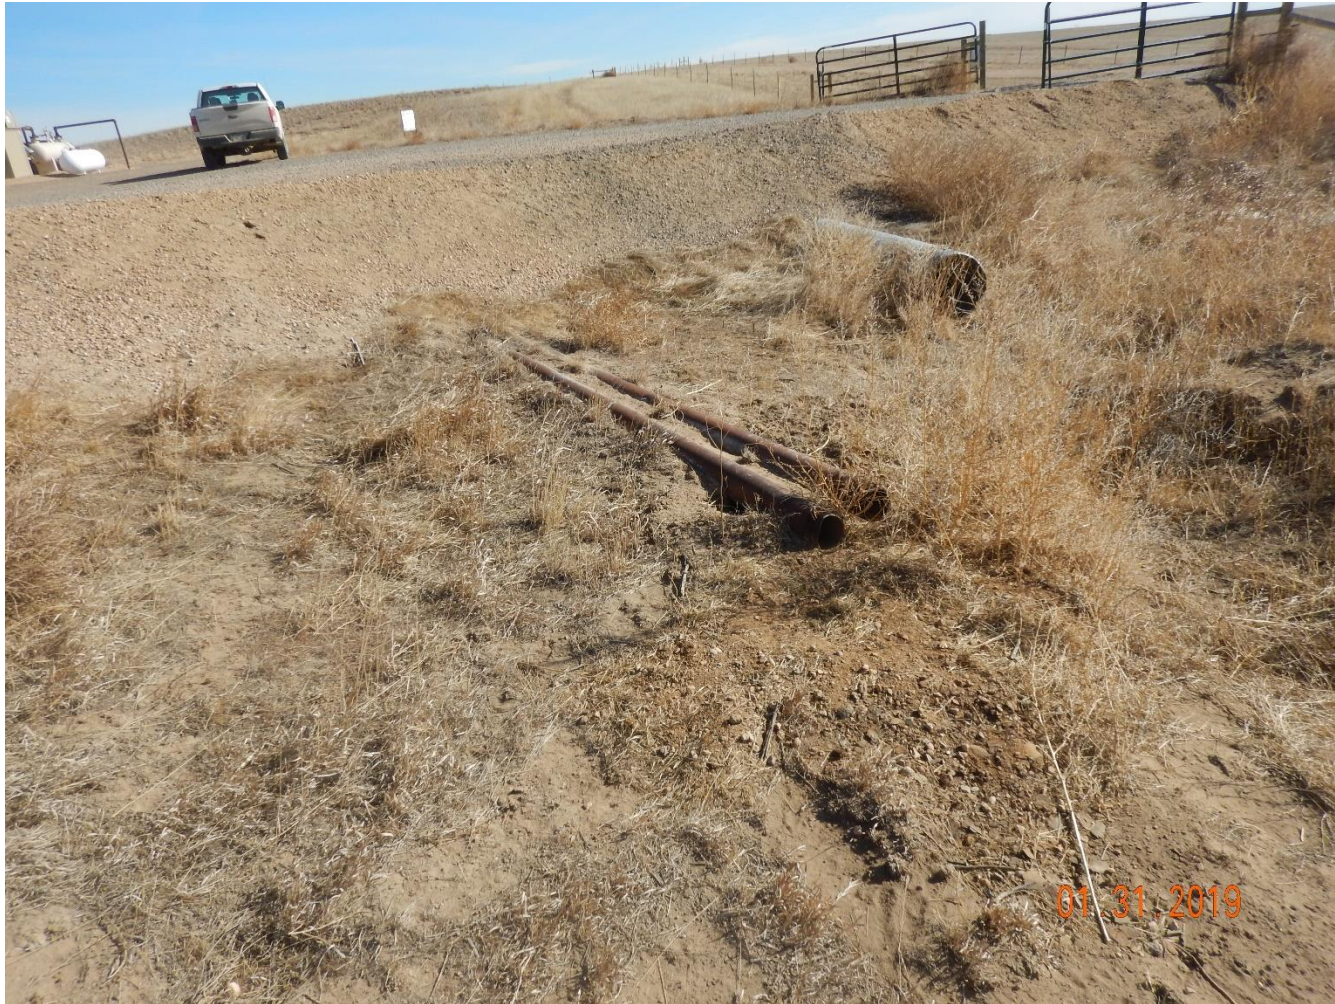
Photo 8: Photo taken from the south end of the location, facing east. Photo shows two pieces of pipe equipment stored off of the location.
