# Inspection Photos

Operator: VERDAD RESOURCES LLC - 10651

Location ID: 429096

Inspection Doc. Number: 682504469

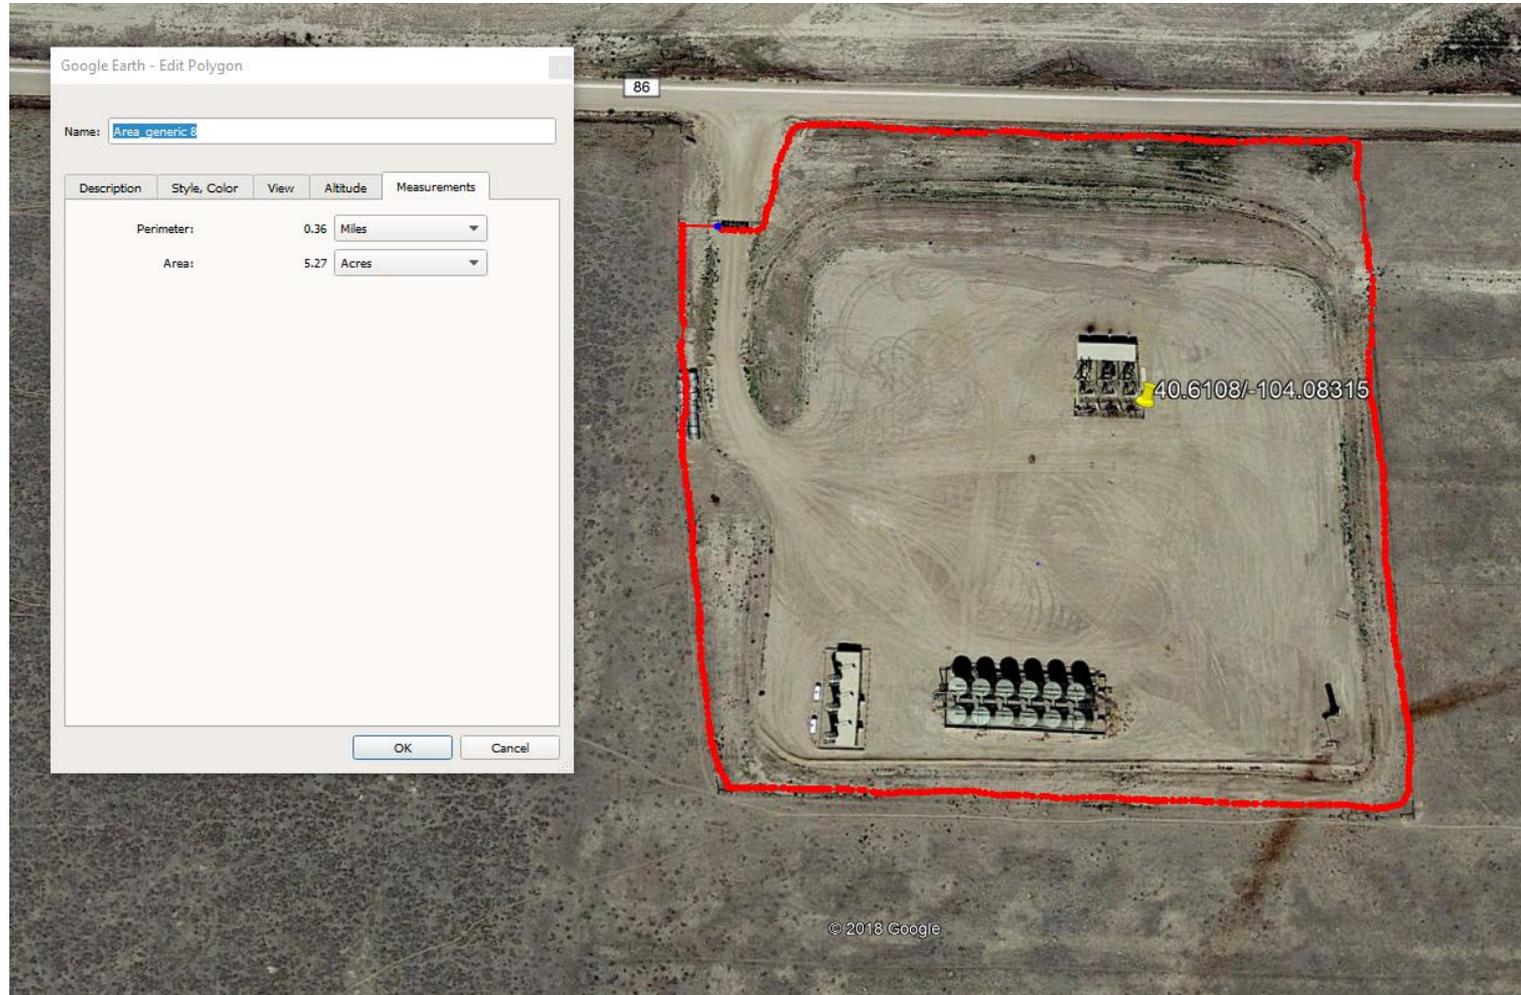
**Photo 1:** 2013 Google earth aerial imagery. Photo shows disturbance area for the location. A disturbance area of 5.27 acres was measured using a Trimble Juno 3B handheld device. This exceeds the permitted disturbance area of 4.1 acres.

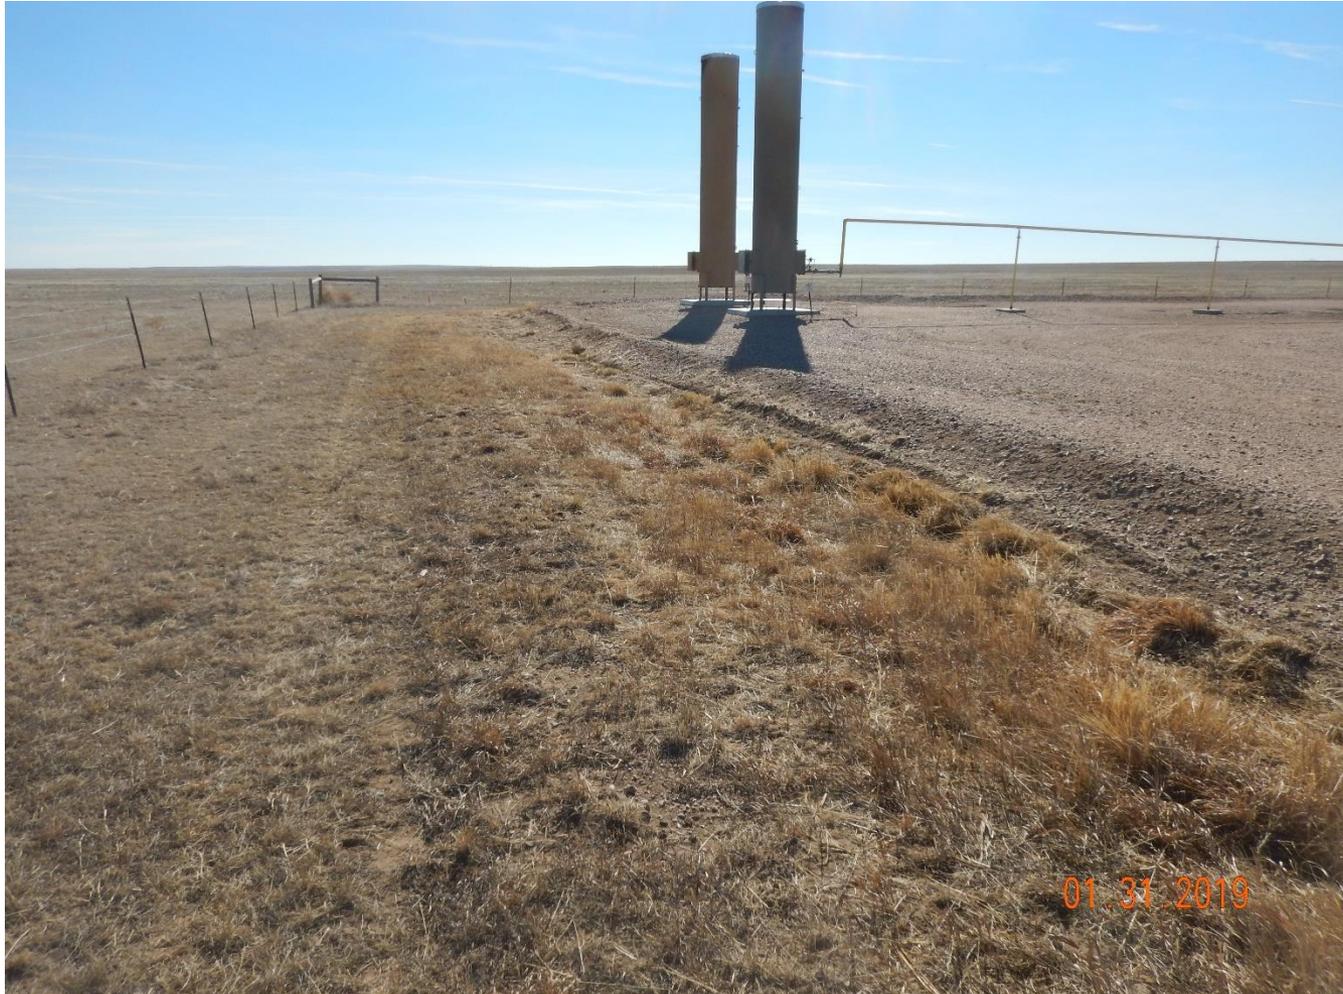
**Photo 2:** Photo taken from the east end of the location, facing south. Photos 2-5 provides an overview of the location from south, southwest, northwest to north. Photos also show interim reclamation has not been conducted in accordance with COGCC rule 1003.

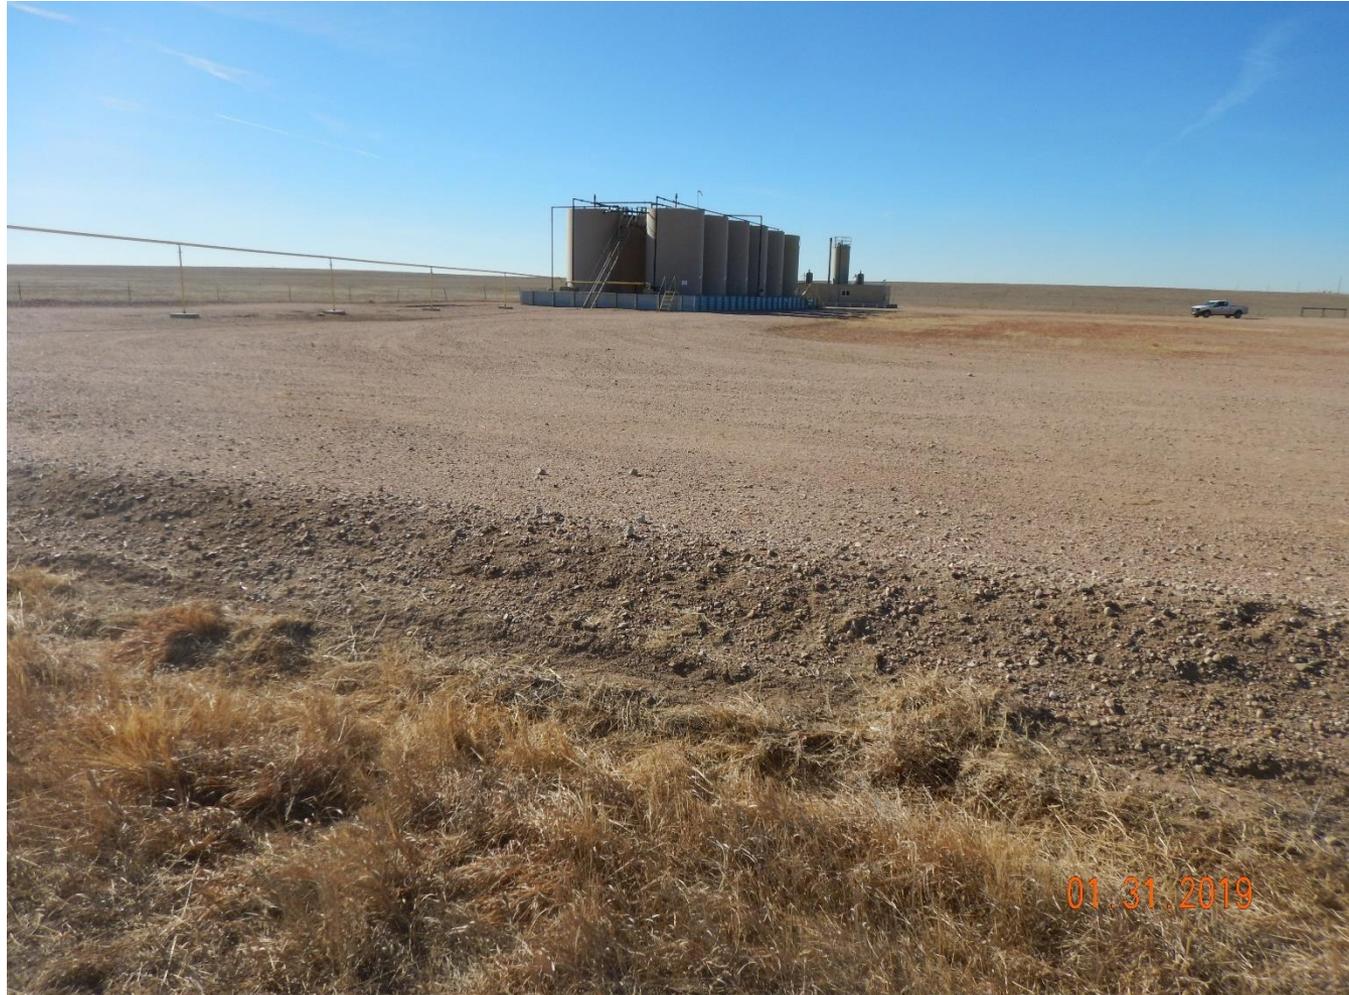
**Photo 3:** See comments under photo 2.

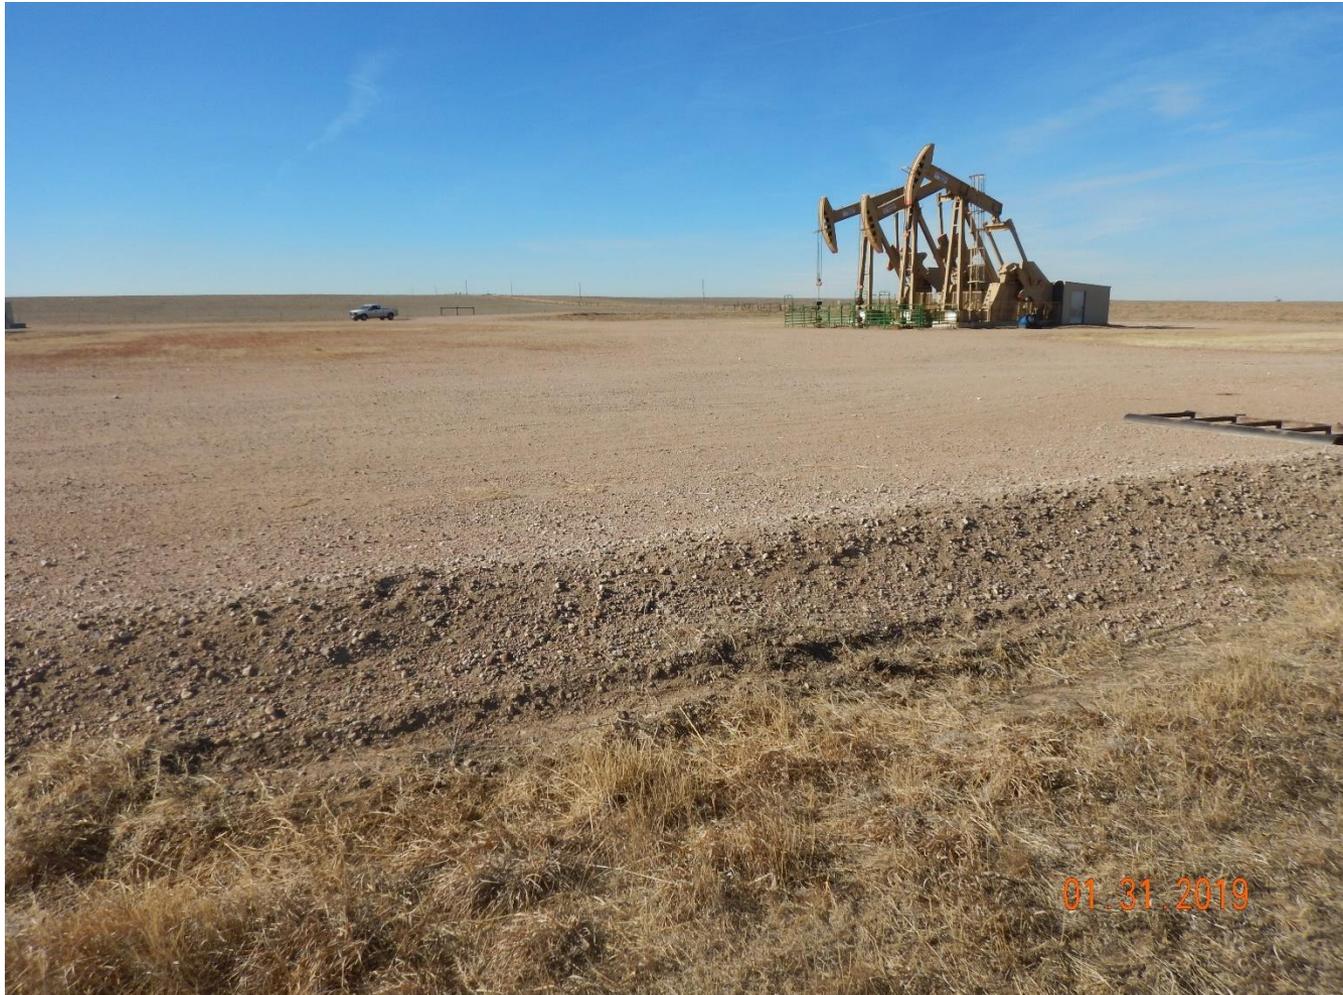
**Photo 4:** See comments under photo 2.

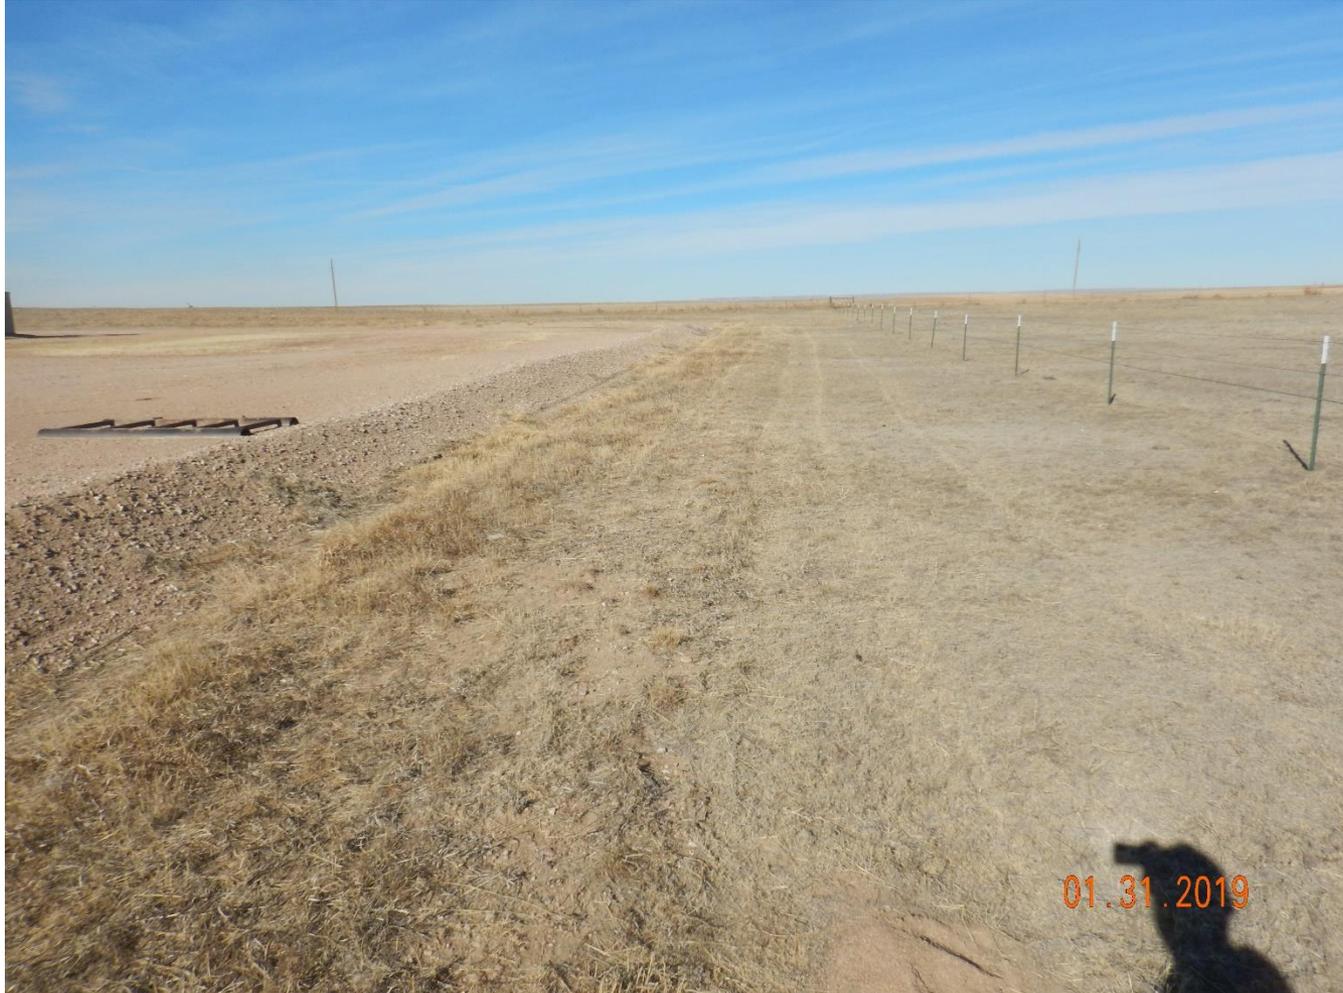
**Photo 5:** See comments under photo 2

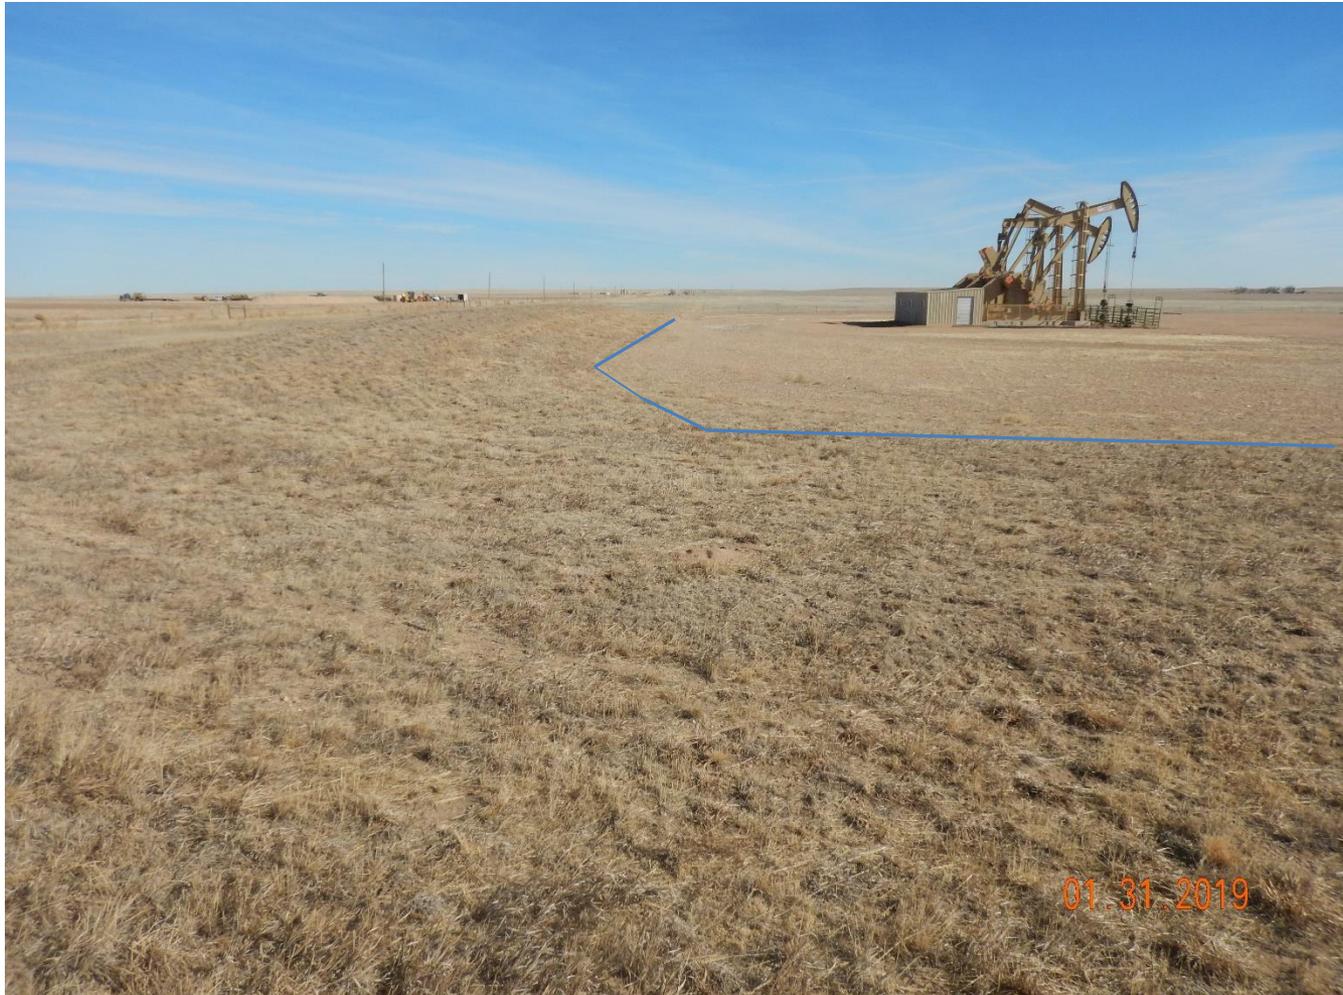
**Photo 6:** Photo taken from the west end of the location, facing east. Photo shows interim reclamation has not been conducted in accordance with COGCC rule 1003. Blue line shows pad perimeter.

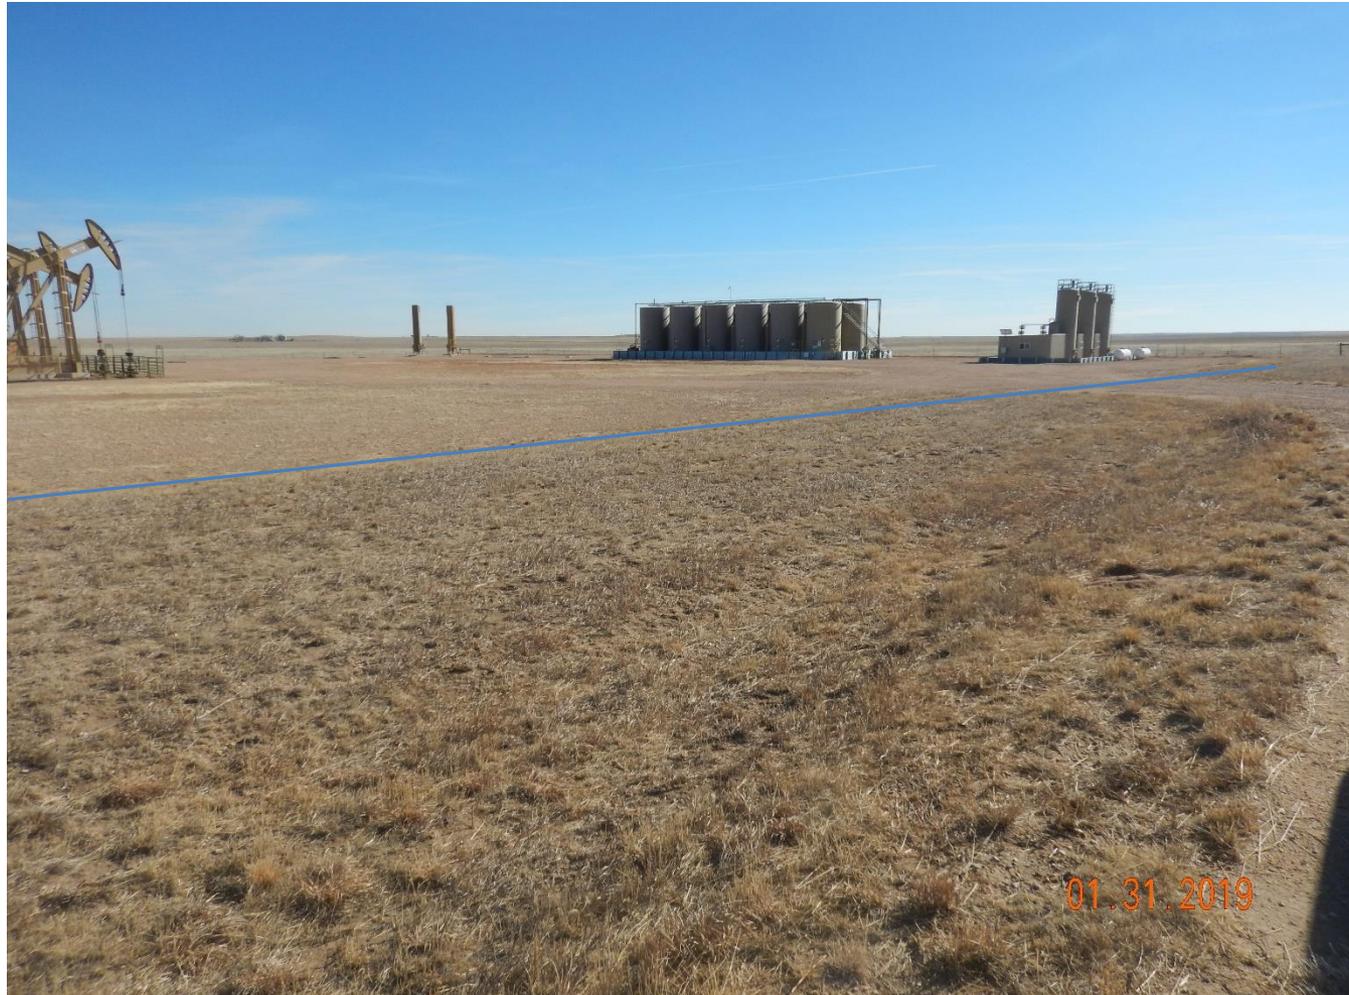
**Photo 7:** Photo taken from the west end of the location, facing east. Photo shows interim reclamation has not been conducted in accordance with COGCC rule 1003. Blue line shows pad perimeter.
