Inspection Photos

Operator: VERDAD RESOURCES LLC - 10651

Location ID: 424238

Inspection Doc. Number: 682504471

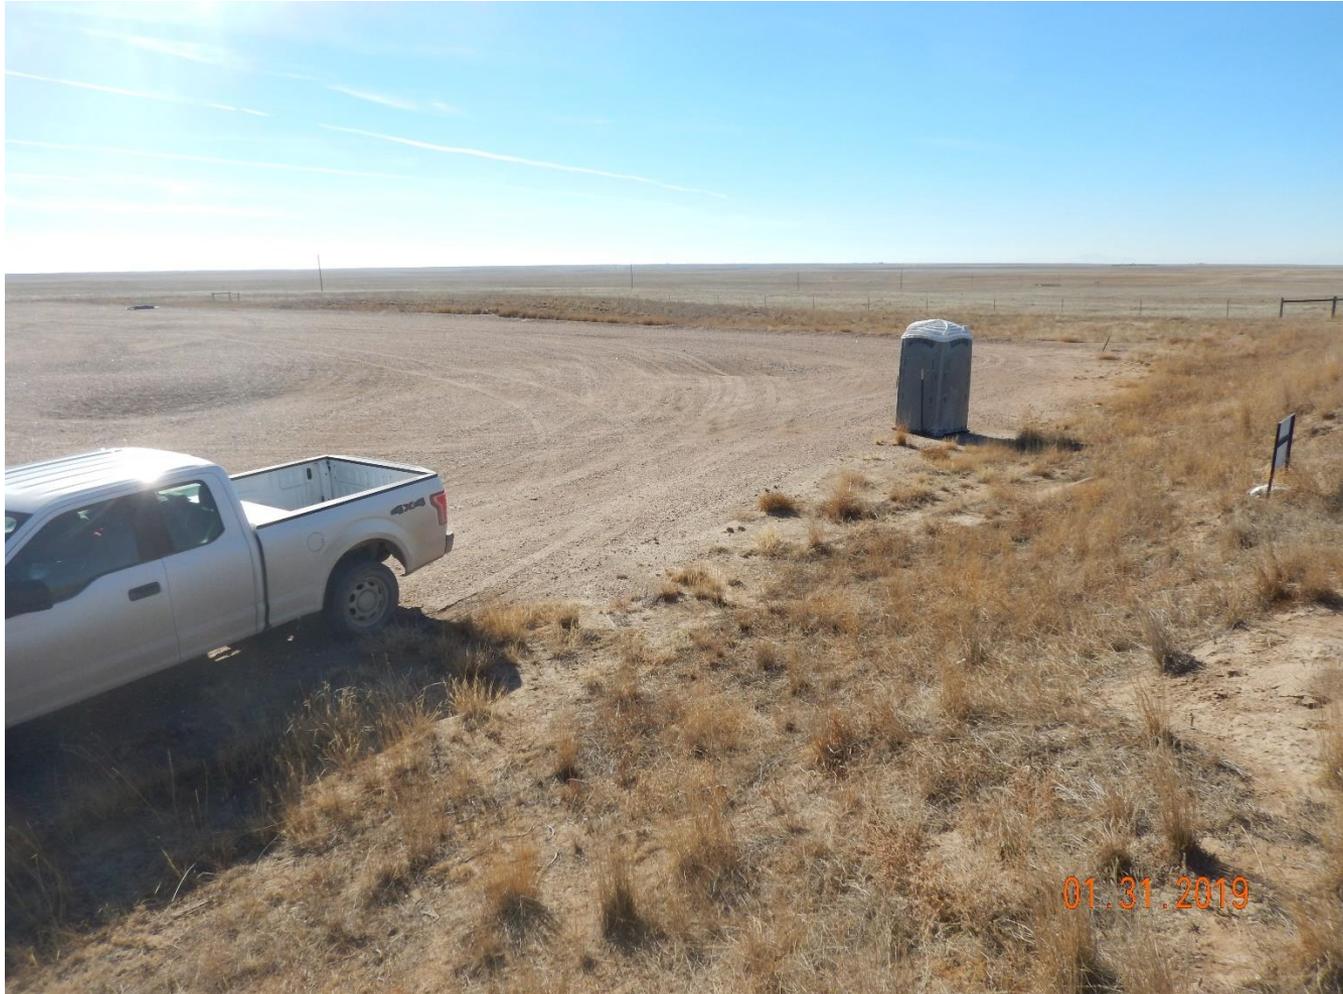
Photo 2: Photo taken from the north end of the pad, facing southwest. Photos 2-5 provides an overview of the location from west, southwest, southeast, to east. Photos also show interim reclamation has not been conducted in accordance with COGCC rule 1003.

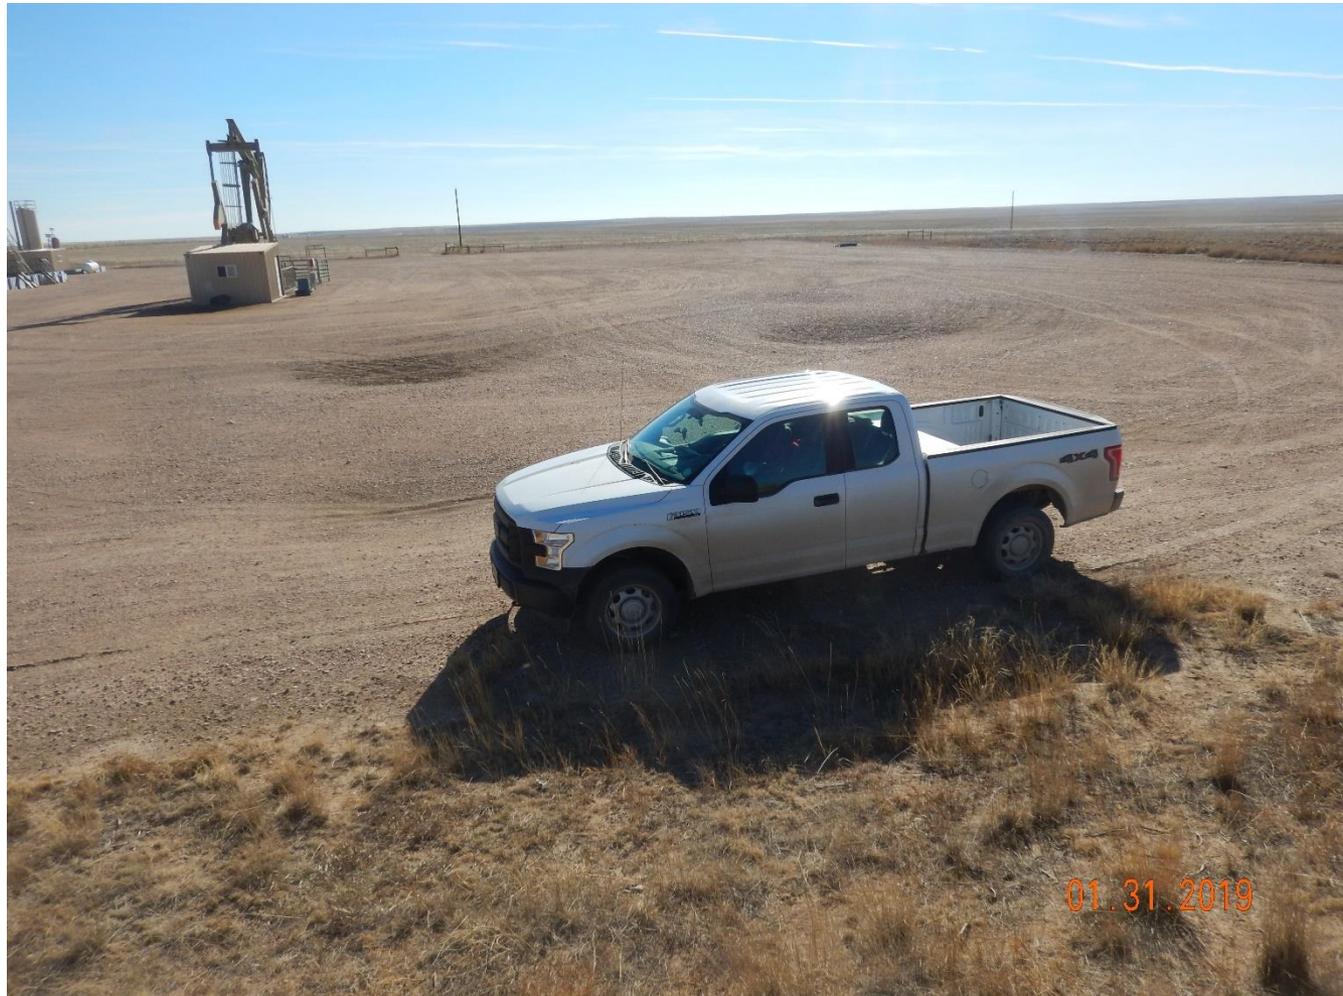
Photo 3: See comments under photo 2.

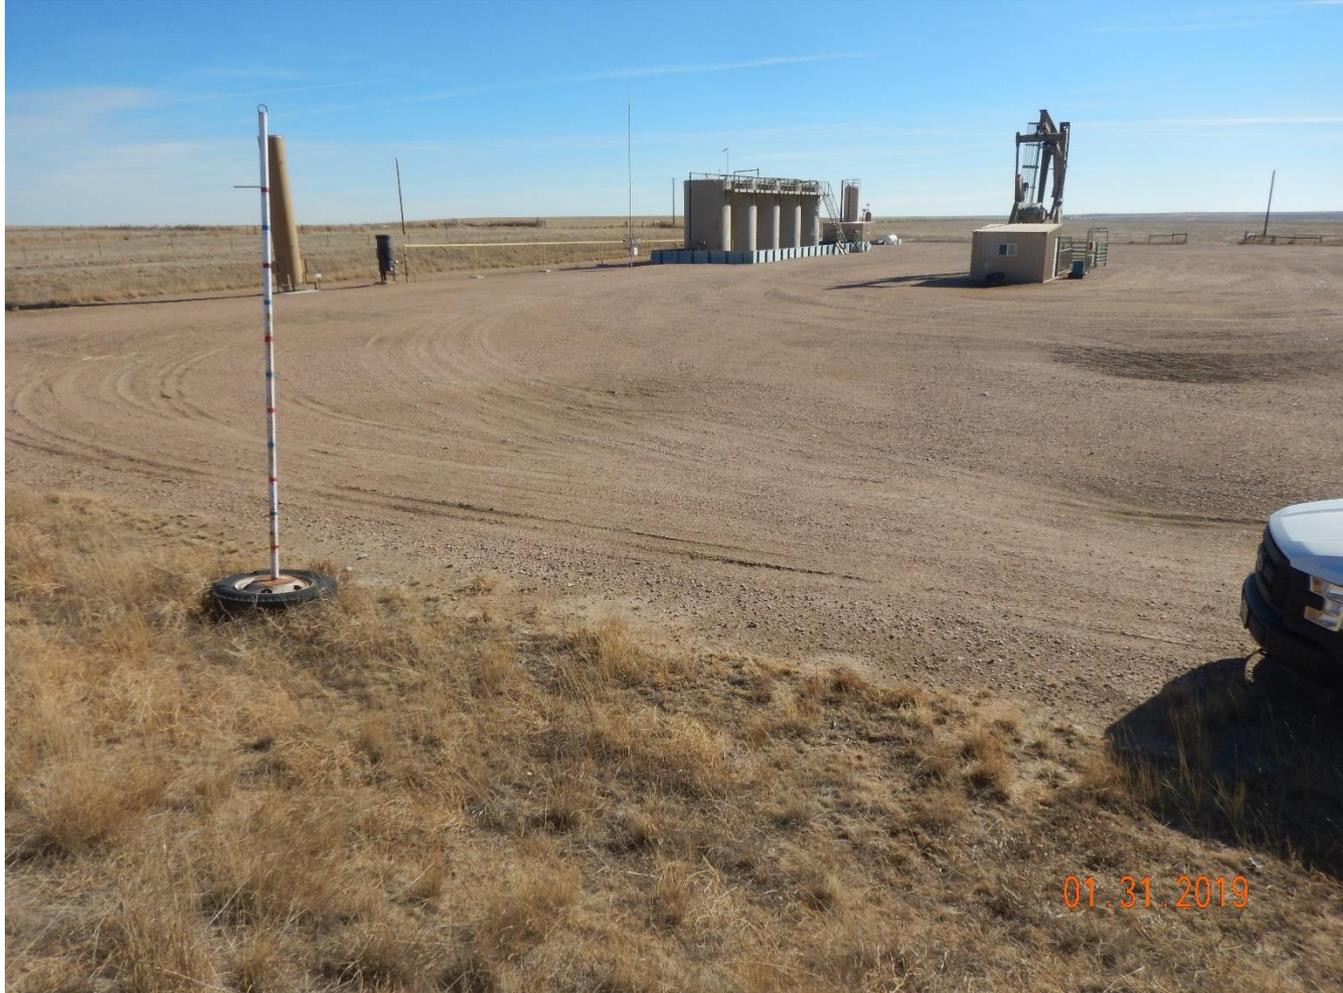
Photo 4: See comments under photo 2.

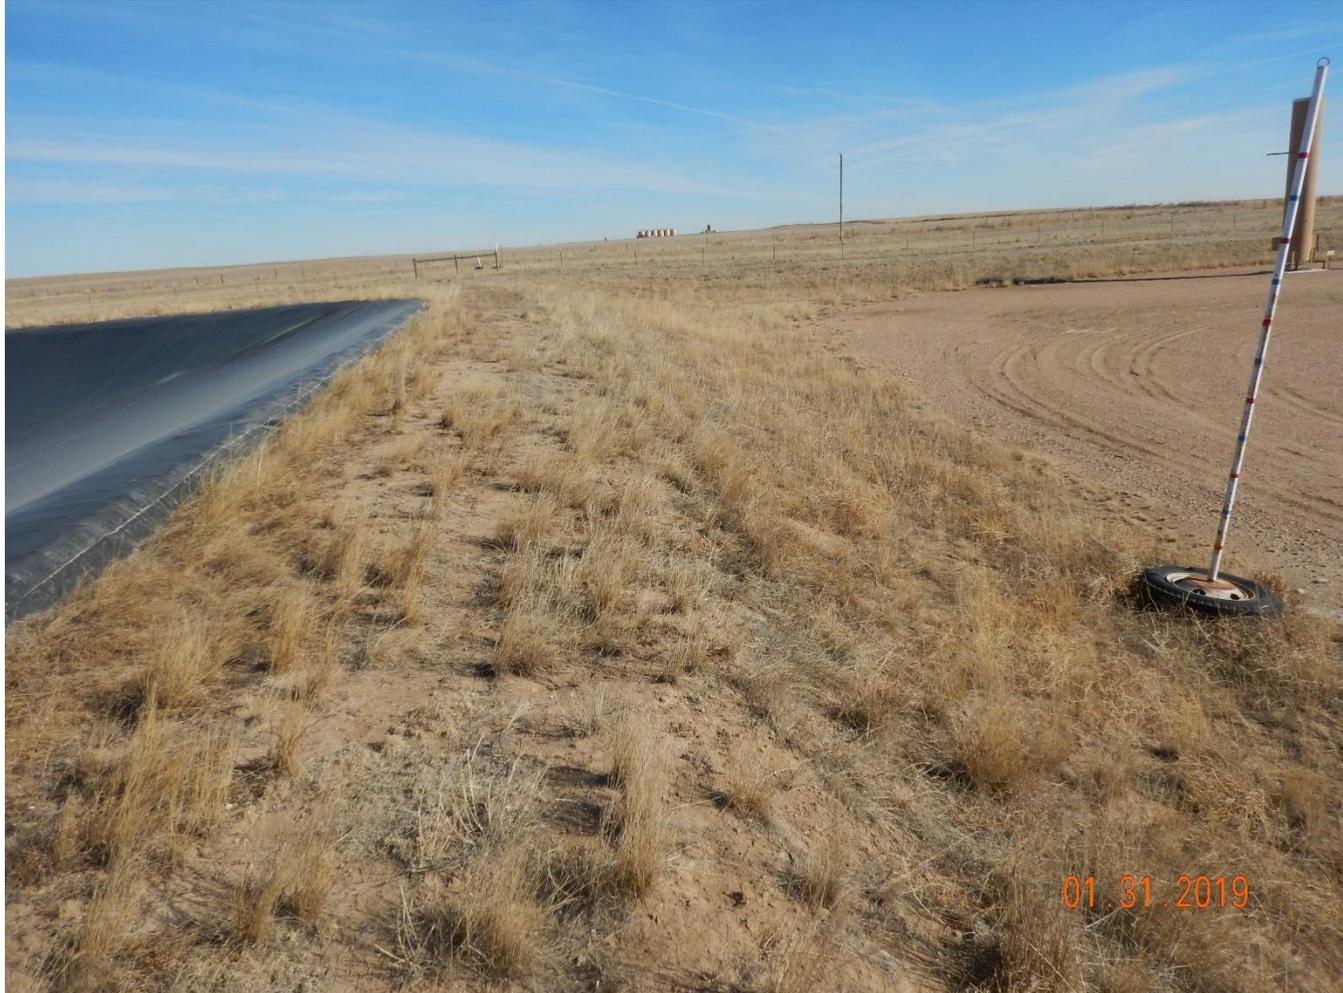
Photo 5: See comments under photo 2

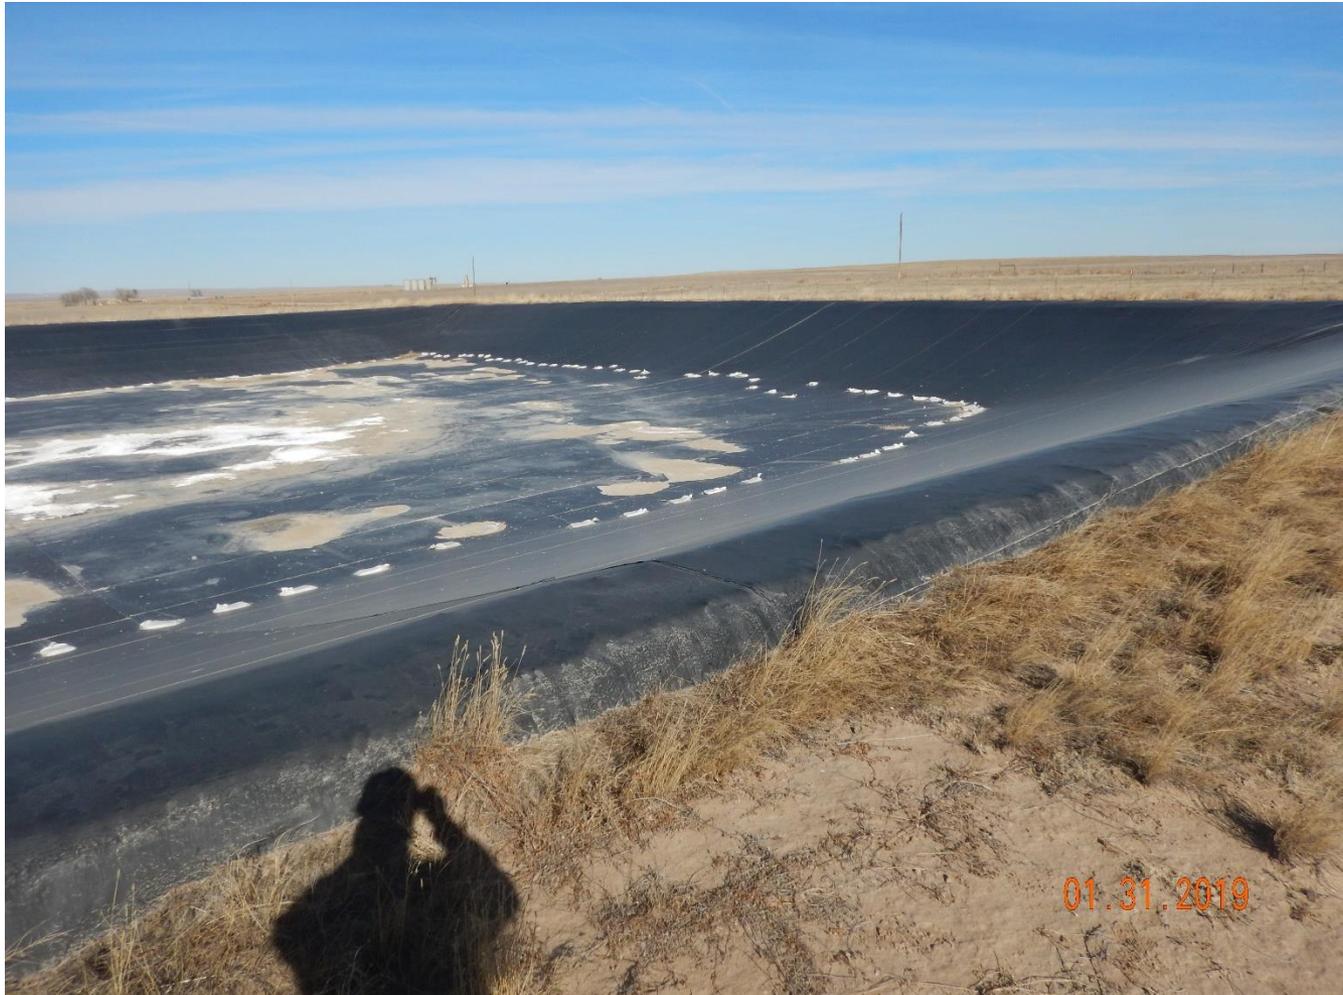
Photo 6: Photo taken from the south end of the pit #430101, facing northeast. Location received an approved 502.b variance to delay interim reclamation of the location for three (3) years until 12/03/2018. Photos 6-7 shows pit has not been closed/reclaimed.

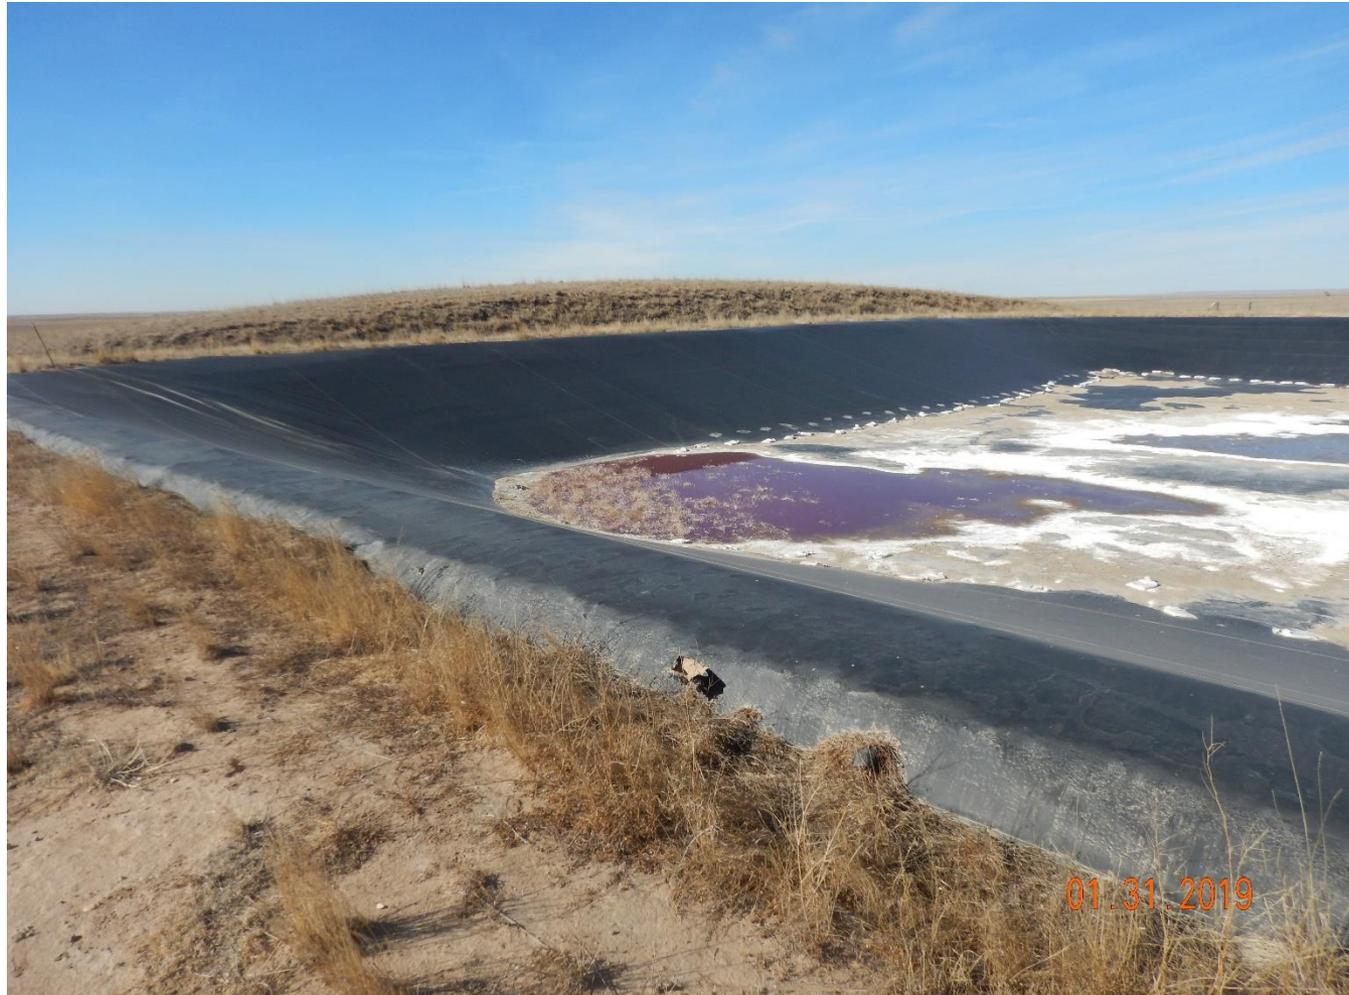
Photo 7: Photo taken from the south end of the pit #430101, facing northwest. See comments under photo 6.

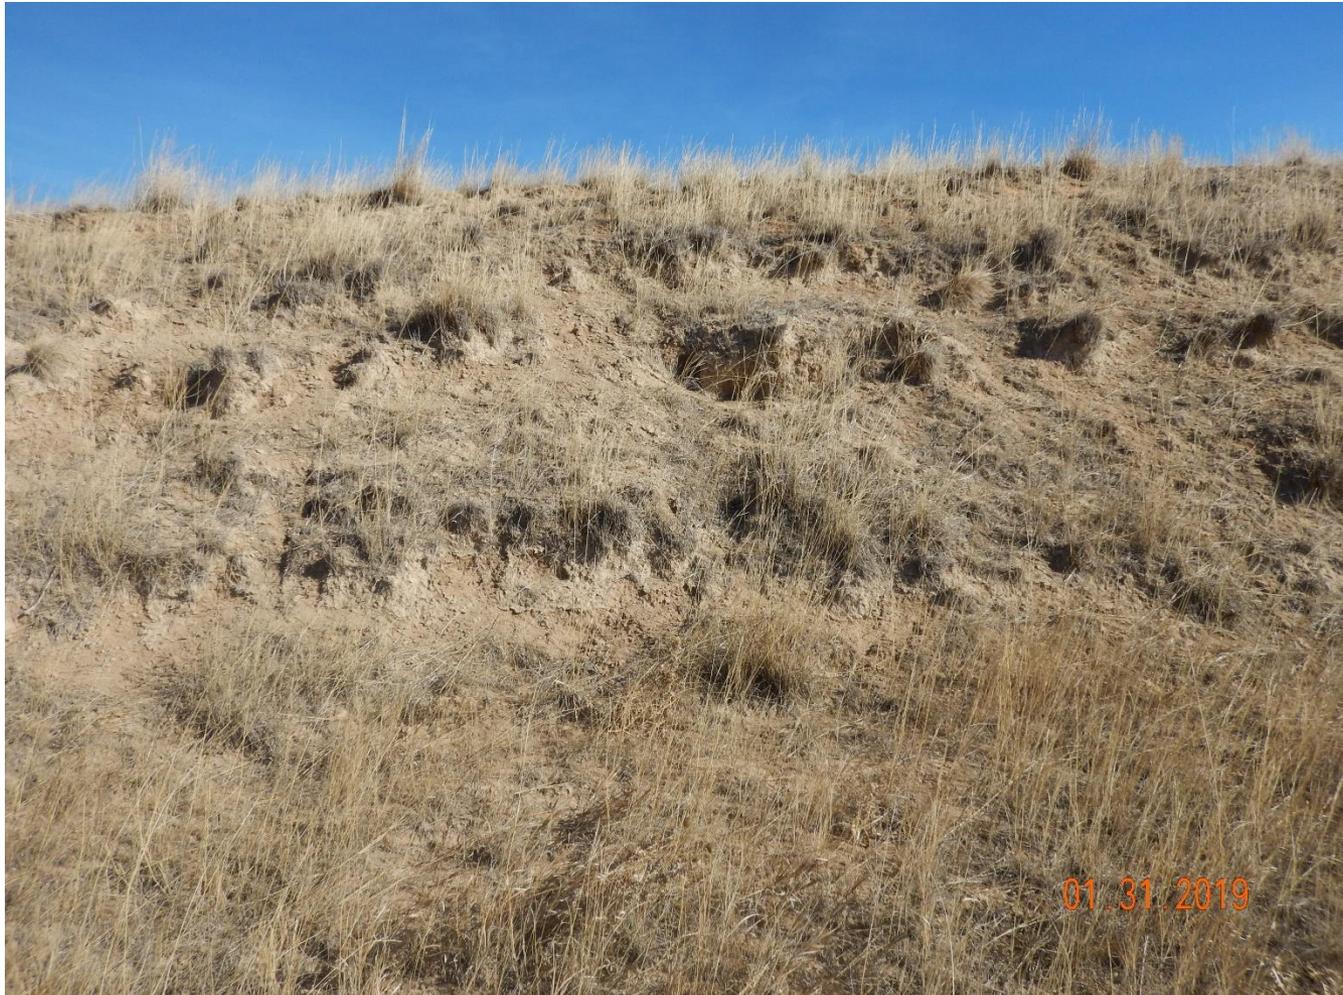
Photo 8: Photo taken from the soil stockpile on the northwest end of the location. Photo shows stormwater erosion degradation along slopes of soil stockpile.

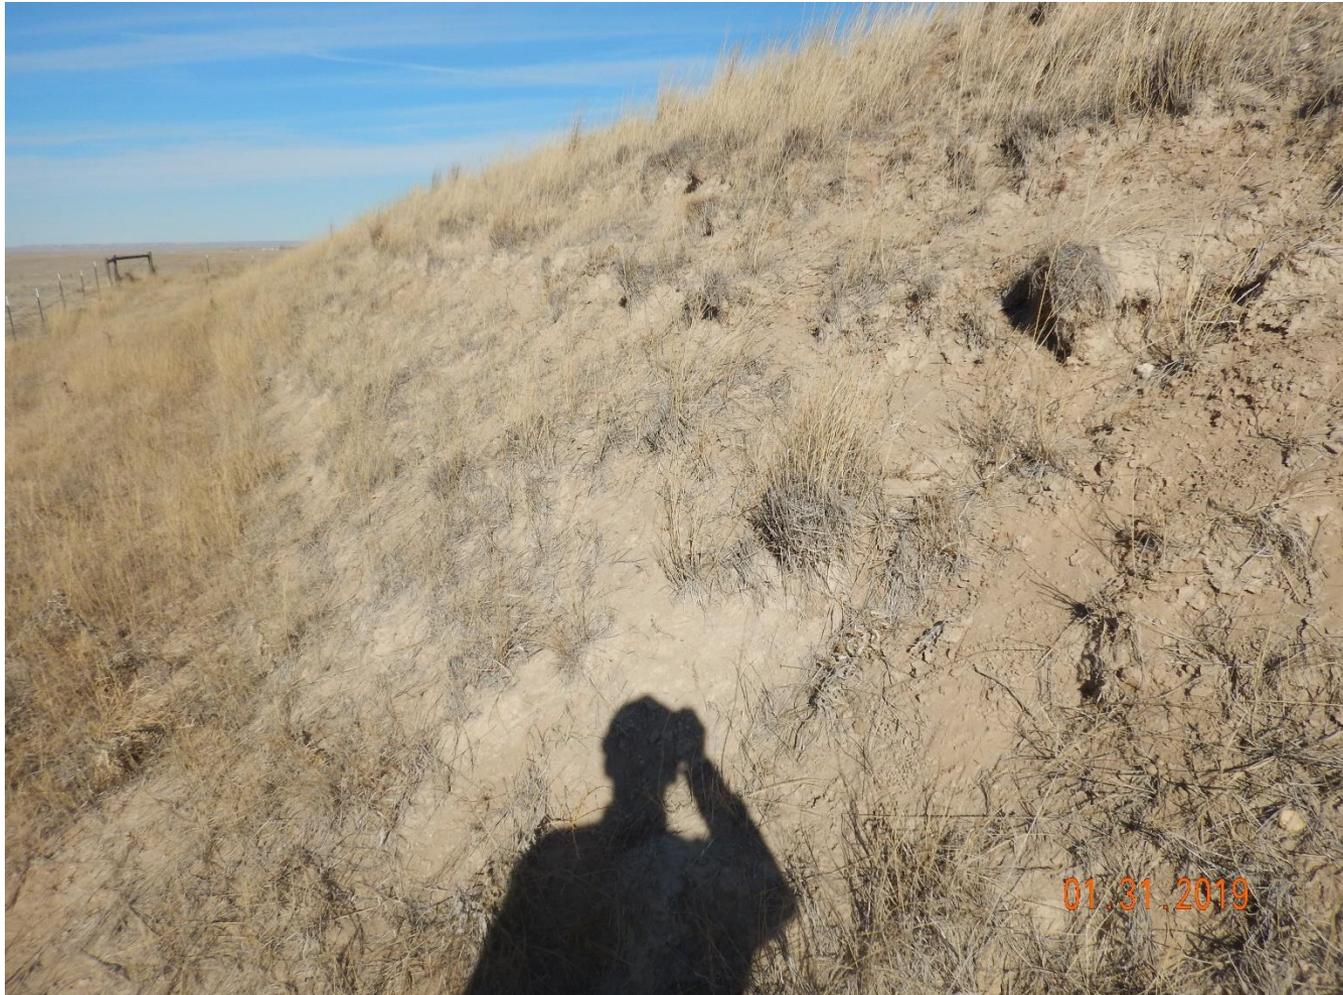
Photo 9: Photo taken from the soil stockpile on the northwest end of the location, facing north. Photo shows stormwater erosion degradation along slopes of soil stockpile.
