# Inspection Photos

Operator: VERDAD RESOURCES LLC - 10651

Location ID: 425439

Inspection Doc. Number: 682504473

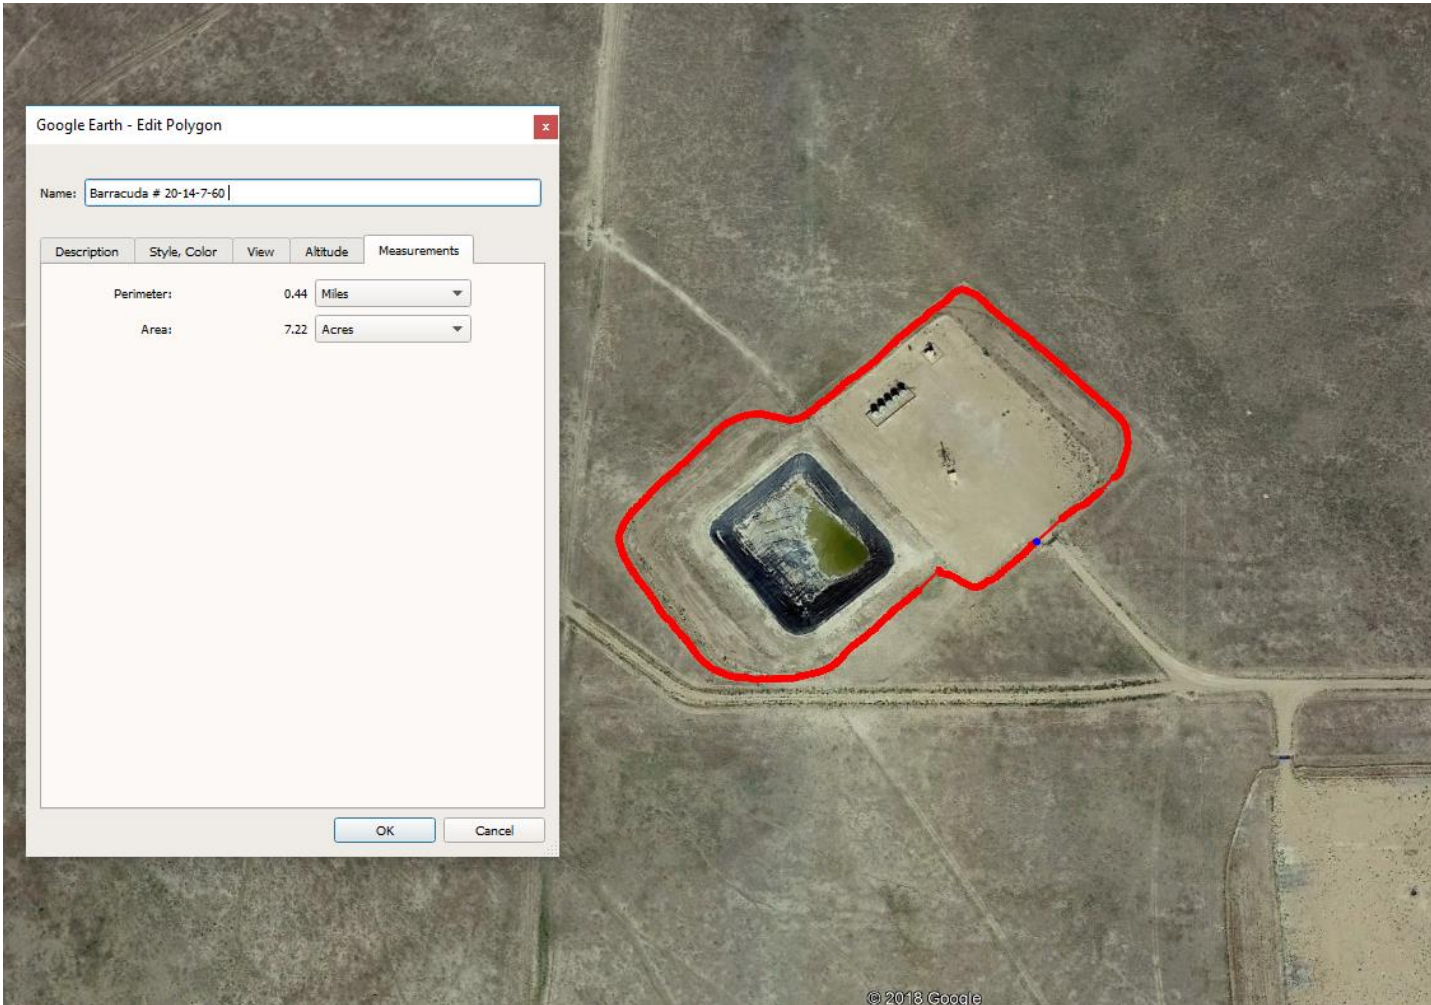
**Photo 1:** 2013 Google earth aerial imagery. Photo shows disturbance area for the location. A disturbance area of 7.2 acres was measured using a Trimble Juno 3B handheld device. This exceeds the permitted disturbance area of 6.6 acres.

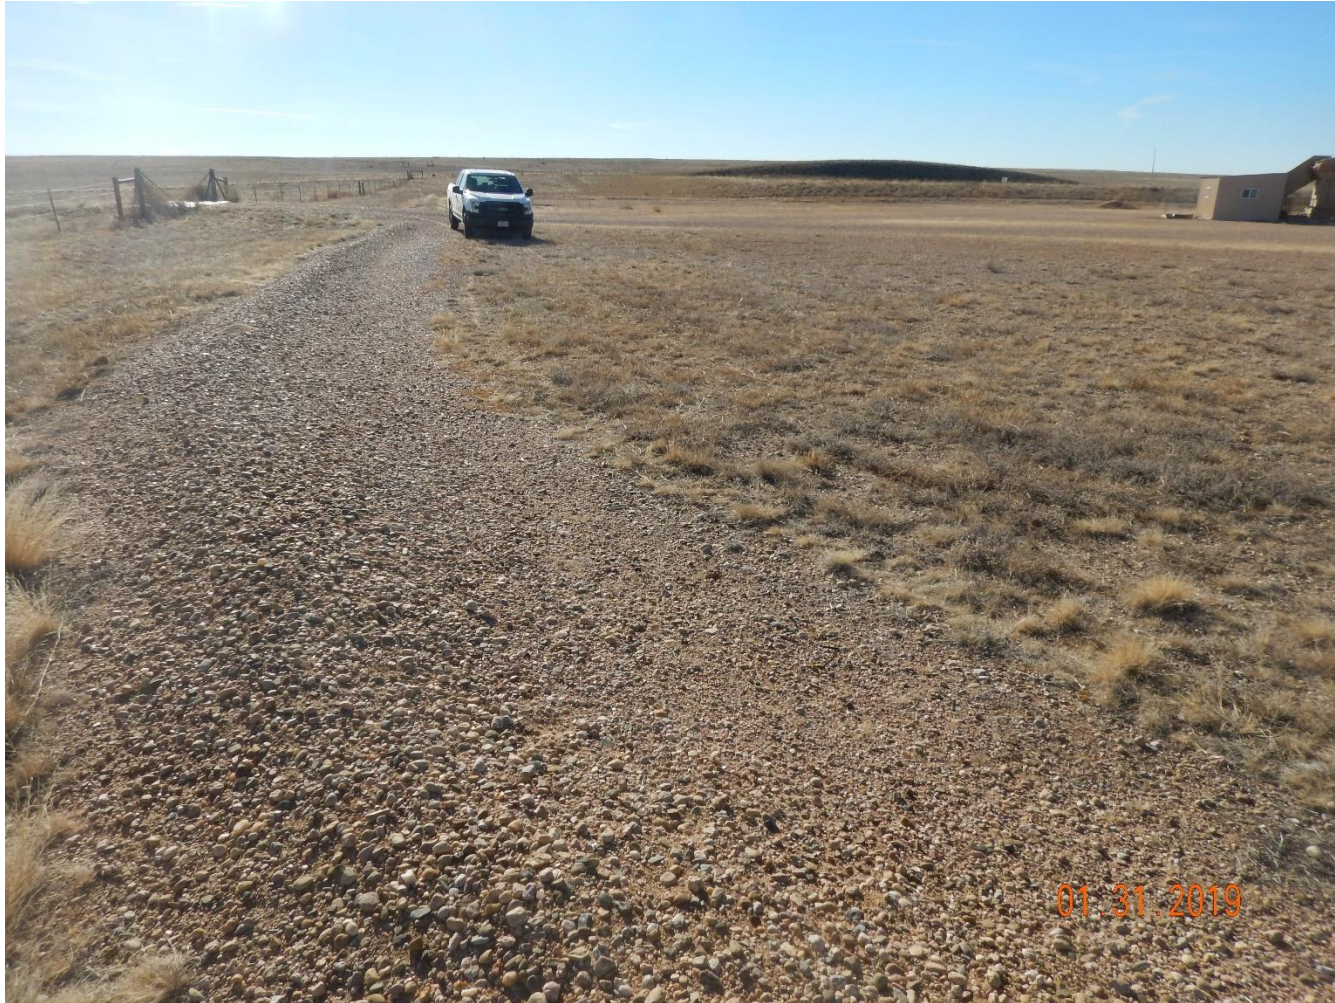
**Photo 2:** Photo taken from the nsoutheast end of the pad, facing west. Photos 2-5 provides and overview of the location from west, northwest to north. Photos also show interim reclamation has not been conducted in accordance with COGCC rule 1003.

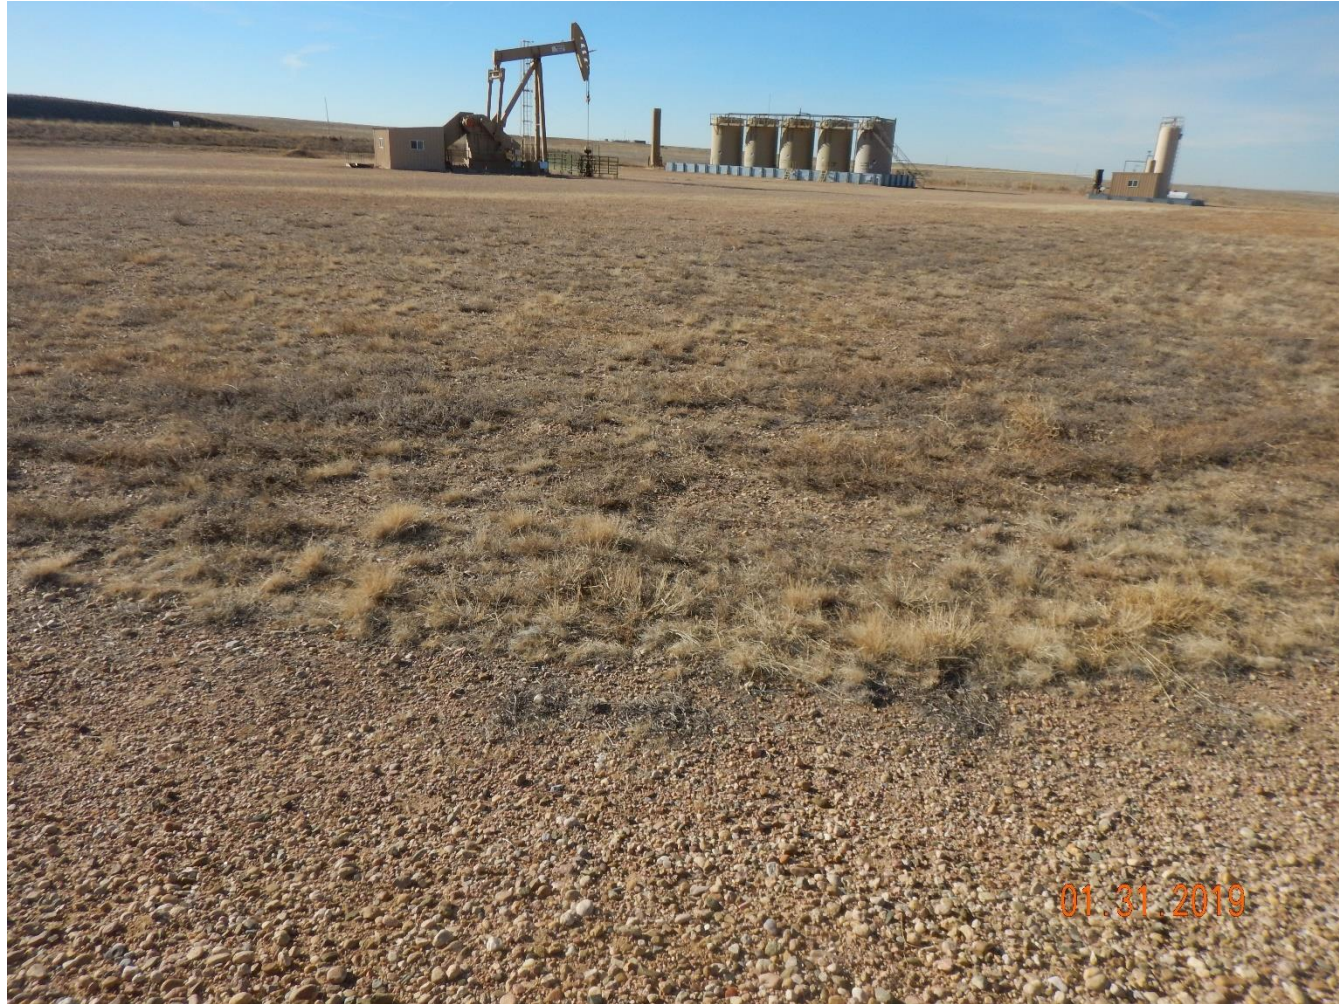
**Photo 3:** See comments under photo 2.

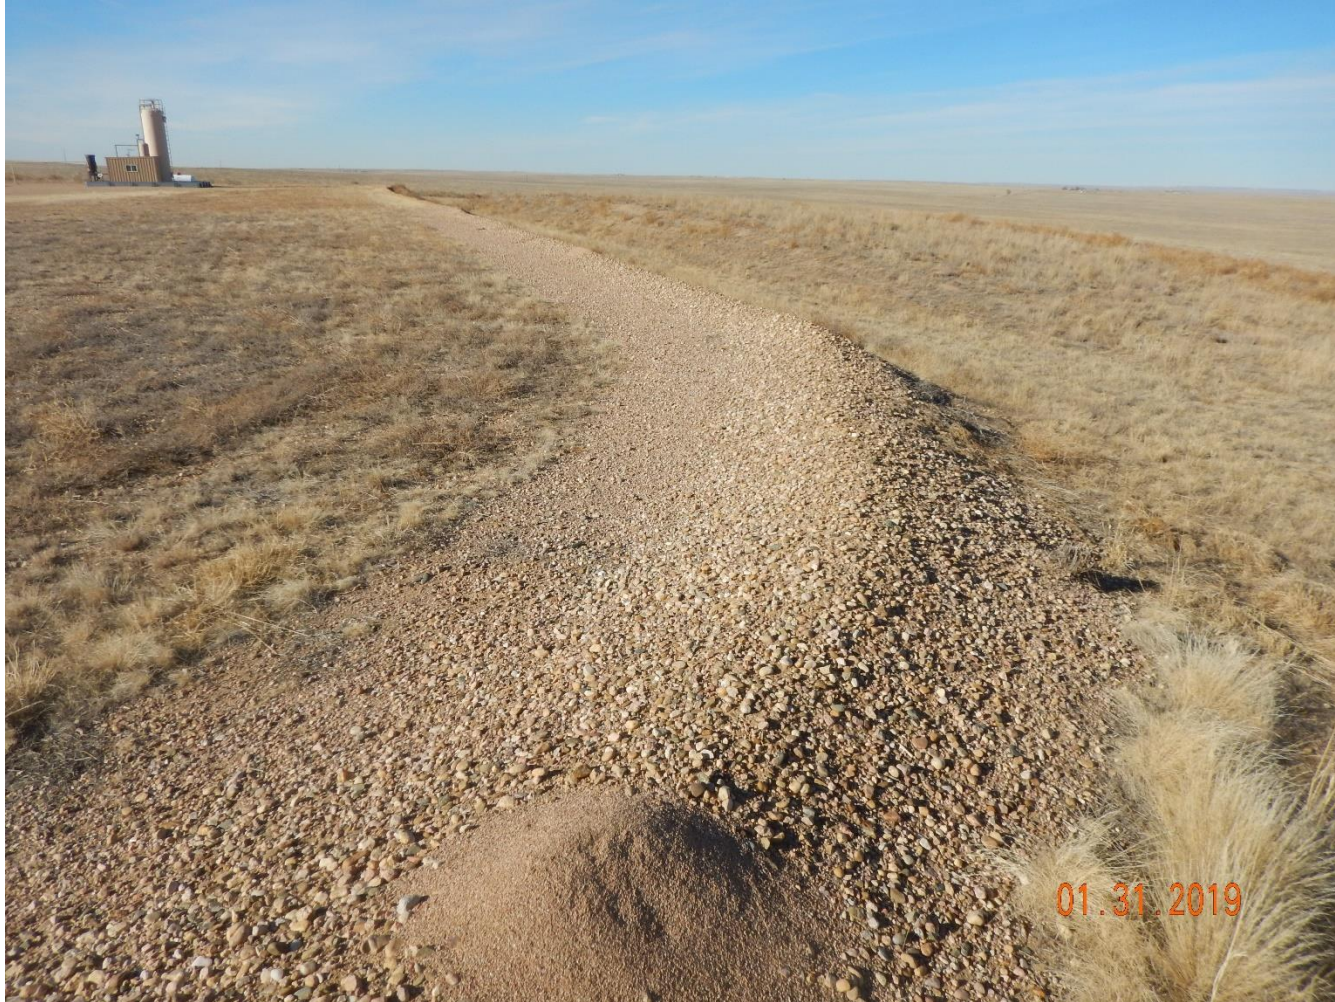
**Photo 4:** See comments under photo 2.

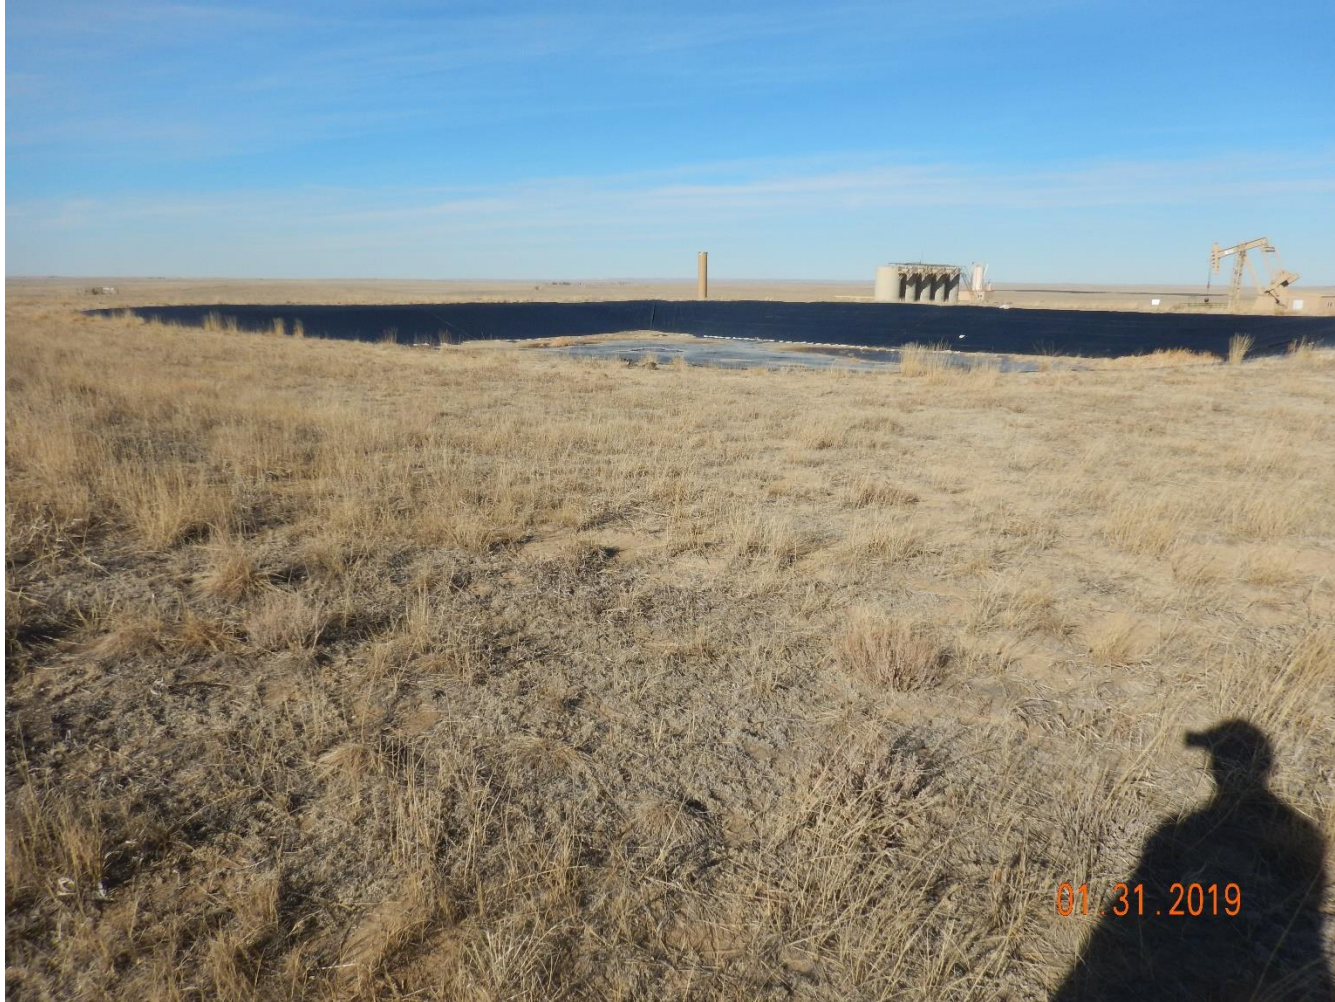
**Photo 5:** Photo taken from the south end of the pit #431610, facing northeast. Location received an approved 502.b variance to delay interim reclamation of the location for three (3) years until 12/03/2018. Photos shows pit has not been closed/reclaimed.

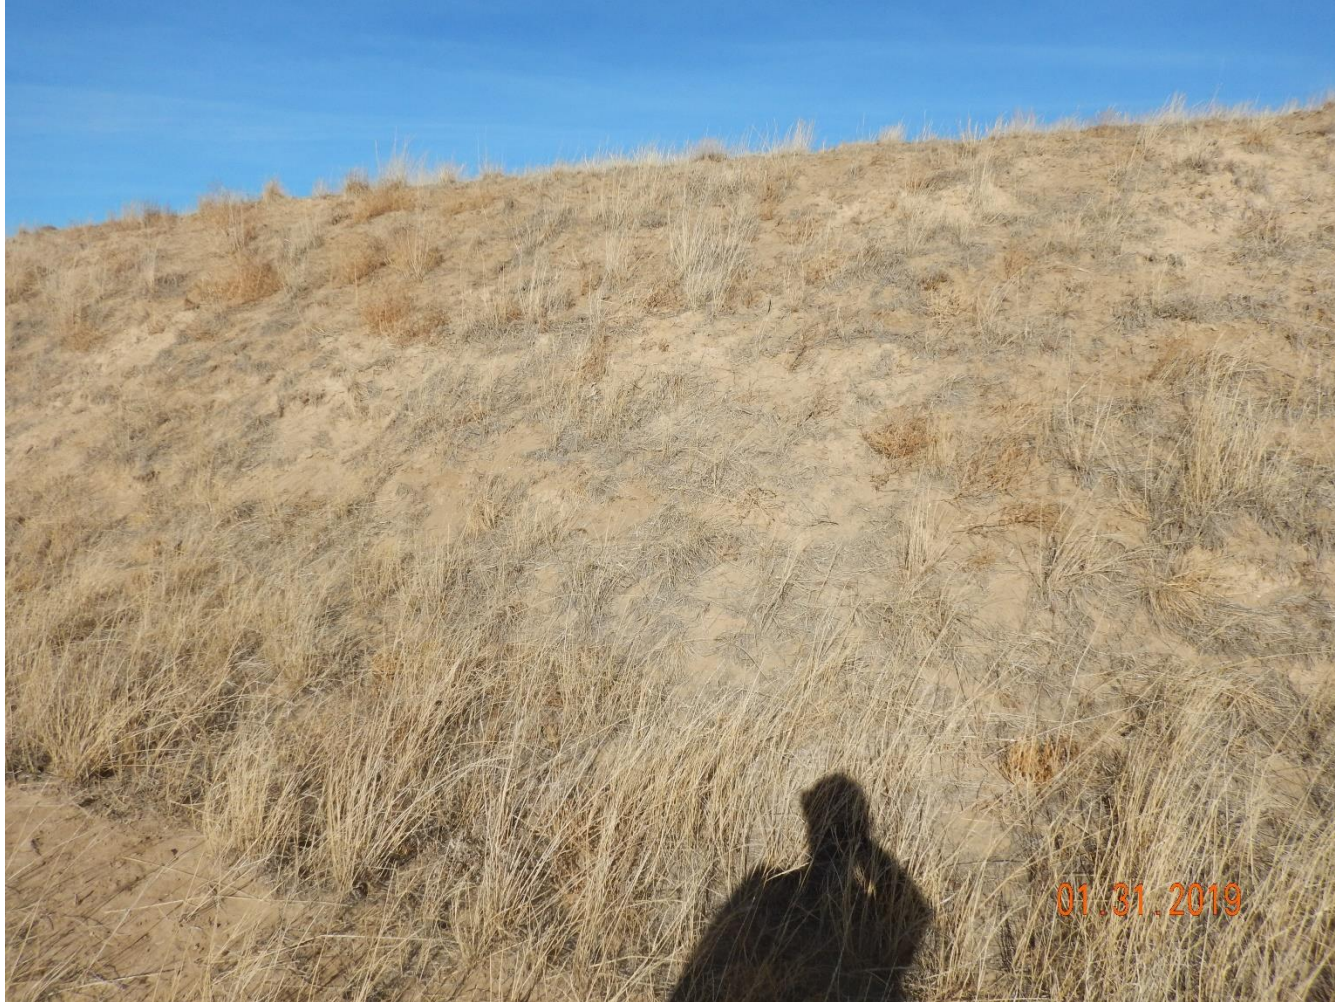
**Photo 6:** Photo taken from the soil stockpile on the west end of the location, facing north. Photo shows stormwater erosion degradation along slopes of soil stockpile.
