## Inspection Photos

Location Name: My Way Ranch 17-7 Pad

Location ID: #334518 Spill/Release ID: #460723

Inspection Date: January 15, 2019

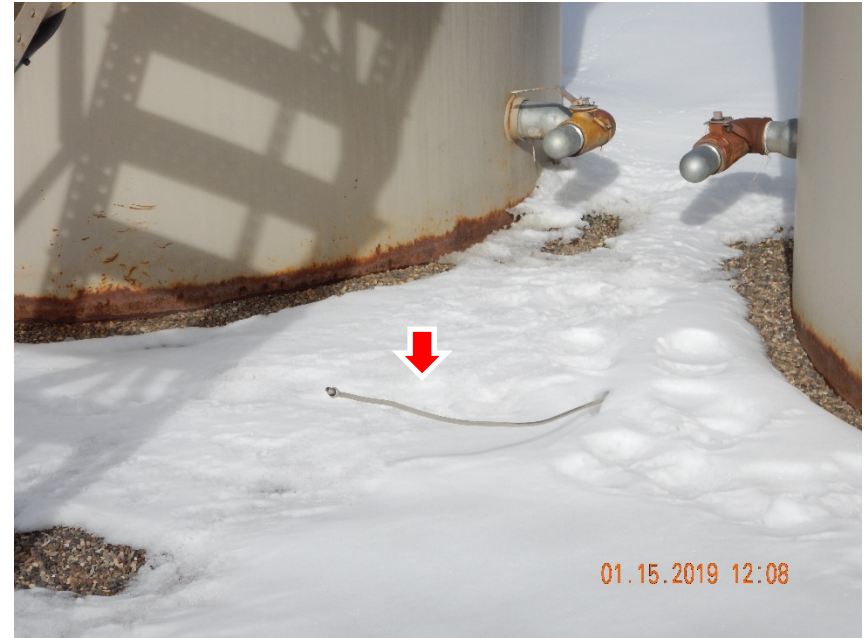
Photo #2 – View of NW tank battery from south side. Red arrow points to location of 1/4" stainless steel line inside of tank battery SPCC.

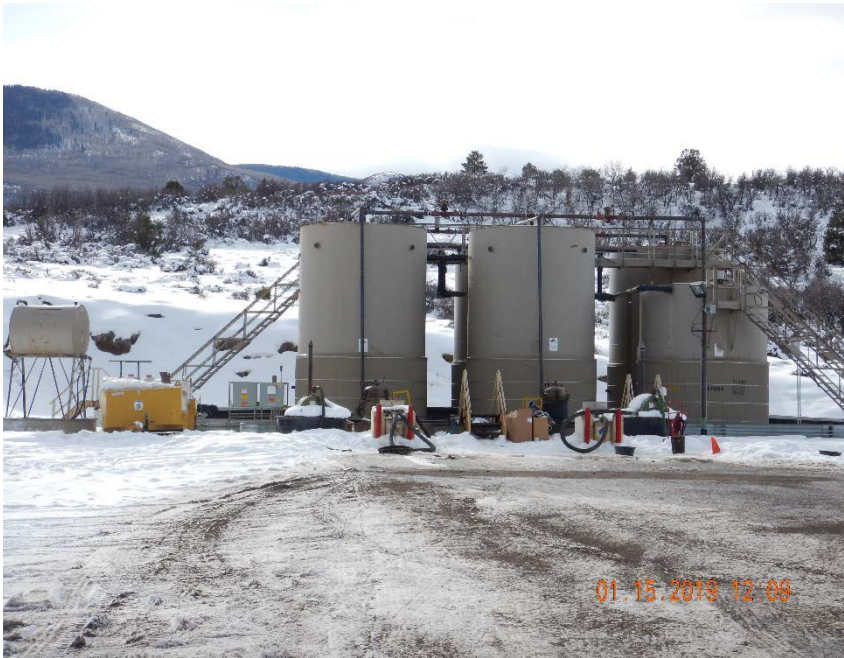
**Photo #3 – View of SW tank battery from north.  
Spill/Release ID #460723 occurred on the south side of this  
tank battery.**

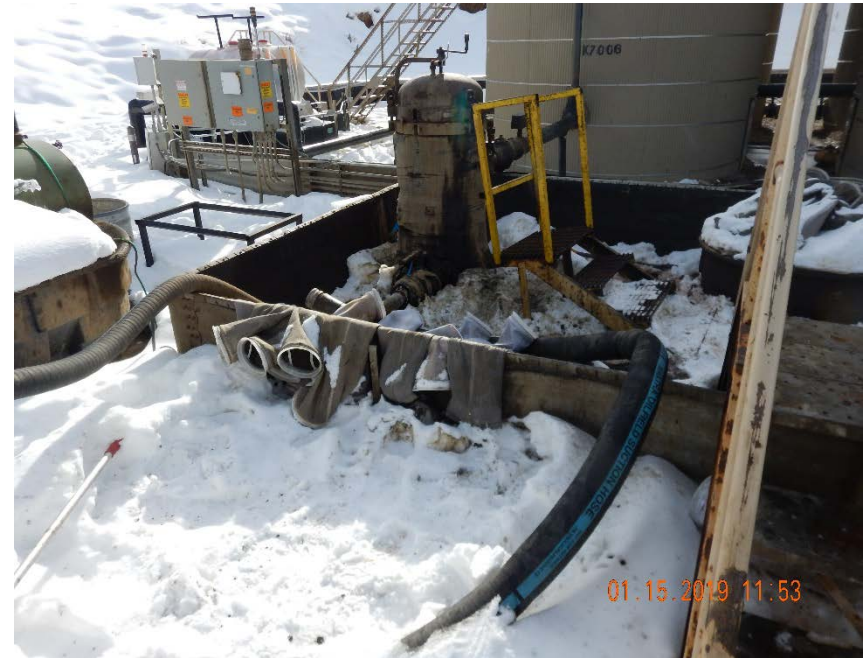
**Photo #4 – View of filter socks and stained snow inside of  
SW tank battery truck loadout SPCC. Refer to R. Murray's  
inspection (doc #693200212) for corrective action.**

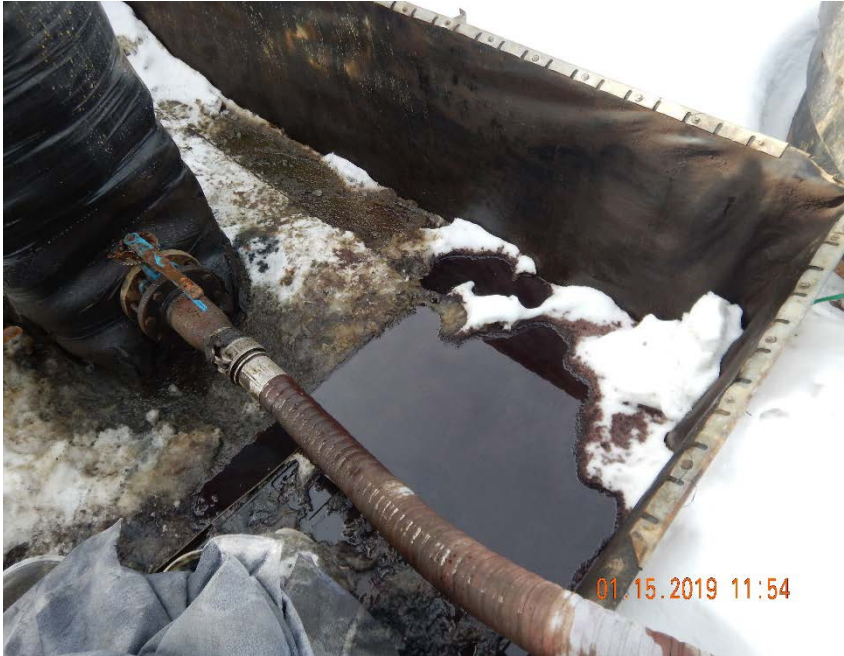
**Photo #5 – Free product inside of SW tank battery truck loadout SPCC. Refer to R. Murray’s inspection (doc #693200212) for corrective action.**

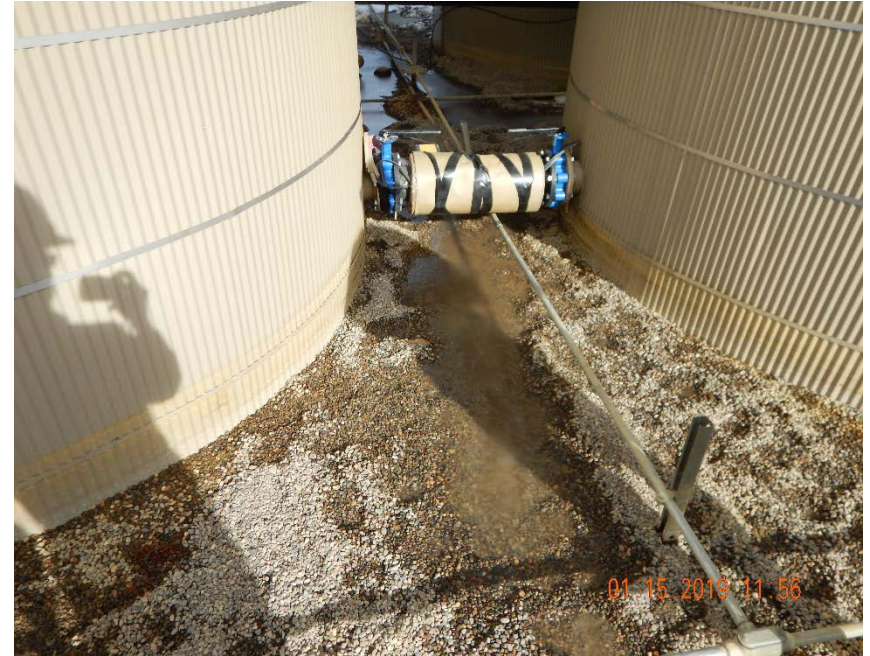
**Photo #6 – View of tank leveling pipe that was the source of fluids released by Spill/Release ID #460723 from south side of tank battery.**

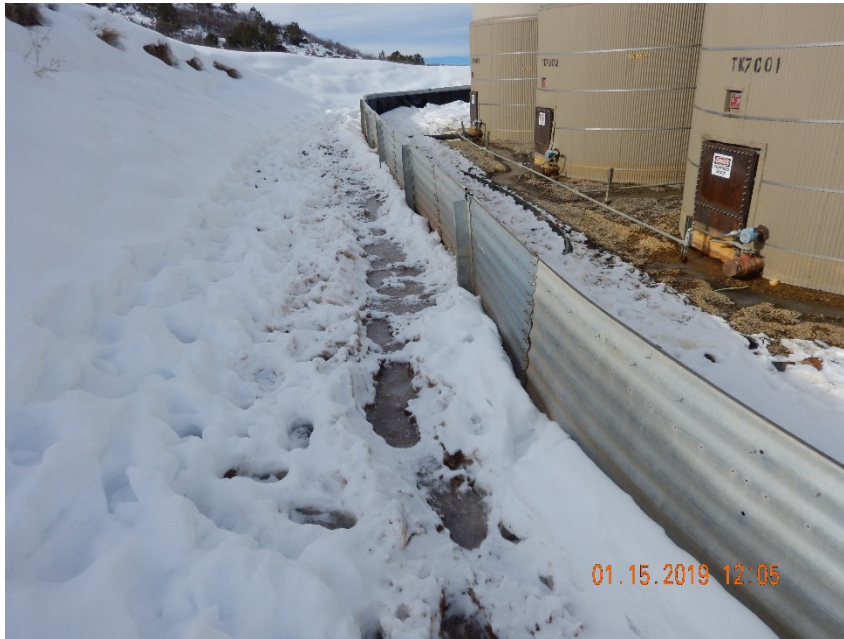
**Photo #7 – View of areas inside and outside of tank battery SPCC from east side. Operator indicated that fluids released during Spill/Release ID #460723 had impacted soil outside of SPCC.**

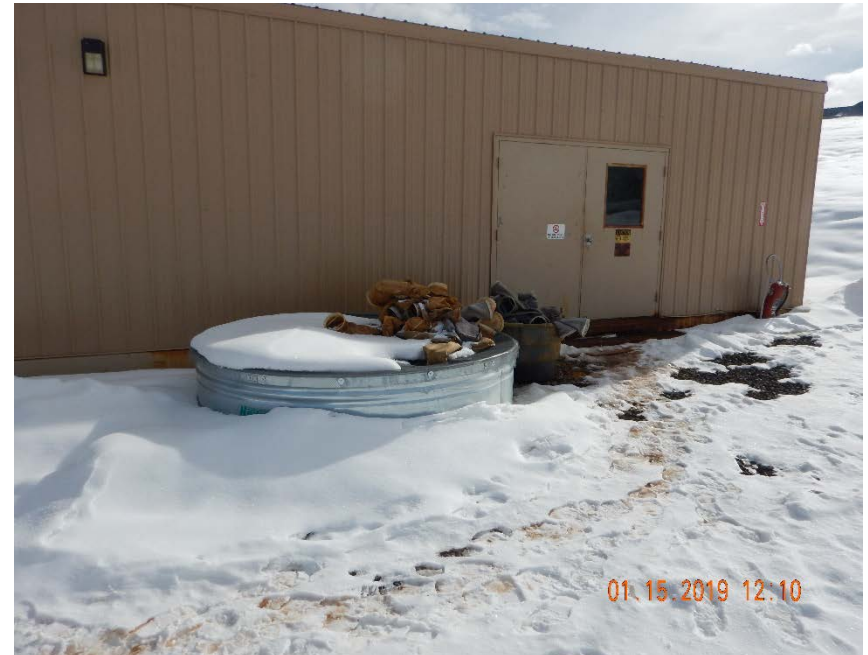
**Photo #8 – Additional used filter socks stored on location. Refer to R. Murray's inspection (doc #693200212) for corrective action.**
