# Final Reclamation Inspection

Operator: NOBLE ENERGY INC - #100322

Location ID: 327954

Inspection Photos  
Location Name: MYERS #14-21  
Location ID: 327954

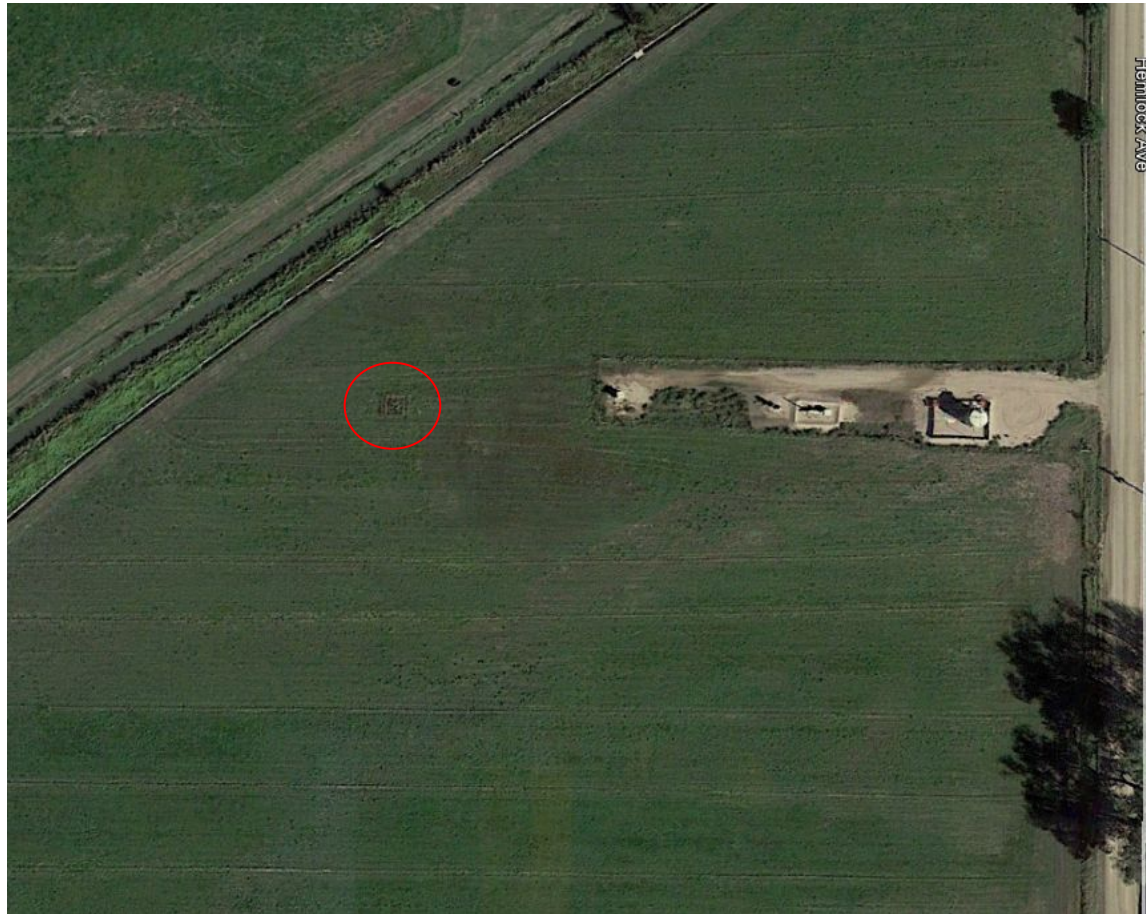
Google Earth aerial imagery taken September 7, 2016 during active operations illustrating the well location (red circle) and production facility.

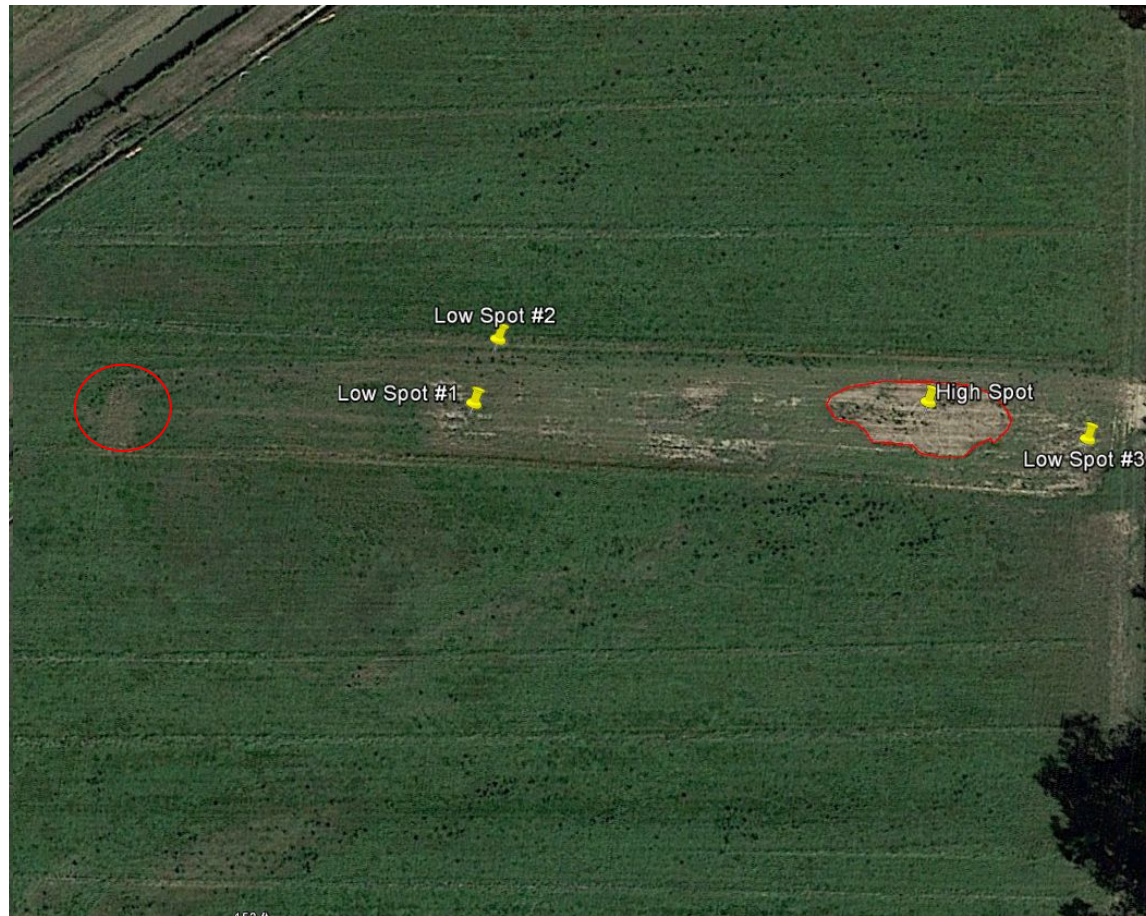
Google Earth aerial imagery taken September 12, 2018, after plugging and abandonment operations. COGCC Staff conducted a site investigation and determined the Location has not been properly contoured. There were observed low and high spots which are affecting revegetation throughout the Location and flood irrigation operations. Using a Trimble Juno handheld device, Staff mapped the observed areas of concern.

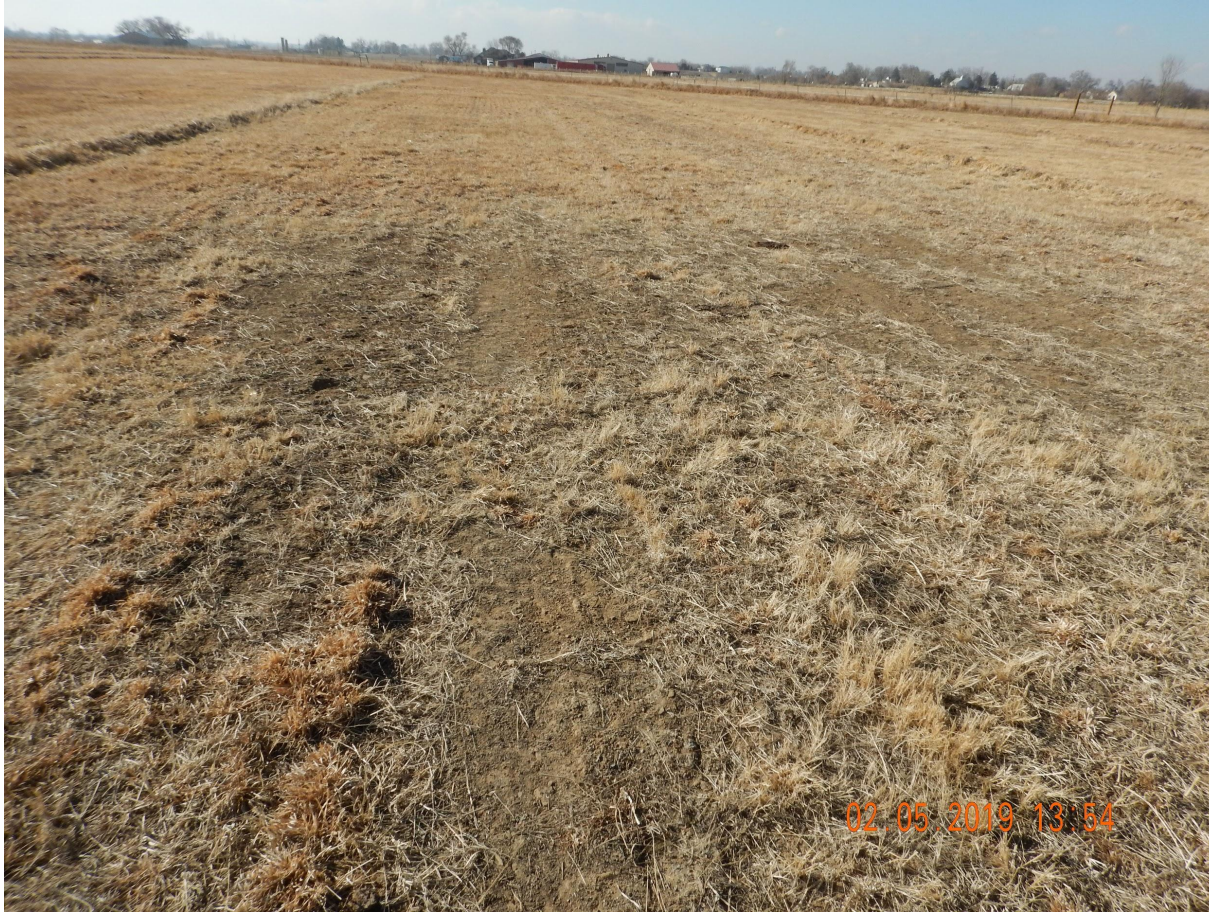
**Photo 1.** Photo taken from Low Spot #1, facing West. The Location has not been properly contoured per Rule 1004. Photo illustrates an observed low spot which is affecting revegetation and flood irrigation operations.

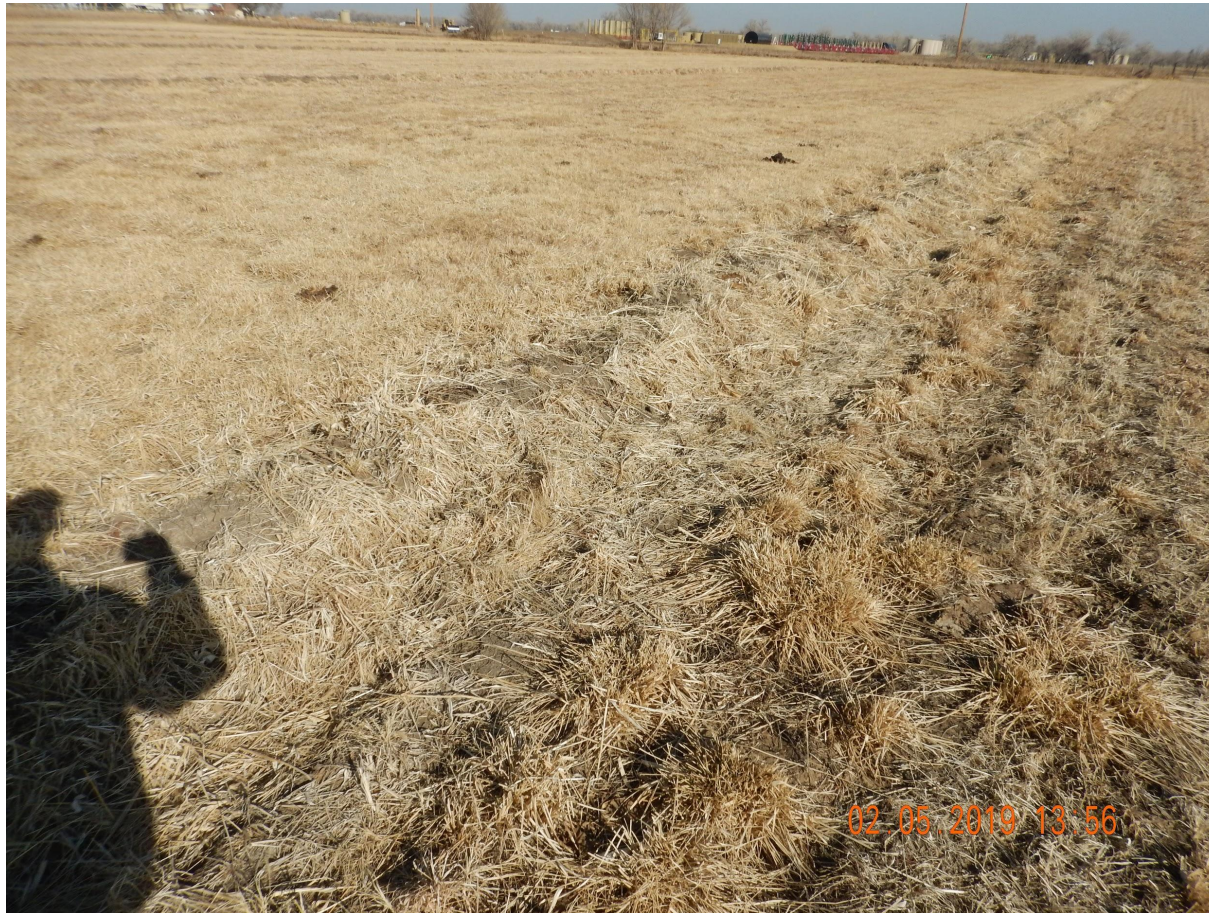
**Photo 2.** Photo taken from Low Spot #2, facing East. Photo illustrates an observed low spot along the irrigation berm. This low spot does not allow the irrigation berm to properly function to control flood irrigated water. Complainant indicated the flood water escapes from this spot not allowing for successful flood irrigation.

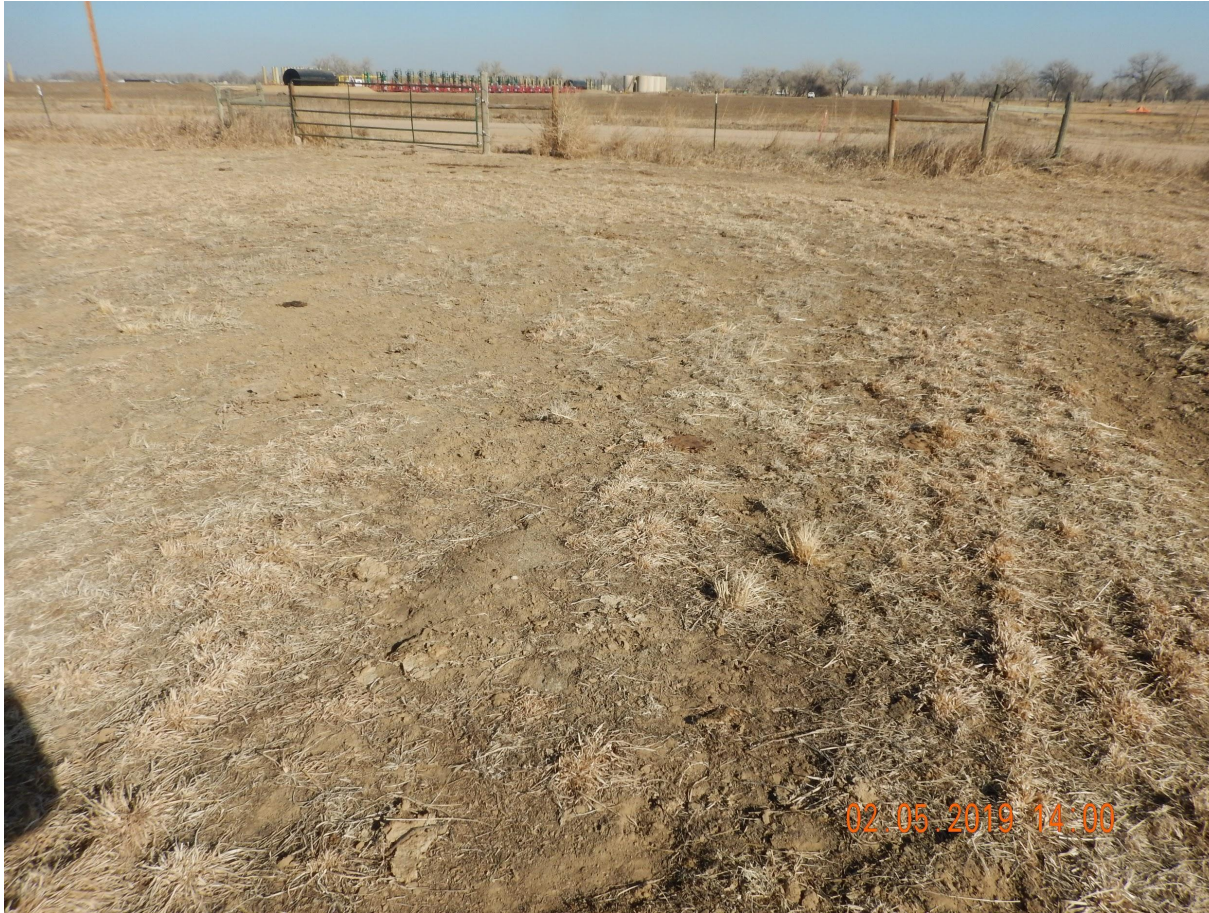
**Photo 3.** Photo taken from Low Spot #3, facing East. See comments under Photo 1.

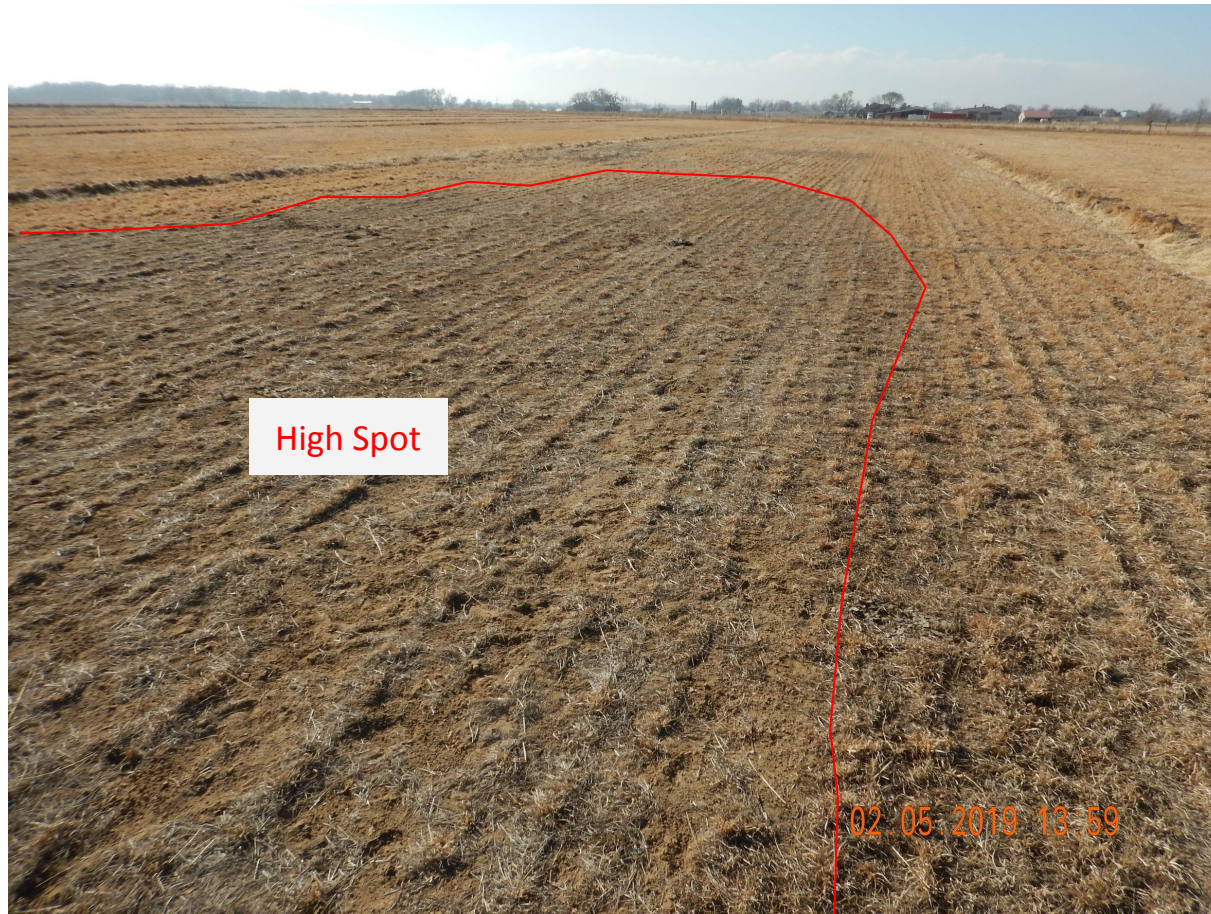
**Photo 4.** Photo taken from the eastern High Spot, facing West. See comments under Photo 1.

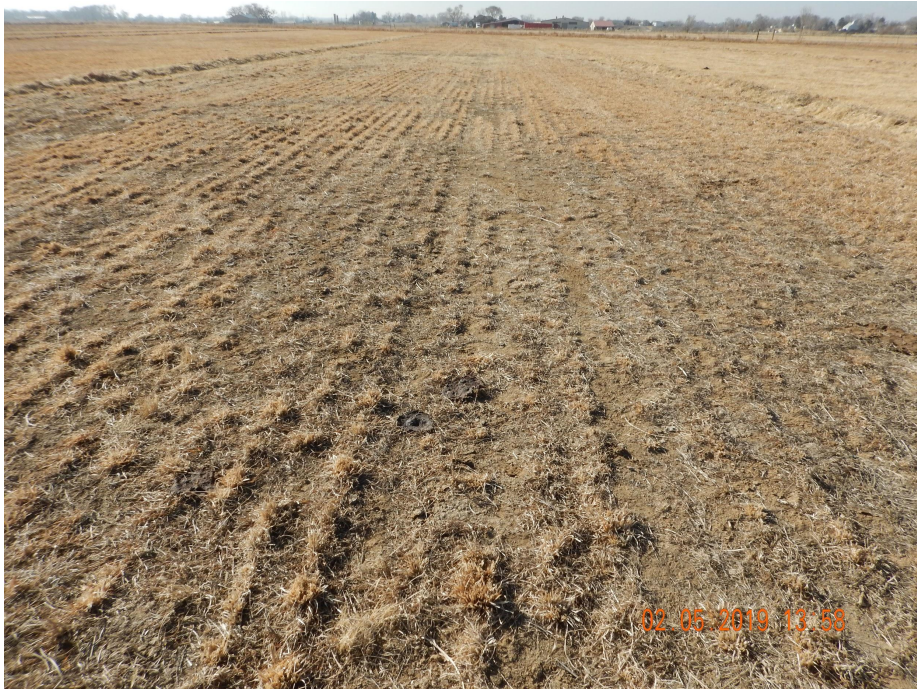
**Photo 5.** Photo taken from the central Location, facing West. See comments under Photo 1.

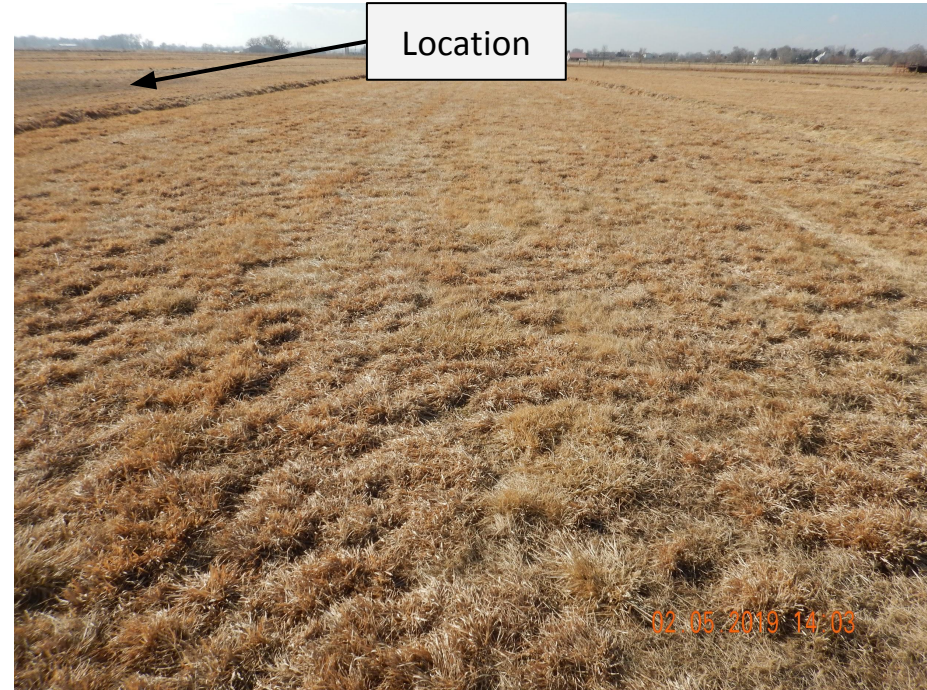
**Photo 6.** Reference photo taken north of the Location, facing West. Photo illustrates vegetation is not reflective of reference area vegetative levels per Rule 1004.
