Construction and Storm Water Inspection

Operator: CRESTONE PEAK RESOURCES OPERATING LLC – 10633

Location ID: 451044

Location Name: CRESTONE PEAK RESOURCES OPERATING LLC – 10633/2N68W19

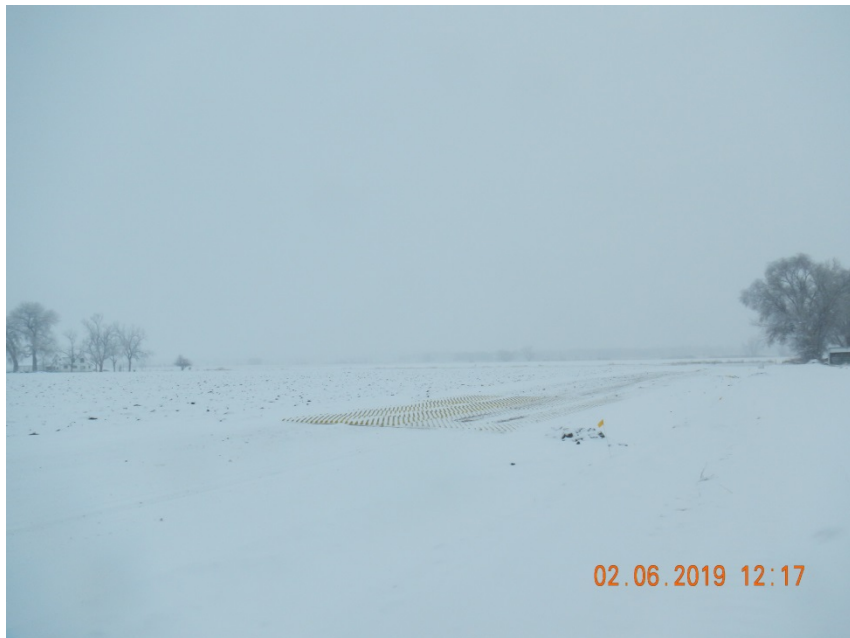
Photo 1. Photo taken from the access road near the entrance of the location off CR 20.5, facing North. Operator has installed a track pad and gravel potentially to limit tracking onto the county road.

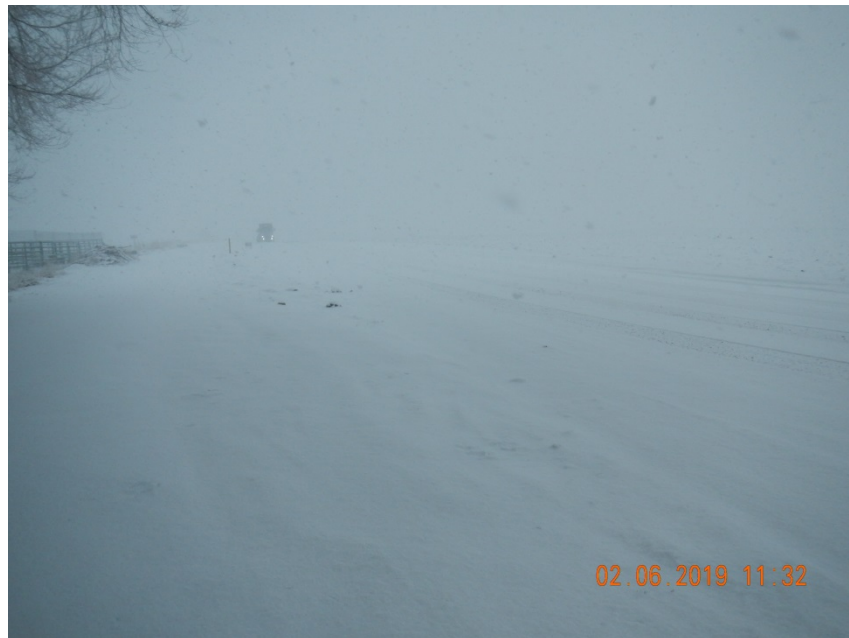
Photo 2. Photo taken from the entrance of the location off CR 20.5, facing South. See comments from Photo 1.

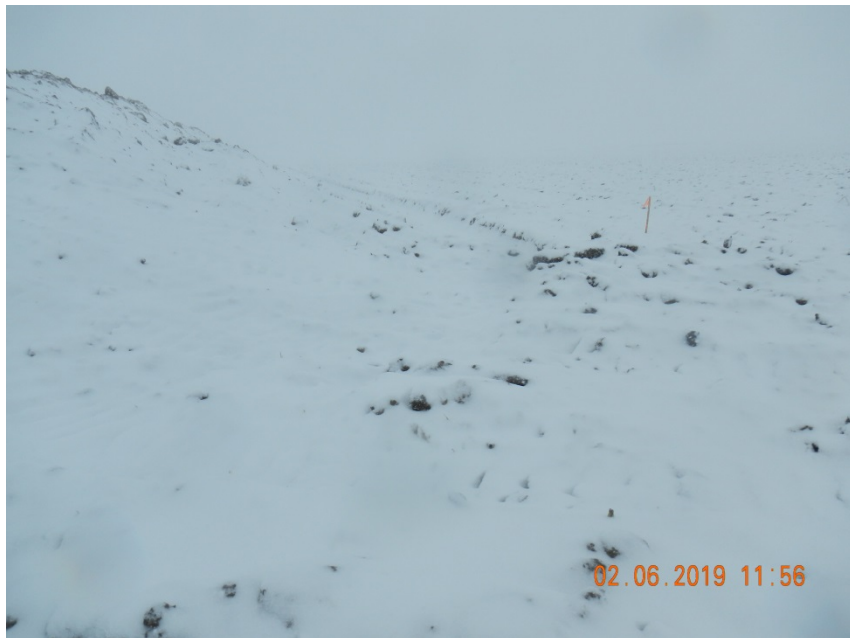
Photo 3. Photo taken from northeastern perimeter of the location, facing West. Photo illustrates the ditch and berm BMP that has been installed around the perimeter of the location has been tracked through by equipment and opens to adjacent field with no stormwater BMP or stabilized outlet.

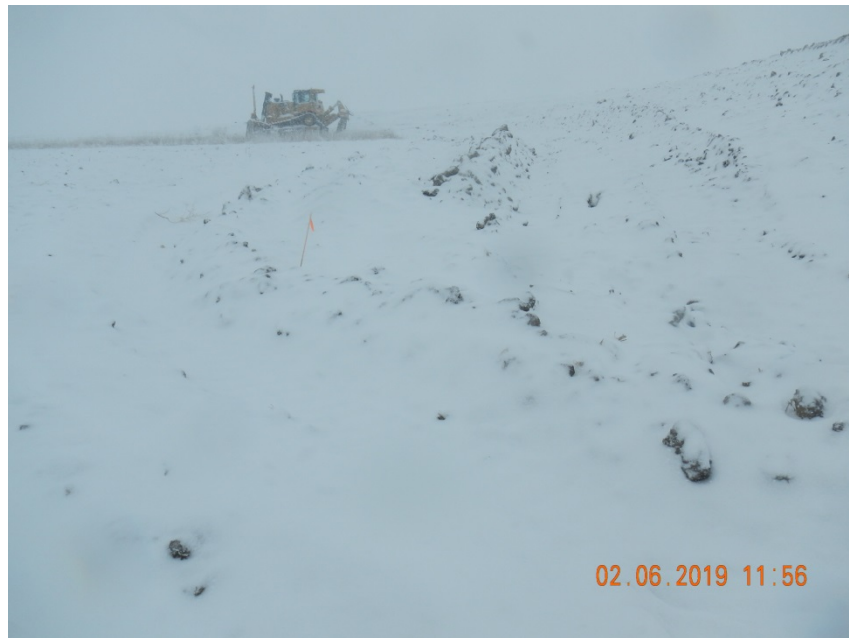
Photo 4. Photo taken from eastern perimeter of the location, facing South. See comments from Photo 3.
