Inspection Photos

Operator: NOBLE ENERGY INC - 100322

Location ID: 421826

Inspection Doc. Number: 682504498

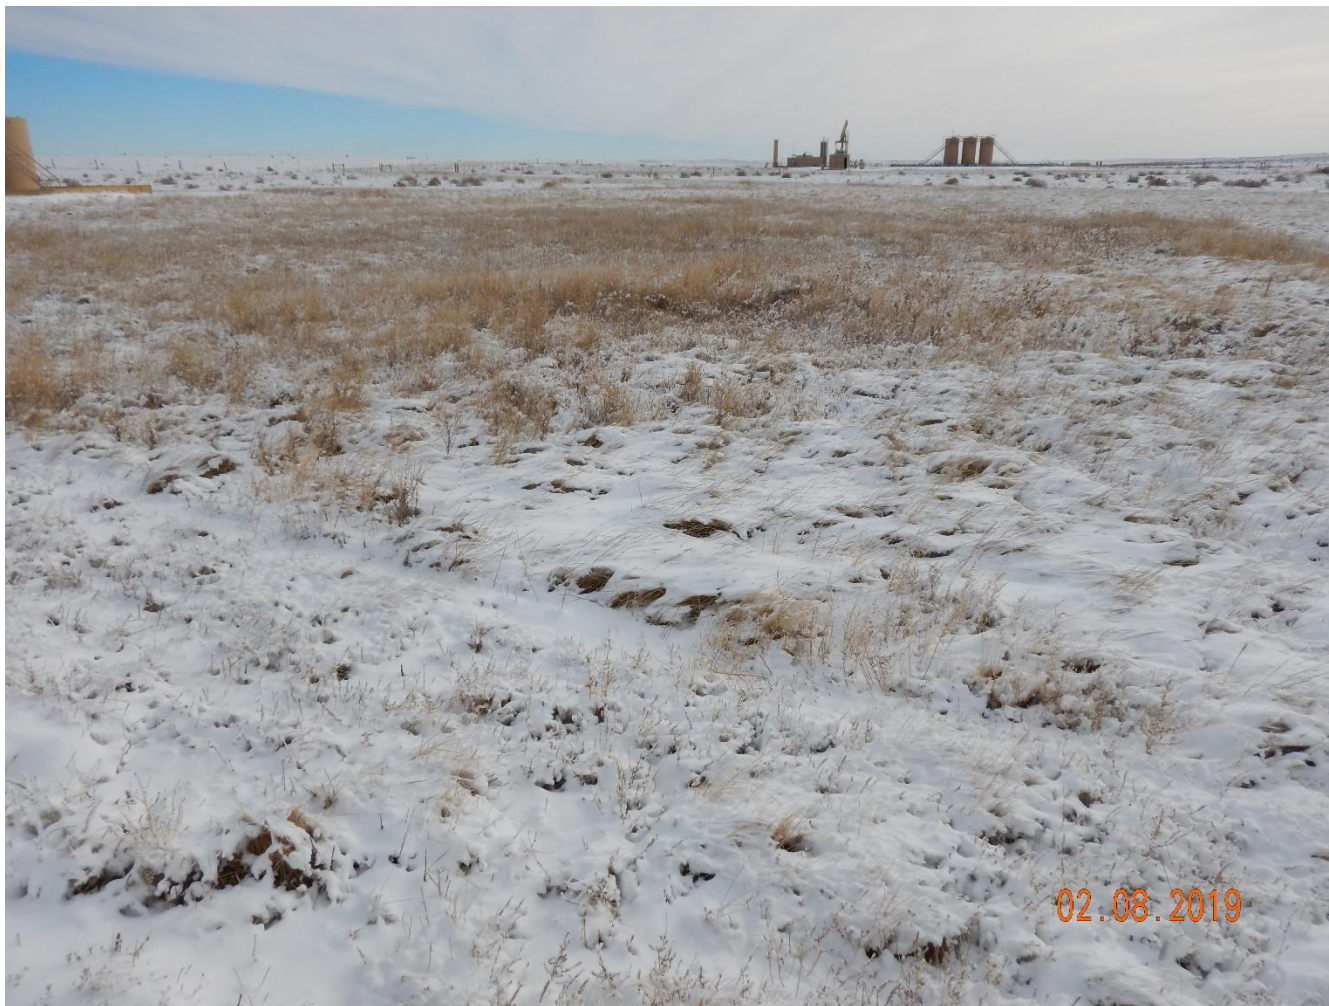
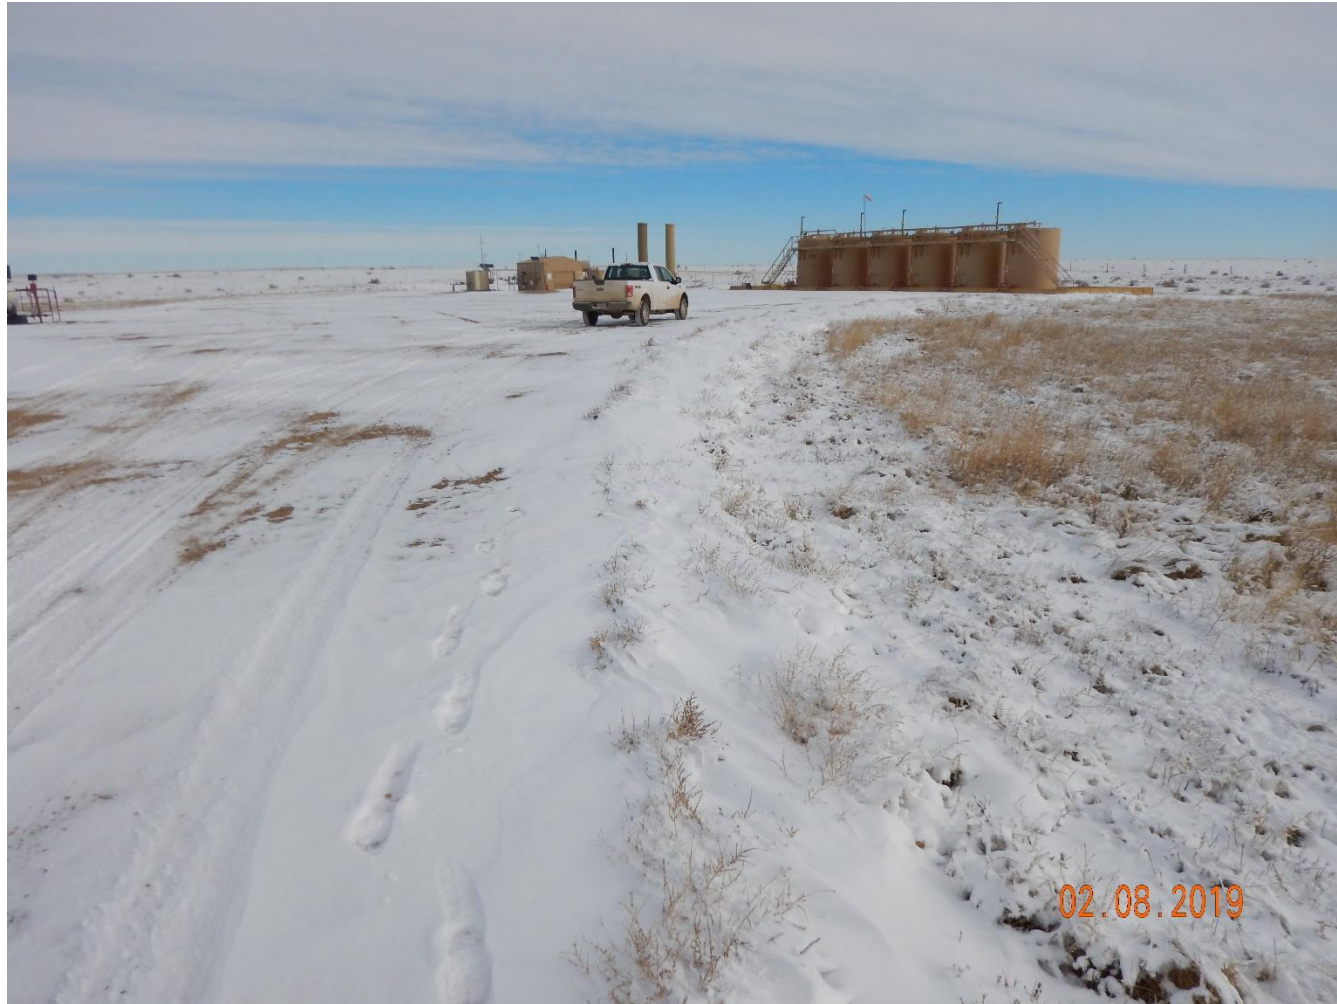
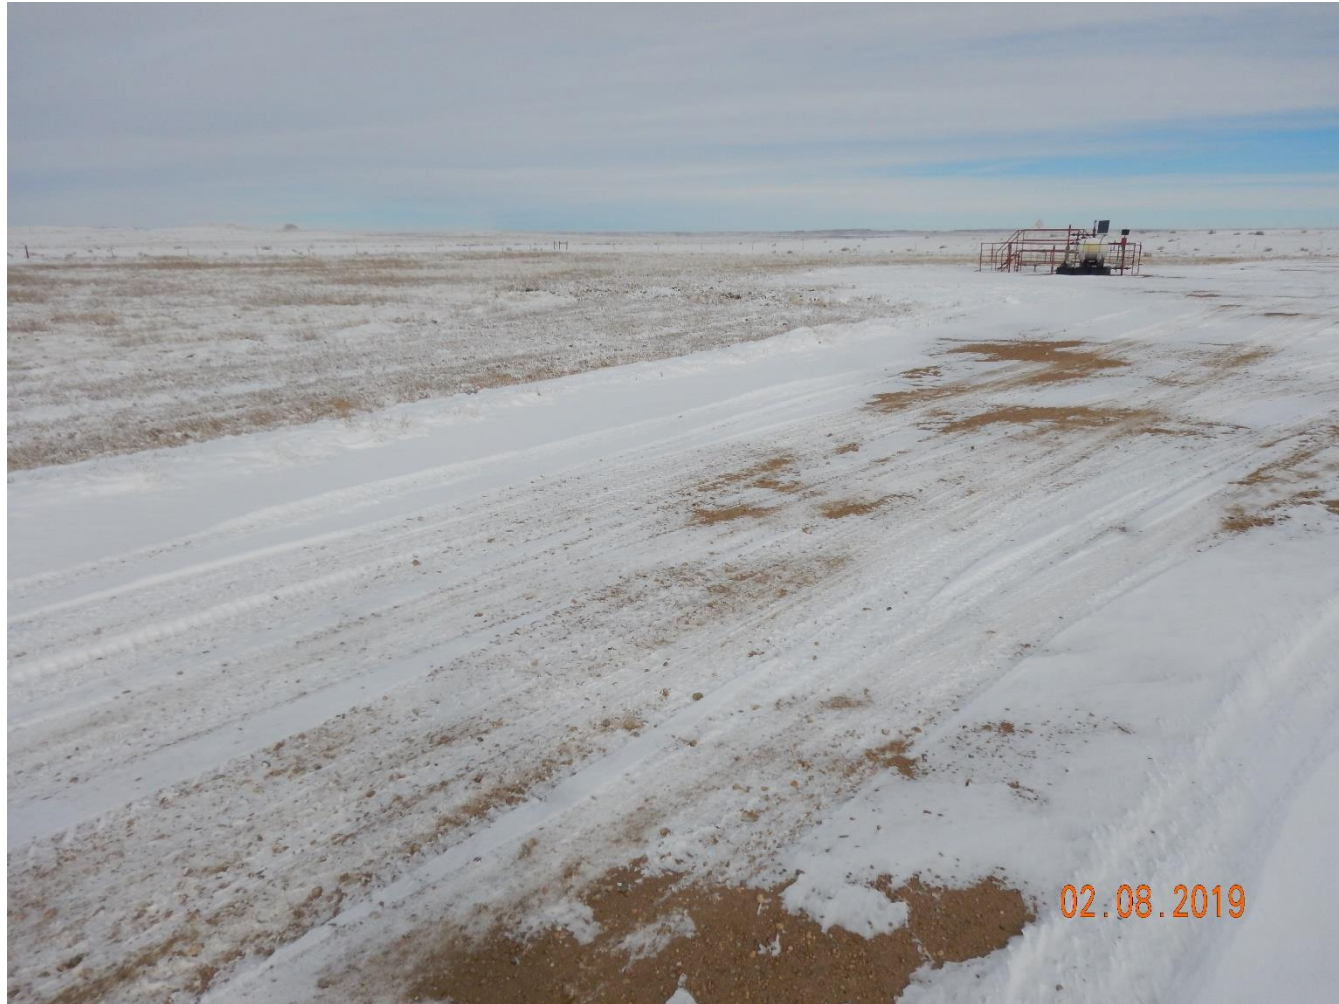
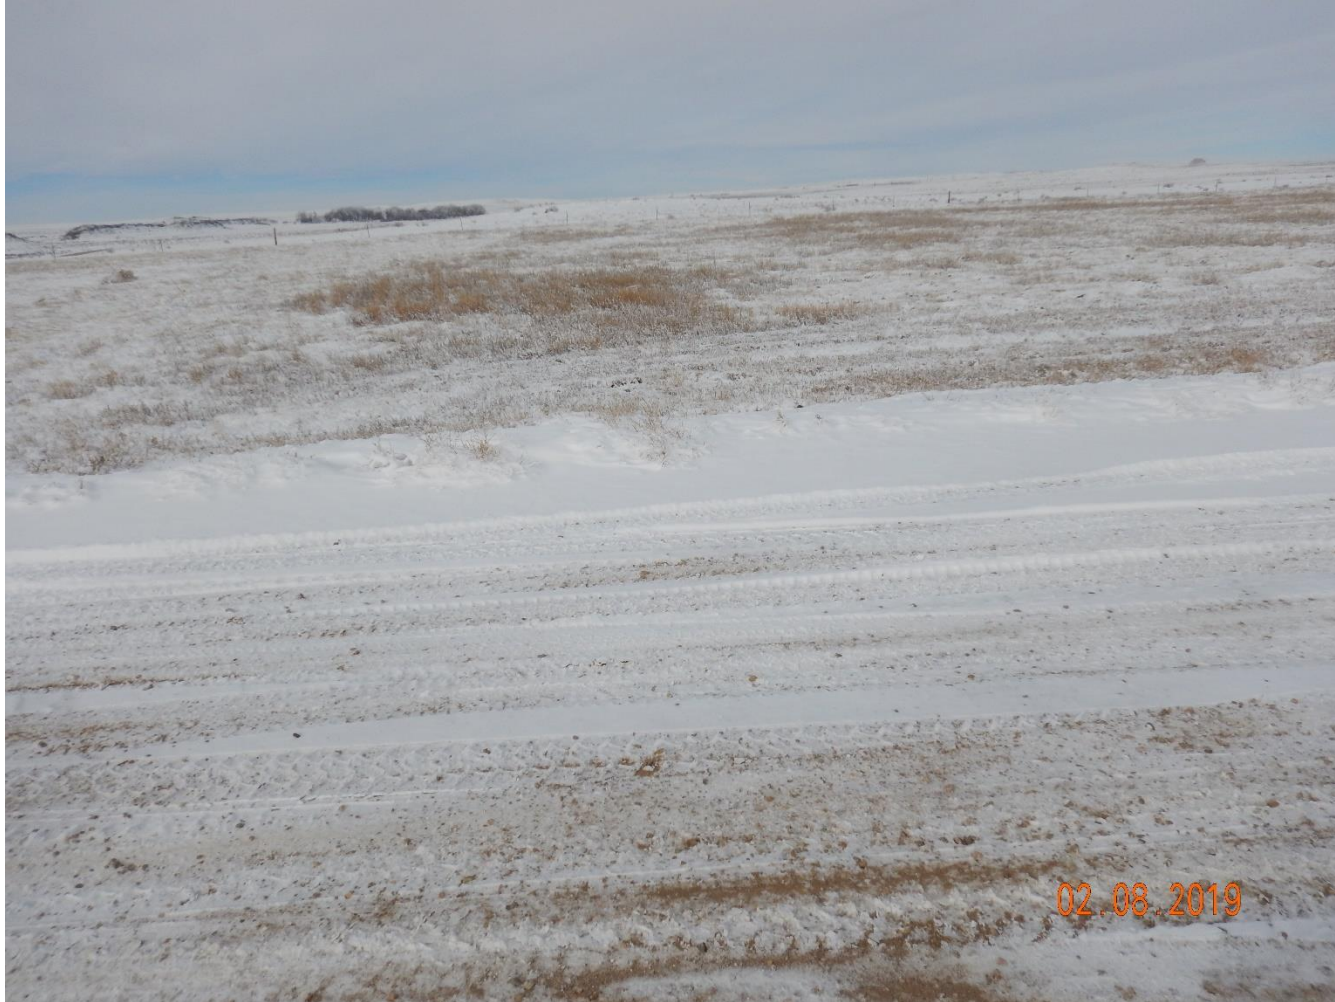
Photo 1: Photo taken from the south end of the location, facing east. Photos 1-4 provide an overview of the location from east, northeast, northwest to west.

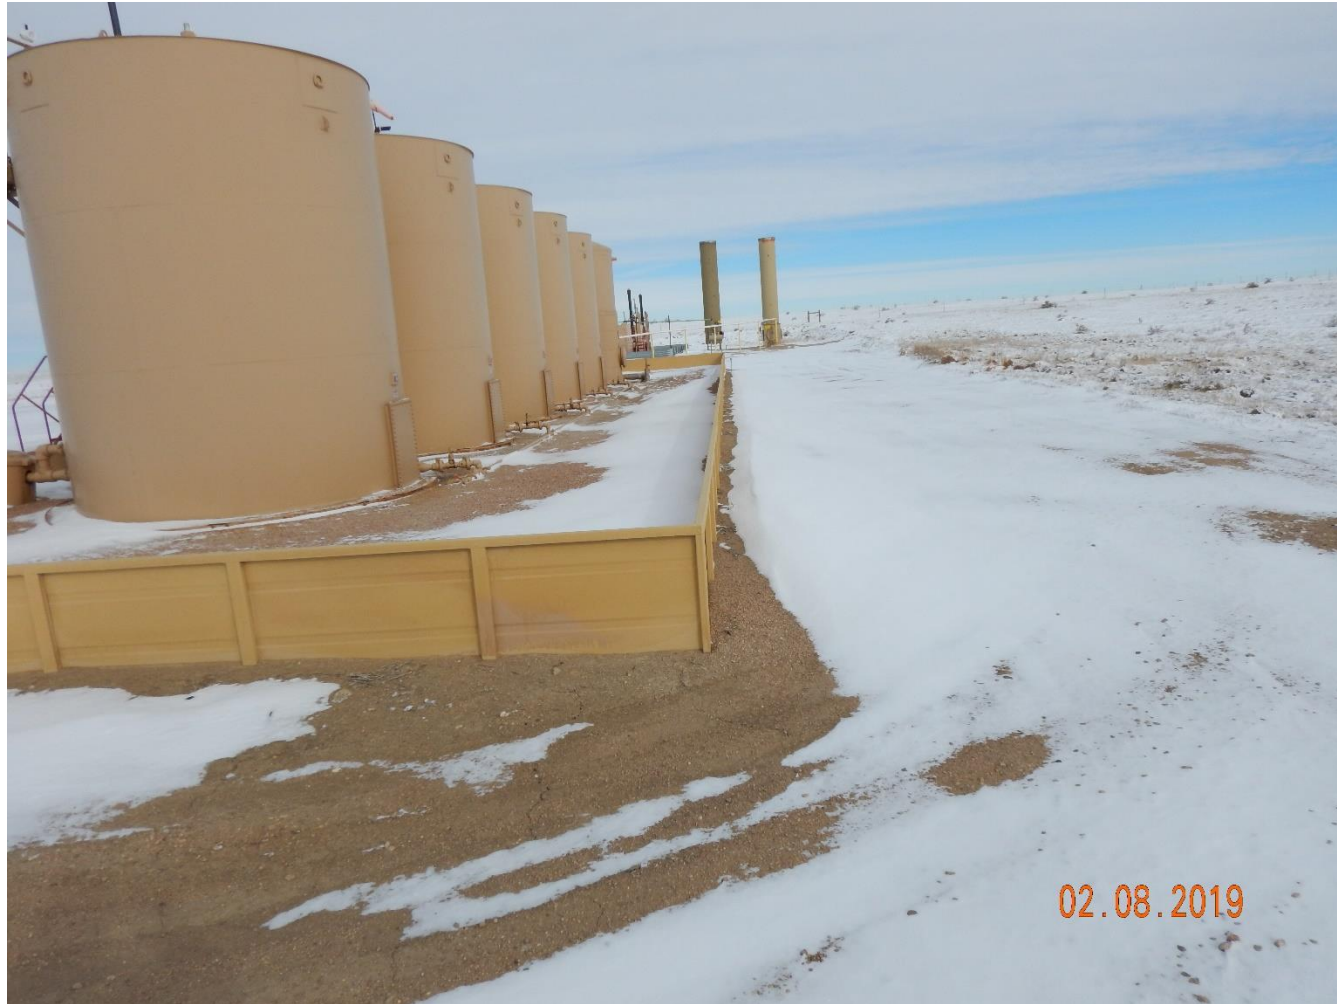
Photo 5: Photo taken from the east end of the location, facing north. Photo shows eastern perimeter of the location and equipment.

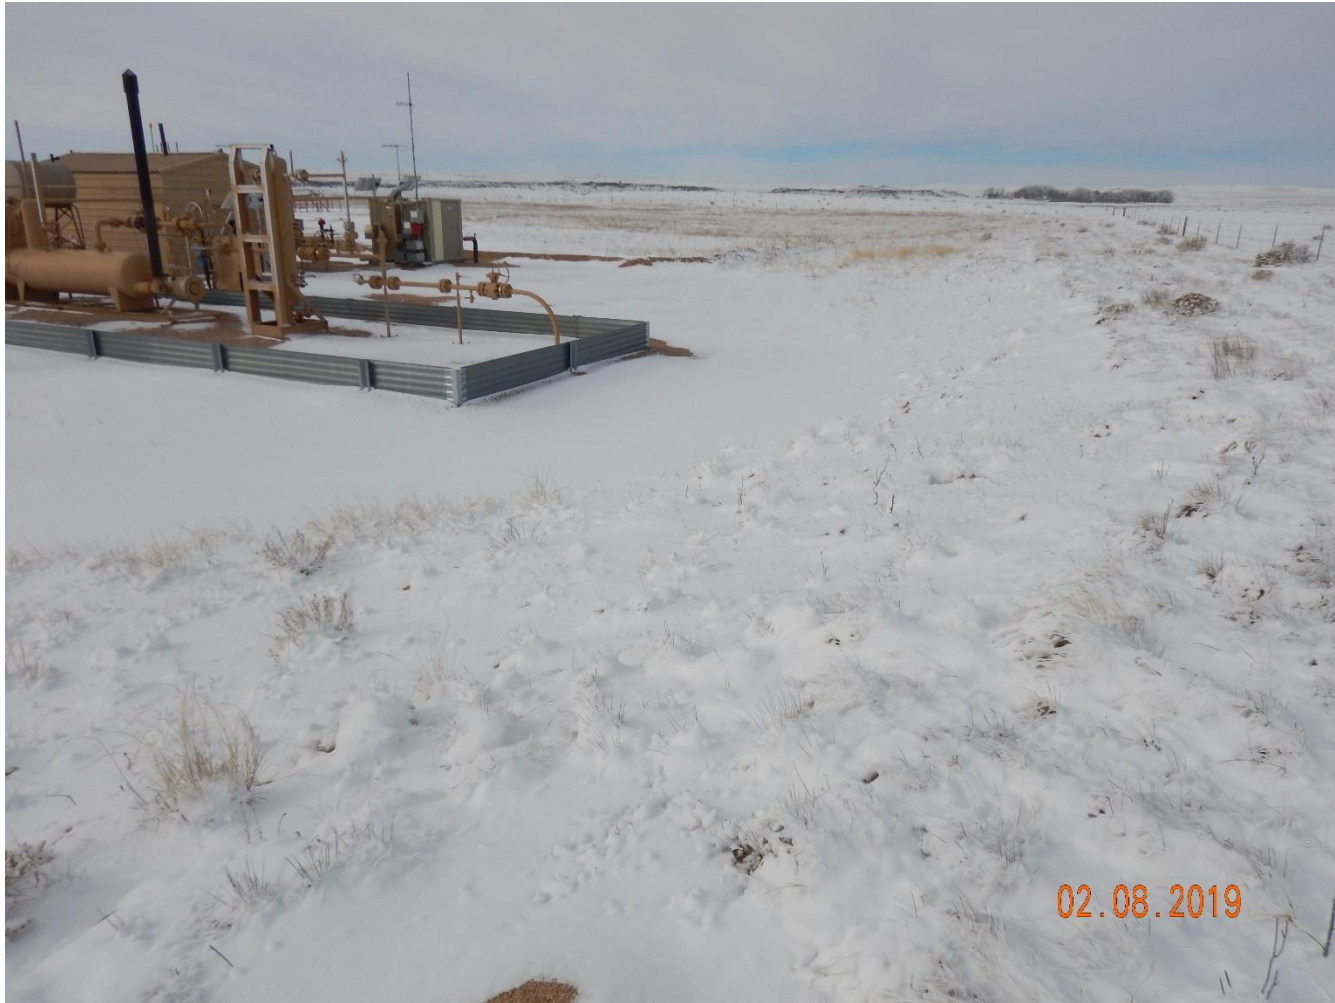
Photo 6: Photo taken from the northeast corner of the location, facing west. Photo shows interim and production areas.

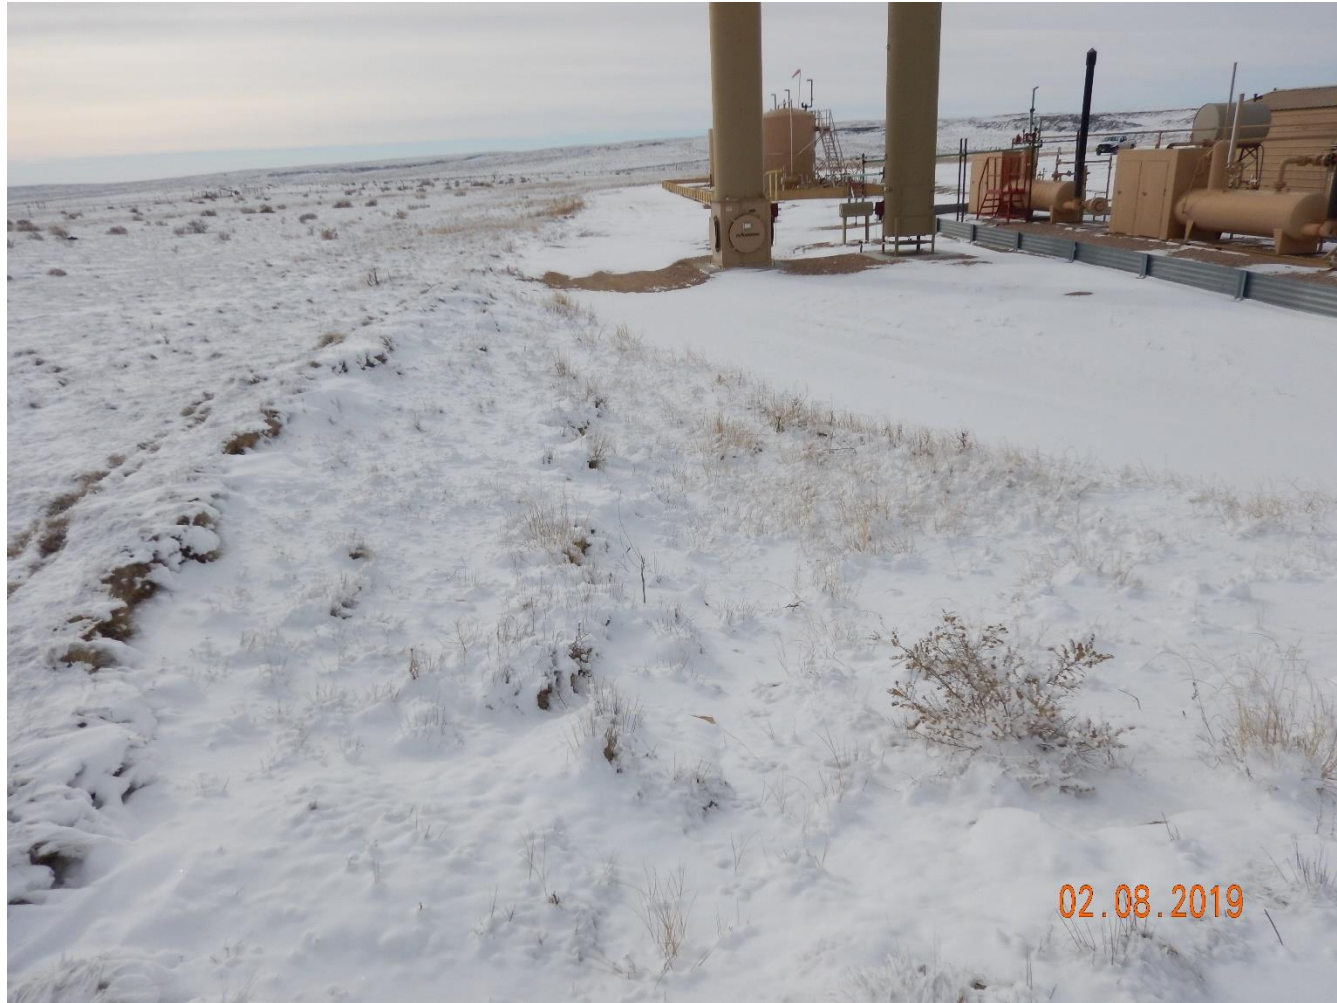
Photo 7: Photo taken from the northeast corner of the location, facing south. Photo shows interim and production areas.

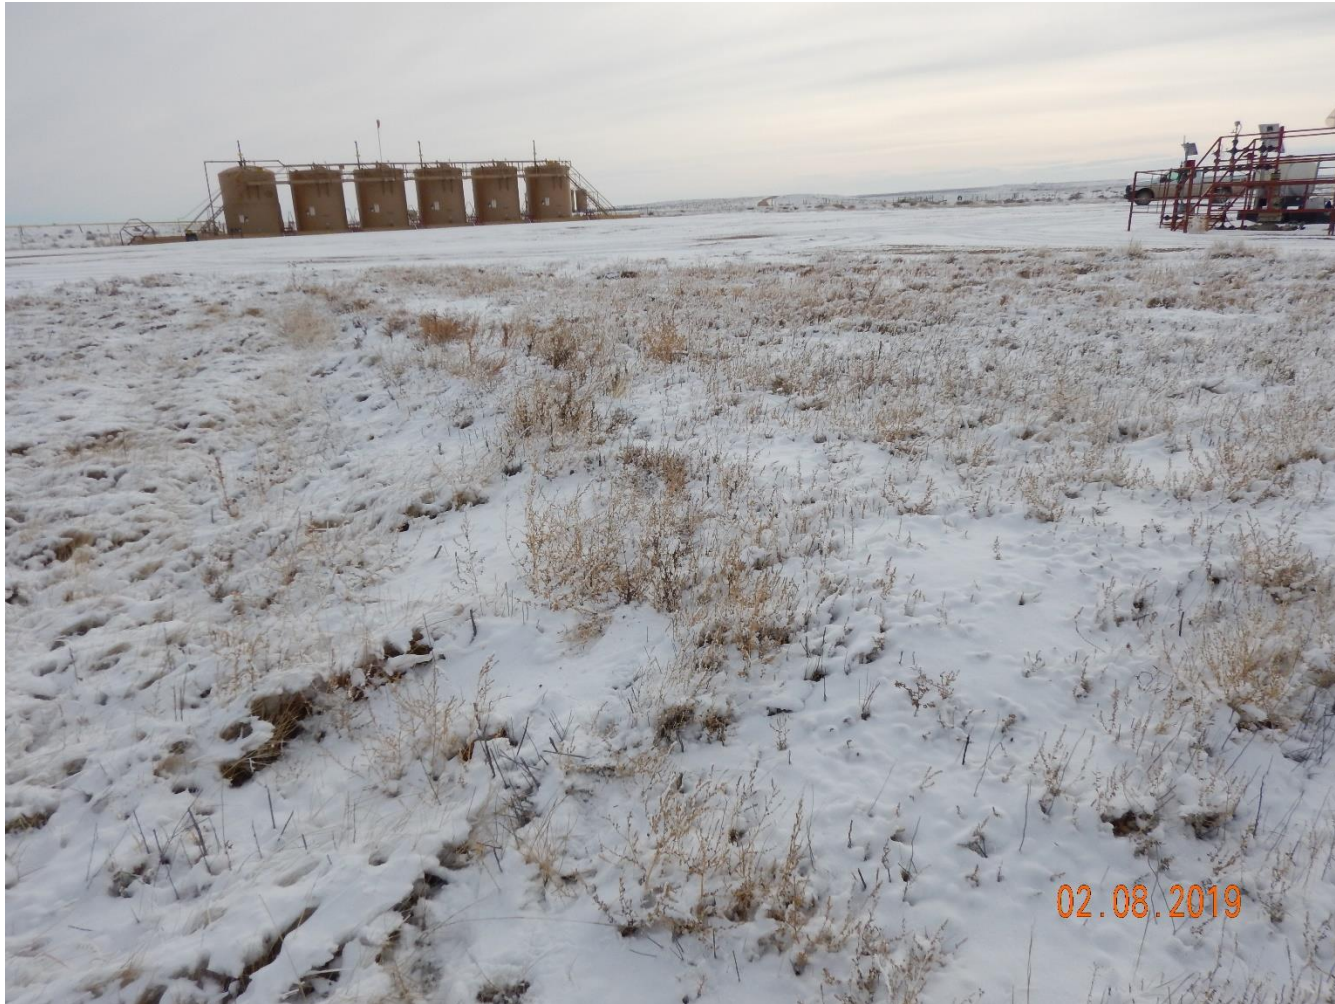
Photo 8: Photo taken from the north end of the location, facing southeast. Photo shows interim and production areas.

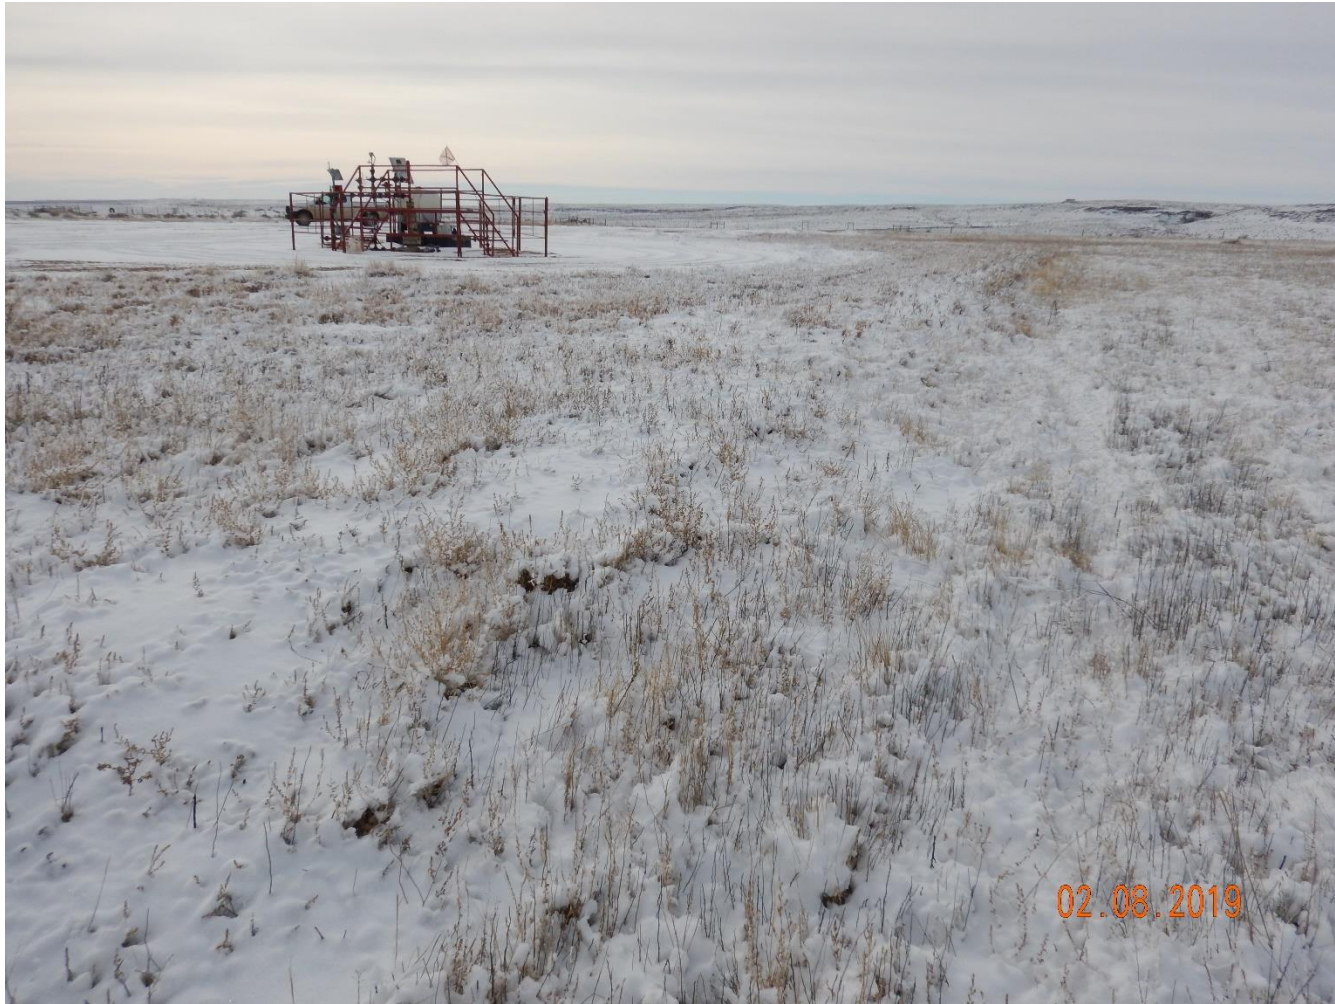
Photo 9: Photo taken from the north end of the location, facing south. Photo shows interim and production areas.

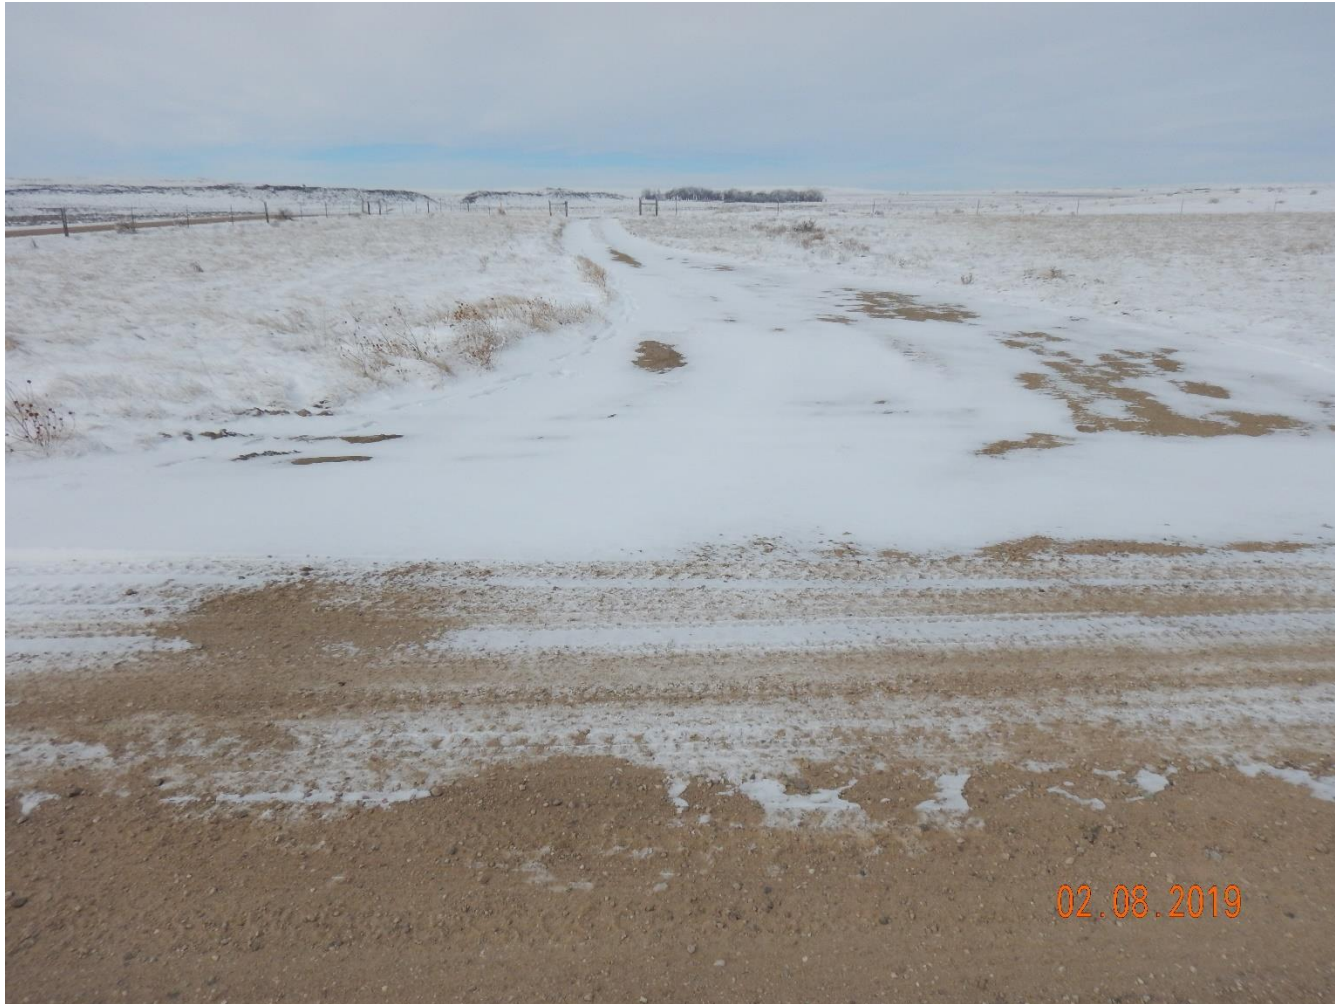
Photo 10: Photo taken from the south end of the location. Photo shows operator appears to have constructed an additional road through the location traveling west. This is being documented for future reclamation as road is not pre-existing, and not on the location drawing or access road map documents submitted by operator with the 2A.
