Inspection Photos

Operator: NOBLE ENERGY INC - 100322

Location ID: 432936

Inspection Doc. Number: 682504506

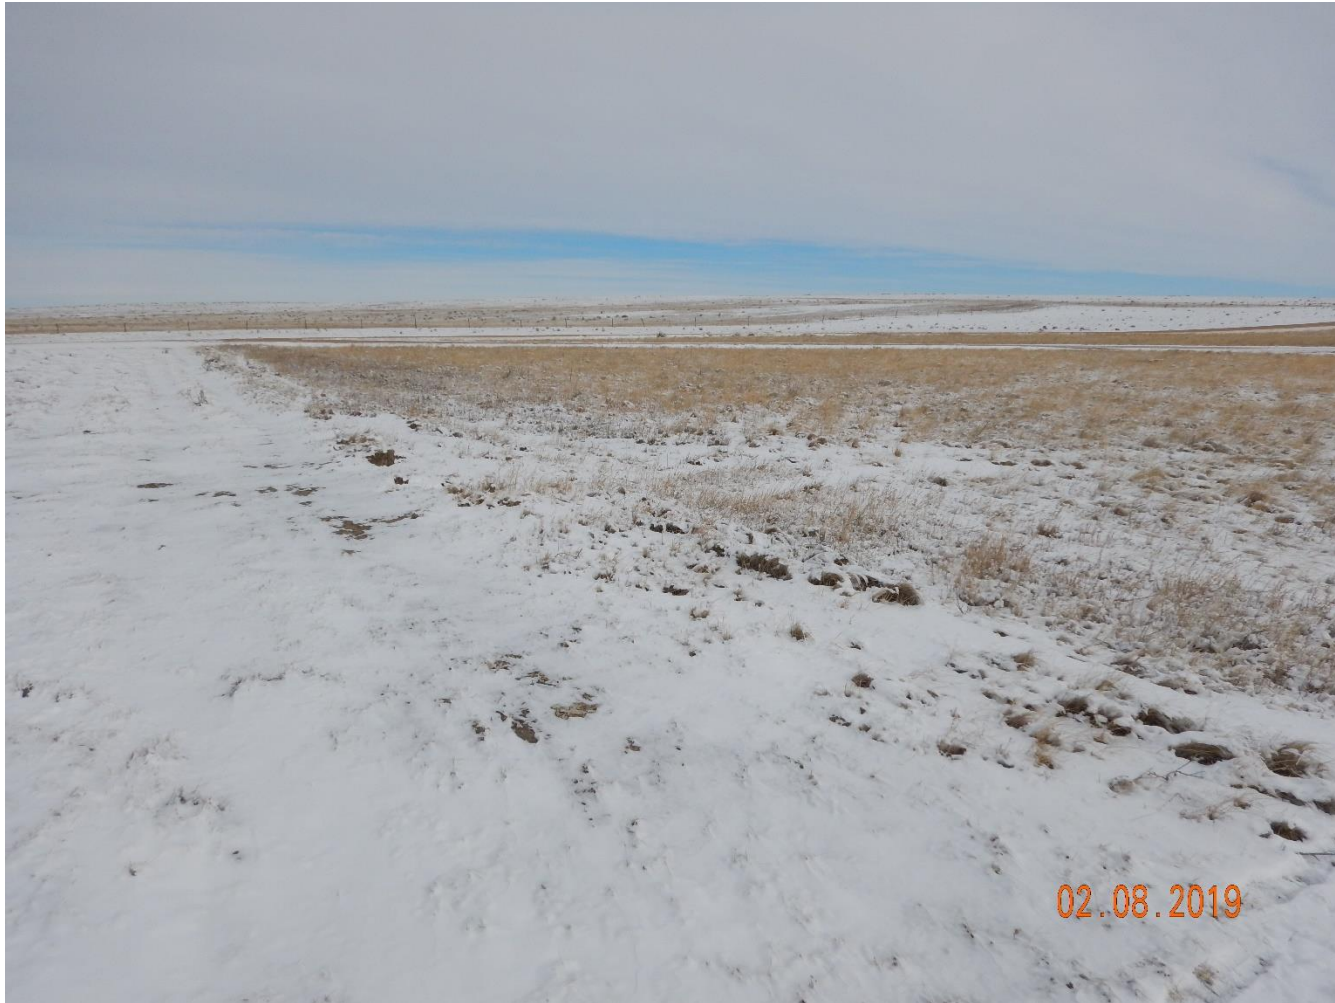
Photo 1: Photo taken from the west end of the location, facing north. Photos 1-4 provide an overview of the location from north, northeast, southeast to south.

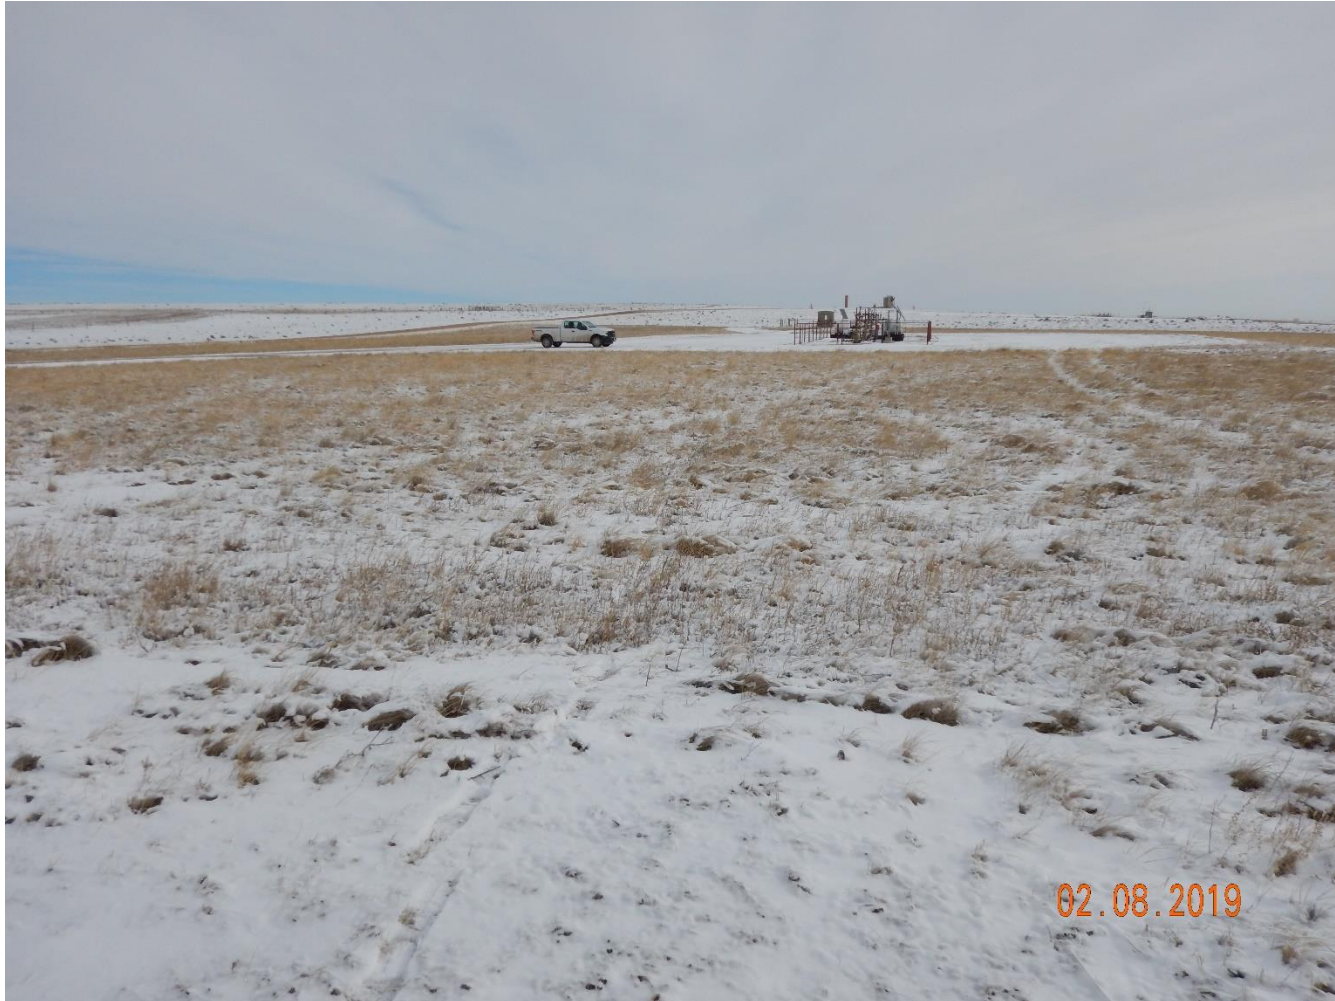
Photo 2: See comments under photo 1.

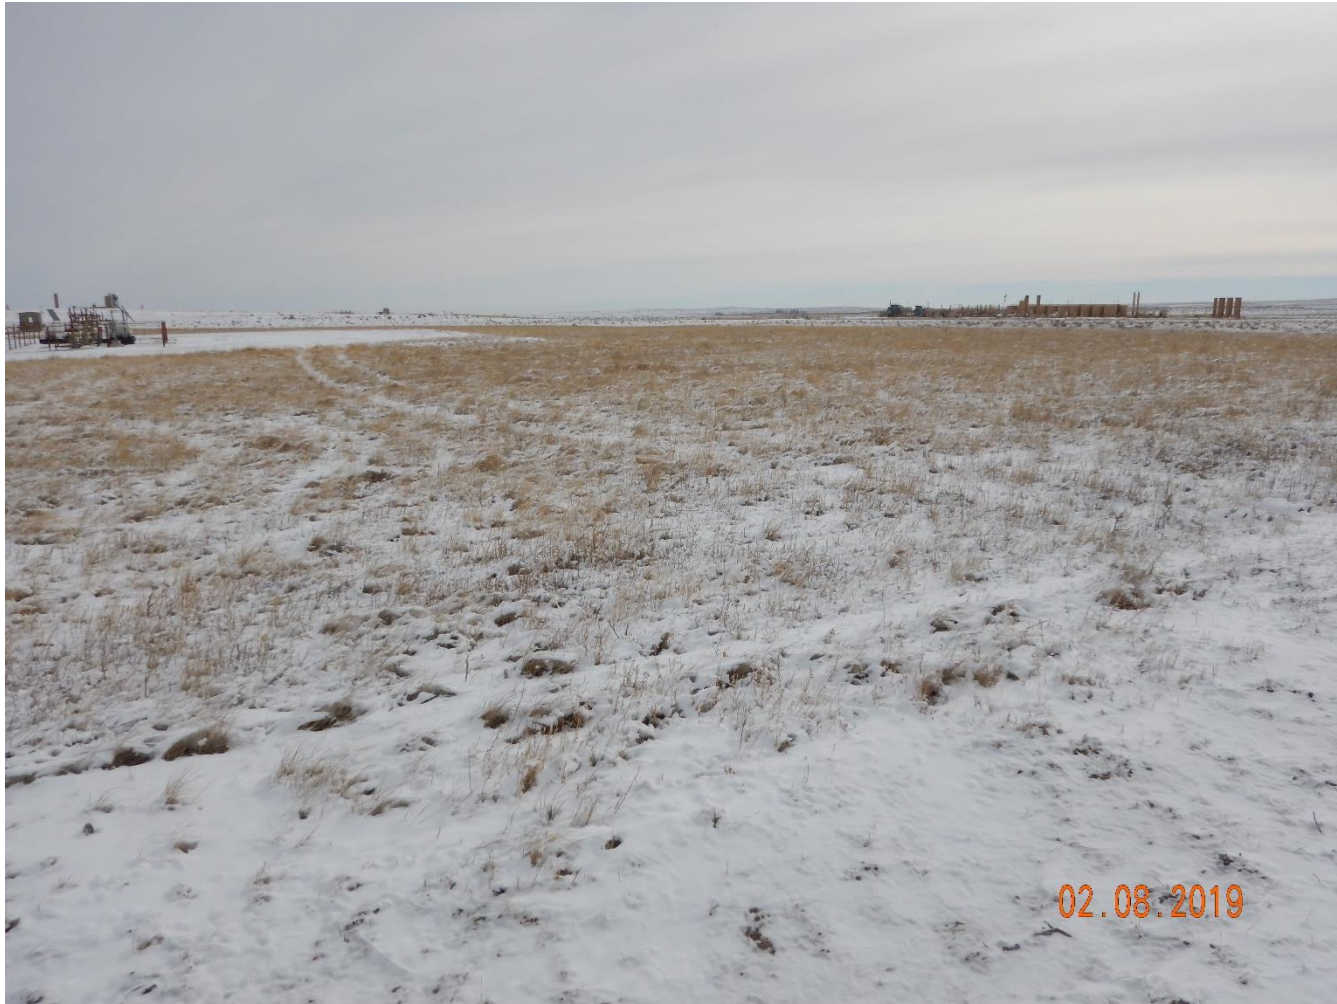
Photo 3: See comments under photo 1.

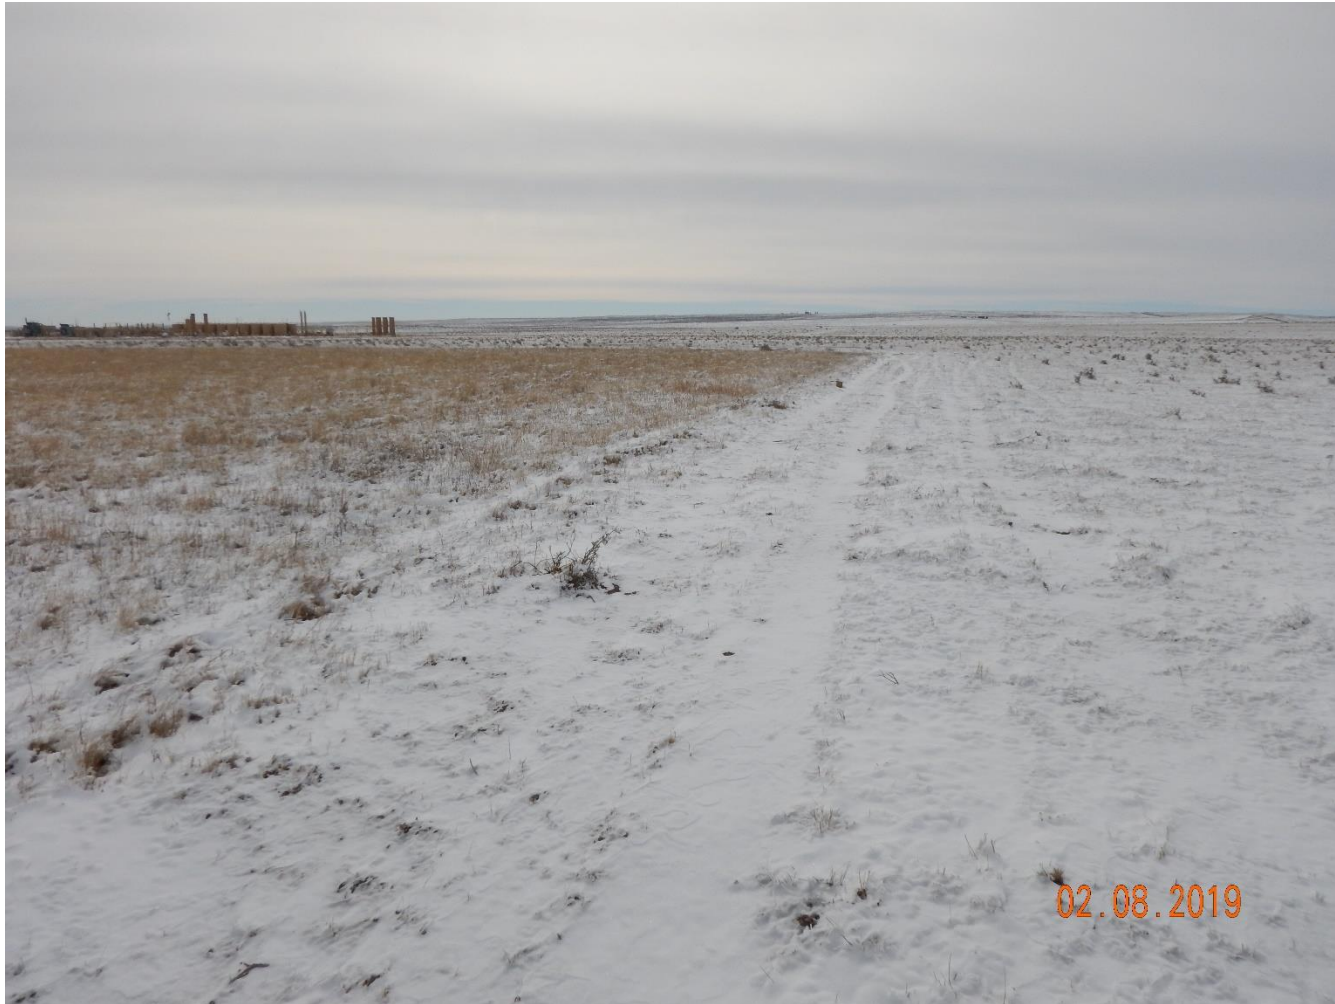
Photo 4: See comments under photo 1.

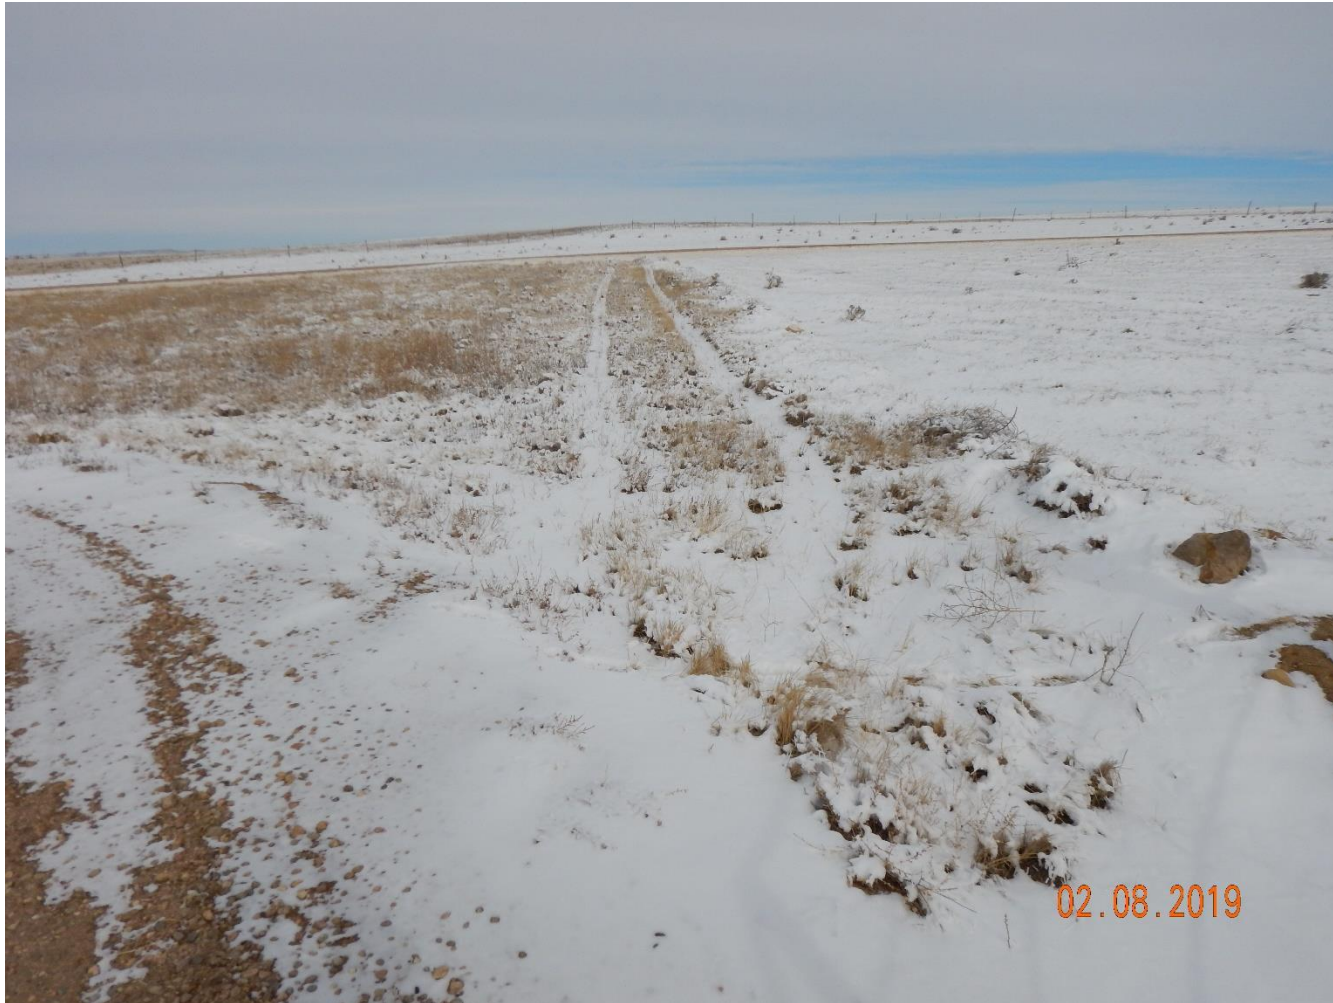
Photo 5: Photo taken from the east end of the location, facing north. Photo shows vehicle tracks over the interim areas, leading from the east end of the pad to the north. This does not comply with 1002.e, surface disturbance minimization.

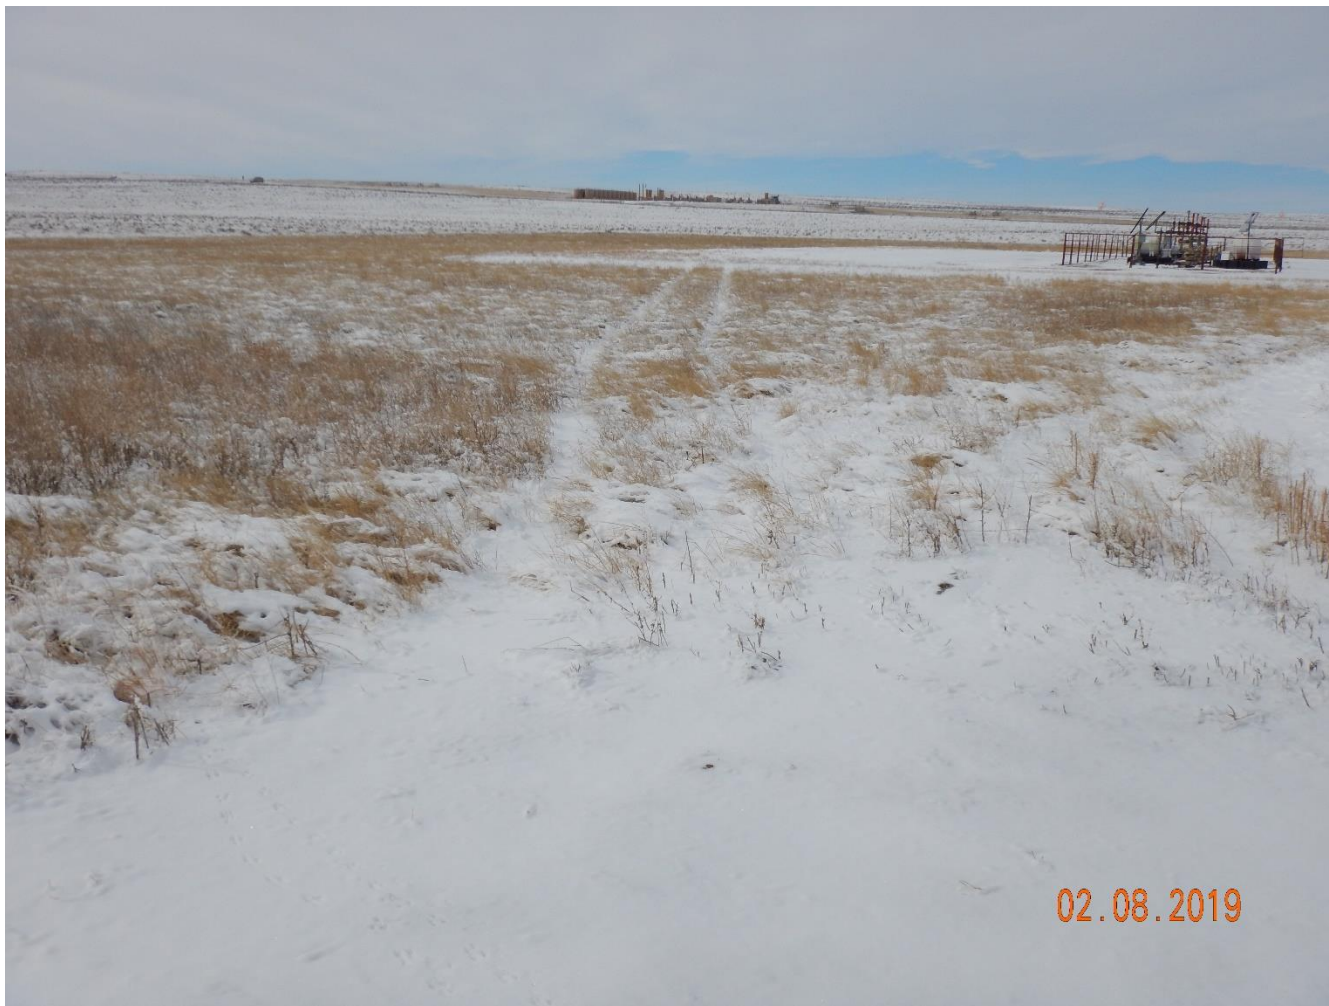
Photo 6: Photo taken from the east end of the location, facing west. Photo shows vehicle tracks over the interim areas, leading from the east end of the location to the southeast corner of the pad. This does not comply with 1002.e, surface disturbance minimization.

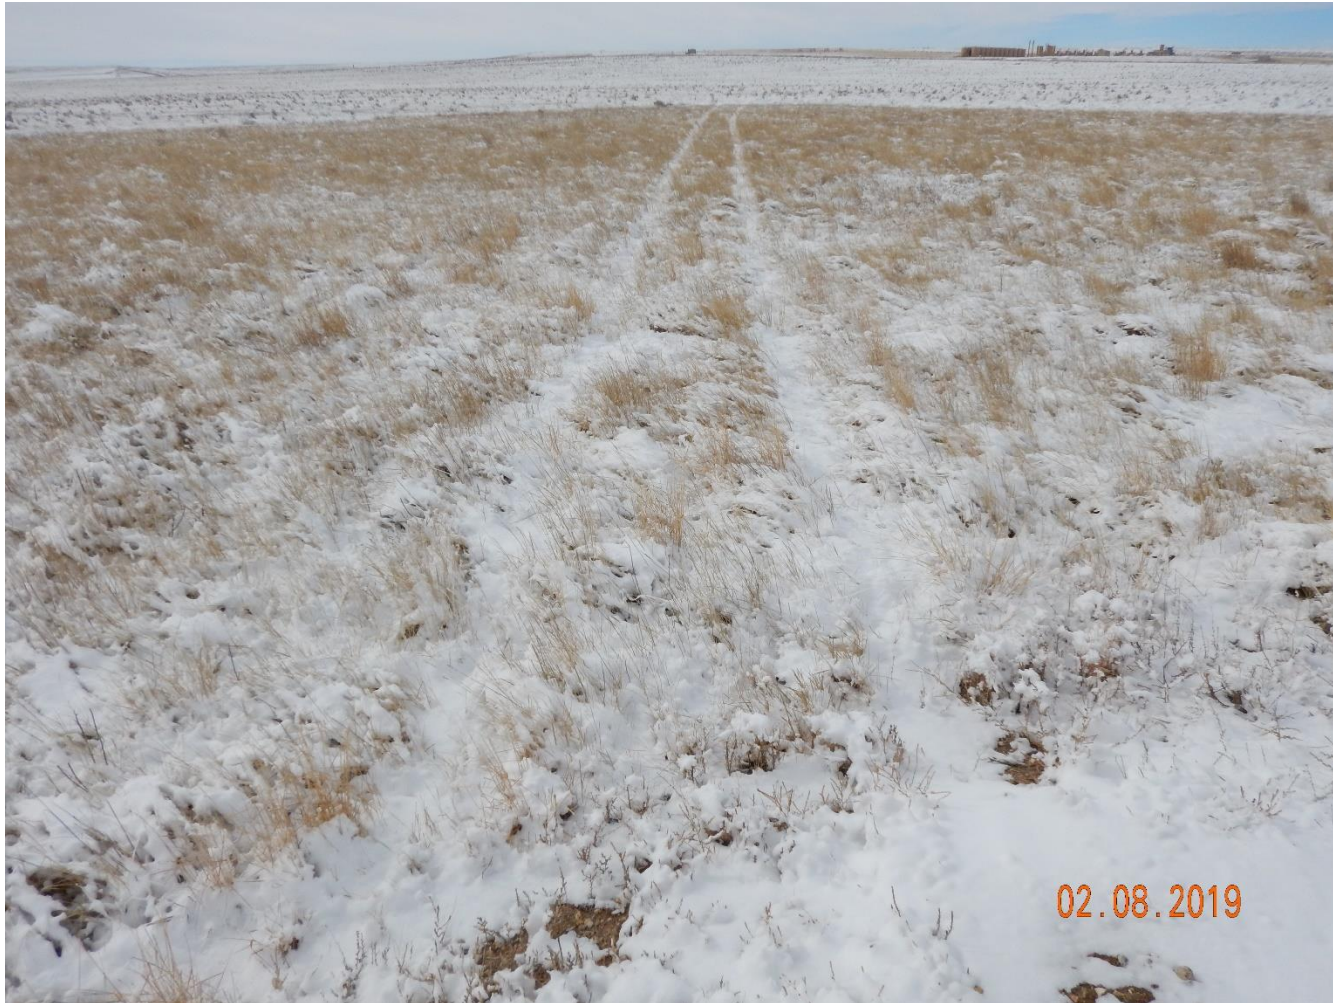
Photo 7: Photo taken from the southwest end of the location, facing southwest. Photo shows vehicle tracks over the interim areas from the pad. This does not comply with 1002.e, surface disturbance minimization.

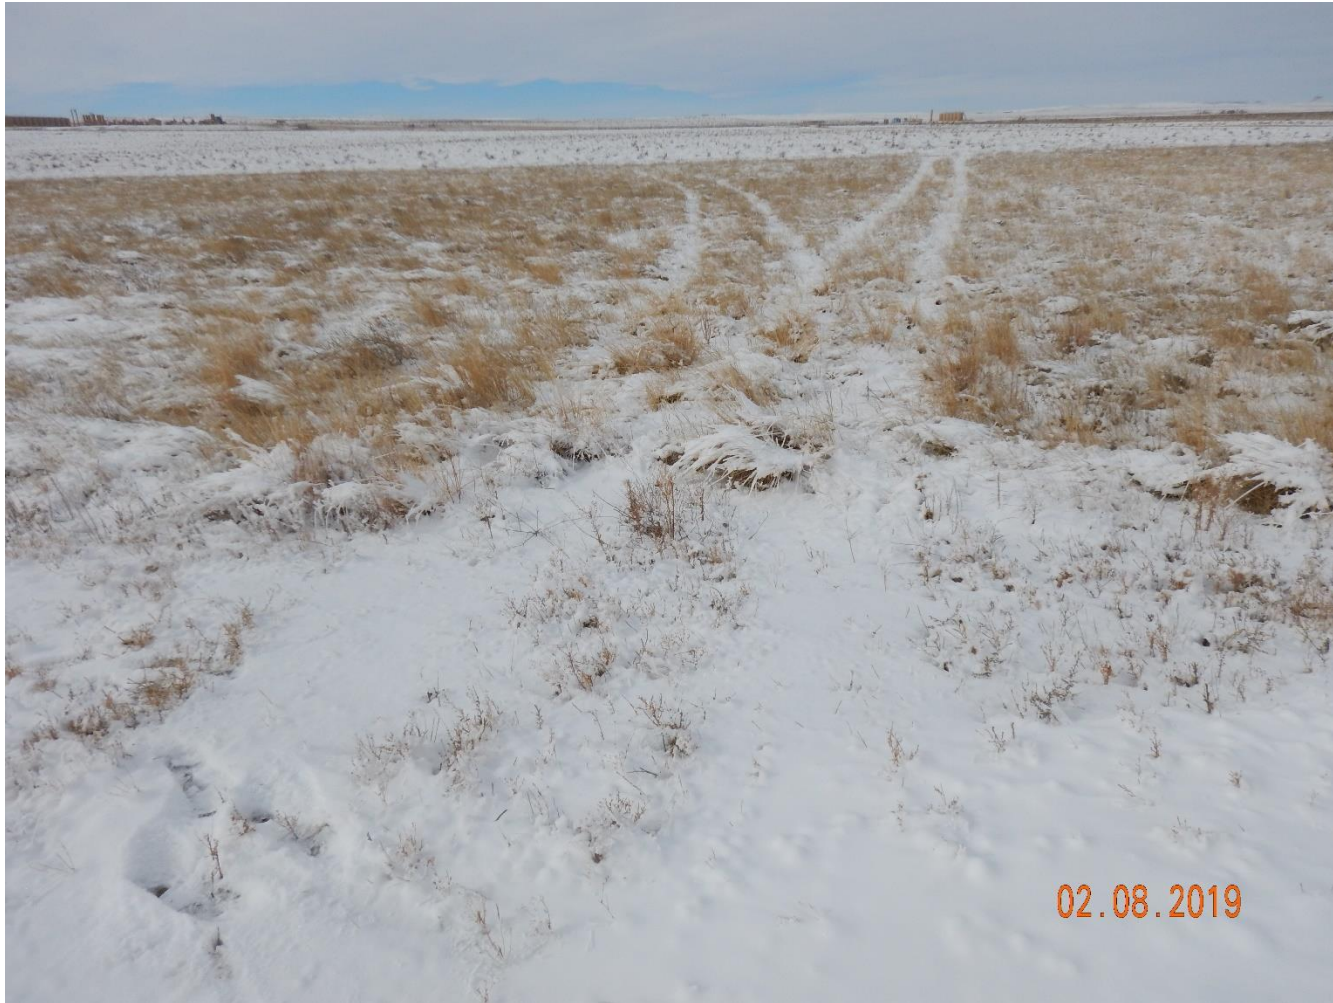
Photo 8: Photo taken from the west end of the pad, facing west. Photo shows vehicle tracks over the interim areas from the pad. This does not comply with 1002.e, surface disturbance minimization.

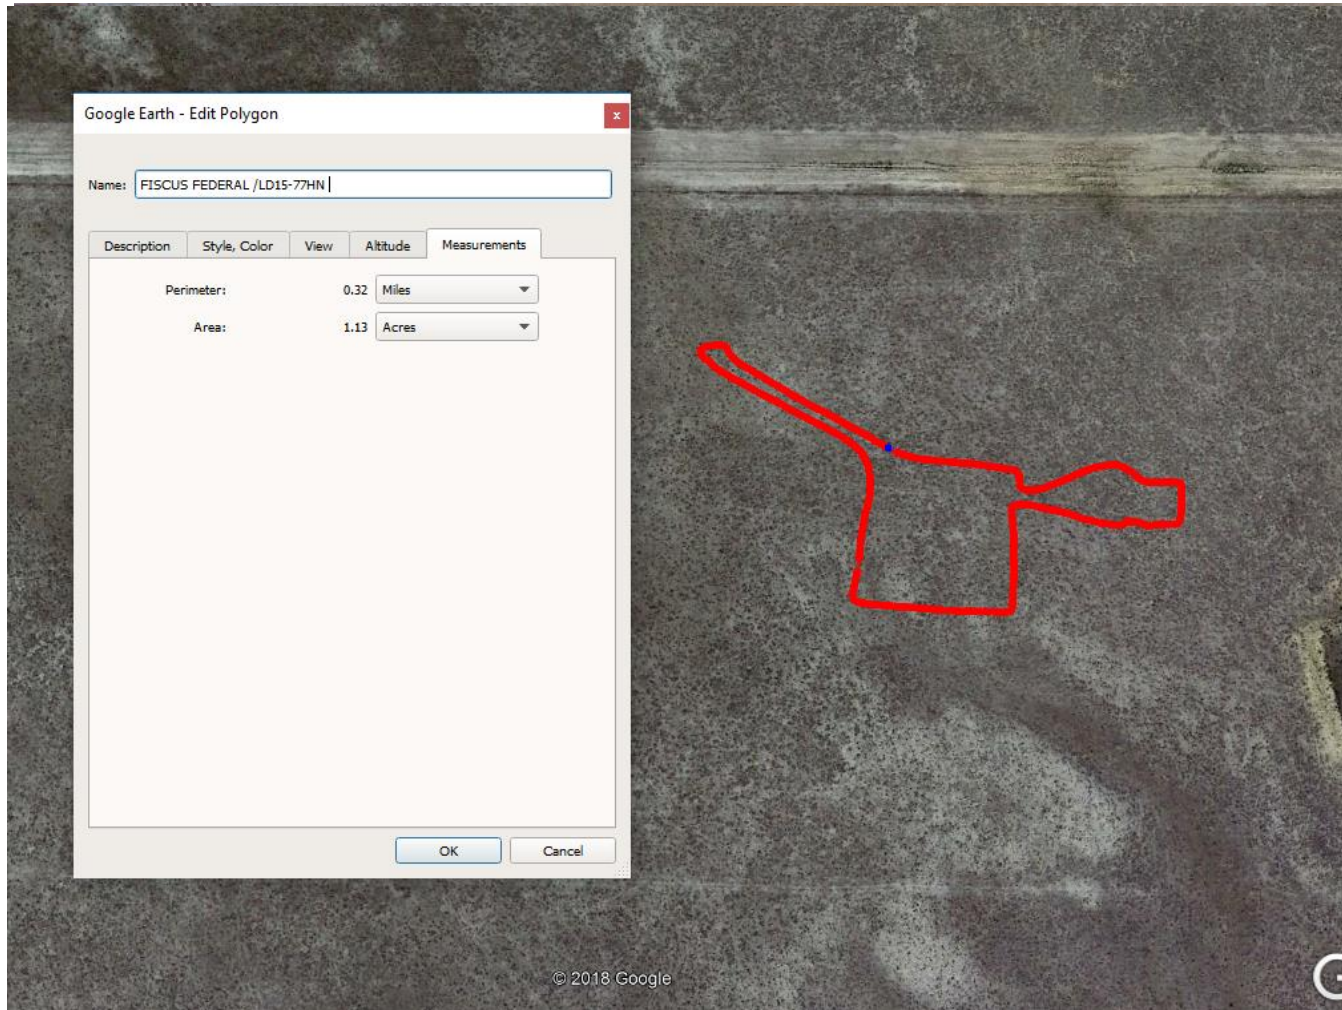
Photo 9: 2013 (most current available) Google Earth aerial image. Inspector mapped a disturbance area of 1.13 acres via a Trimble GPS unit. This appears to exceed the approved Form 2A for the permitted disturbance area post interim reclamation (1 acre).
