Interim Reclamation and Stormwater Inspection

Operator: CRESTONE PEAK RESOURCES OPERATING LLC - 10633

Location ID: 321300

Inspection Photos
Location Name: CALDWELL K UNIT 62N69W / /26
SESE
Location ID: 321300

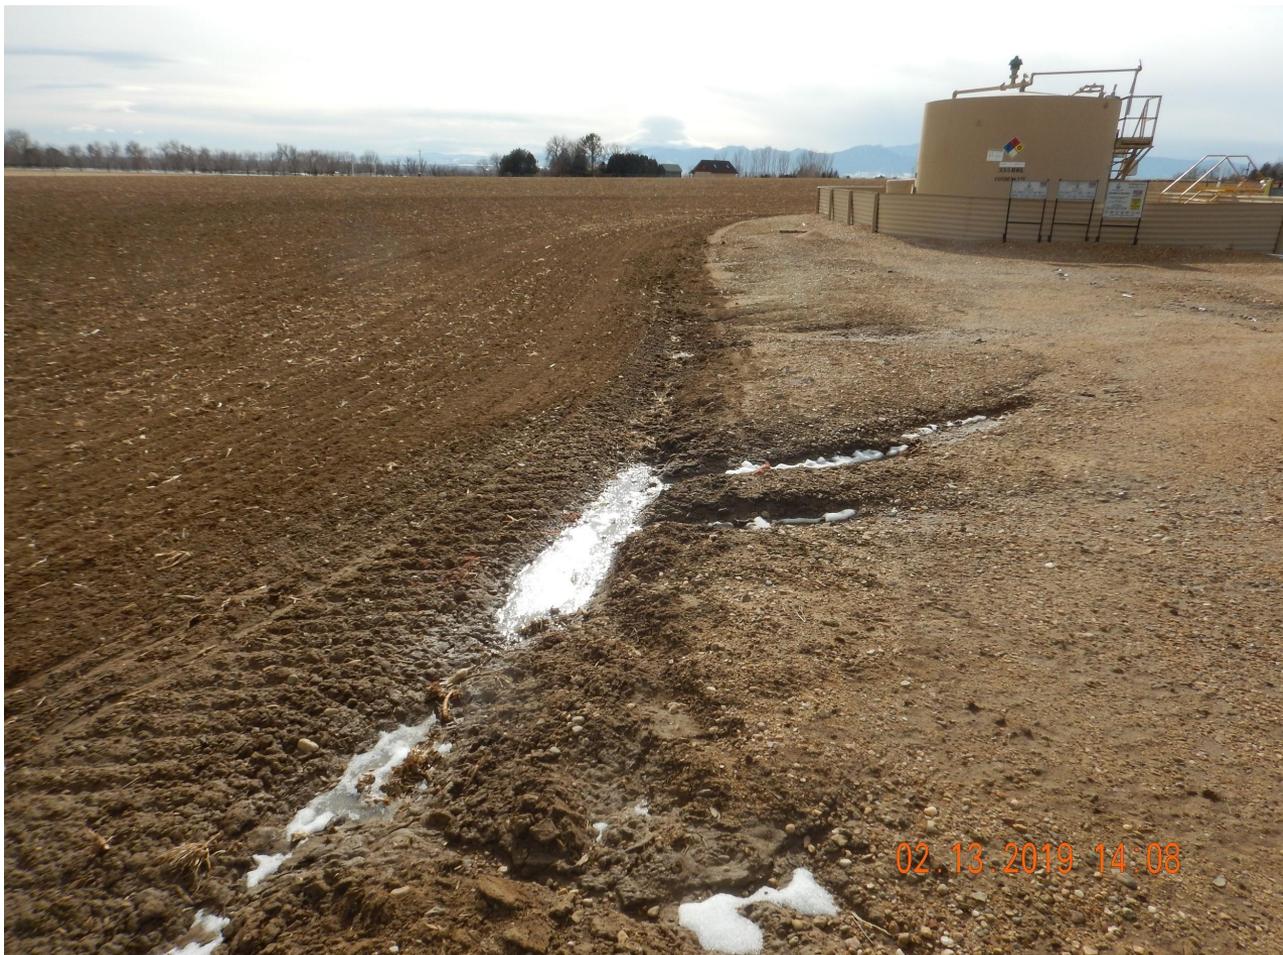
Photo 1. Photo taken from the production/well location, facing Southwest. Operator has failed to stabilize production areas per Rule 1003.b. Photo illustrates erosion along the perimeter of the production area.

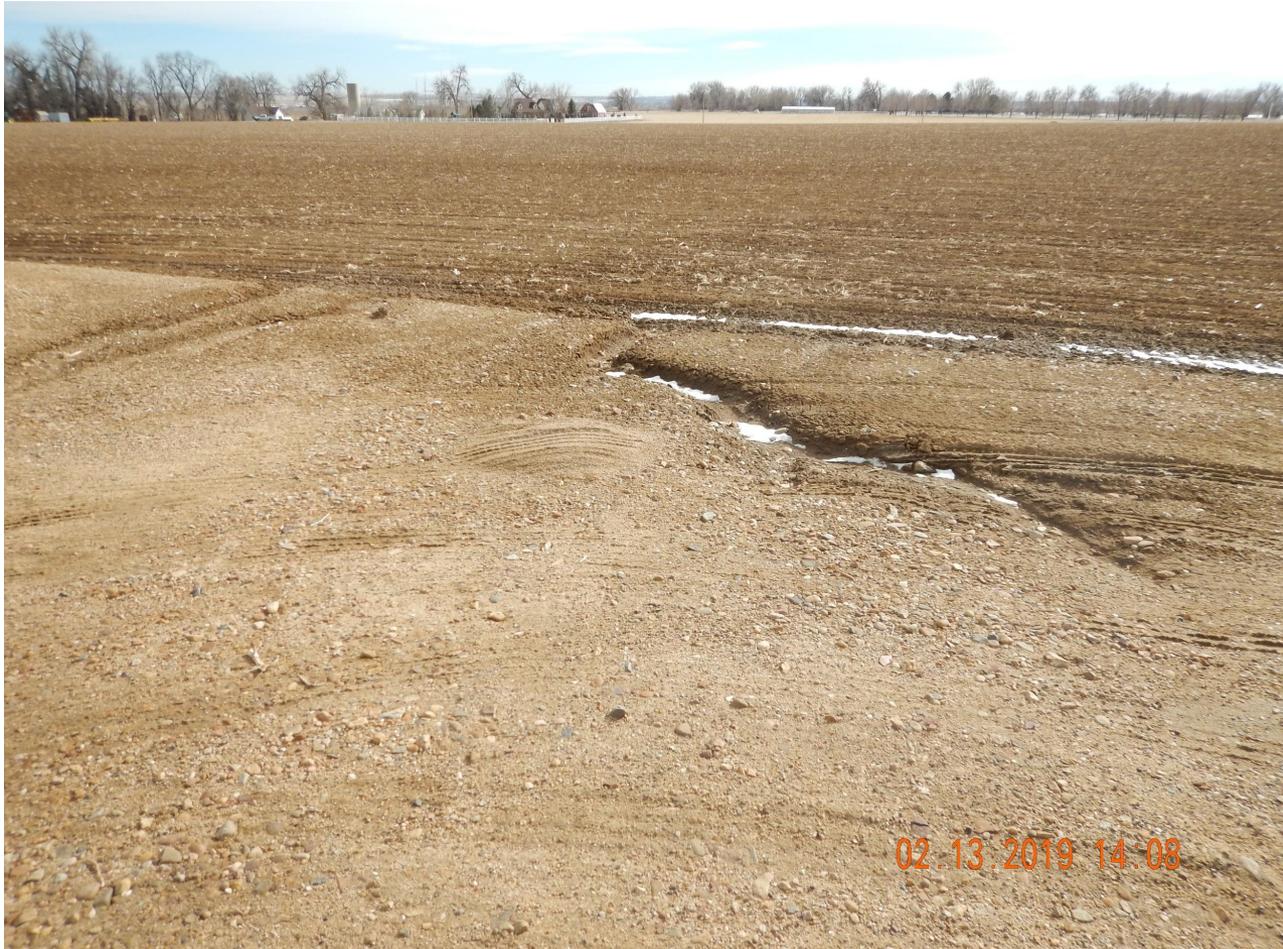
Photo 2. Photo taken from the production/well location, facing South. See comments under Photo 1.
