**Inspection Photos**  
**Location Name: MGP A-3**  
**API #: 05-071-06093**  
**Insp. Doc. # 695100198**

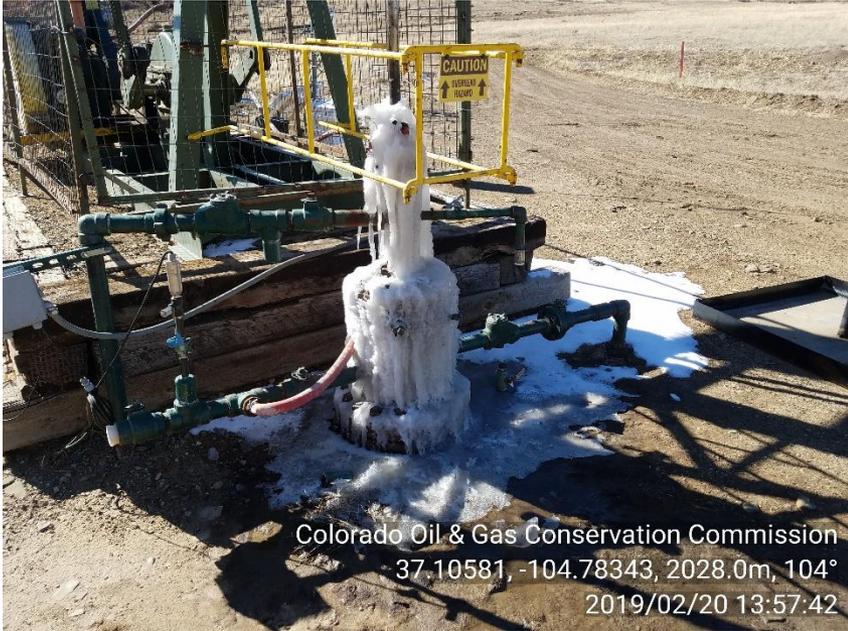
**PHOTO 3: ICE BUILDUP ON WELLHEAD APPEARS TO BE PRODUCED WATER FROM LEAKING ROD PACKING**

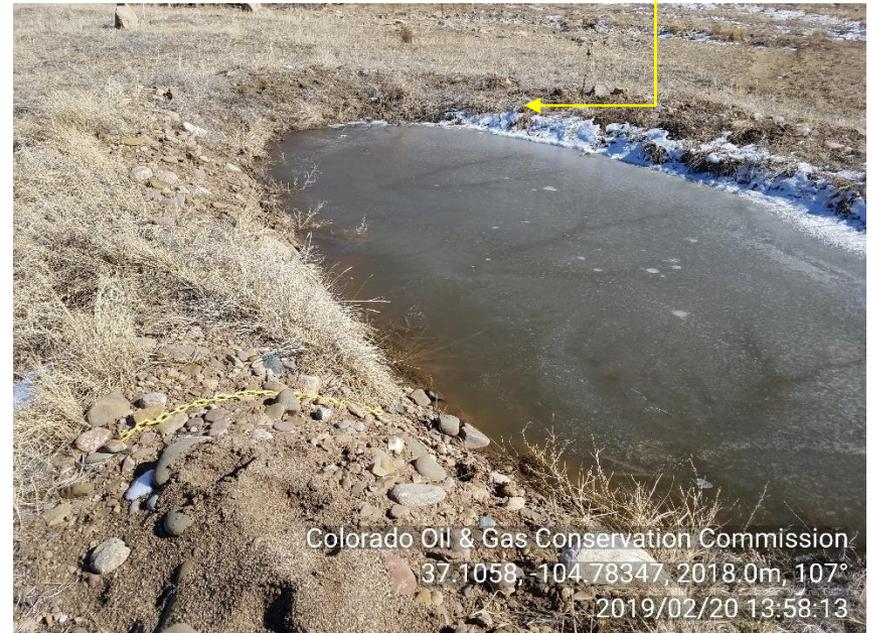
LOWEST  
ELEVATION

**PHOTO 4: PRODUCED WATER LEVEL IN PIT APPEARS TO BE VERY CLOSE TO FREEBOARD/ FREEBOARD MARKER NOT INSTALLED CORRECTLY**
