Final Reclamation Inspection

Operator: PDC ENERGY INC - 69175

API: 05-123-20677

Inspection Photos
Location Name: STATE 5519 #42-8
API: 05-123-20677

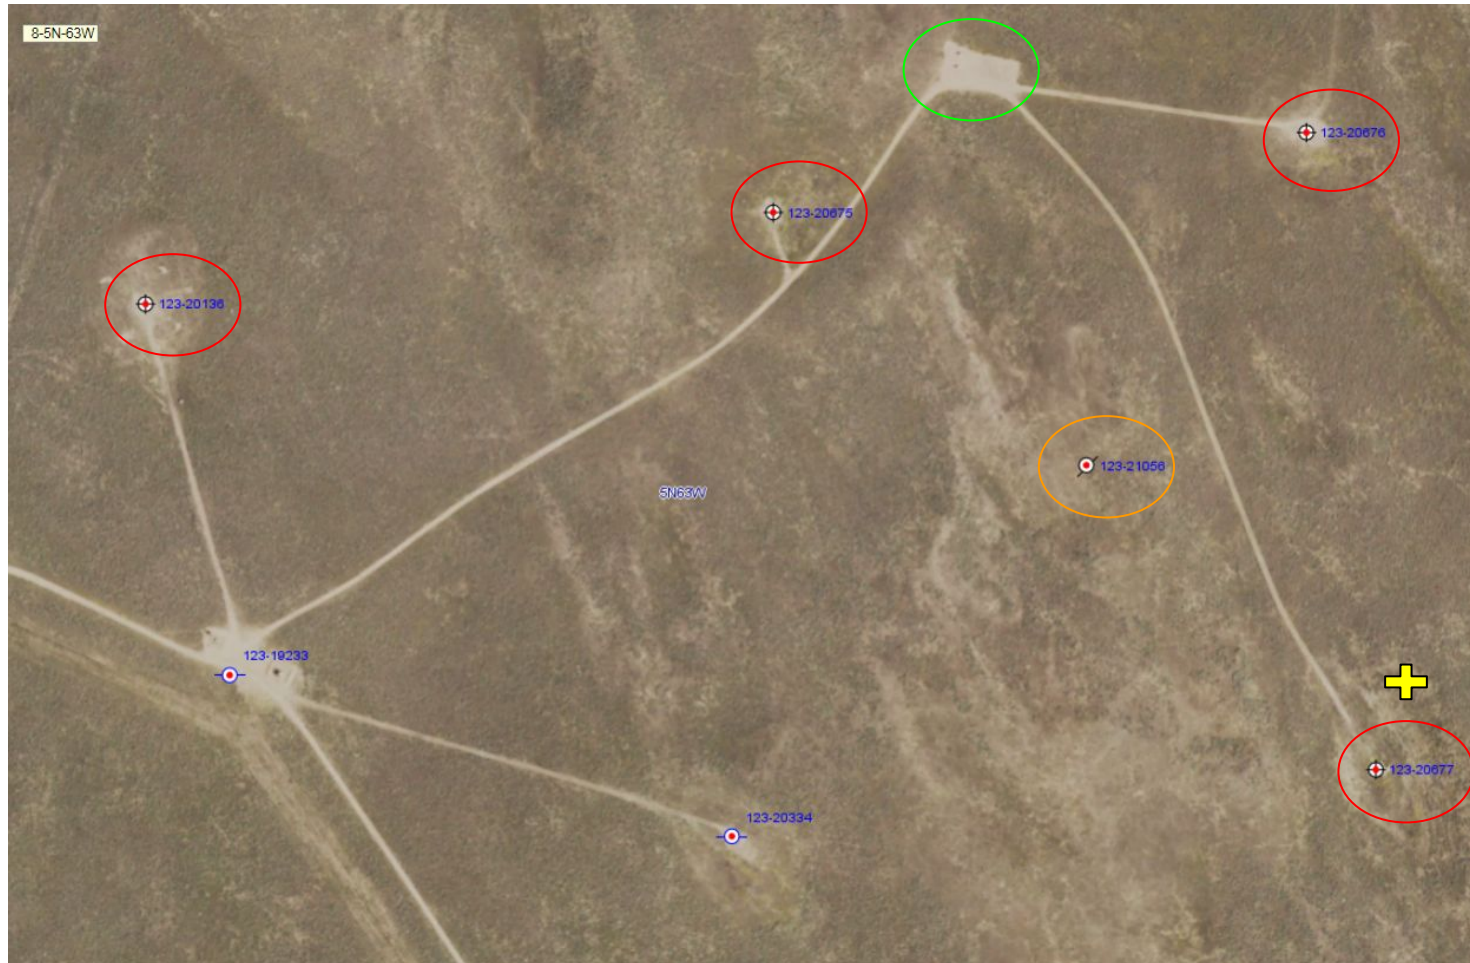
COGCC aerial imagery from 2017 illustrating Plugged and Abandoned (PA) locations (red circles), an Abandoned Location (orange circle), and an Abandoned tank battery (green circle). This inspection is for 123-20677 (yellow plus sign). Operator has failed to perform Final Reclamation at the well location and has failed to perform Final Reclamation on any of the associated PA access roads.

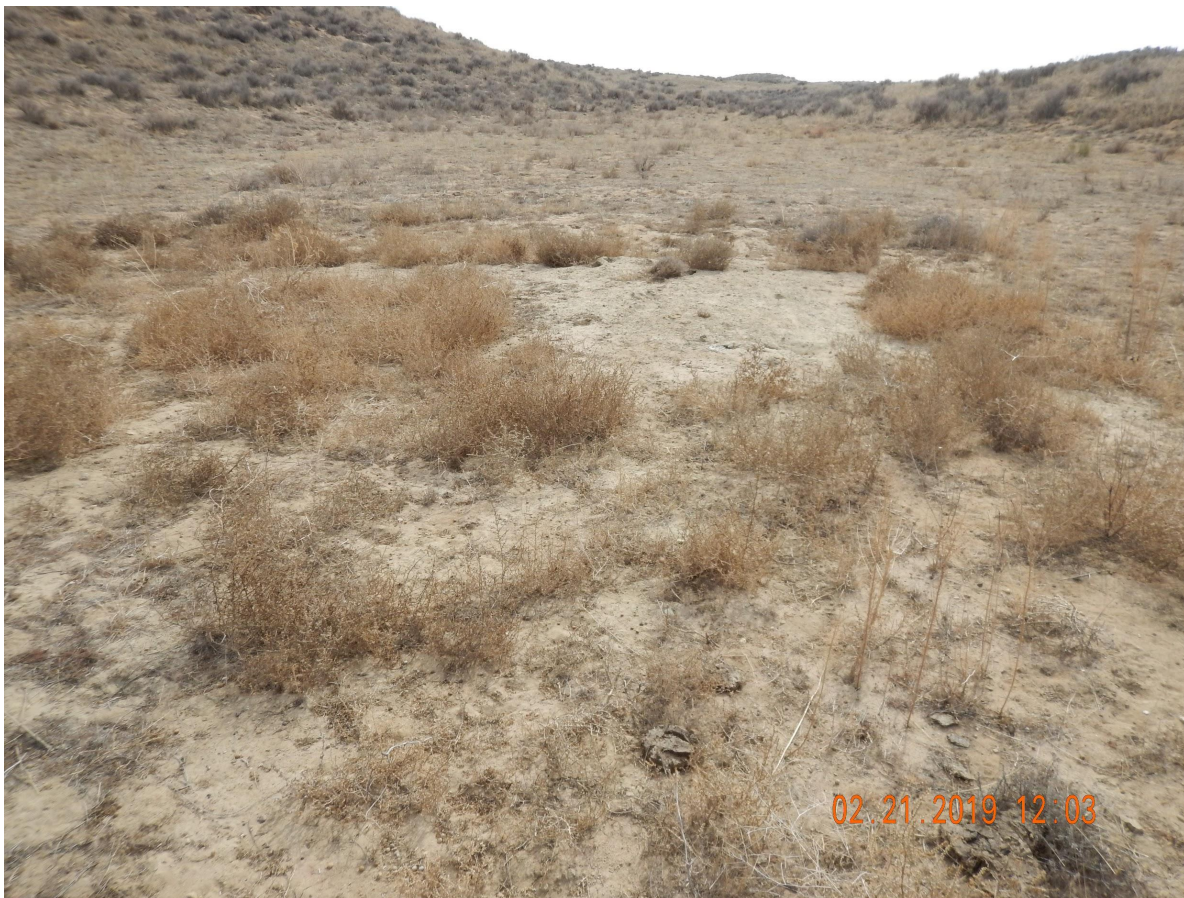
Photo 1. Photo taken from the PA location, facing South. Operator has not performed Final Reclamation activities at the well location. There is no evidence to suggest that Final Reclamation activities were performed (e.g., drill rows, mulch, or any desirable vegetation) and there is no evidence that portions have been contoured back to pre-existing conditions.

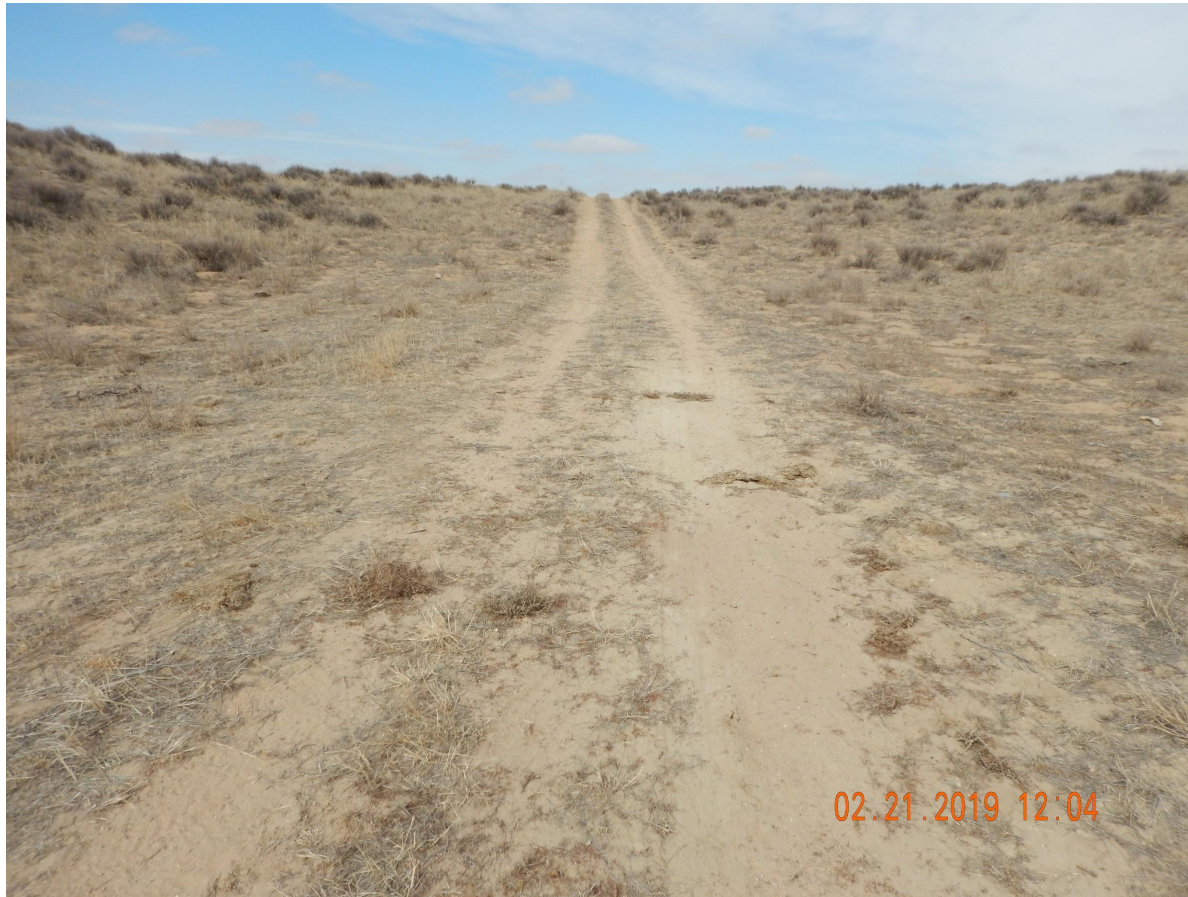
Photo 2. Photo taken from the PA location, facing North. Operator has not performed Final Reclamation activities along the former access road. See comments under Photo 1.
