Final Reclamation Inspection

Operator: PDC ENERGY INC - 69175

API: 05-123-20675

Inspection Photos
Location Name: STATE 5519 # 31-8
API: 05-123-20675

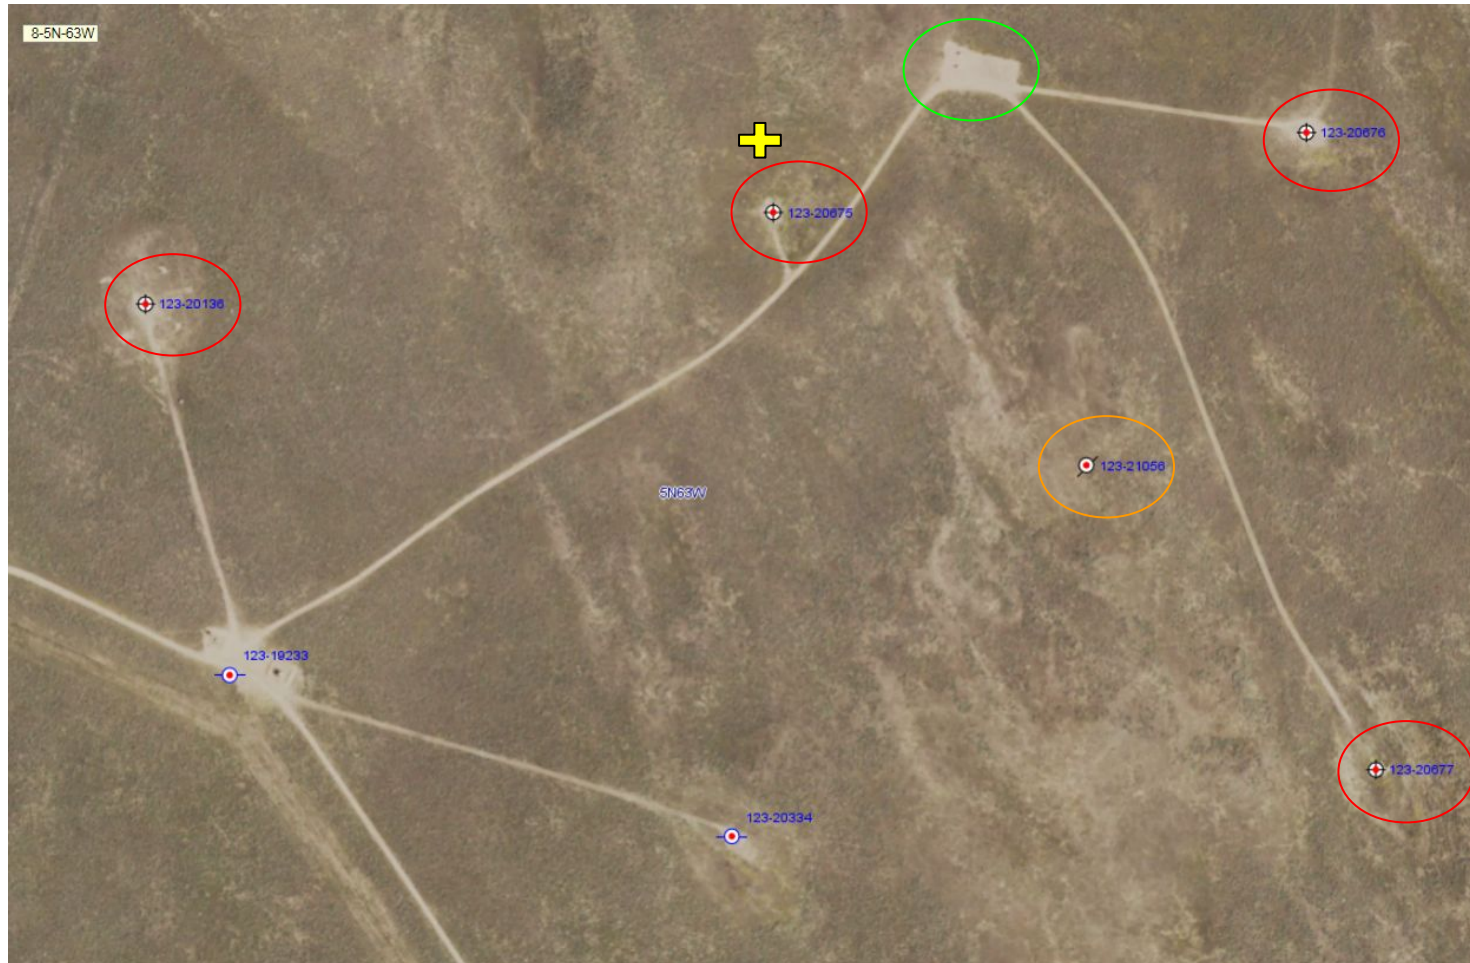
COGCC aerial imagery from 2017 illustrating Plugged and Abandoned (PA) locations (red circles), an Abandoned Location (orange circle), and an Abandoned tank battery (green circle). This inspection is for 123-20675 (yellow plus sign). Operator has failed to perform Final Reclamation at the well location and any of the associated PA access roads.

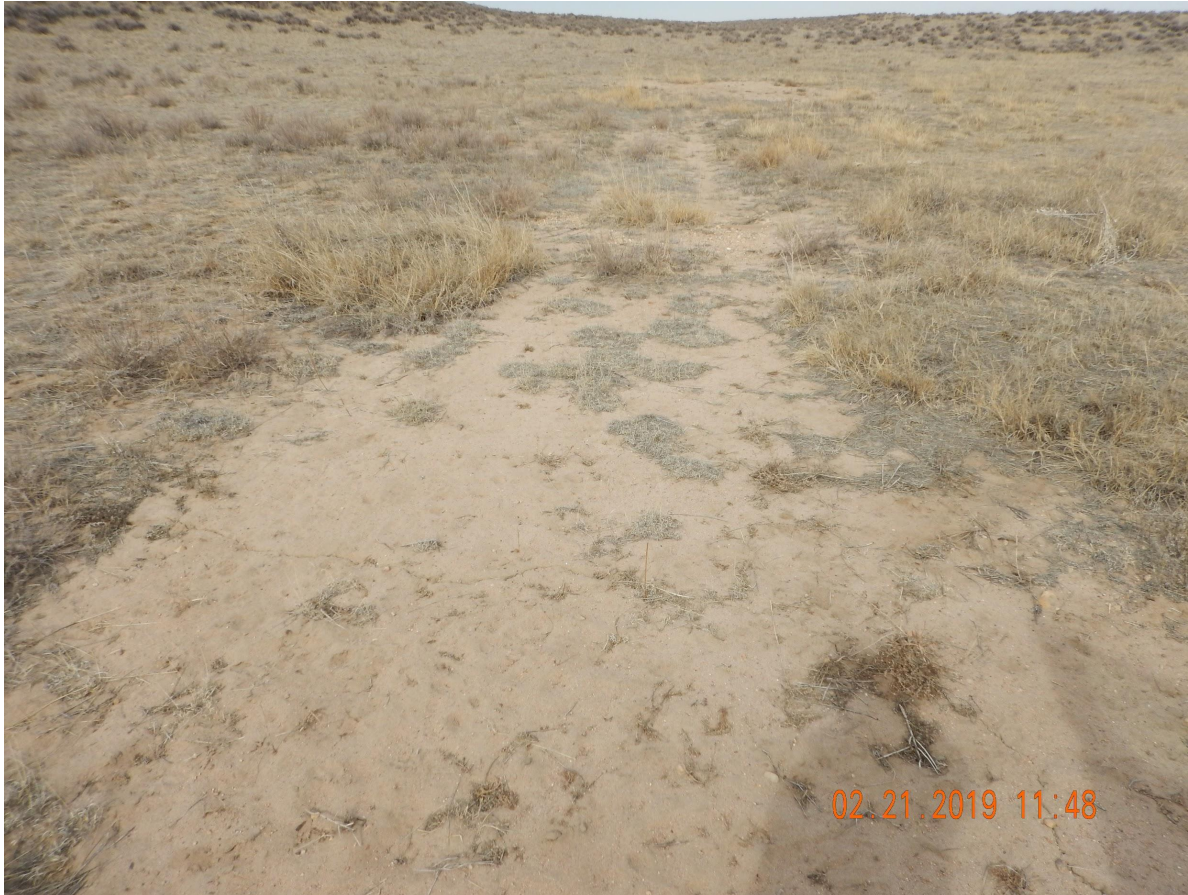
Photo 1. Photo taken from the southern PA location, facing North. Operator has not performed Final Reclamation activities at the well location. There is no evidence to suggest that Final Reclamation activities were performed (e.g., drill rows, mulch, or any desirable vegetation).

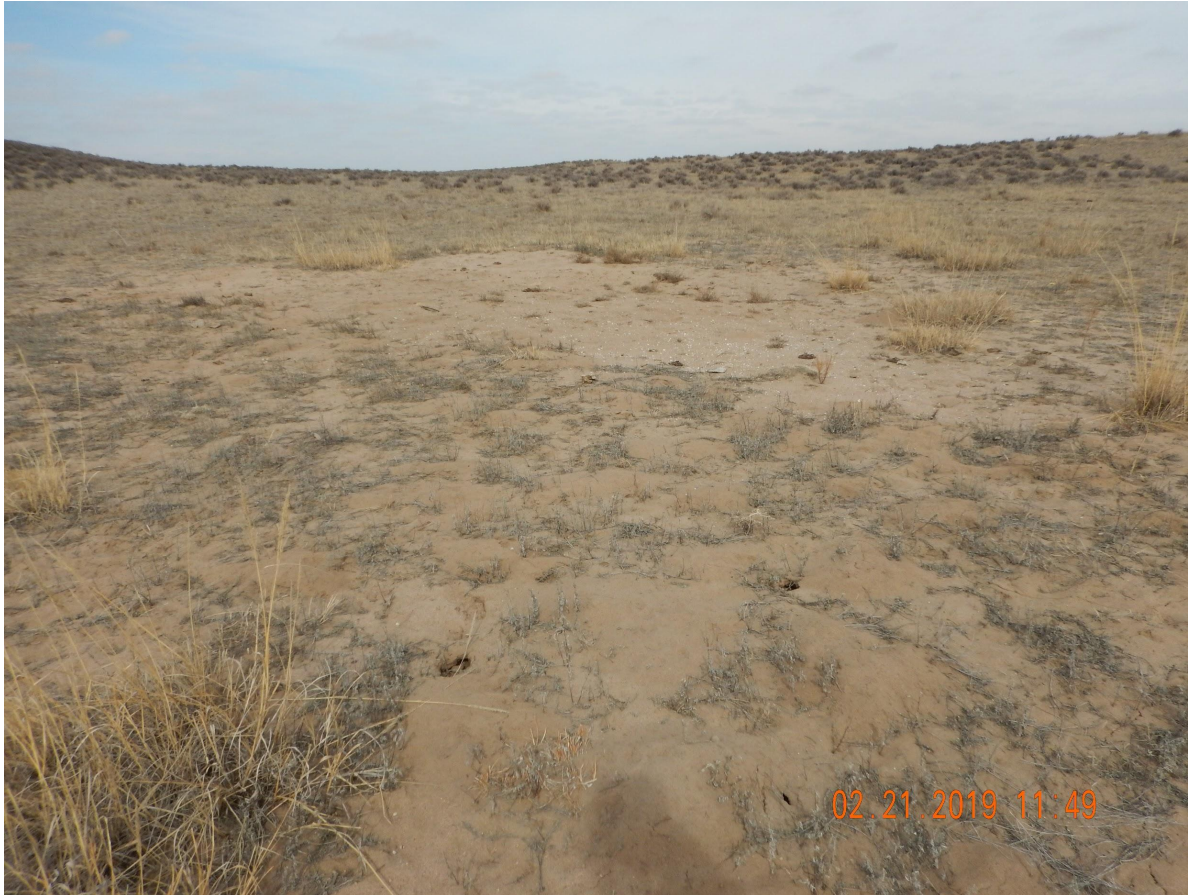
Photo 2. Photo taken from the PA well location, facing North. See comments under Photo 1.

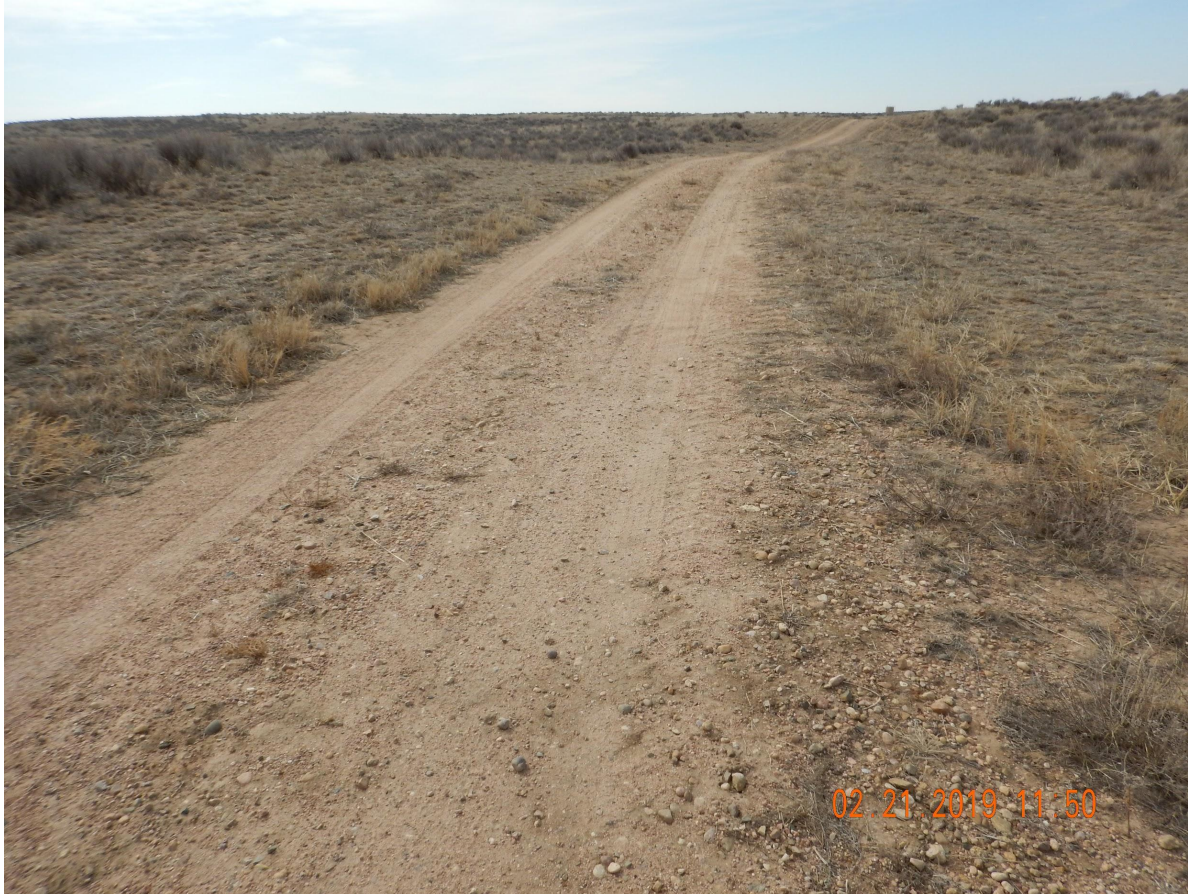
Photo 3. Photo taken from the former PA access road , facing West. Operator has not performed Final Reclamation activities at the access road.
