Final Reclamation Inspection

Operator: PDC ENERGY INC - 69175

API: 05-123-20676

Inspection Photos
Location Name: STATE 5519 #41-8
API: 05-123-20676

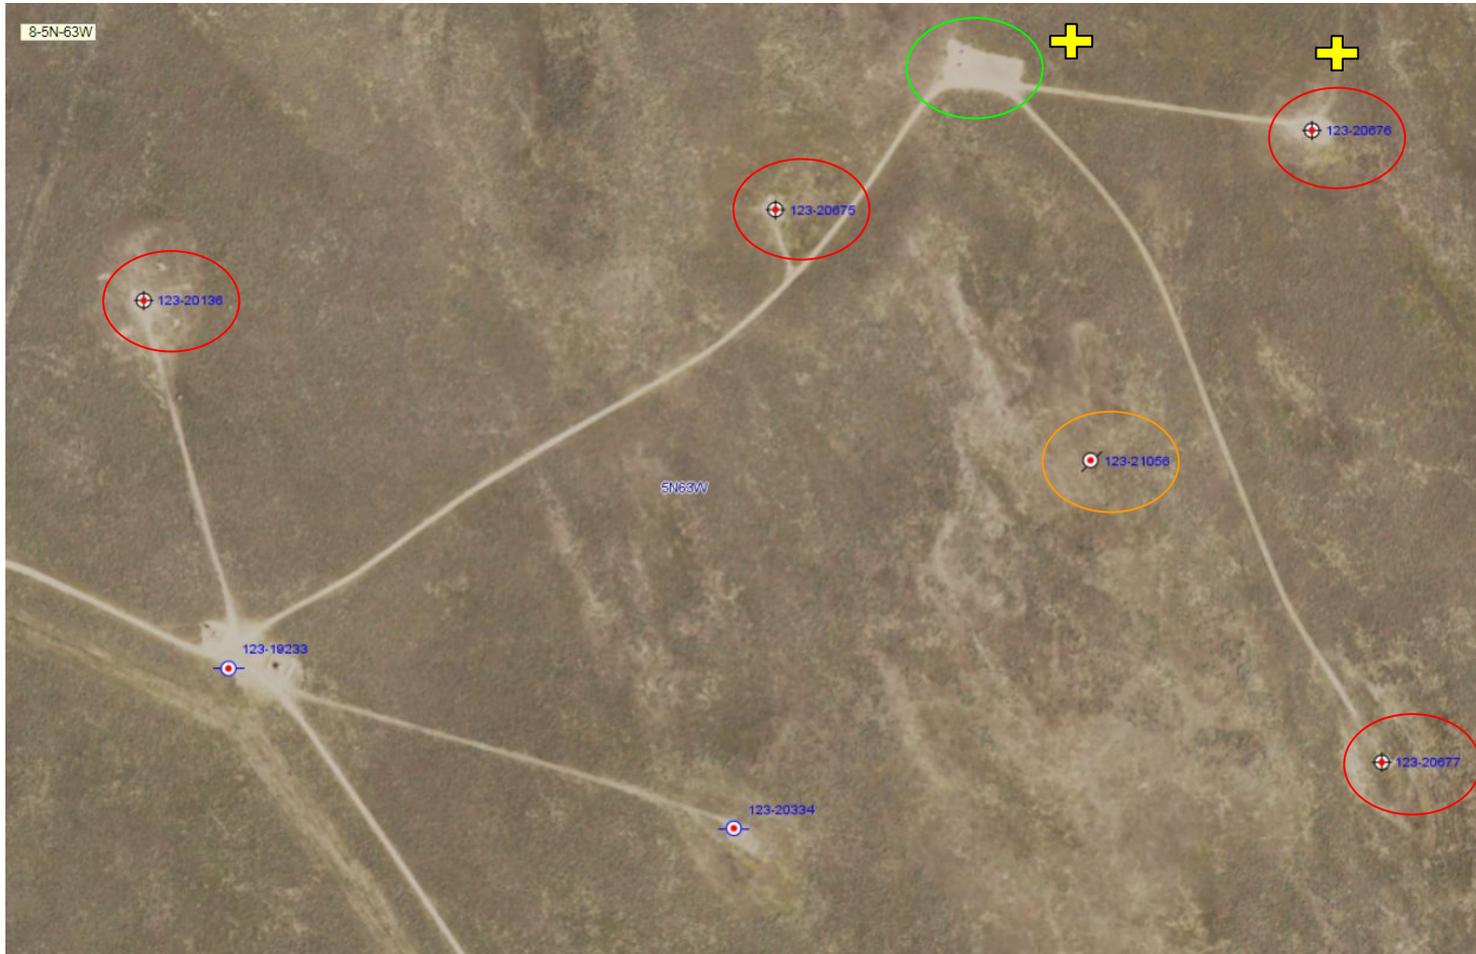
COGCC aerial imagery from 2017 illustrating Plugged and Abandoned (PA) locations (red circles), an Abandoned Location (orange circle), and an Abandoned tank battery (green circle). This inspection is for 123-20676 (yellow plus sign) and the Abandoned tank battery (yellow plus sign). Operator has failed to perform Final Reclamation at the well location, tank battery, and any of the associated PA access roads.

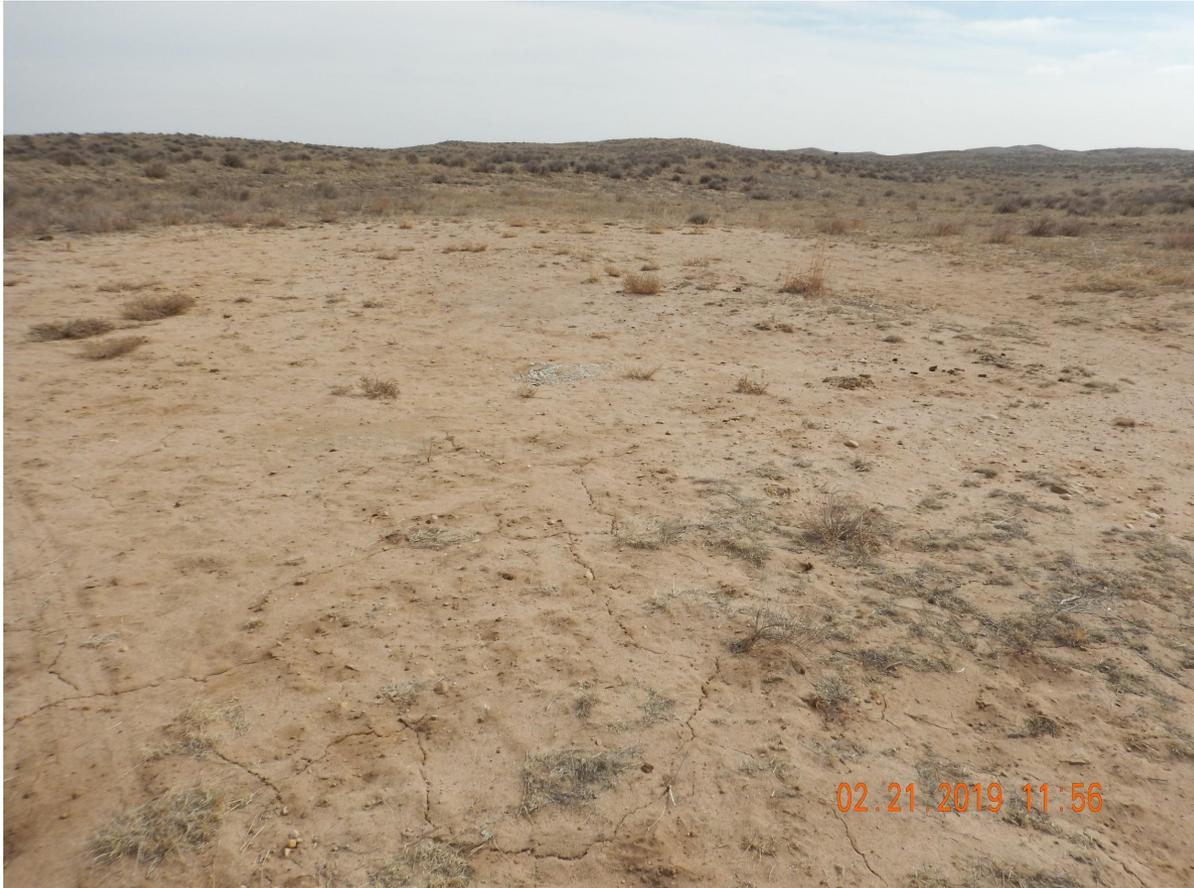
Photo 1. Photo taken from the PA well location, facing East. Operator has not performed Final Reclamation activities at the well location. There is no evidence to suggest that Final Reclamation activities were performed (e.g., drill rows, mulch, or any desirable vegetation).

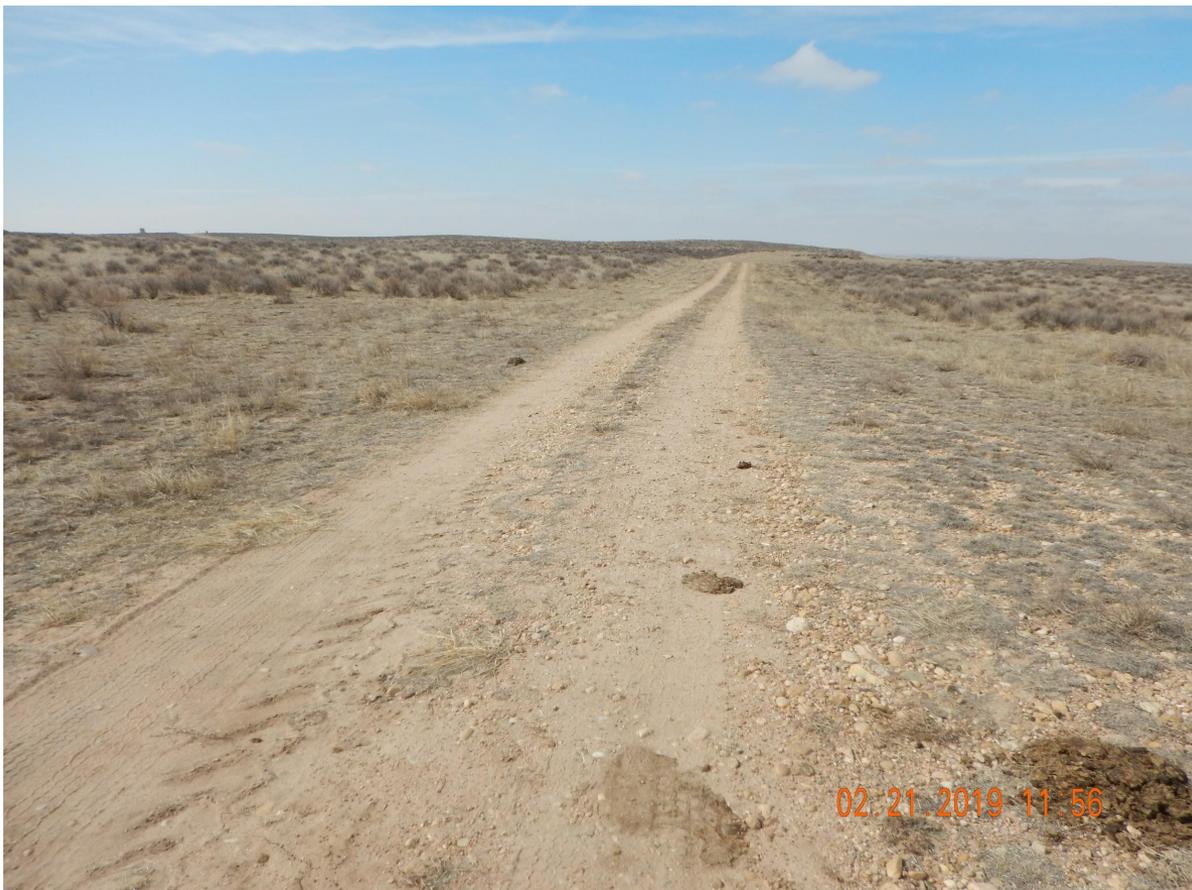
Photo 2. Photo taken from the former PA access road, facing West. Operator has not performed Final Reclamation activities at the access road.

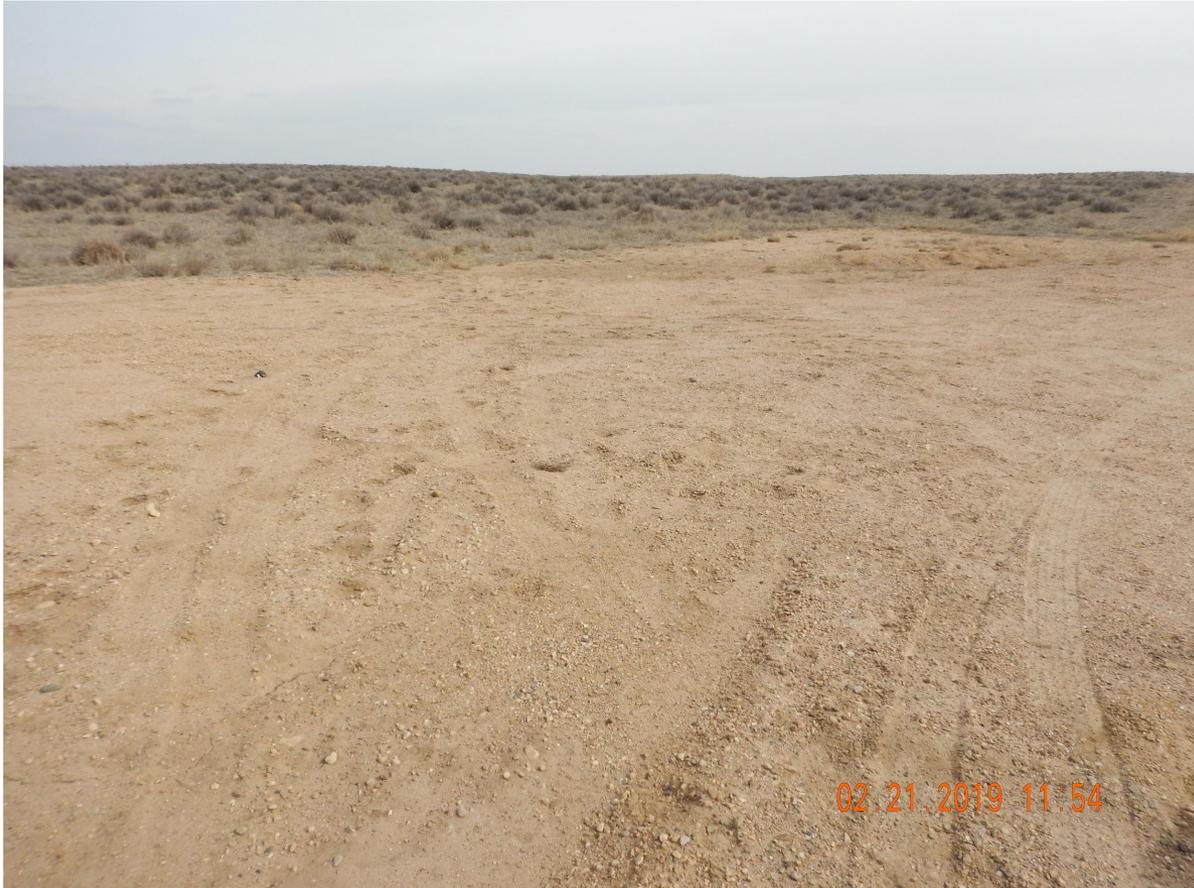
Photo 3. Photo taken from the offsite tank battery, facing East. Operator has not performed Final Reclamation activities at the tank battery. This offsite tank battery location was associated with three wells.
