Final Reclamation Inspection

Operator: PDC ENERGY INC - 69175

API: 05-123-20136

Location Name: STATE 5519 #21-8

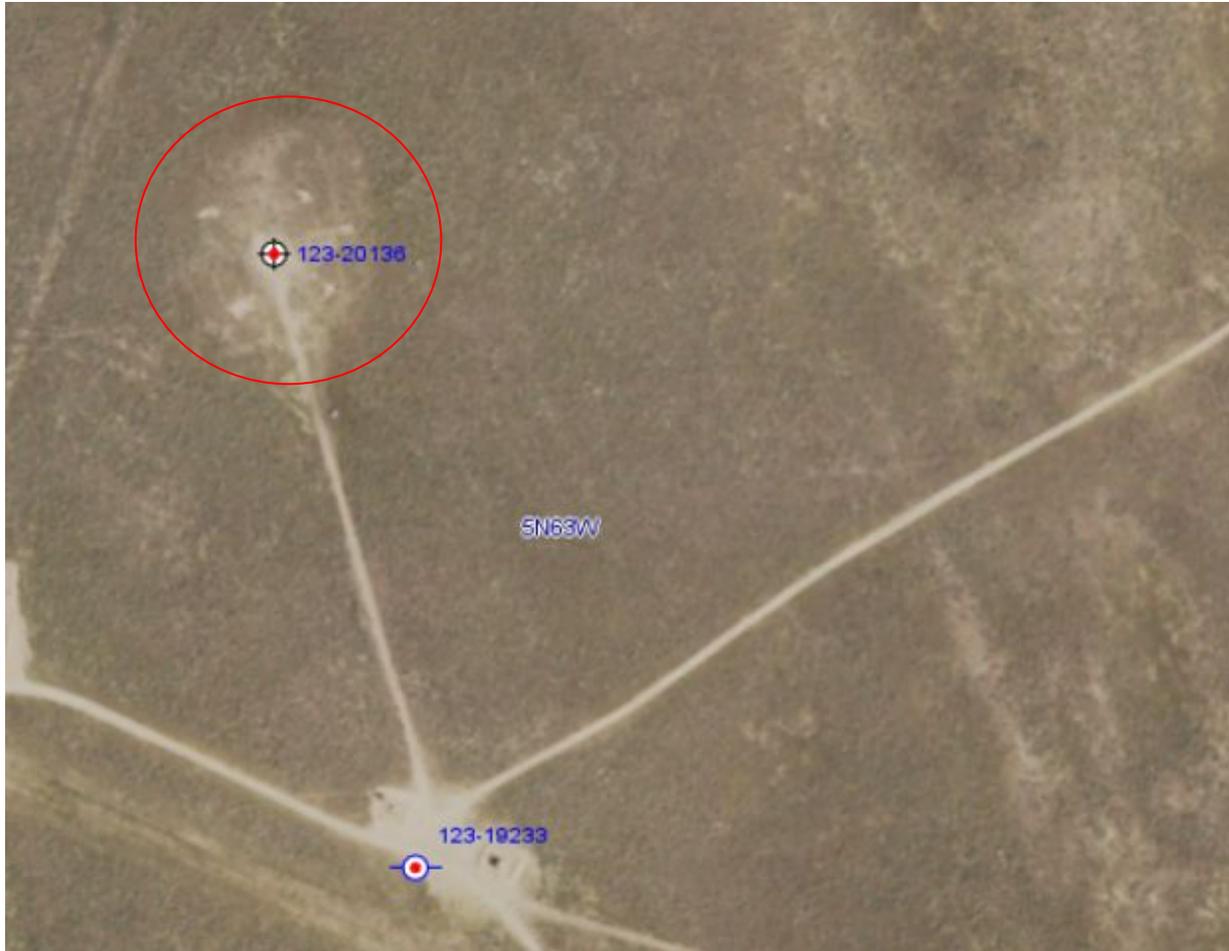
COGCC aerial imagery from 2017 illustrating the Plugged and Abandoned (PA) location (red circle). Operator has failed to perform Final Reclamation on the associated PA access road. The offsite tank battery appears to be active and in use for other nearby wells.

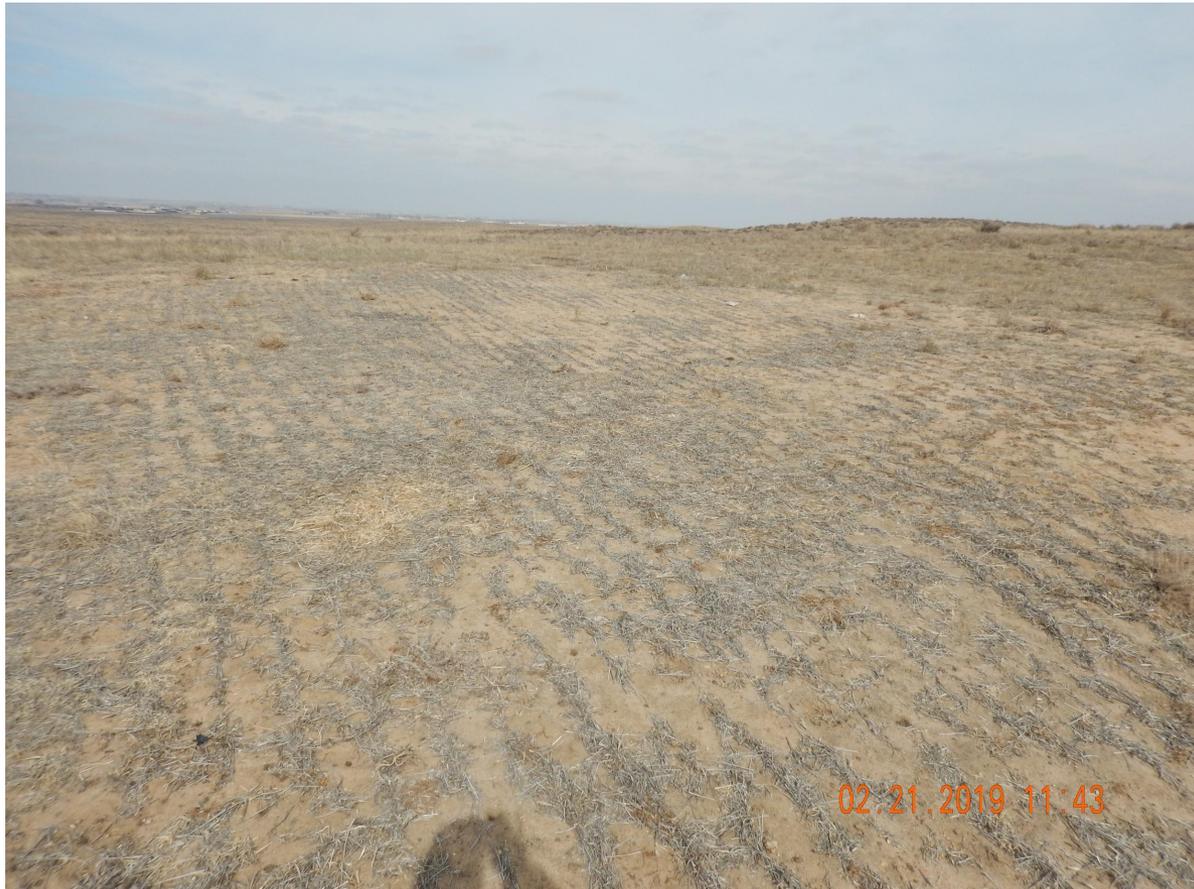
Photo 1. Photo taken from the PA well location, facing North. Appears the Operator has performed Final Reclamation activities at the well location with the evidence of drill rows and mulch. Operator shall continue to monitor and manage this Location until it meets Rule 1004 standards, including weed management.

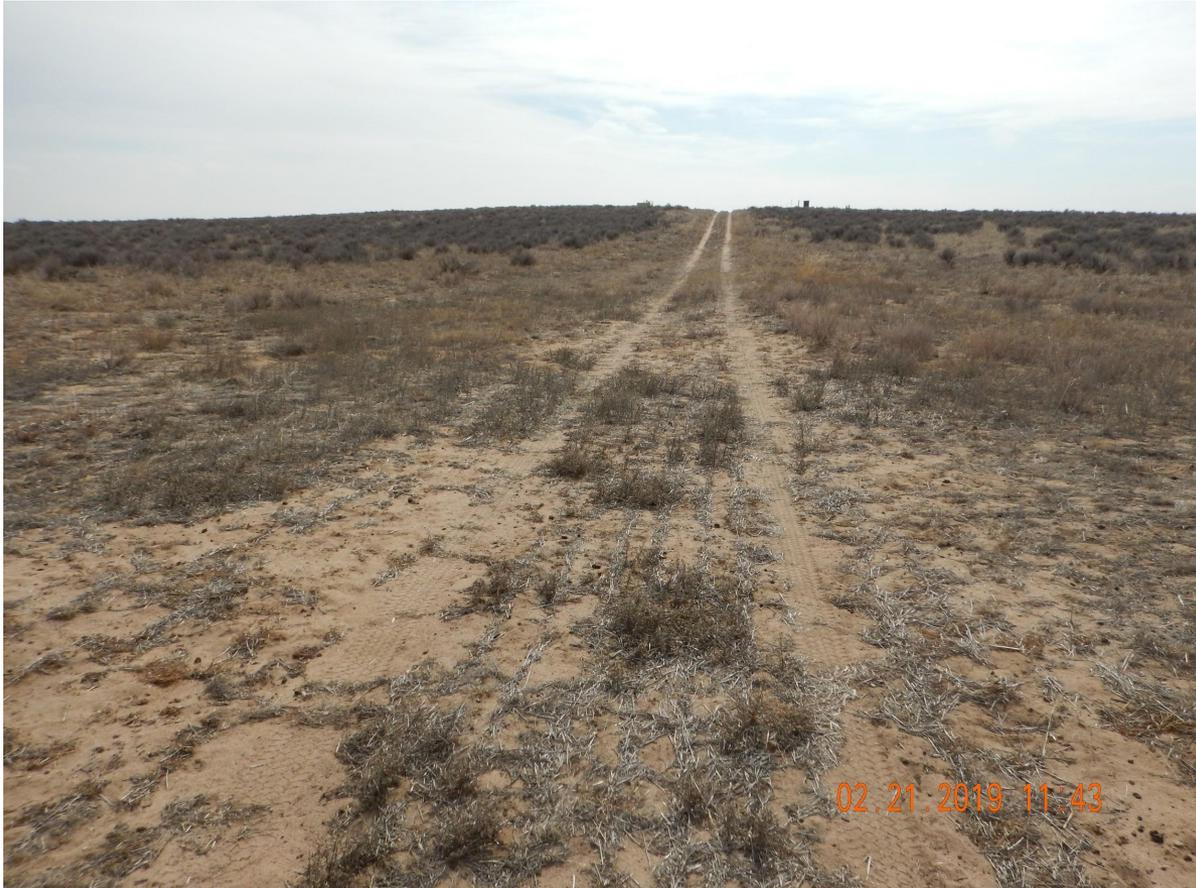
Photo 2. Photo taken from the southern PA well location, facing South. Operator has not performed Final Reclamation activities at the access road. There is no evidence that the access road has been recontoured.
