Final Reclamation Inspection

Operator: PDC ENERGY INC - 69175

API: 05-123-19822

Location Name: STATE 5519 #12-8

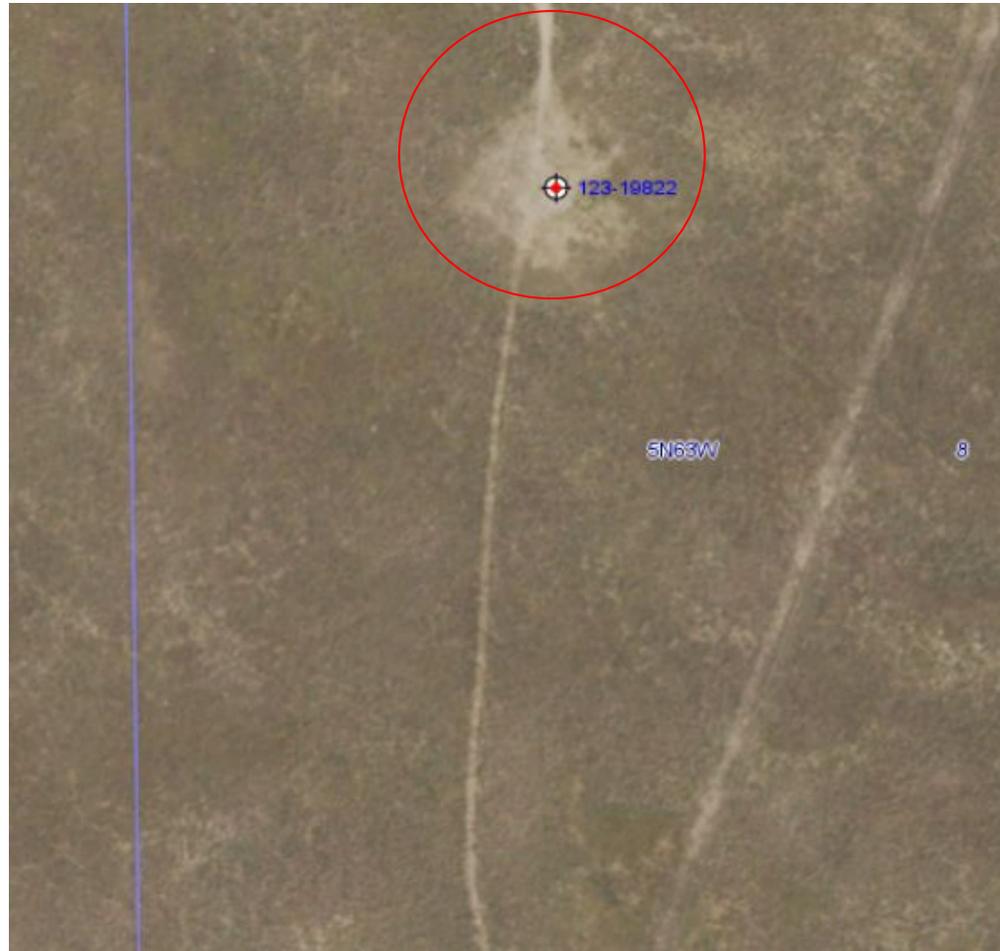
COGCC aerial imagery from 2017 illustrating the Plugged and Abandoned (PA) location (red circle). Operator has failed to perform Final Reclamation at the well location and the associated access road. The offsite tank battery appears to be active and in use for other nearby wells.

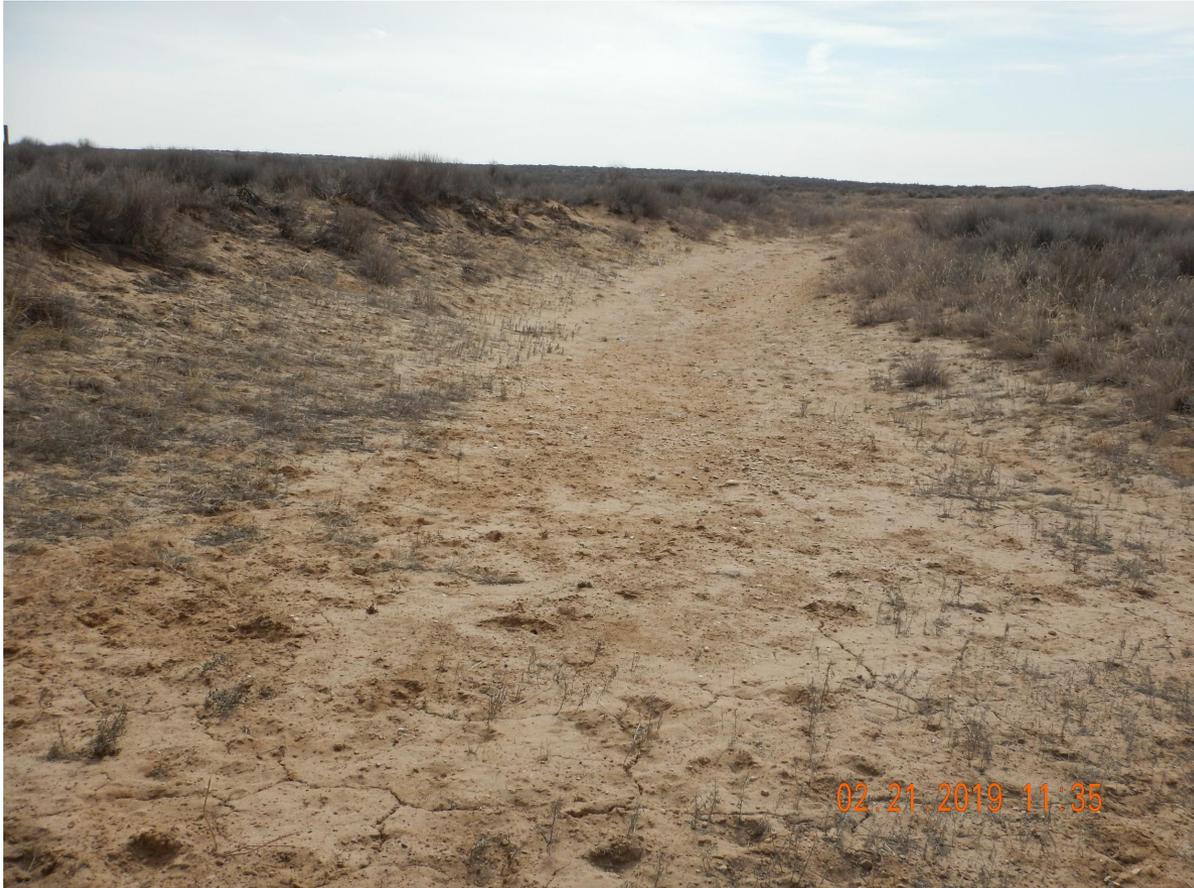
Photo 1. Photo taken from the entrance of PA well location access road, facing South. Operator has not performed Final Reclamation activities at the access road. There is no evidence that the access road has been recontoured.

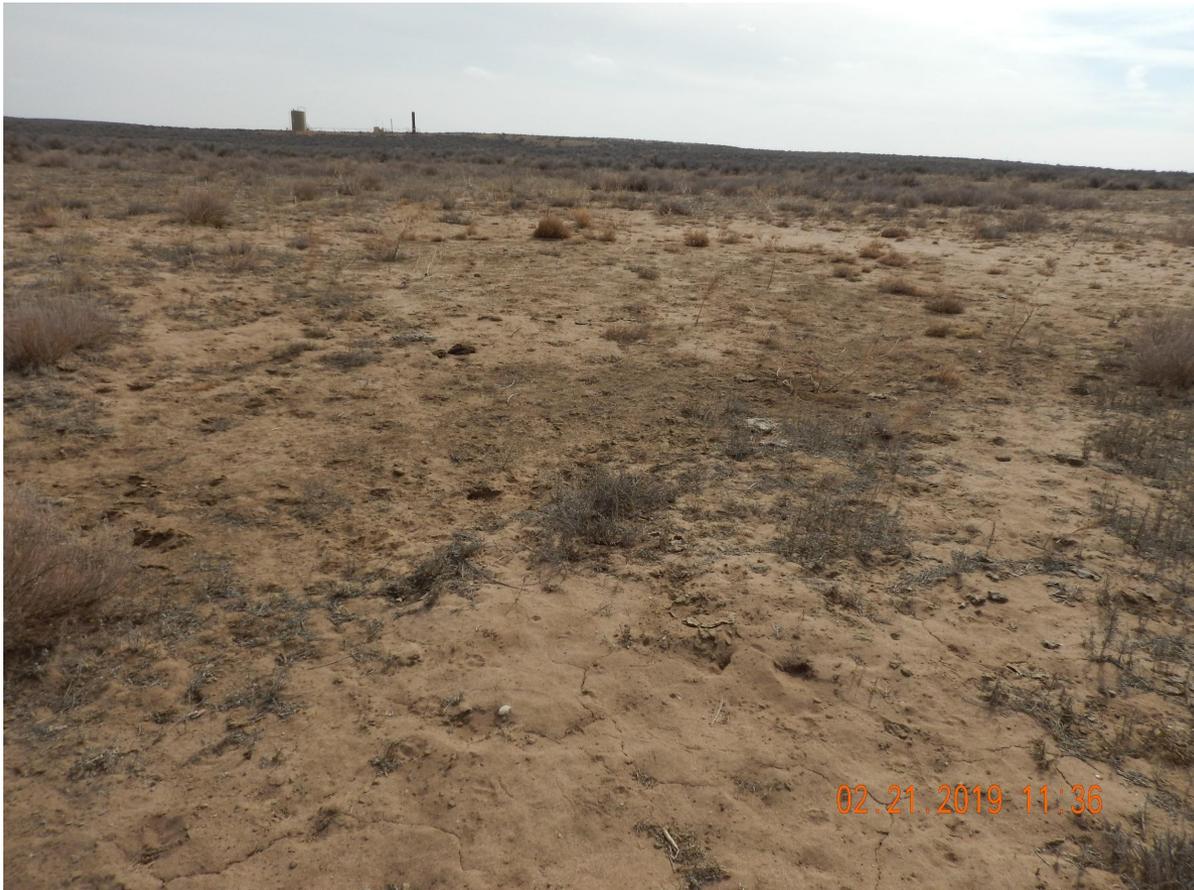
Photo 2. Photo taken from the PA well location, facing Southeast. Operator has not performed Final Reclamation activities at the well. There is no evidence to suggest that Final Reclamation activities were performed (e.g., drill rows, mulch, or any desirable vegetation).
