Inspection Photos
Location Name: HILL RANCH 25-12V
API #: 05-071-07280
Insp. Doc. # 695100244

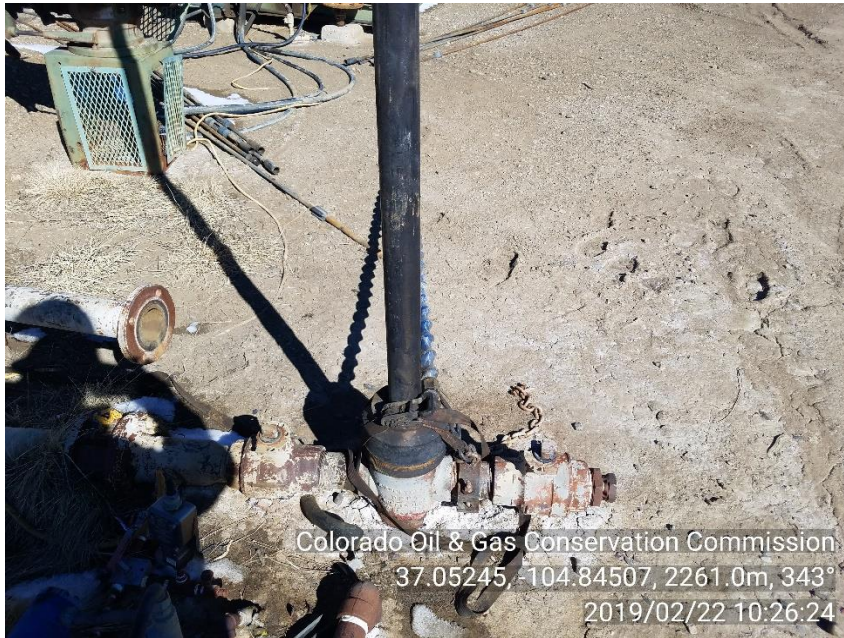
PHOTO 3: WELLHEAD IS IN DISREPAIR AND IS HELD TOGETHER WITH A RATCHET STRAP. I CAN HEAR PRESSURE ESCAPING FROM WELLHEAD.

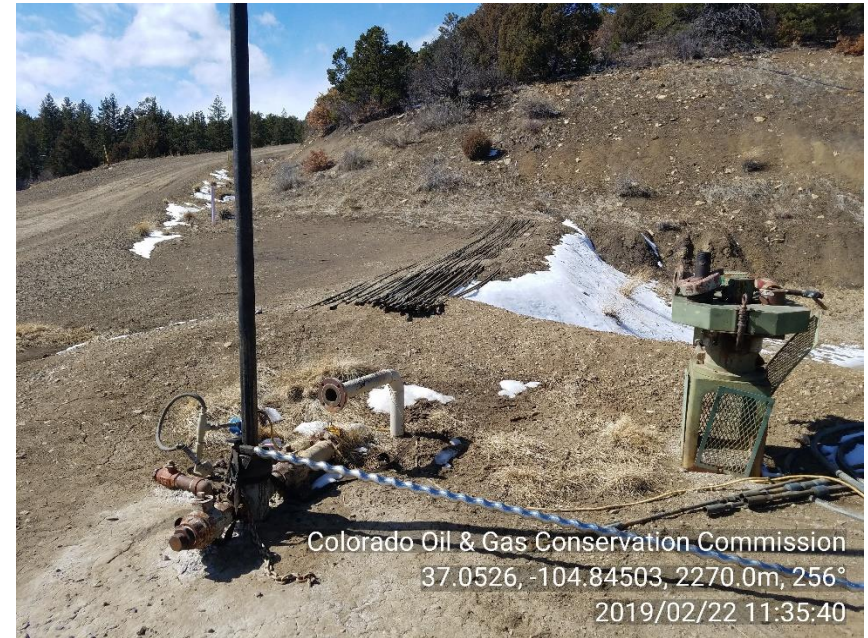
PHOTO 4: UNUSED EQUIPMENT ON LOCATION (UNUDED RISER, POLISH ROD AND RODS.
