Construction and Stormwater Inspection

Operator: NOBLE ENERGY INC- #100322

Location ID: 456174

Inspection Photos
Location Name: BB /07-33 PAD
Location ID: 456174

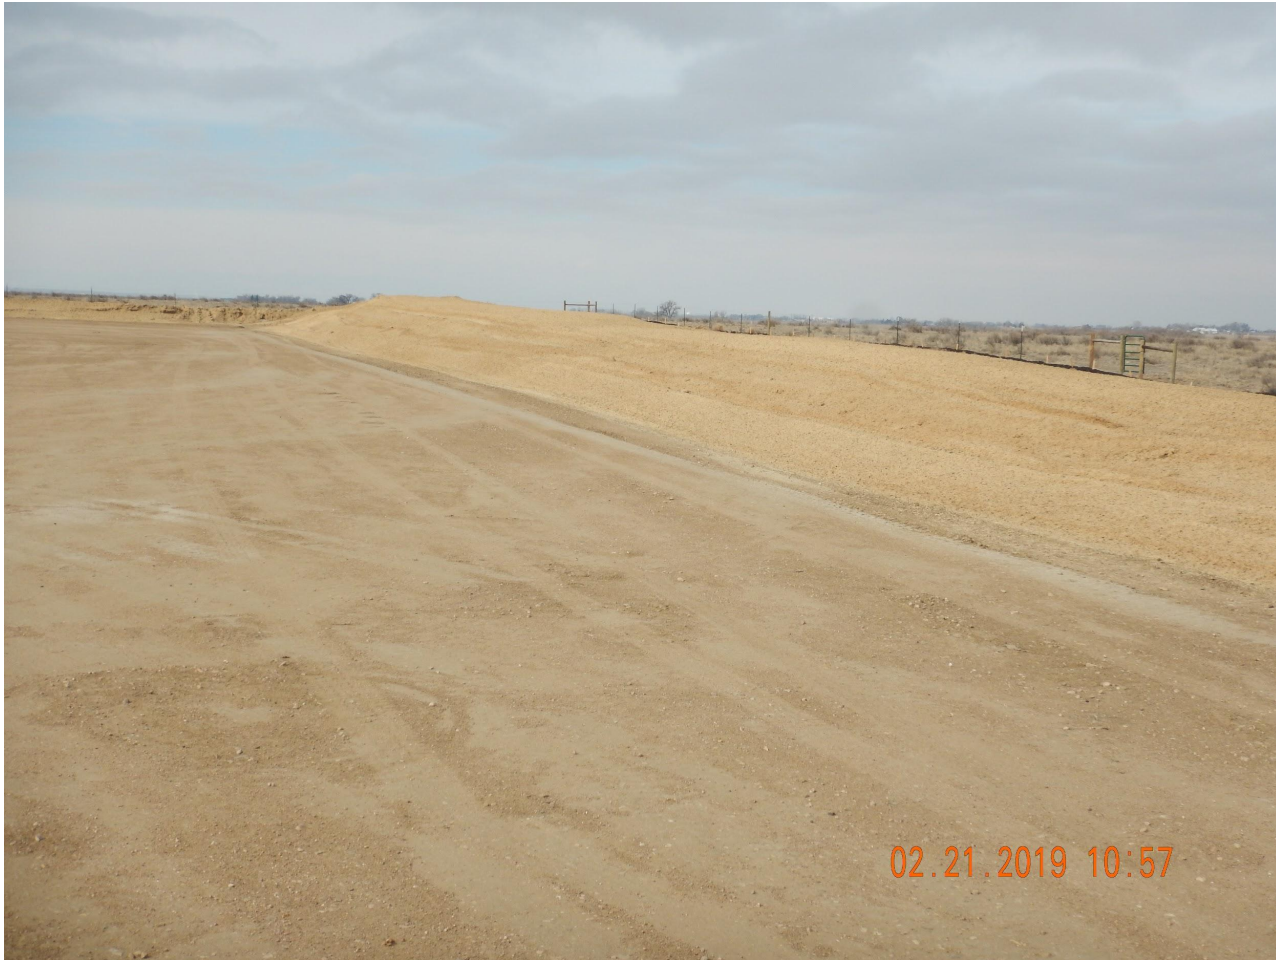
Photo 1. Photo taken from the northern well pad, facing West. Photo illustrates the topsoil stockpile that has been temporarily stabilized with hydromulch. In addition, Operator shall ensure topsoil is protected from weed establishment.

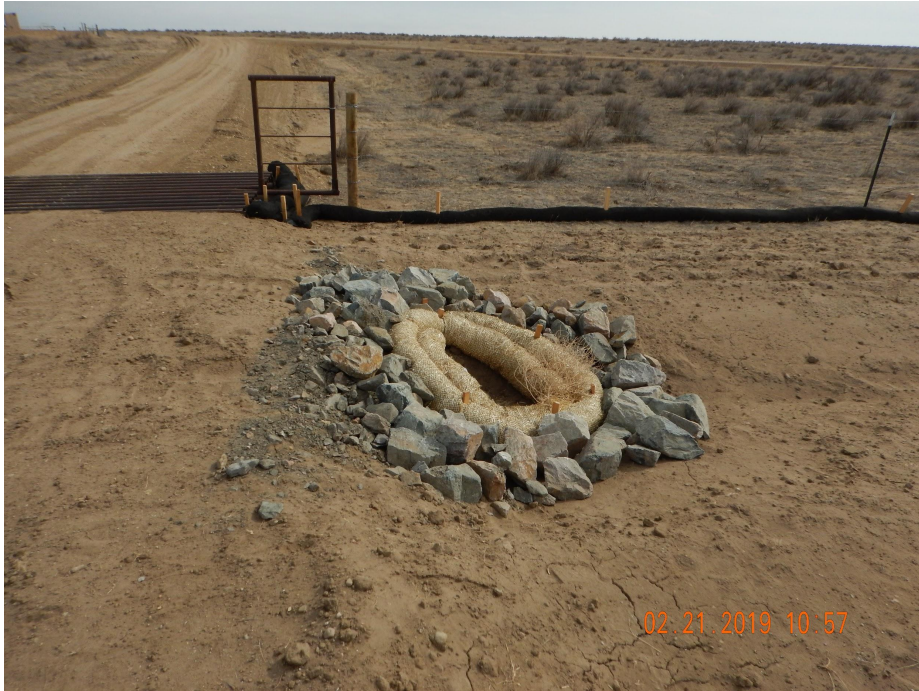
Photo 2. Photo taken from the northeastern entrance to location, facing East. Photo illustrates outlet protection for a culvert installed in conjunction with a ditch and berm which is directed to a retention area.

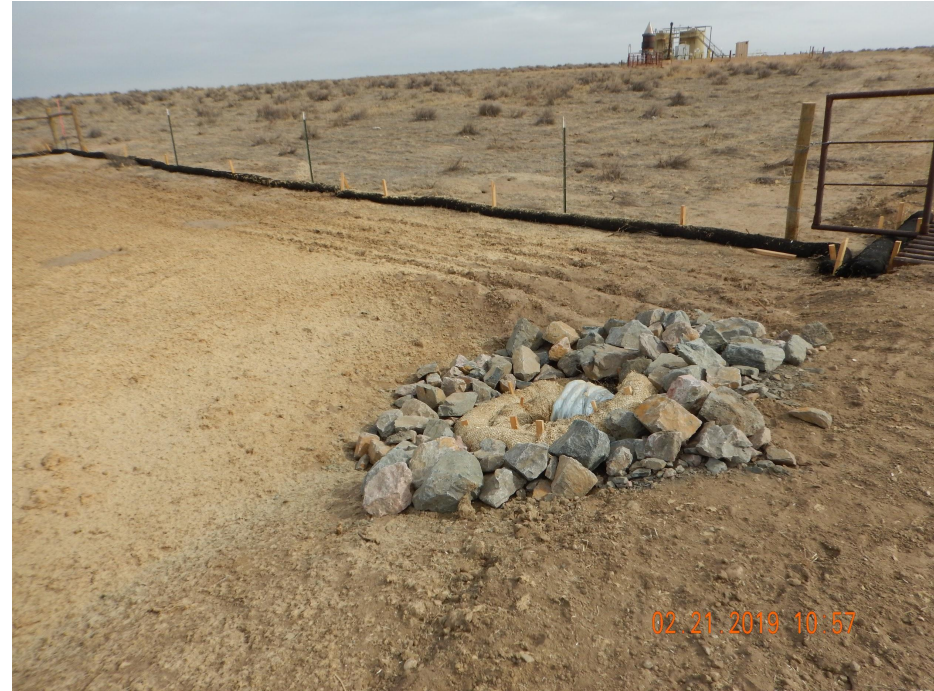
Photo 3. Photo taken from the northeastern entrance to location, facing Northeast. See comments under Photo 2.

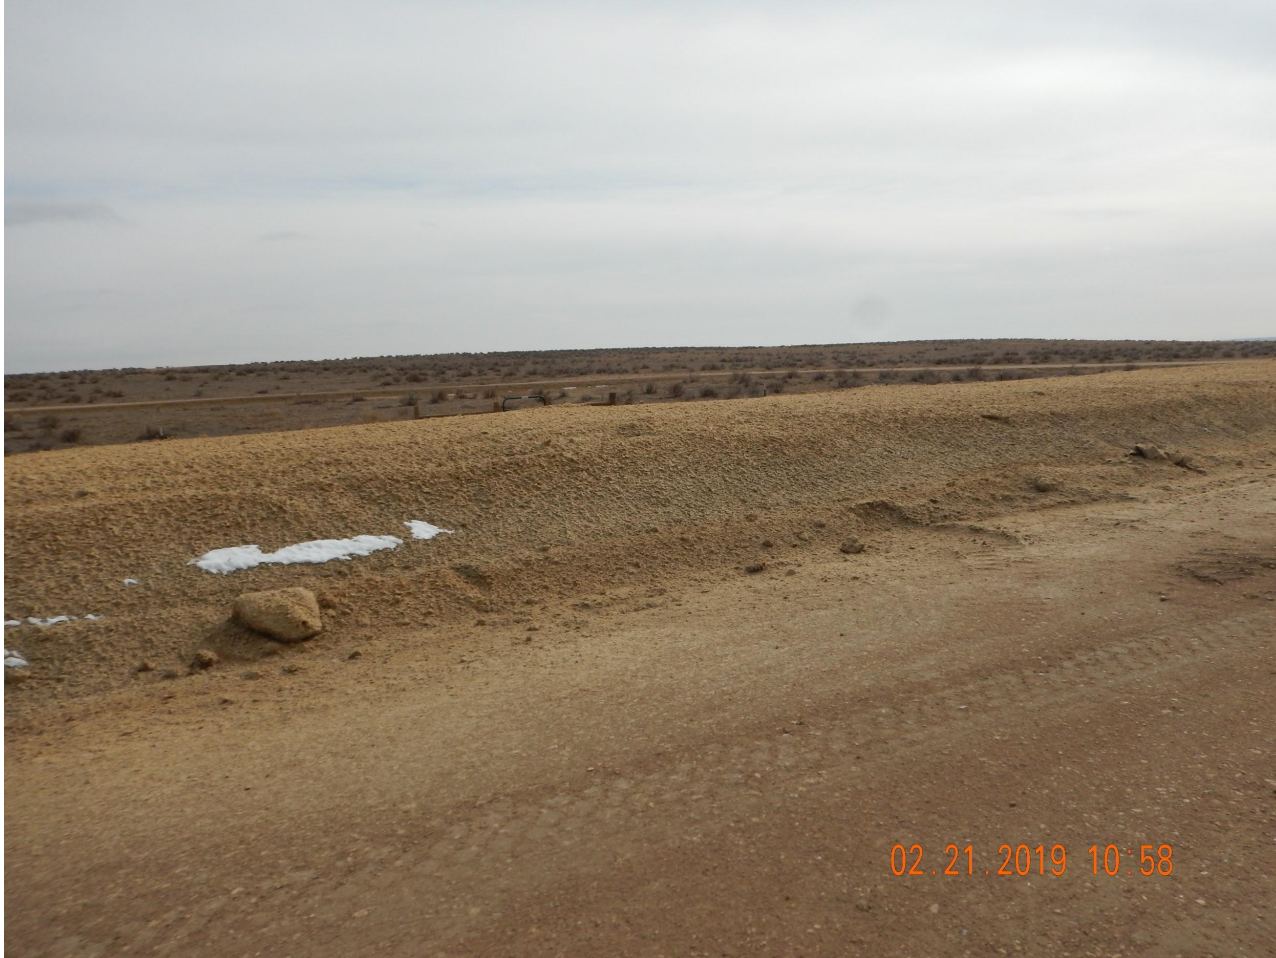
Photo 4. Photo taken from the eastern well pad, facing East. See comments under Photo 1.

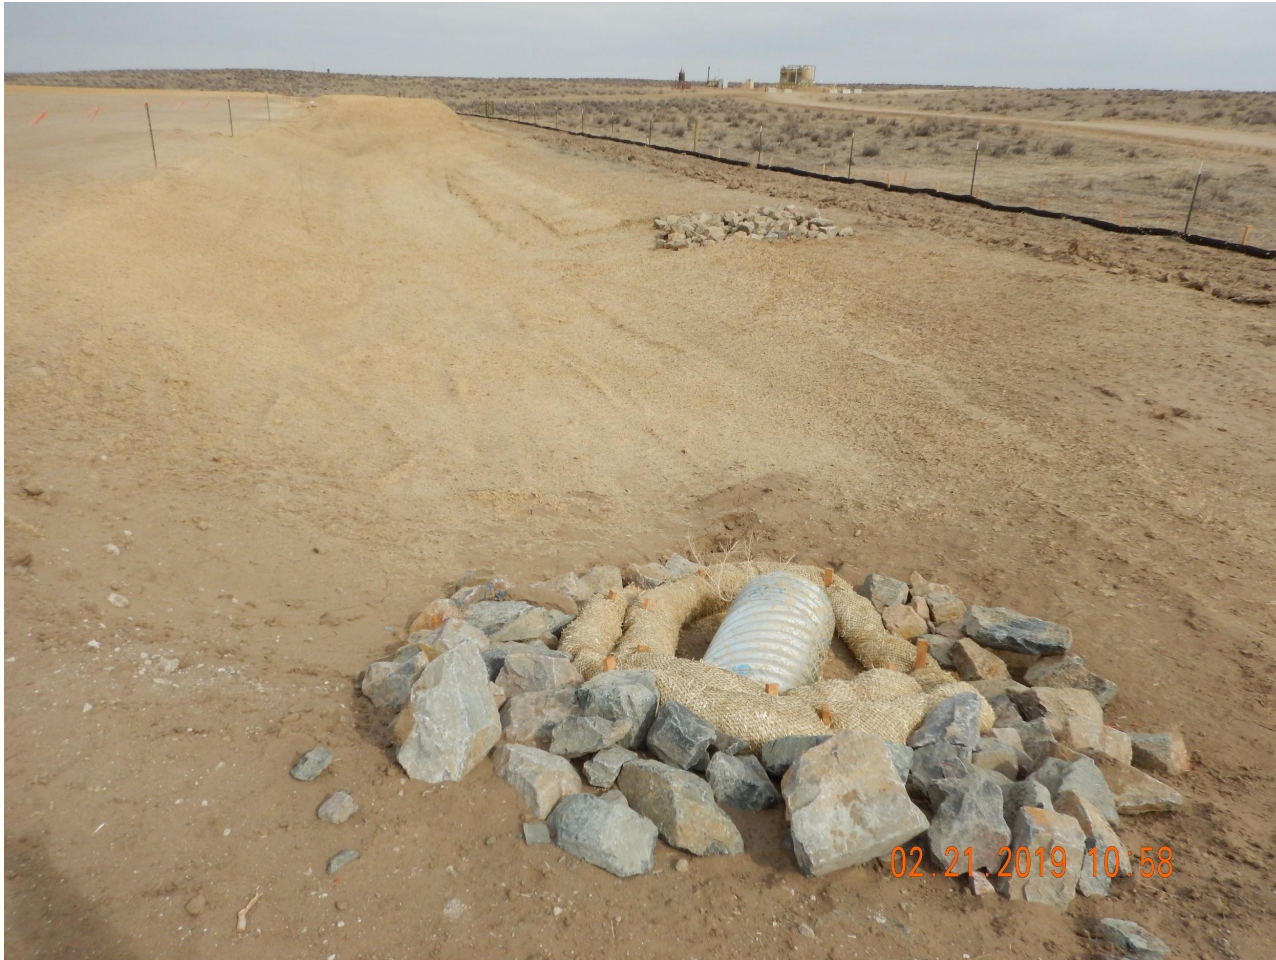
Photo 5. Photo taken from the southeastern well pad, facing North. Photo illustrates a retention area with a stabilized outlet. Hydromulch has also been applied within the retention area.

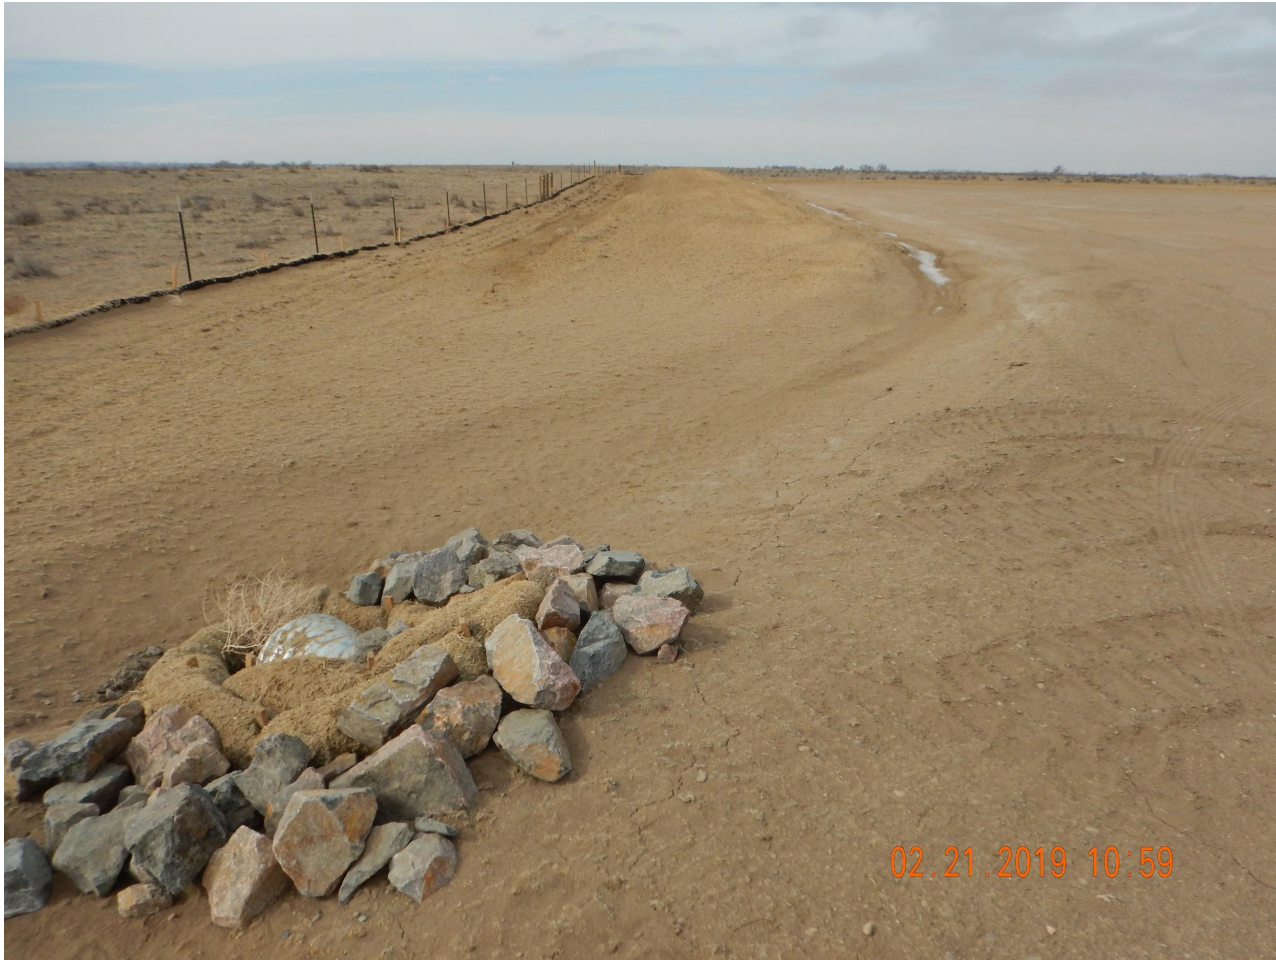
Photo 6. Photo taken from the southeastern well pad, facing West. Photo illustrates the southern topsoil stockpile- see comments under Photo 1. Photo also illustrates the ditch and berm BMP with a stabilized inlet for the culvert which is directed to a retention area.
