# Construction and Storm Water Inspection

February 26, 2019

Operator: GREAT WESTERN OPERATING COMPANY LLC – 10110

Location ID: 452180

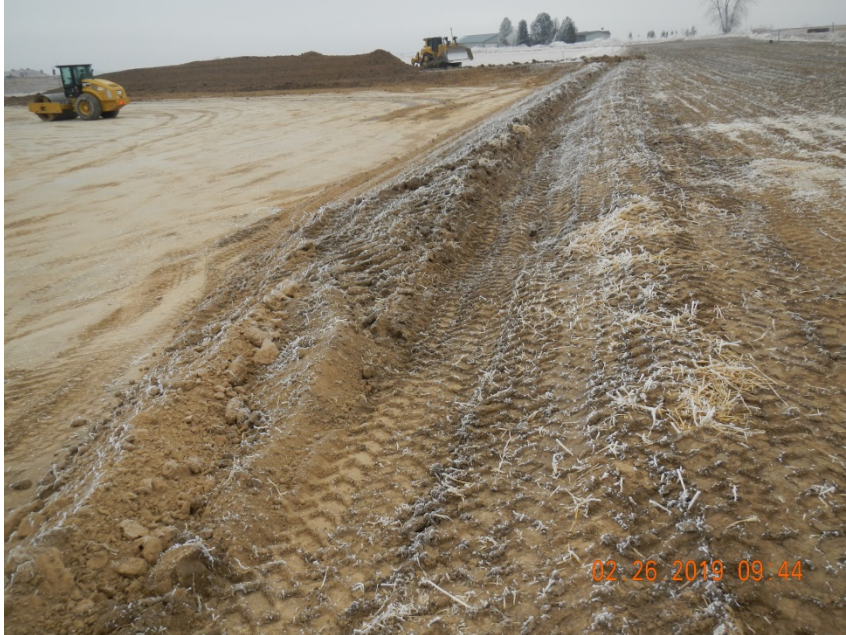
**Photo 1.** Photo taken from the northwestern perimeter of the location, facing South. Photo illustrates a compacted BMP that has been installed around the perimeter of the location.

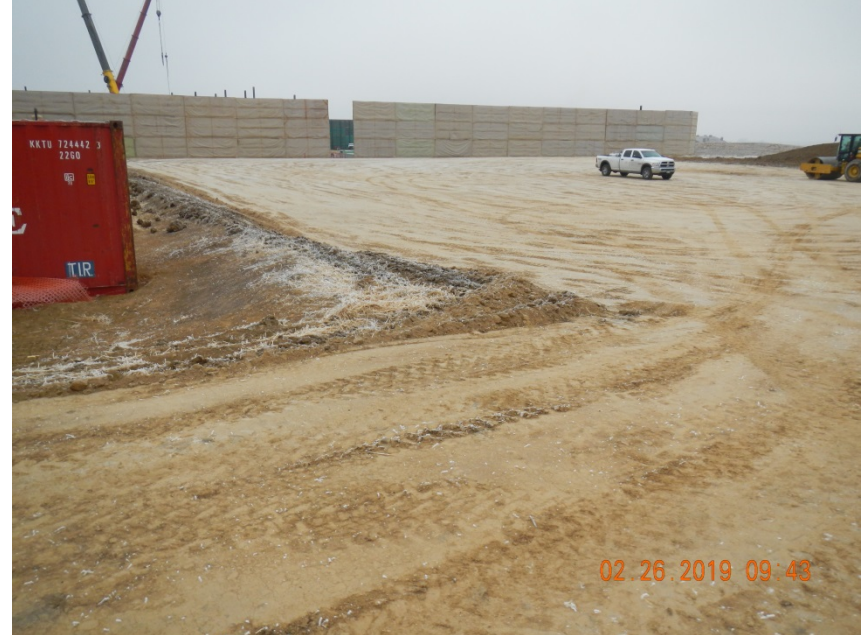
**Photo 2.** Photo taken from the northwestern perimeter of the location, facing East. See comments from Photo 1.

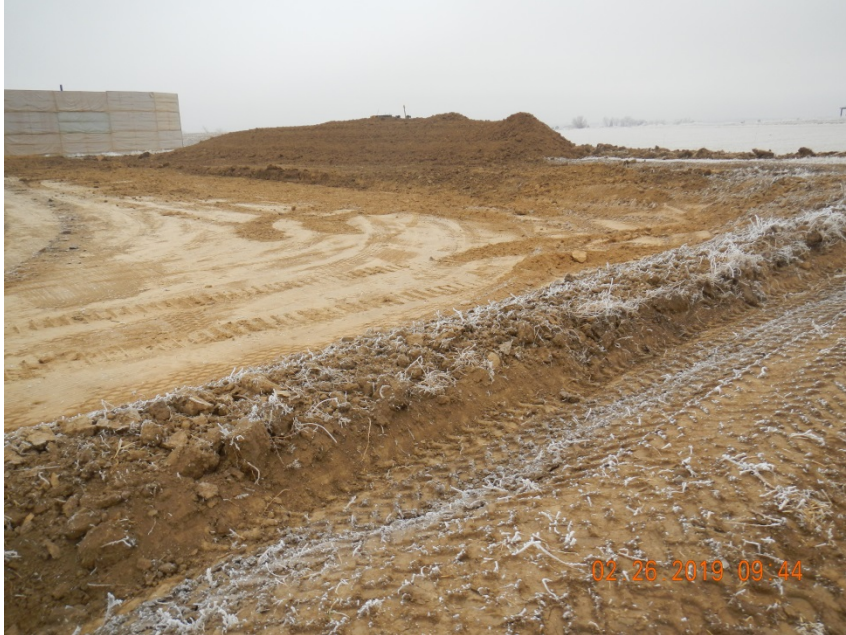
**Photo 3.** Photo taken from the western perimeter of the location, facing Southeast. Photo illustrates the topsoil stockpile being stored along the southern area.

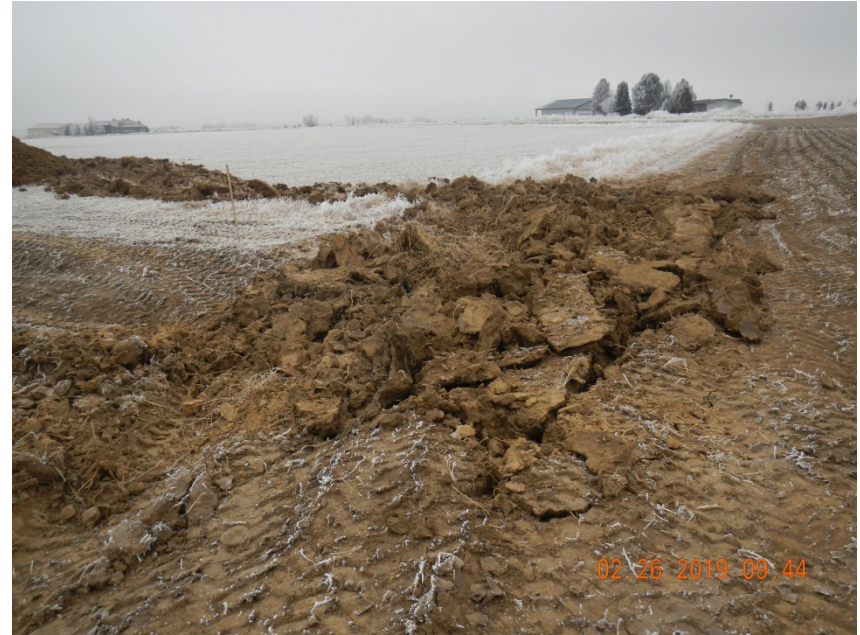
**Photo 4.** Photo taken from the southwestern perimeter of the location, facing South. A ditch and berm BMP was being installed around the topsoil pile at the time of the inspection and have not been completed due to lack of compaction and has not been installed with best engineering practices. However this should have been complete at the time of inspection because major dirt work activities had already been completed.

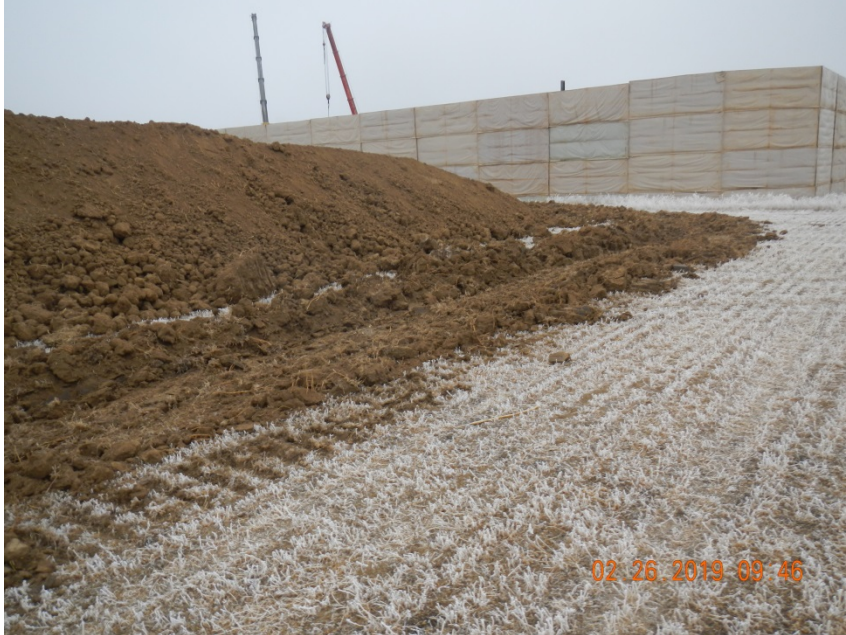
**Photo 5.** Photo taken from the southern perimeter of the location, facing East. Photo illustrates the topsoil stockpile being stored along the southern area is not stabilized . See comments from Photo 4.

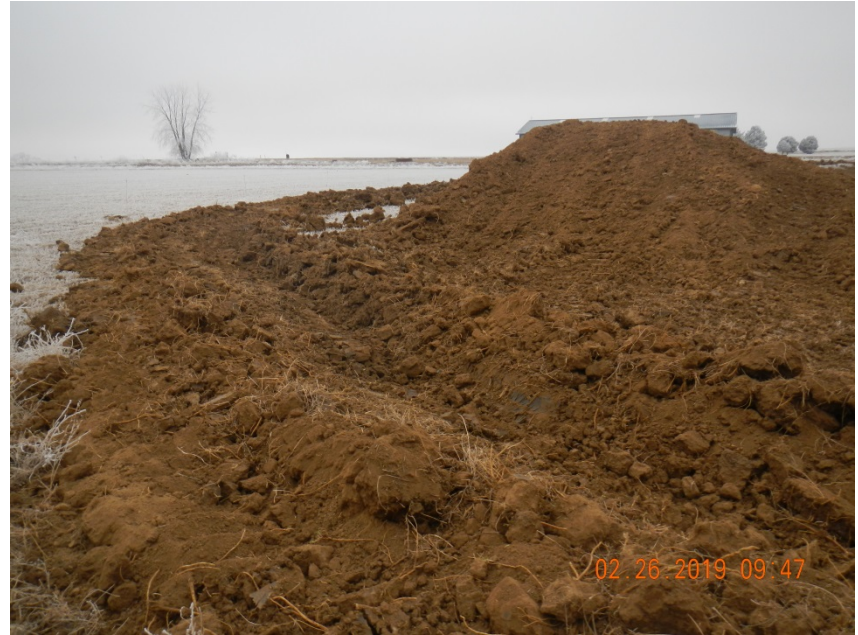
**Photo 6.** Photo taken from the southeastern perimeter of the location, facing West. See comments from Photos 4 and 5.

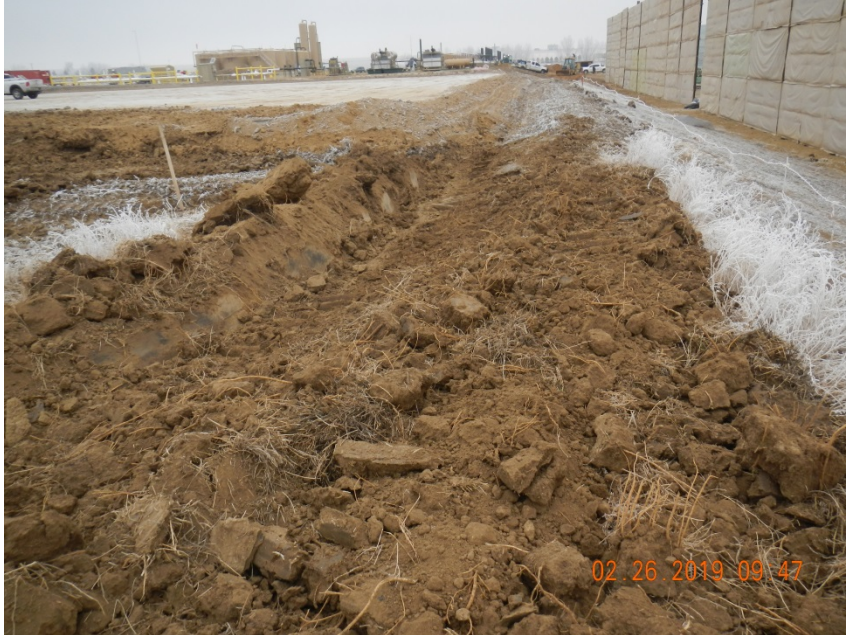
**Photo 7.** Photo taken from the southeastern perimeter of the location, facing North. See comments from Photo 4.

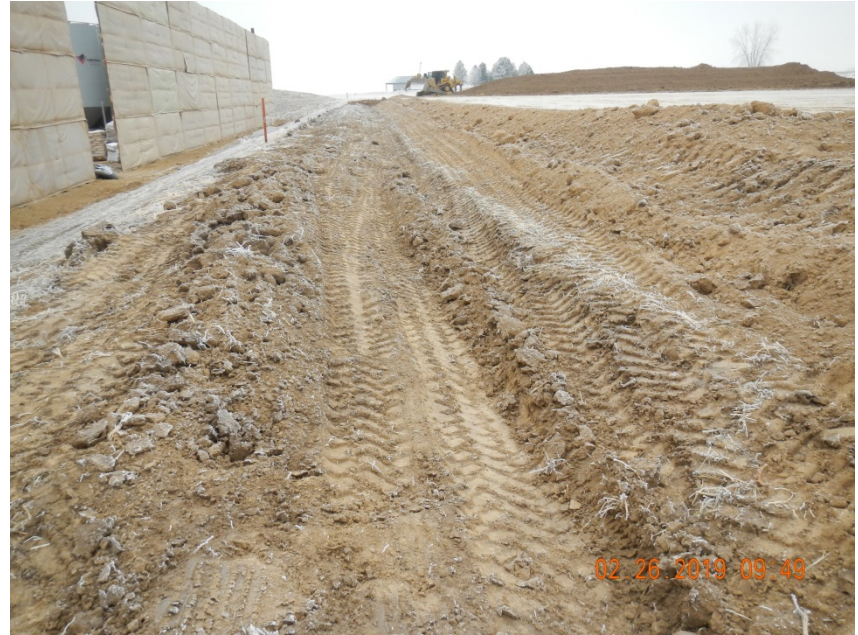
**Photo 8.** Photo taken from the northeastern perimeter of the location, facing South. See comments from Photo 1.
