Construction and Storm Water Inspection

March 1, 2019

Operator: NGL WATER SOLUTIONS DJ LLC - 10373

Location Name: NGL WATER SOLUTIONS DJ LLC – 10373/1N66W30

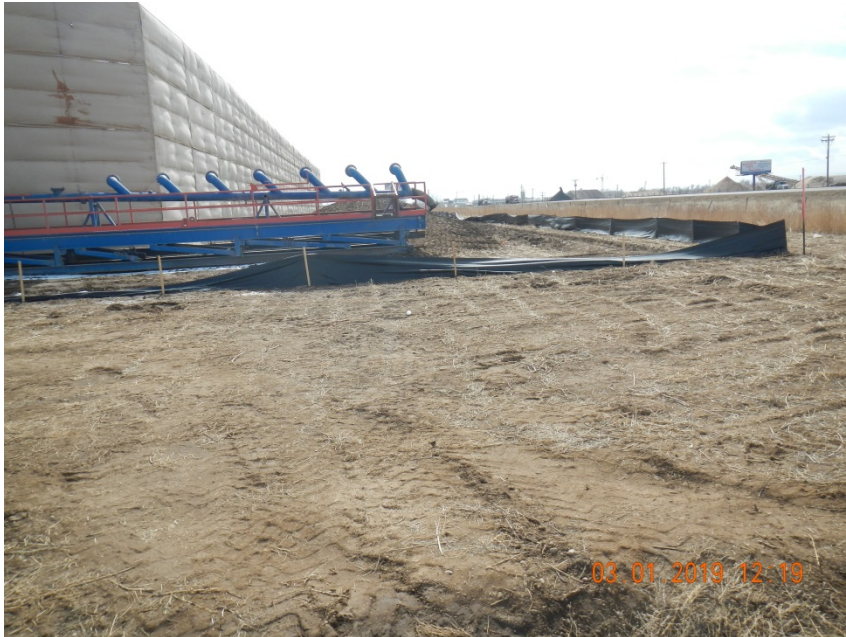
Photo 1. Photo taken from the northwestern perimeter of the location, facing South. Photo illustrates the installed silt fence BMP is not in proper functioning condition.

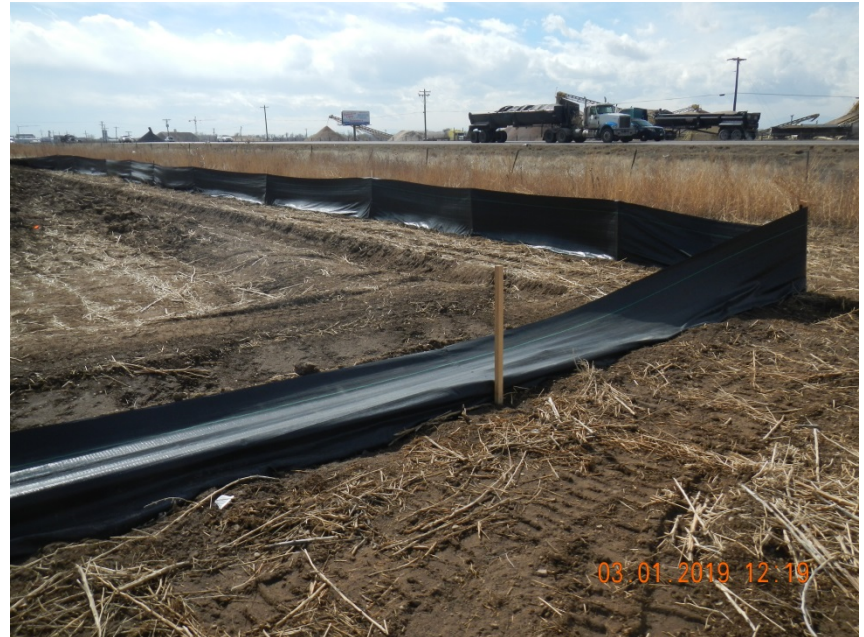
Photo 2. Photo taken from the northwestern perimeter of the location, facing Southeast. See comments from Photo 1. There is also a ditch and berm BMP installed around the perimeter. However there are no sediment traps with stabilized outlets observed on location at the time of inspection.

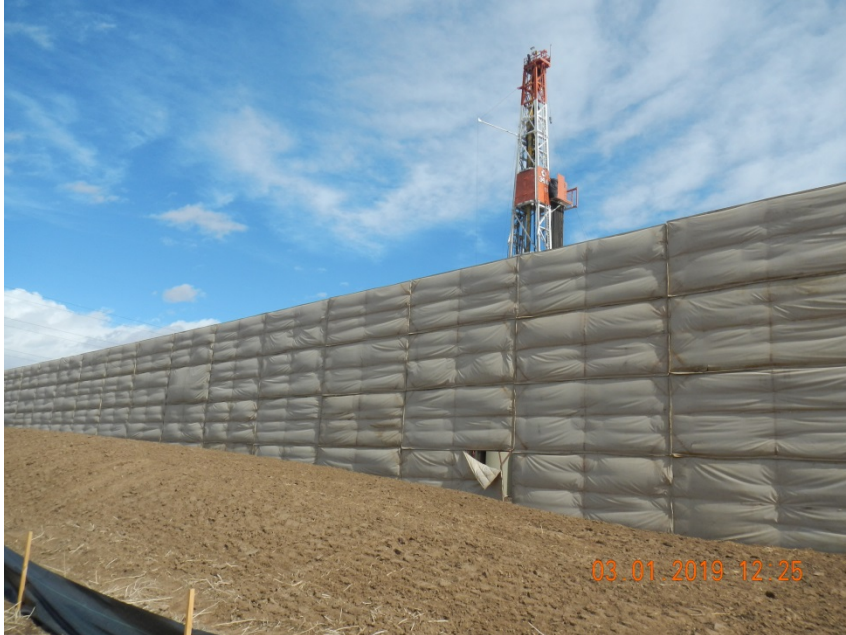
Photo 3. Photo taken from the western perimeter of the location, facing Northeast. Photo depicts the drilling rig is on location and no sediment traps with stabilized outlets were observed on location at the time of inspection.

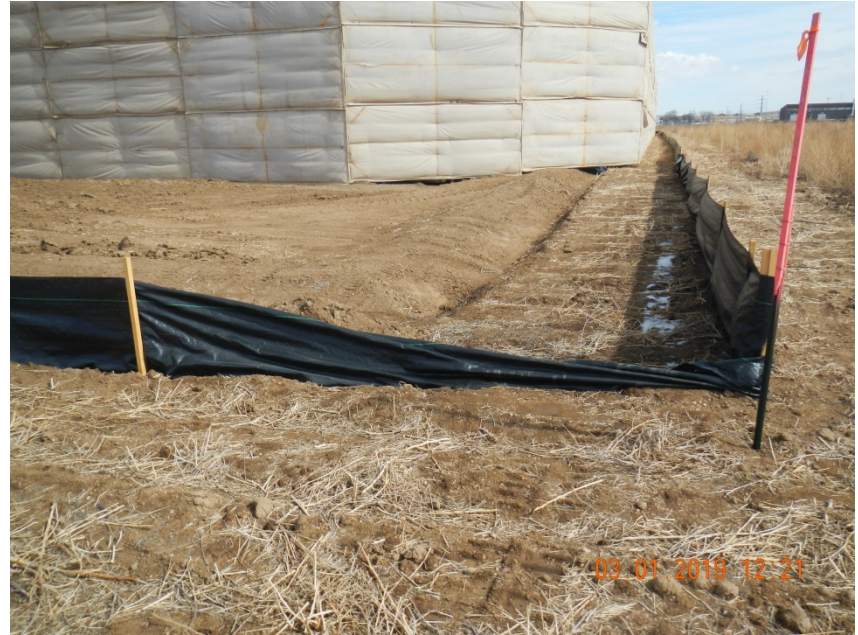
Photo 4. Photo taken from the southwestern perimeter of the location, facing East. See comments from Photos 1 and 2.

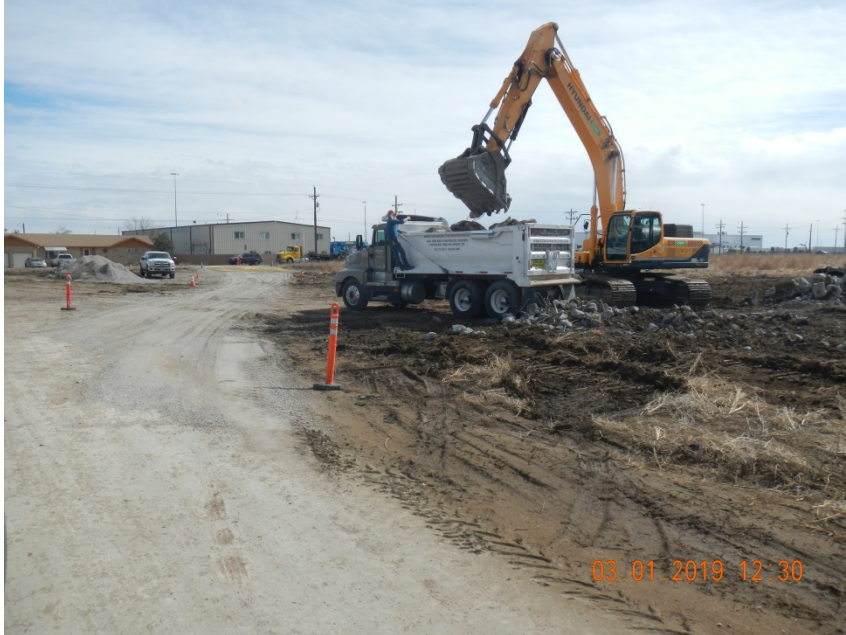
Photo 5. Photo taken from the access road off CR 27, facing Southeast. The access road has been rerouted to the south due to an apparent culvert failure on the previous access road entrance.

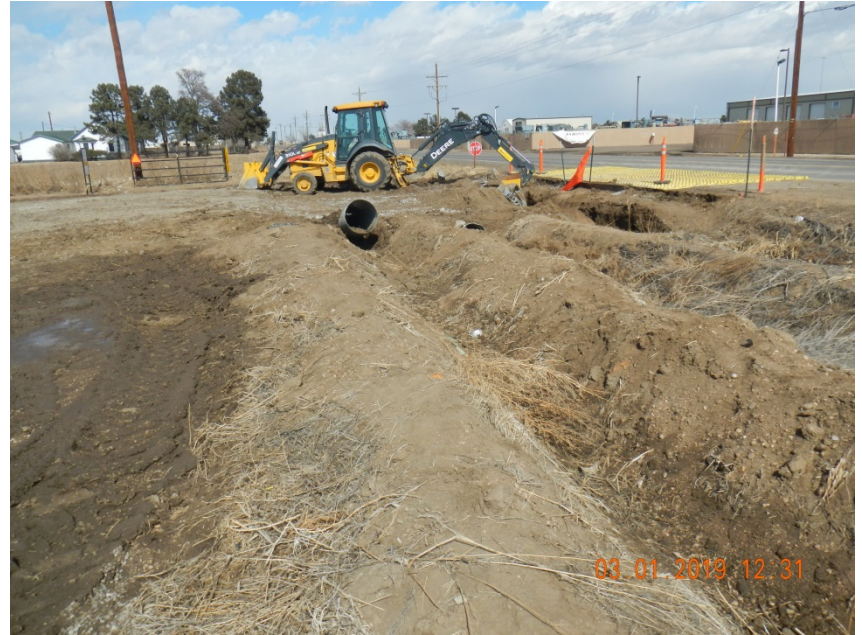
Photo 6. Photo taken from the access road off CR 27 looking into where the original entrance was, facing North. See comments from Photo 5.

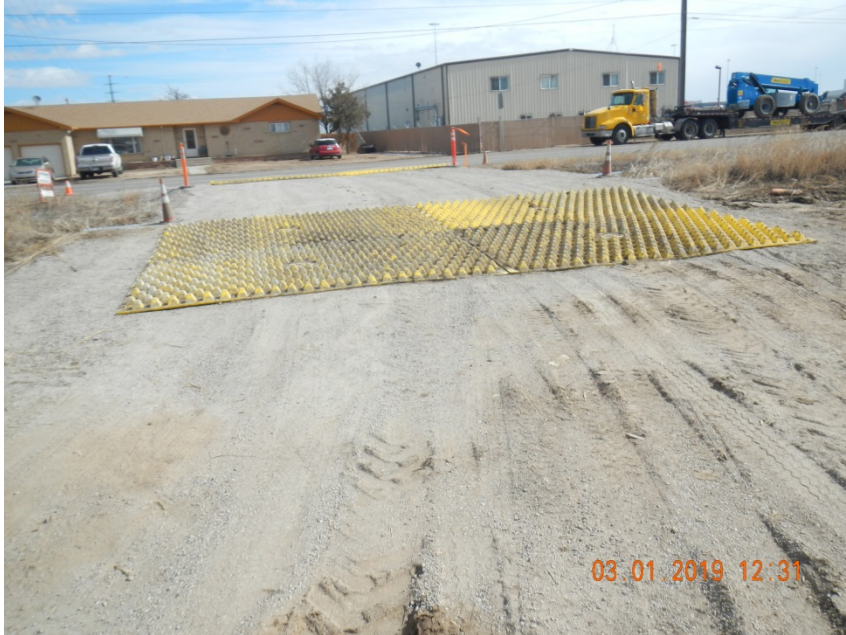
Photo 7. Photo taken from the access road off CR 27, facing East. Appears Operator has installed tracking pads and gravel to potentially limit tracking onto the county road.

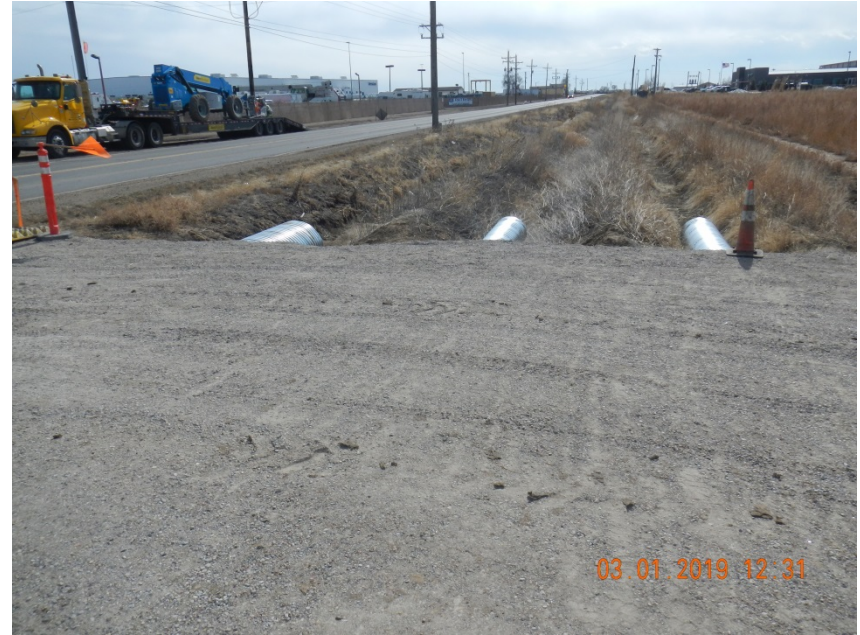
Photo 8. Photo taken from the access road off CR 27, facing South. Photo depicts the three new culverts installed.
