# Construction and Stormwater Inspection

Operator: ENERPLUS RESOURCES (USA) CORPORATION - #10177

Location ID: 461838

Inspection Photos  
Location Name: Colorado Rivers Pad  
Location ID: 461838

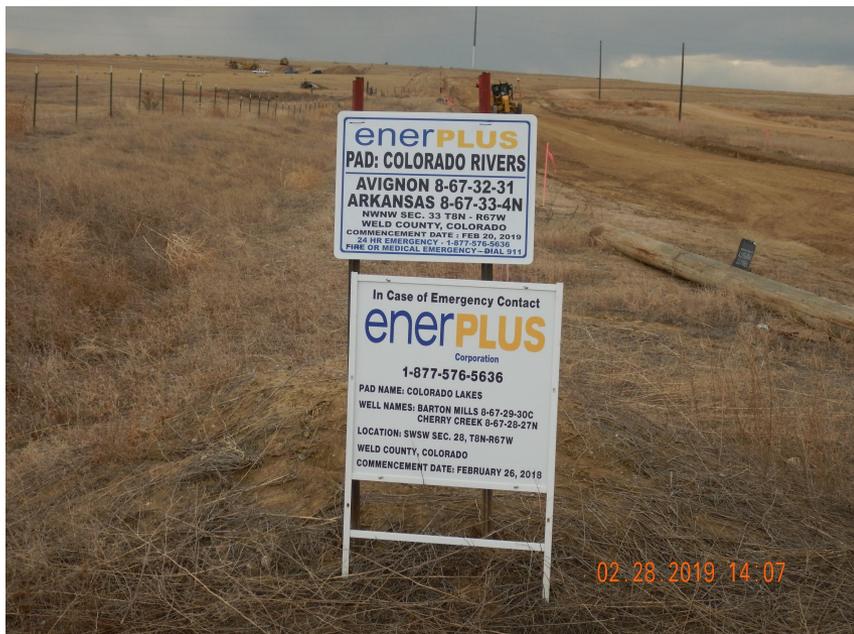
**Photo 1.** Photo taken from the entrance of location, facing West. Photo illustrates Operator sign.

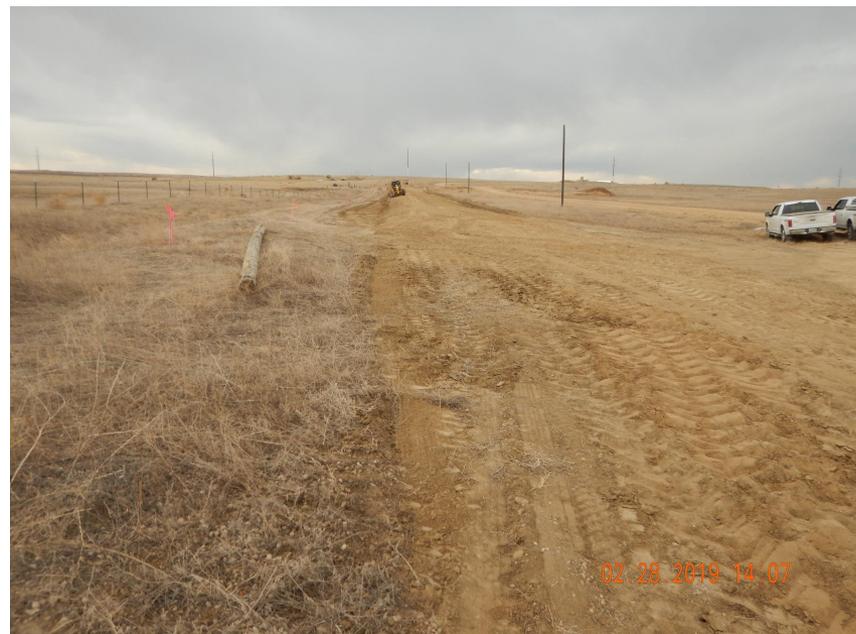
**Photo 2.** Photo taken from the entrance of location, facing West. Photo illustrates access road in-process of being constructed. Operator salvaged and stored topsoil from the access.

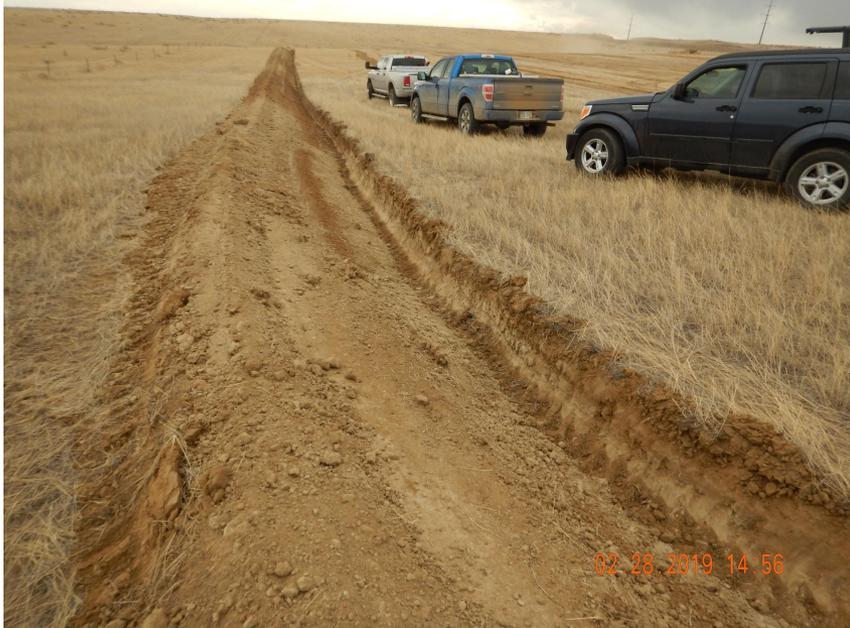
**Photo 3.** Photo taken from the northeastern perimeter of location, facing South. Photo illustrates a ditch and berm BMP installed around the Location. Operator shall stabilize the berm BMP, as an unconsolidated berm BMP is not a proper functioning BMP. Operator indicated that the berm would be stabilized the day of this inspection.

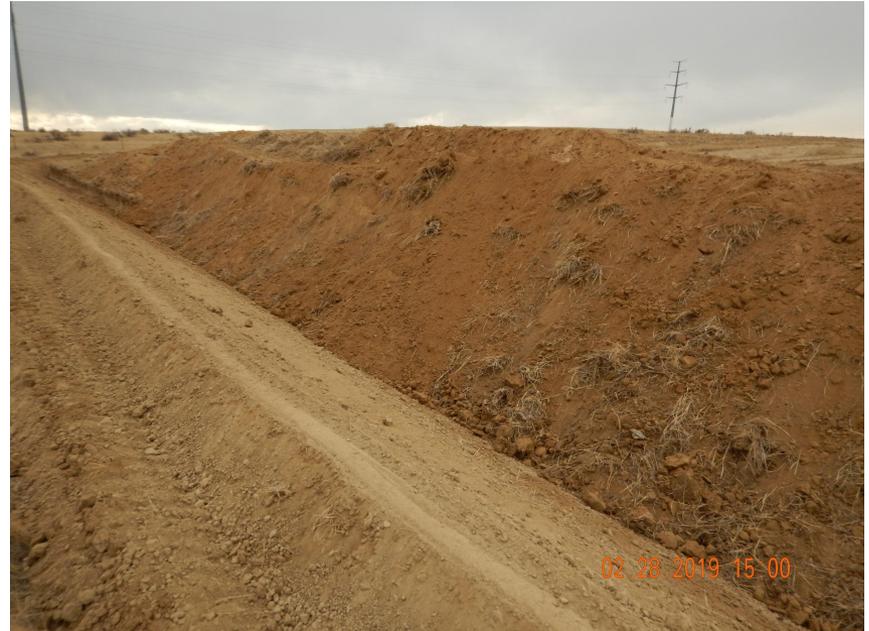
**Photo 4.** Photo taken from the southern perimeter of location, facing West. Photo illustrates topsoil from the Location.

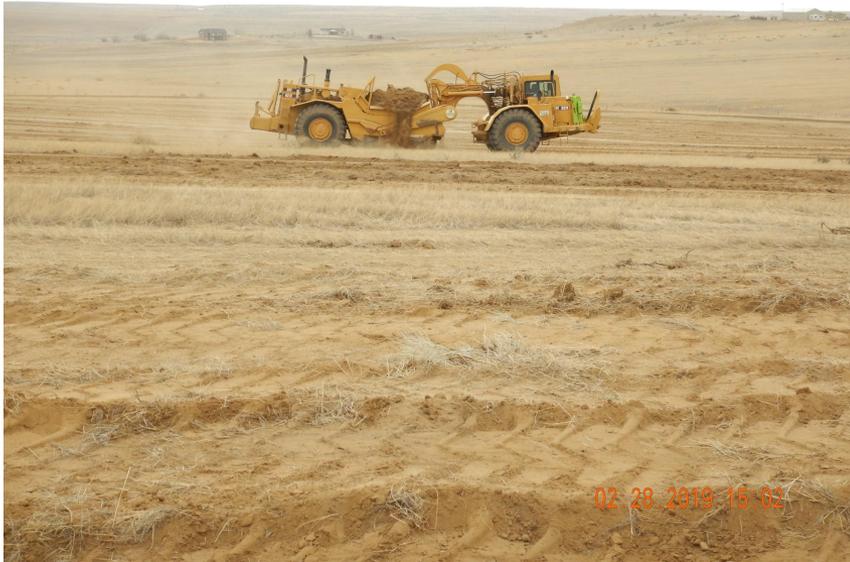
**Photo 5.** Photo taken from the western perimeter of the location, facing East. Photo illustrates Operator in-process of salvaging topsoil.

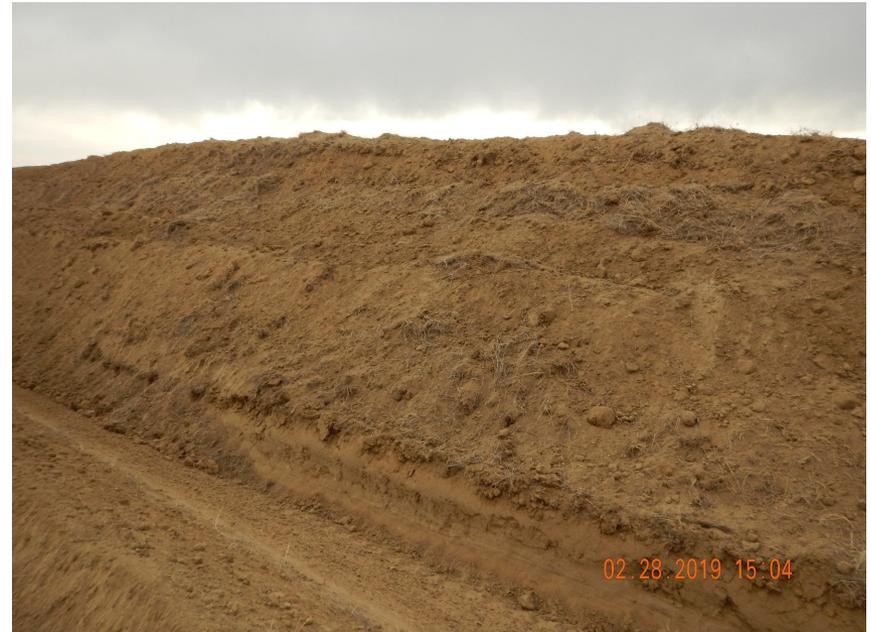
**Photo 6.** Photo taken from the northern perimeter of location, facing East. Photo illustrates topsoil from the access road.
