Inspection Photos
Location Name: Ludwig #3
Facility ID: 444255

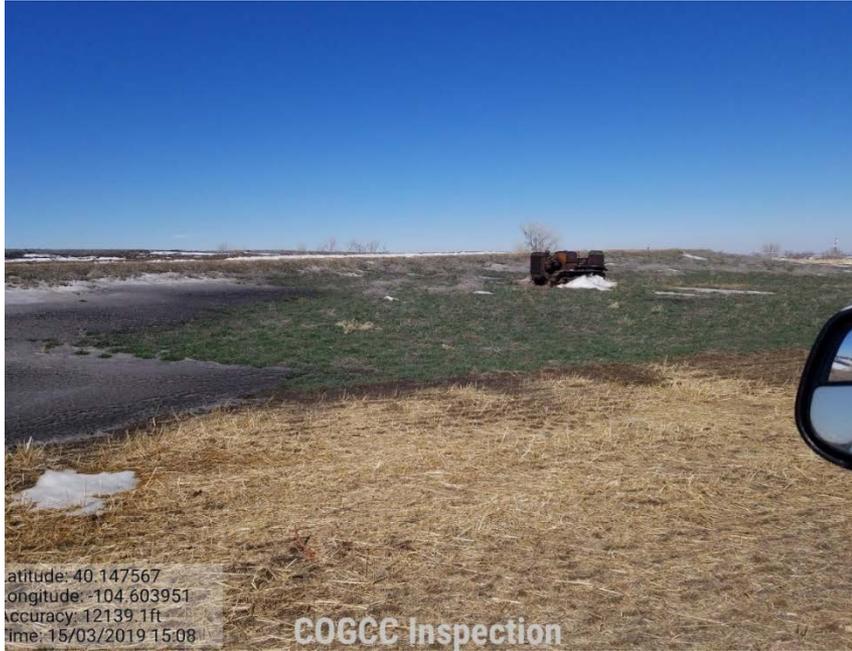
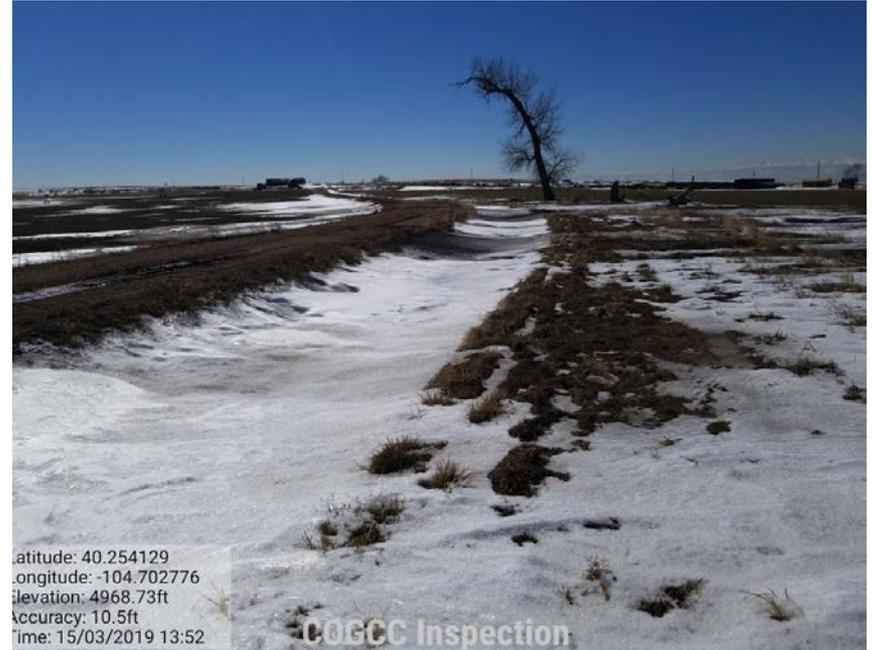
Photo 1 & 2 – Windblown dust from cuttings directly south of facility on adjacent neighbors property- areas of accumulation extend up to 1,000 feet into field. Full impacts to be defined upon snow melt to minimize damage to crops.

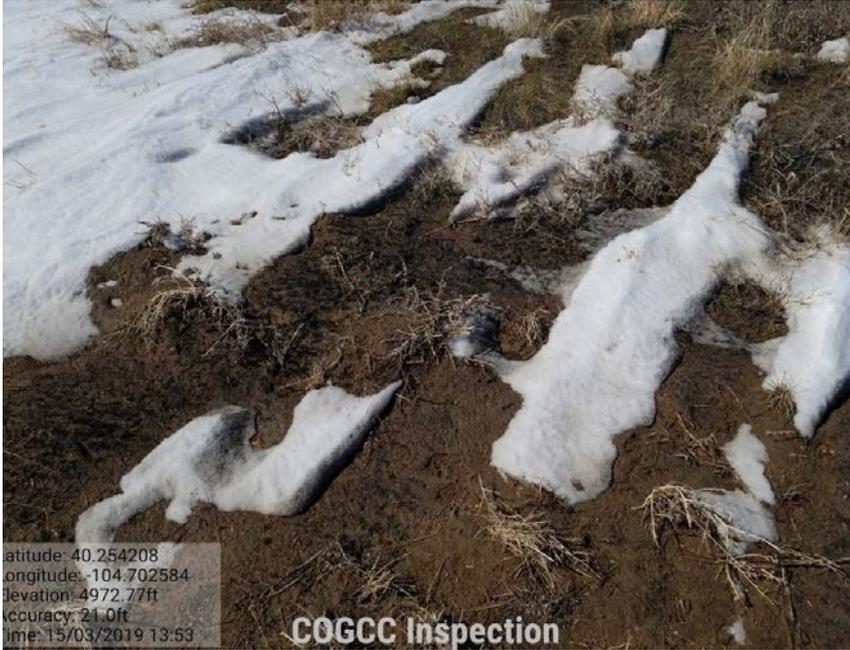
Photo 3 – Windblown dust in area where snow has melted.

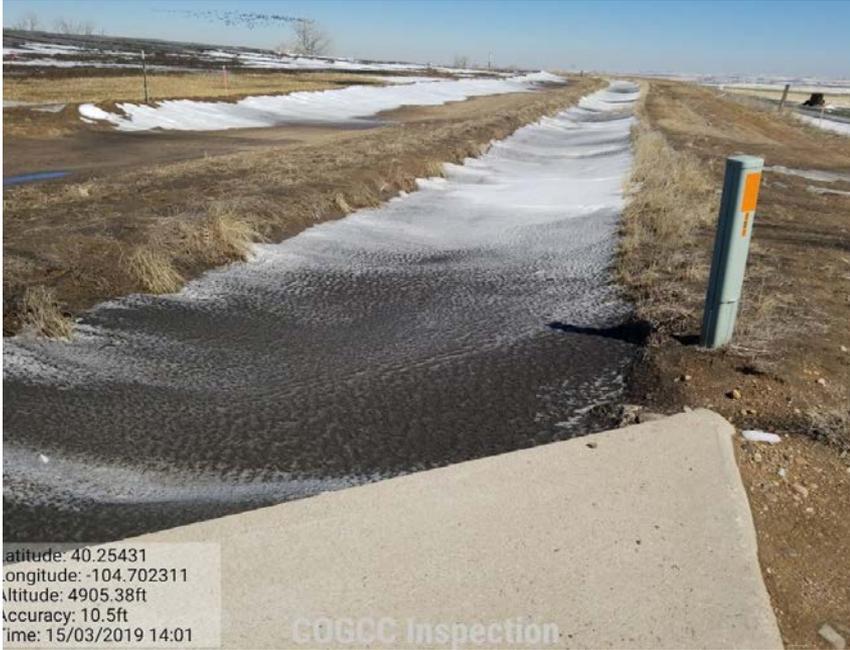
Photo 5 – Windblown dust on ice in the Spear Canal (canal not flowing). Spill cleanup pending permission from owners of canal.
