Construction and Stormwater Inspection

March 15, 2019

Operator: CCRP OPERATING INC- 10665

Location ID: 454351

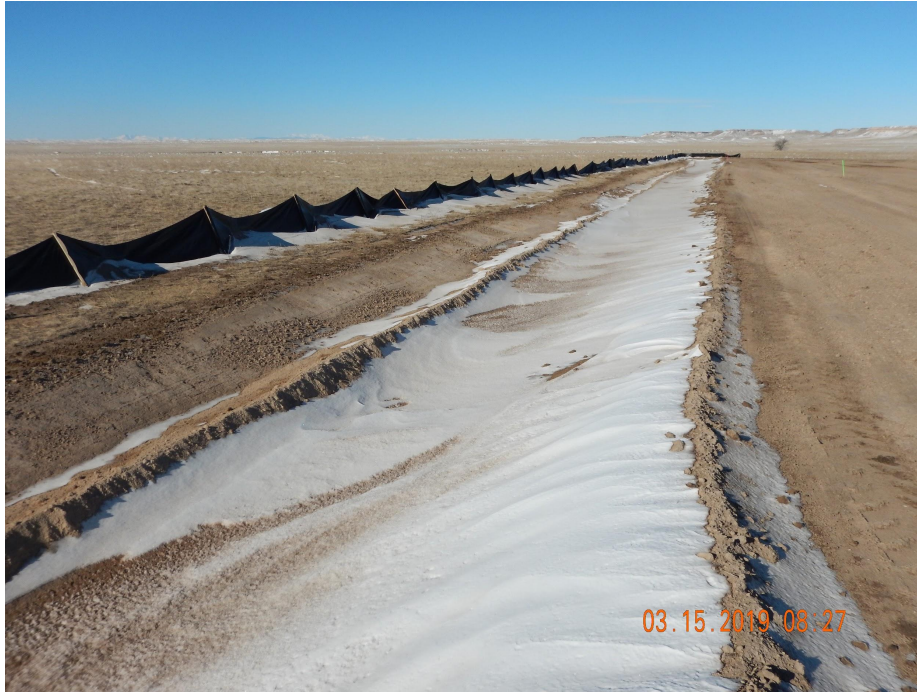
Photo 1. Photo taken from the southern location, facing West. Operator has installed a ditch around the perimeter of the location and has installed a silt fence BMP around portions of the location. Silt fence BMP is in need of maintenance from the recent storm on March 13th. Operator representative on location indicated that repairs were already on order.

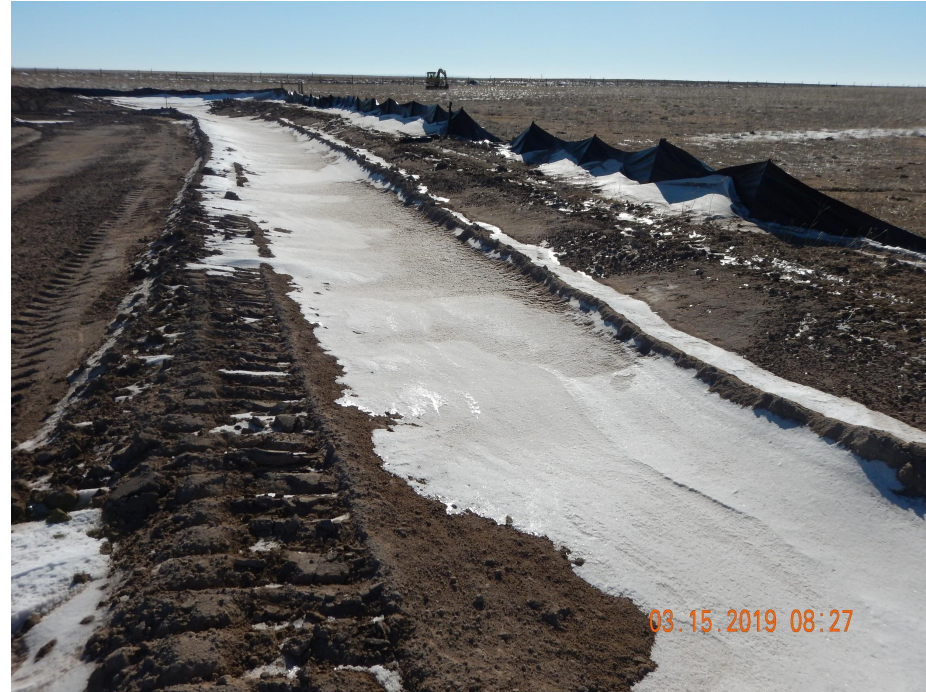
Photo 2. Photo taken from the southern location, facing East. See comments under Photo 1.

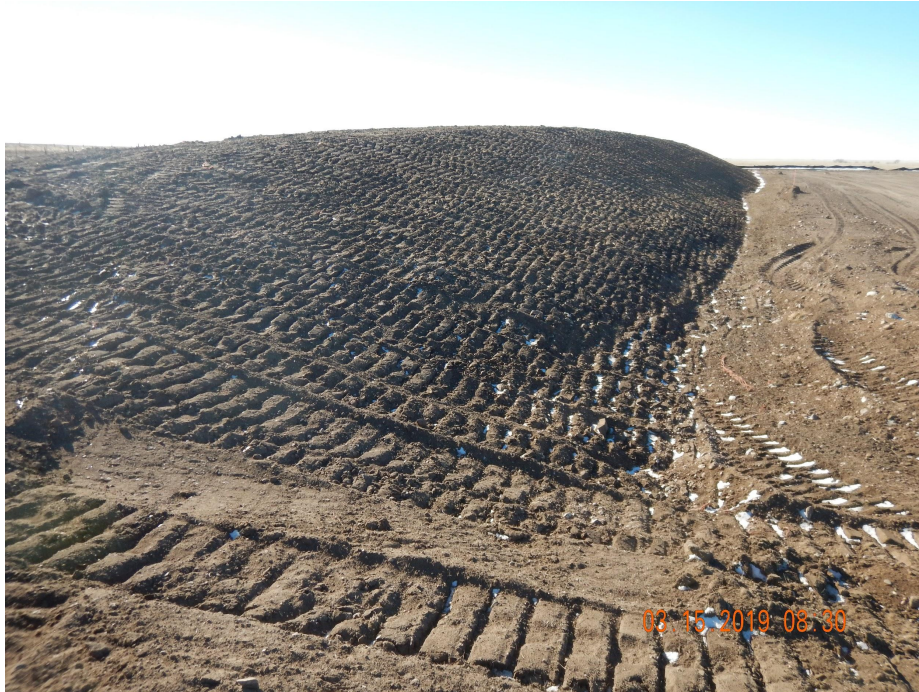
Photo 3. Photo taken from the northeastern location, facing South. Photo illustrates the topsoil stockpile which has been temporarily stabilized with equipment tracking.

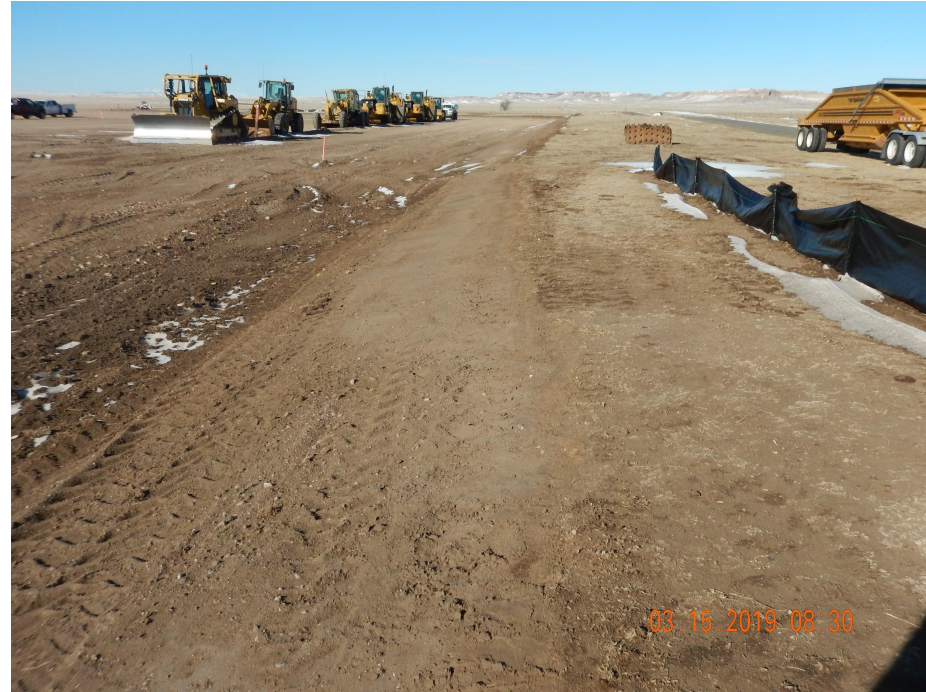
Photo 4. Photo taken from the northeastern location, facing West. See comments under Photo 1.

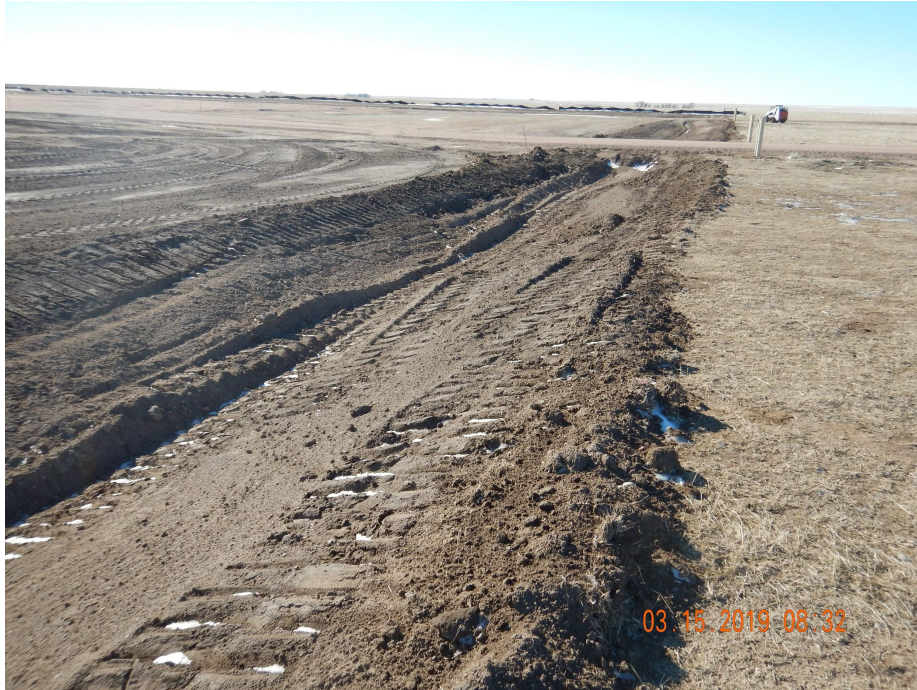
Photo 5. Photo taken from the northwestern location, facing South. See comments under Photo 1.

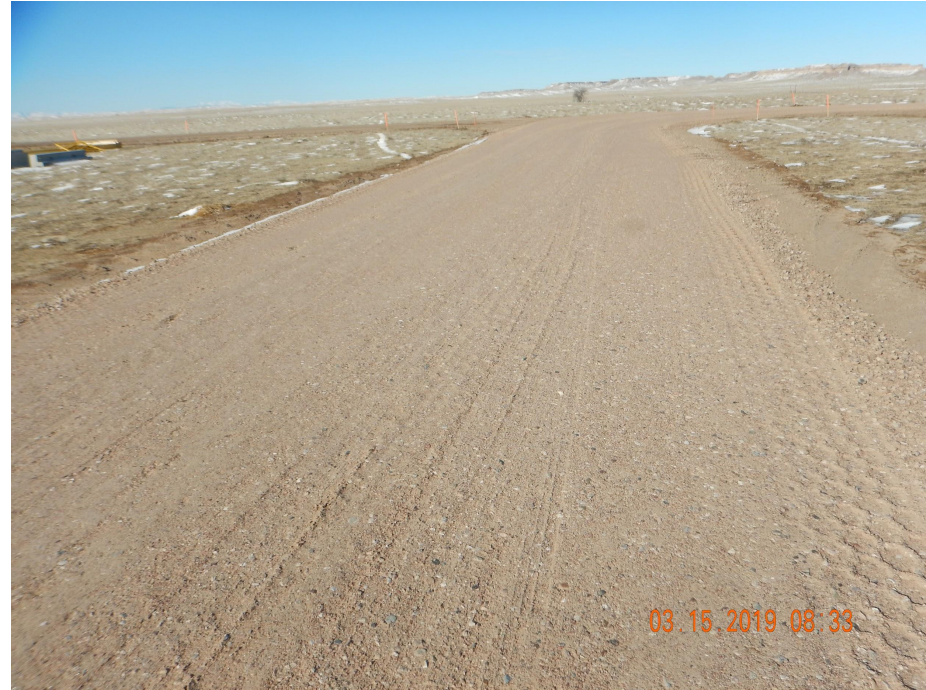
Photo 6. Photo taken from the western location along the northern access road, facing West. Operator has stabilized the access road with gravel.

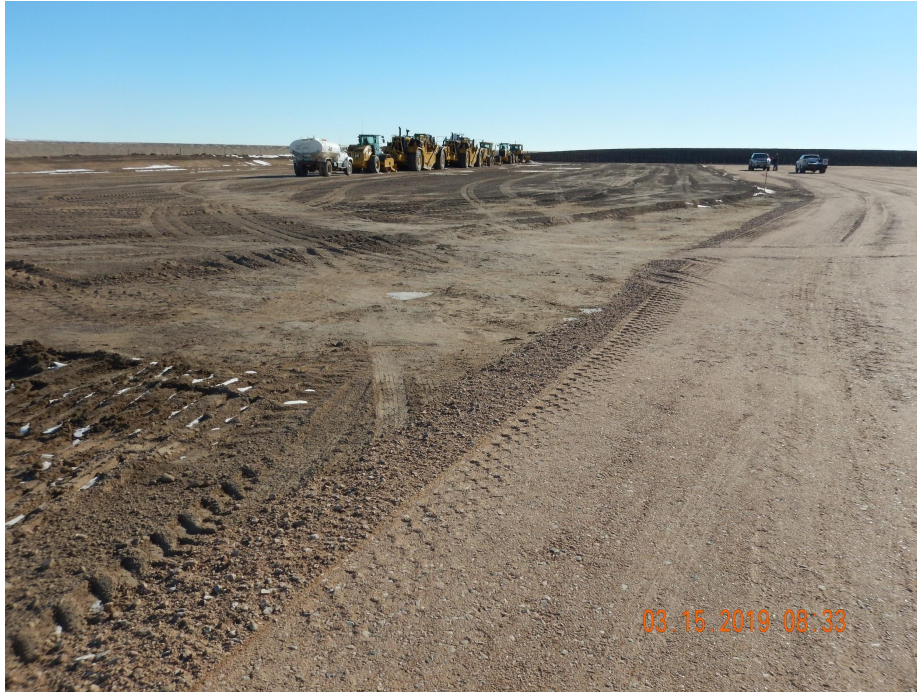
Photo 7. Photo taken from the western location, facing East. Operator is in-process of stabilized the well pad with gravel.

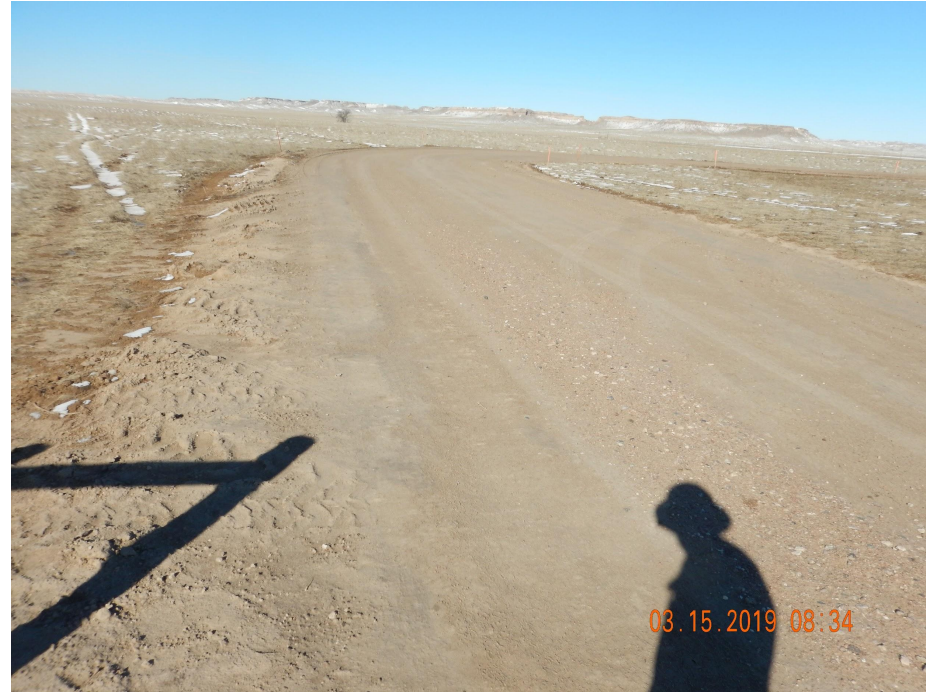
Photo 8. Photo taken from the western location along the northern access road, facing West. Operator plans to install gravel along all access road.
