# Final Reclamation and Stormwater Inspection

Operator: KERR MCGEE OIL & GAS # 47120

Location ID: 327691

Inspection Document #: 674902565

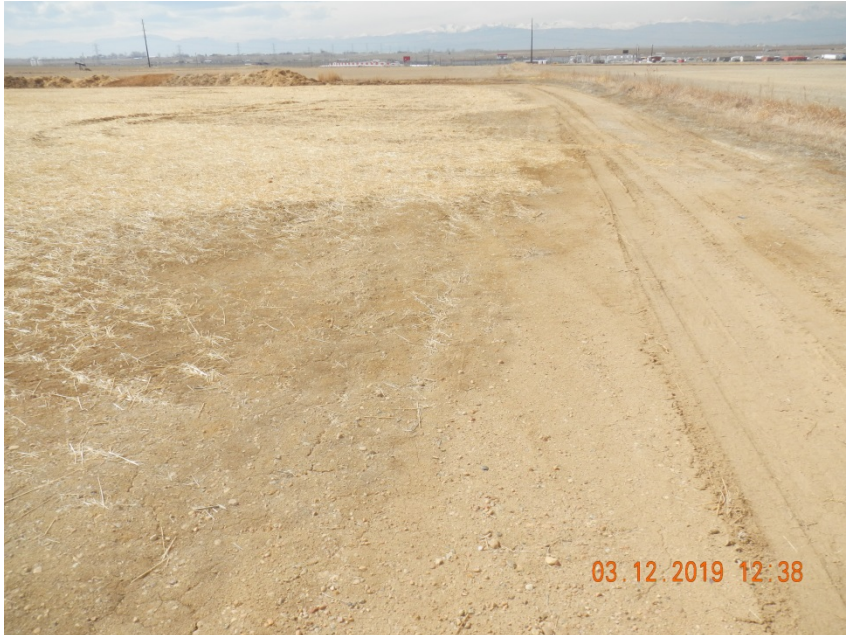
**Photo 1.** Photo taken from the access road looking into the location, facing West. Appears the access road is routinely used. Appears Operator has recently performed final reclamation activities with the evidence of drill rows and straw crimped mulch.

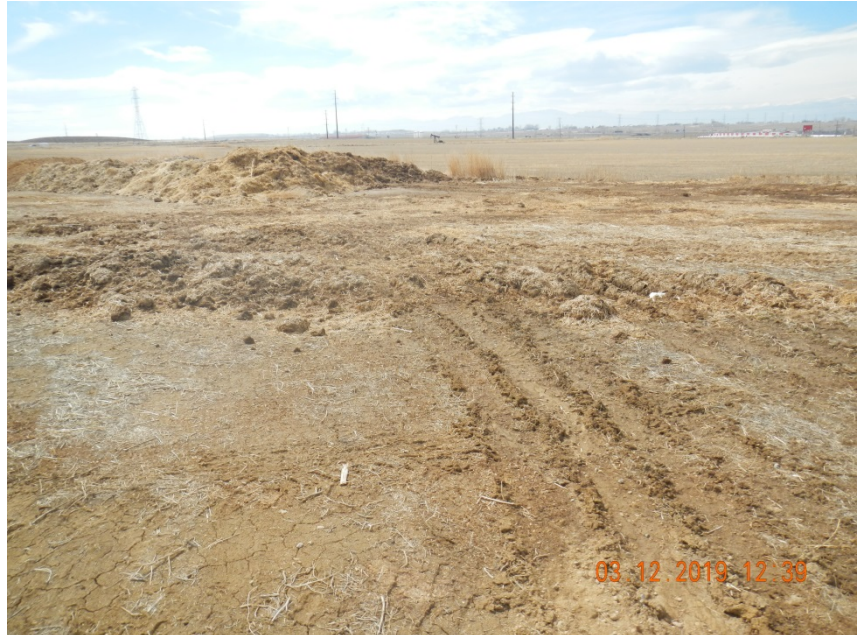
**Photo 2.** Photo taken from the location, facing Southwest. Photo depicts debris piles being stored on location potentially by the landowner.

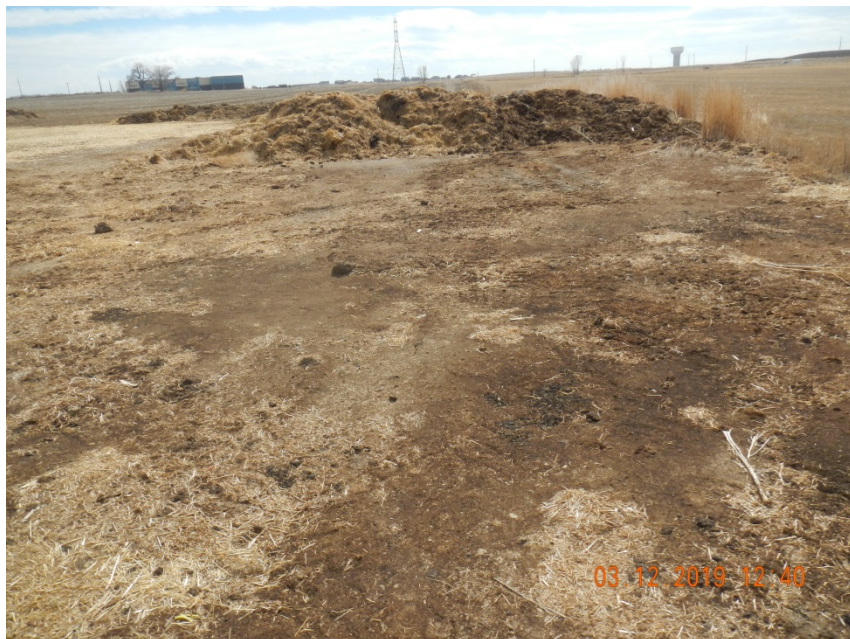
**Photo 3.** Photo taken from the location, facing South.  
See comments from Photo 2.

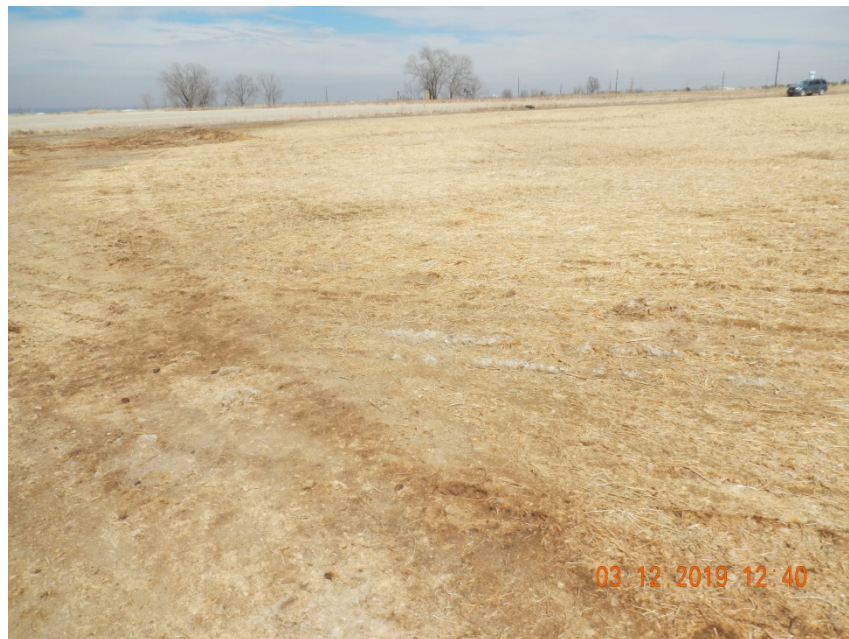
**Photo 4.** Photo taken from the well location, facing Northeast.  
See comments from Photo 1.

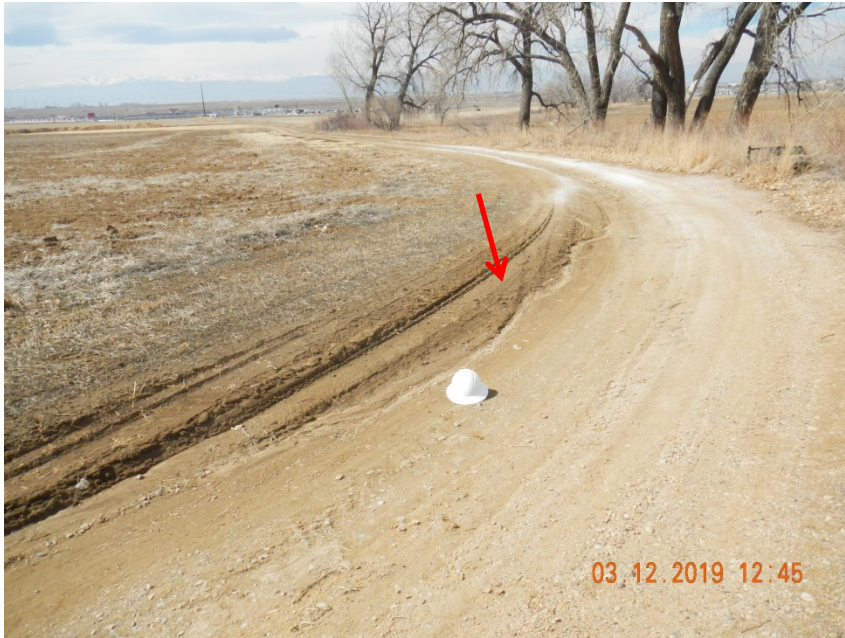
**Photo 5.** Photo taken from the access road, facing Northwest. Appears there is erosion along the west edge of the access road.

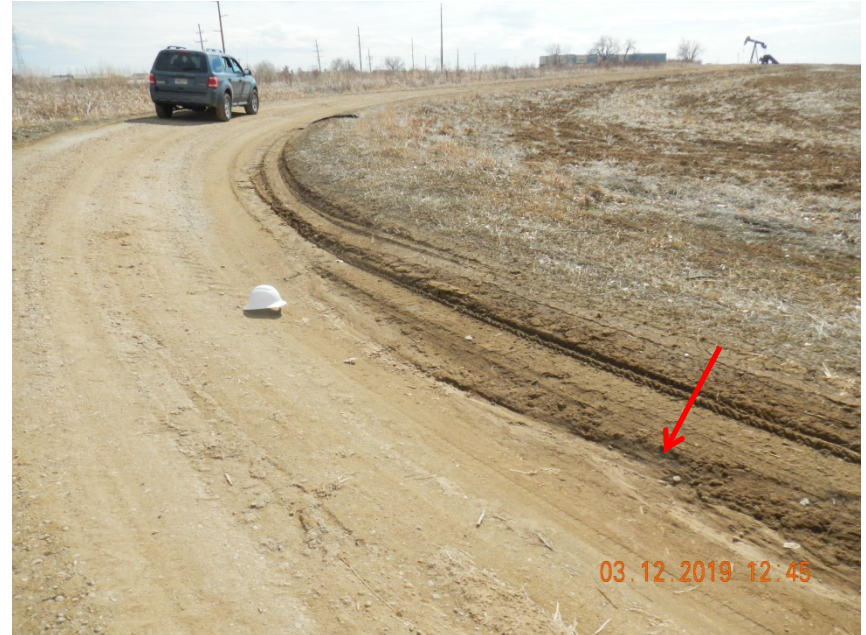
**Photo 6.** Photo taken from the access road, facing Southeast. See comments from Photo 5.
